**F. APPENDIX B**

## INSPECTION PROTOCOL

ESWNG-70032/02

**Subject:** Fin box and rudder inspection on aircraft A300-600, MSN 420 at NASA Langley Research Center in Hampton, Virginia / USA.

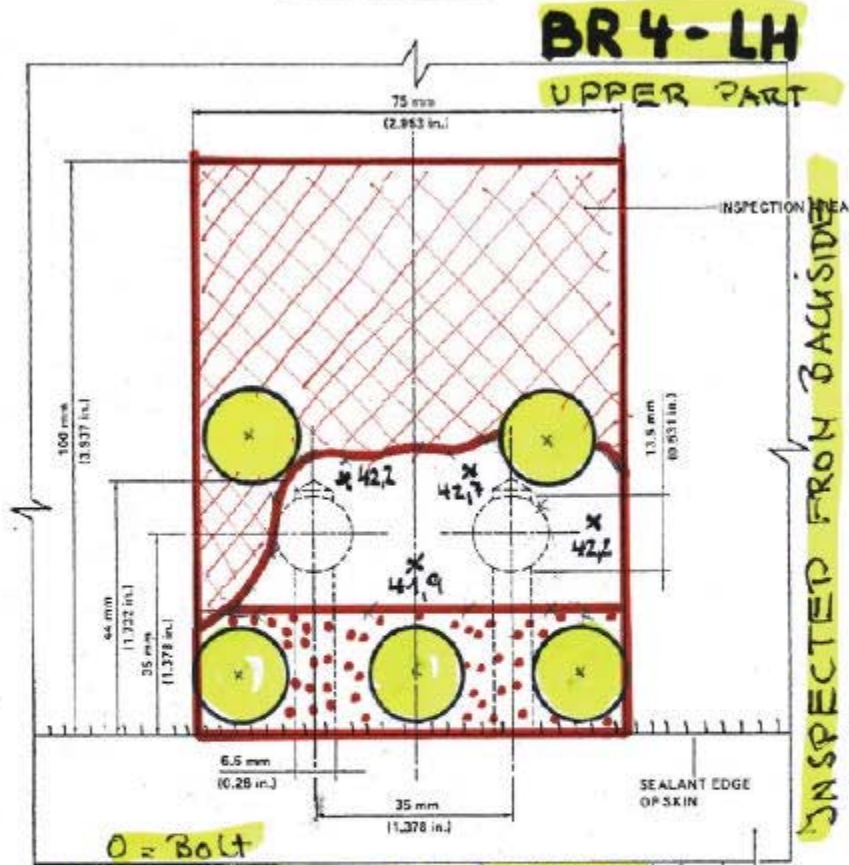
**DAMAGED AREA (NO BACKWALL ECHO)**

**Not inspectable (space between bolts)**

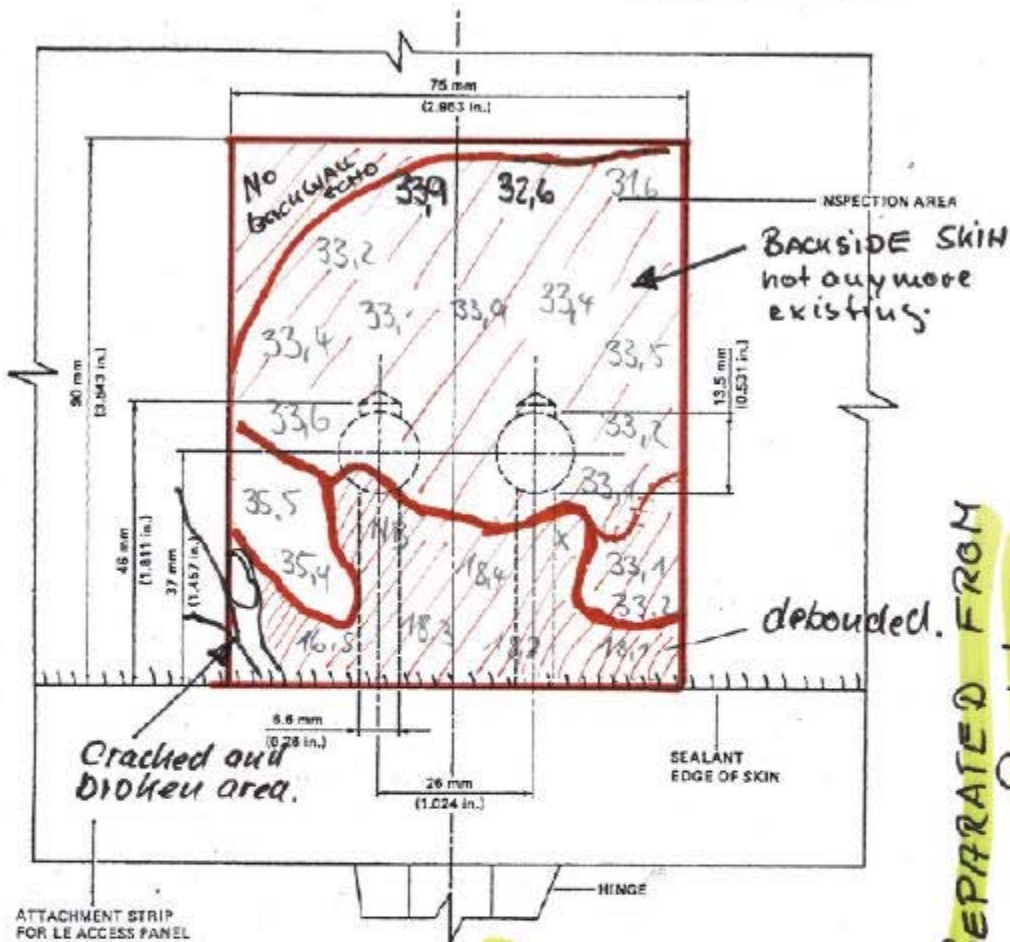
BR7-LH

SEPARATED FROM Rudder

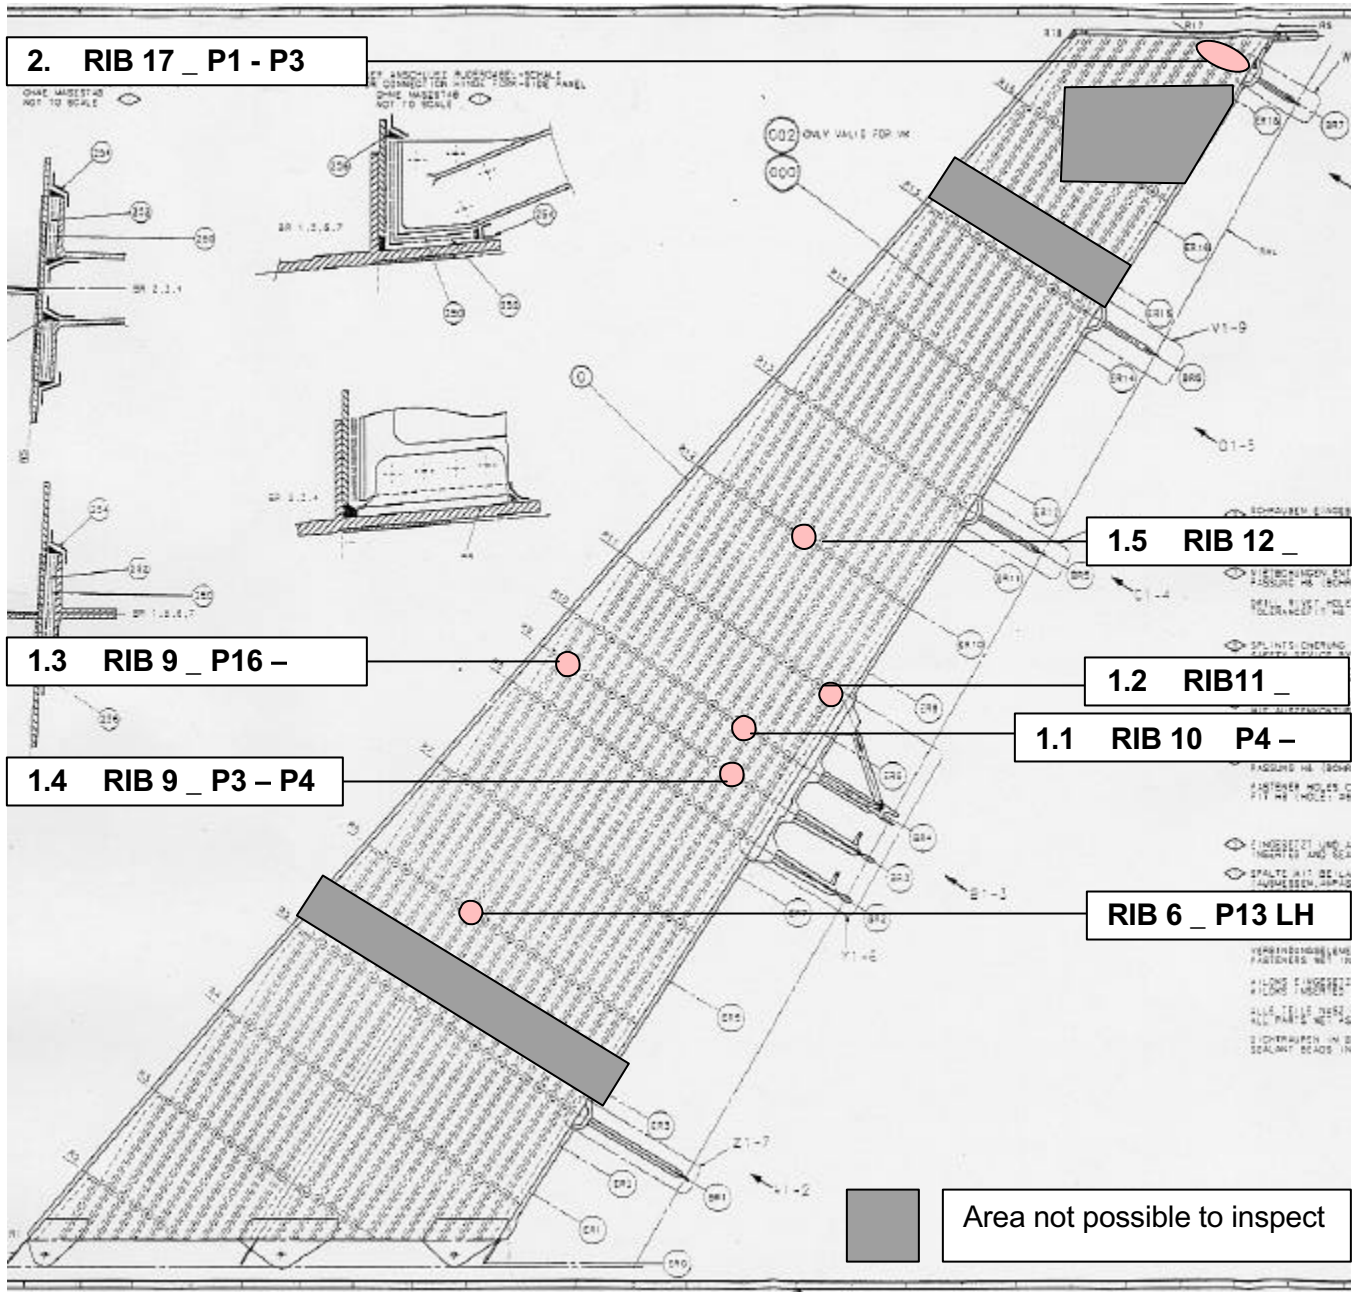
**Indication vertical stabilizer A300-600 MSN420 LH**

**NOTE:** All above documented indications are below the size to be registered in accordance with the quality requirements (see also the following detail sketches).

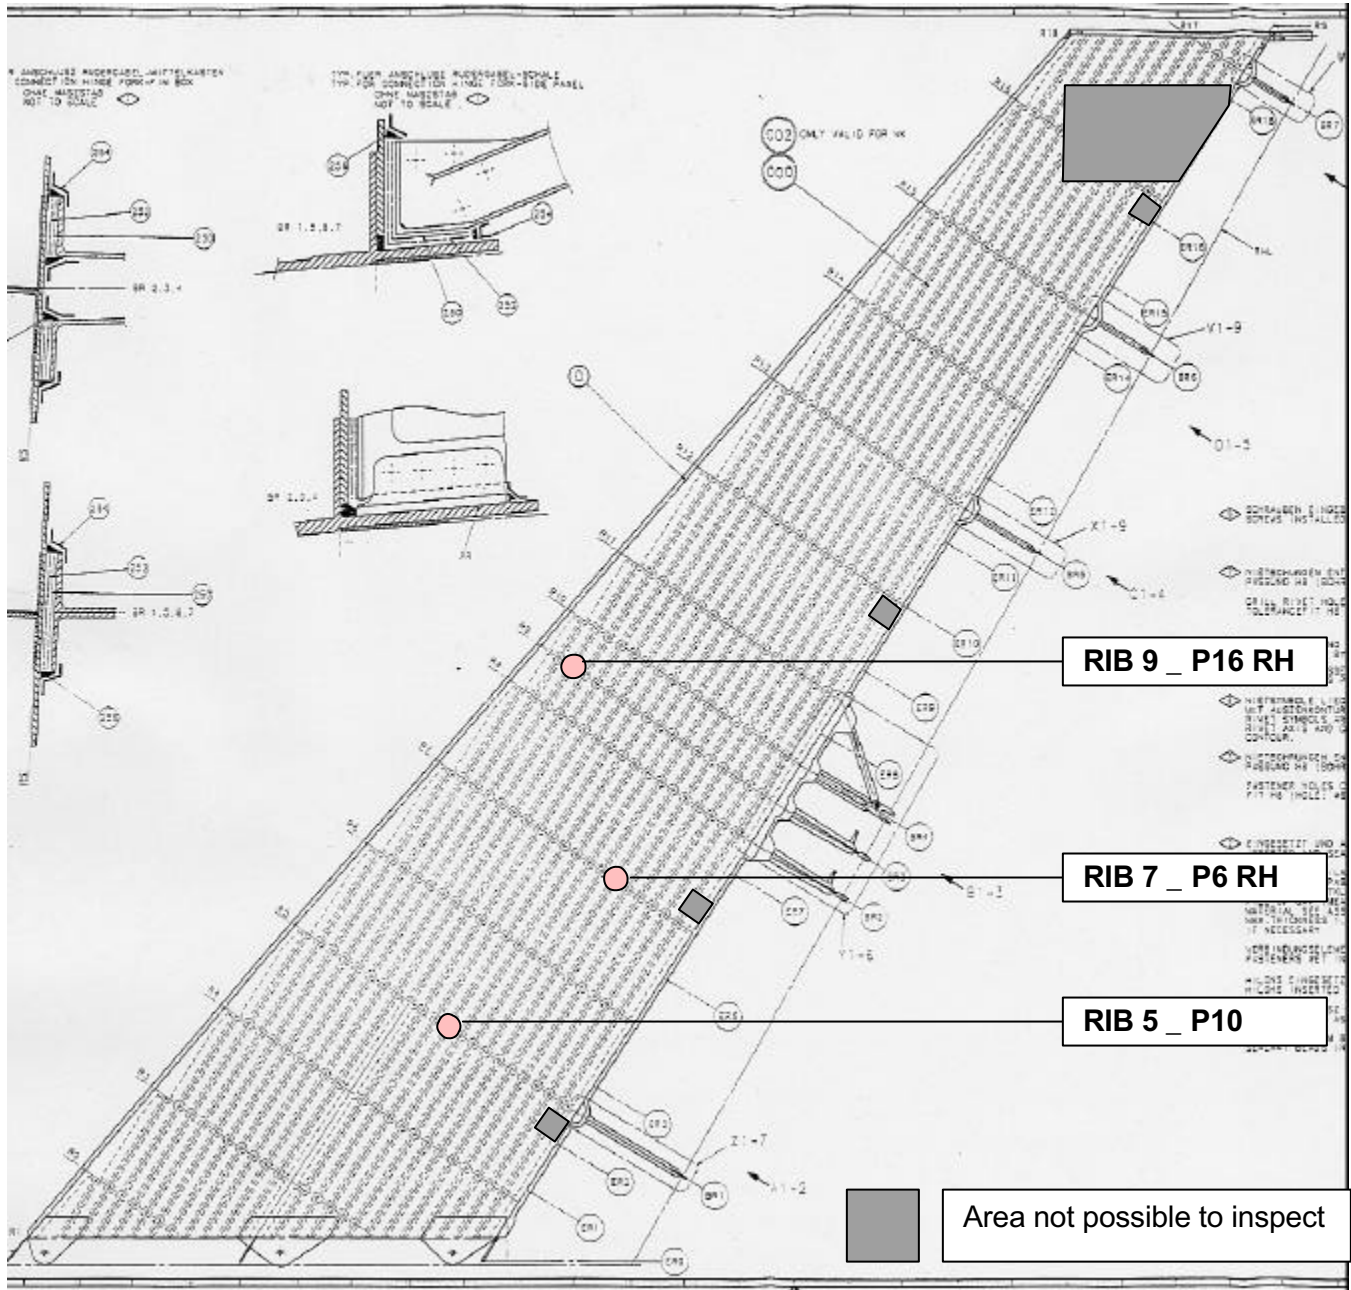
**Indication vertical stabilizer A300-600 MSN420 RH**

**NOTE:** All above documented indications are below the size to be registered in accordance with the quality requirements (see also the following detail sketches).

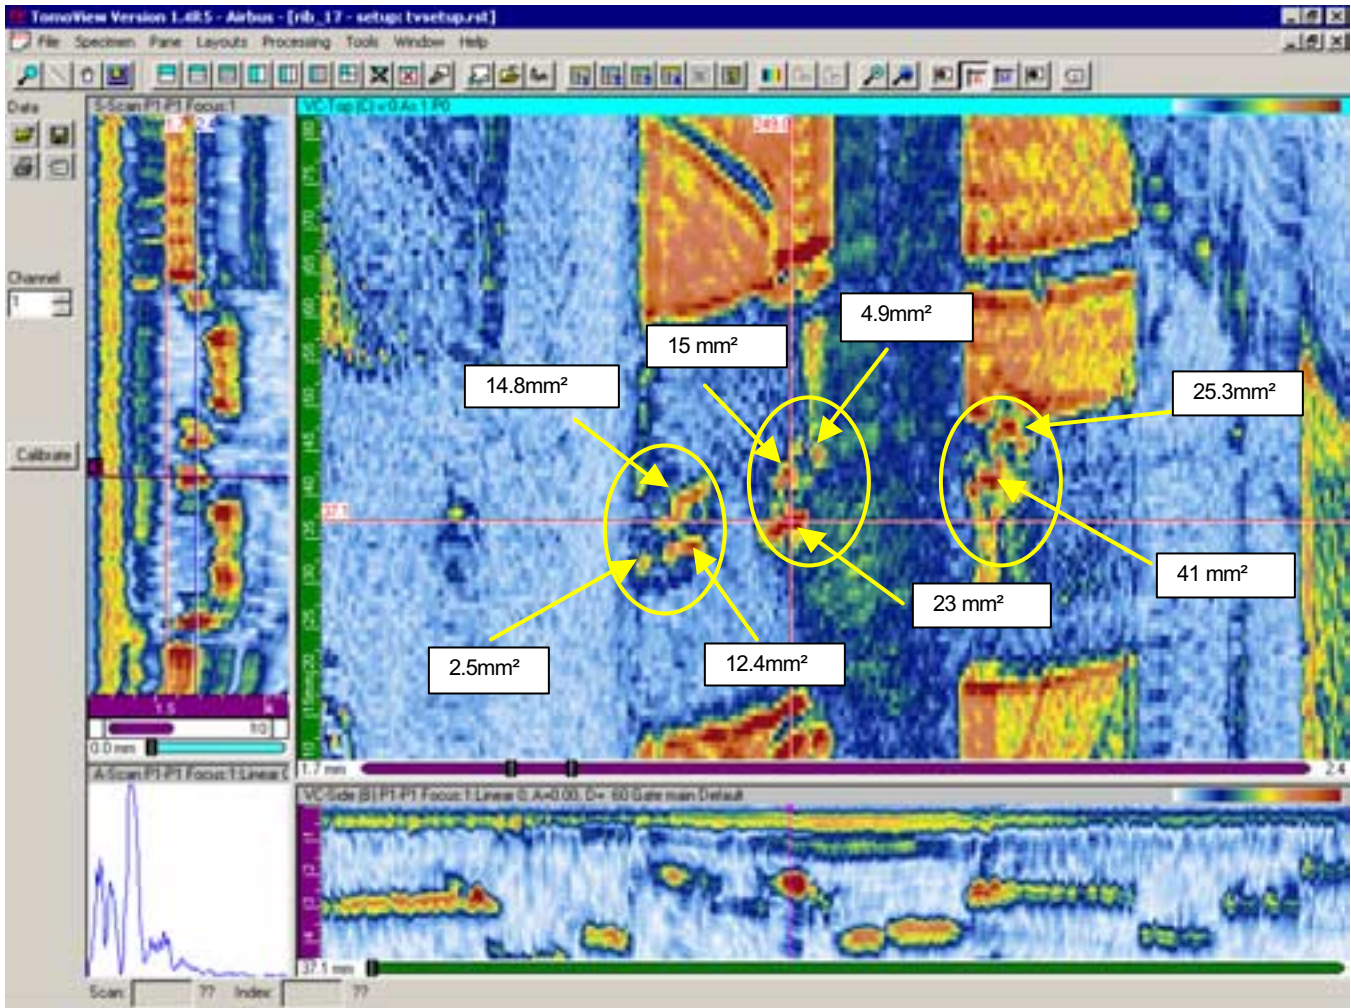
RIB 17 \_ P1 - P3 LH

**NOTE:** The above illustrated area belongs to the quality requirement zone D, which means that a max. extension of de-lamination of 250mm<sup>2</sup> is permissible.

**NOTE:** All above documented indications are below the size to be registered in accordance with the quality requirements.

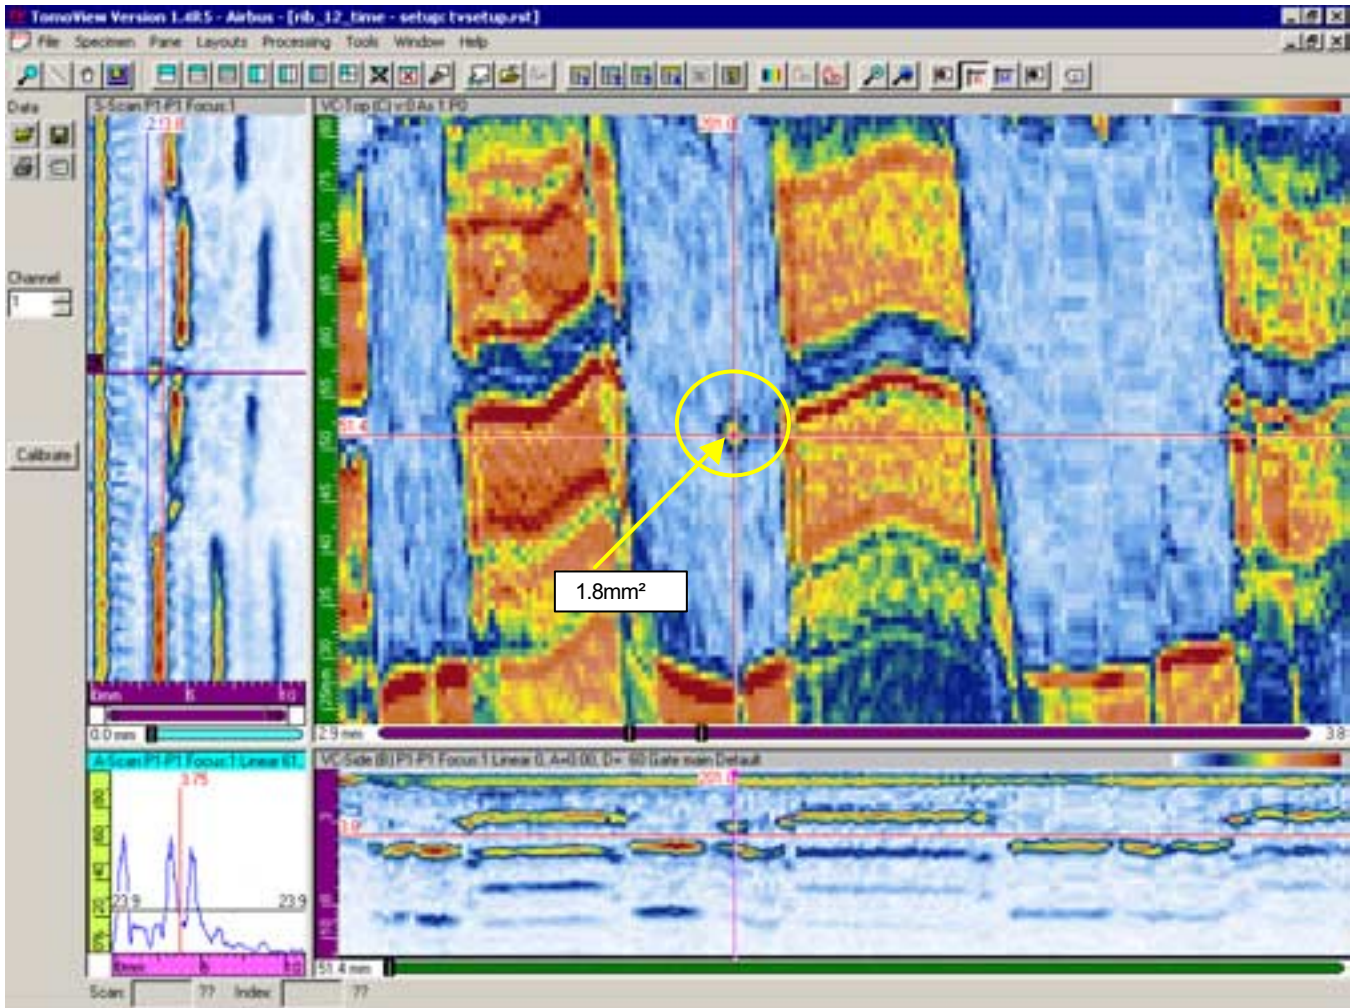
RIB 12 \_ P8 LH

**NOTE:** The above illustrated area belongs to the quality requirement zone D, which means that a max. extension of de-lamination of 250mm<sup>2</sup> is permissible.

**NOTE:** Above documented indication is below the size to be registered in accordance with the quality requirements.

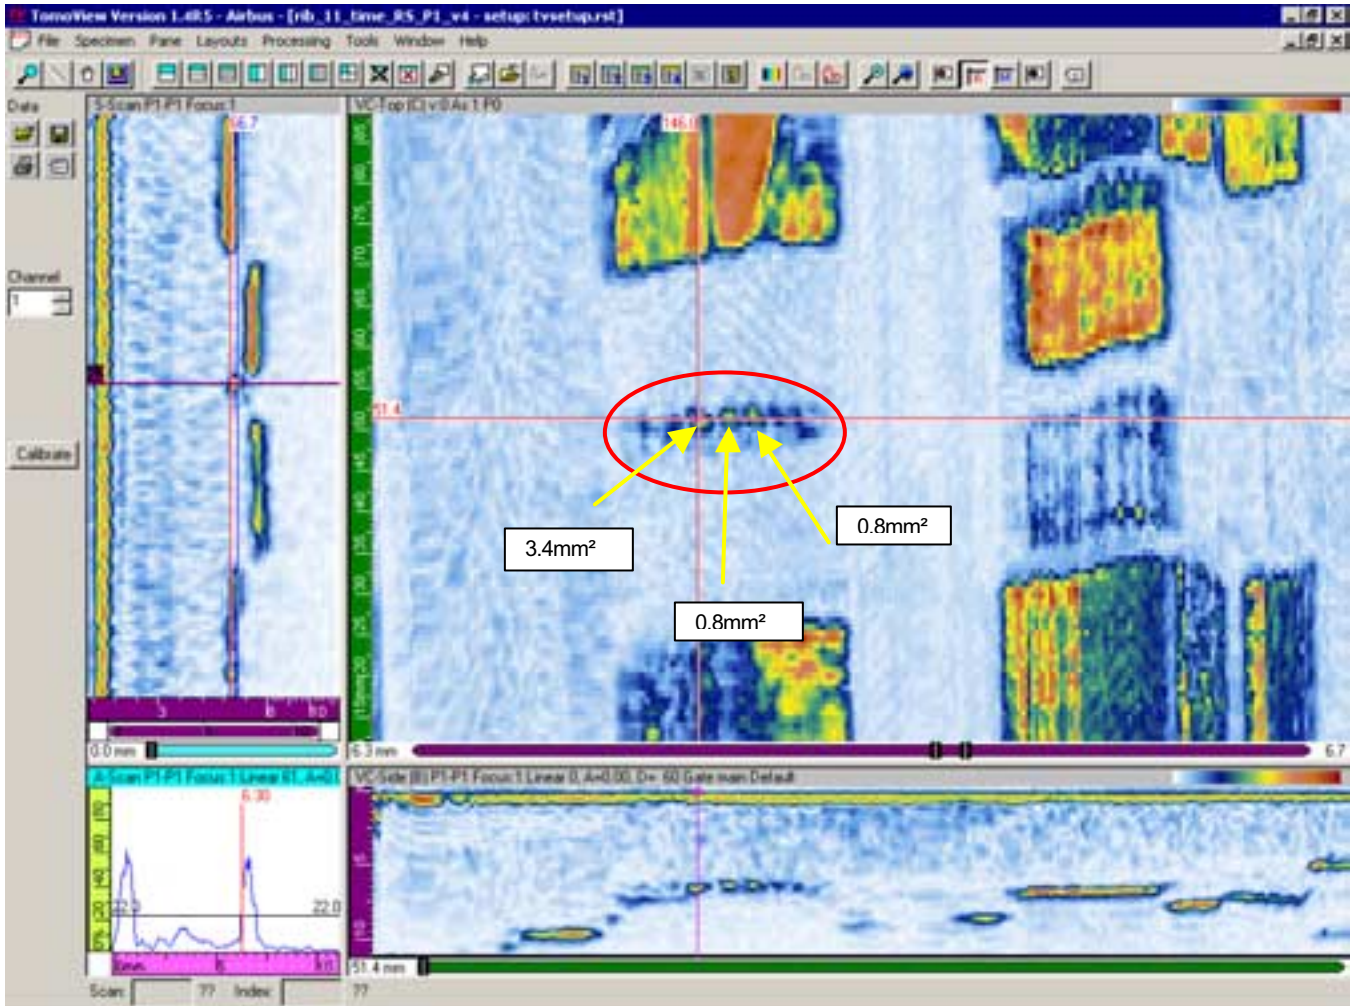
RIB11 \_ P1 LH

**NOTE:** The above illustrated area belongs to the quality requirement zone B, which means that a max. extension of de-lamination of 150mm<sup>2</sup> is permissible.

**NOTE:** All above documented indications are below the size to be registered in accordance with the quality requirements.

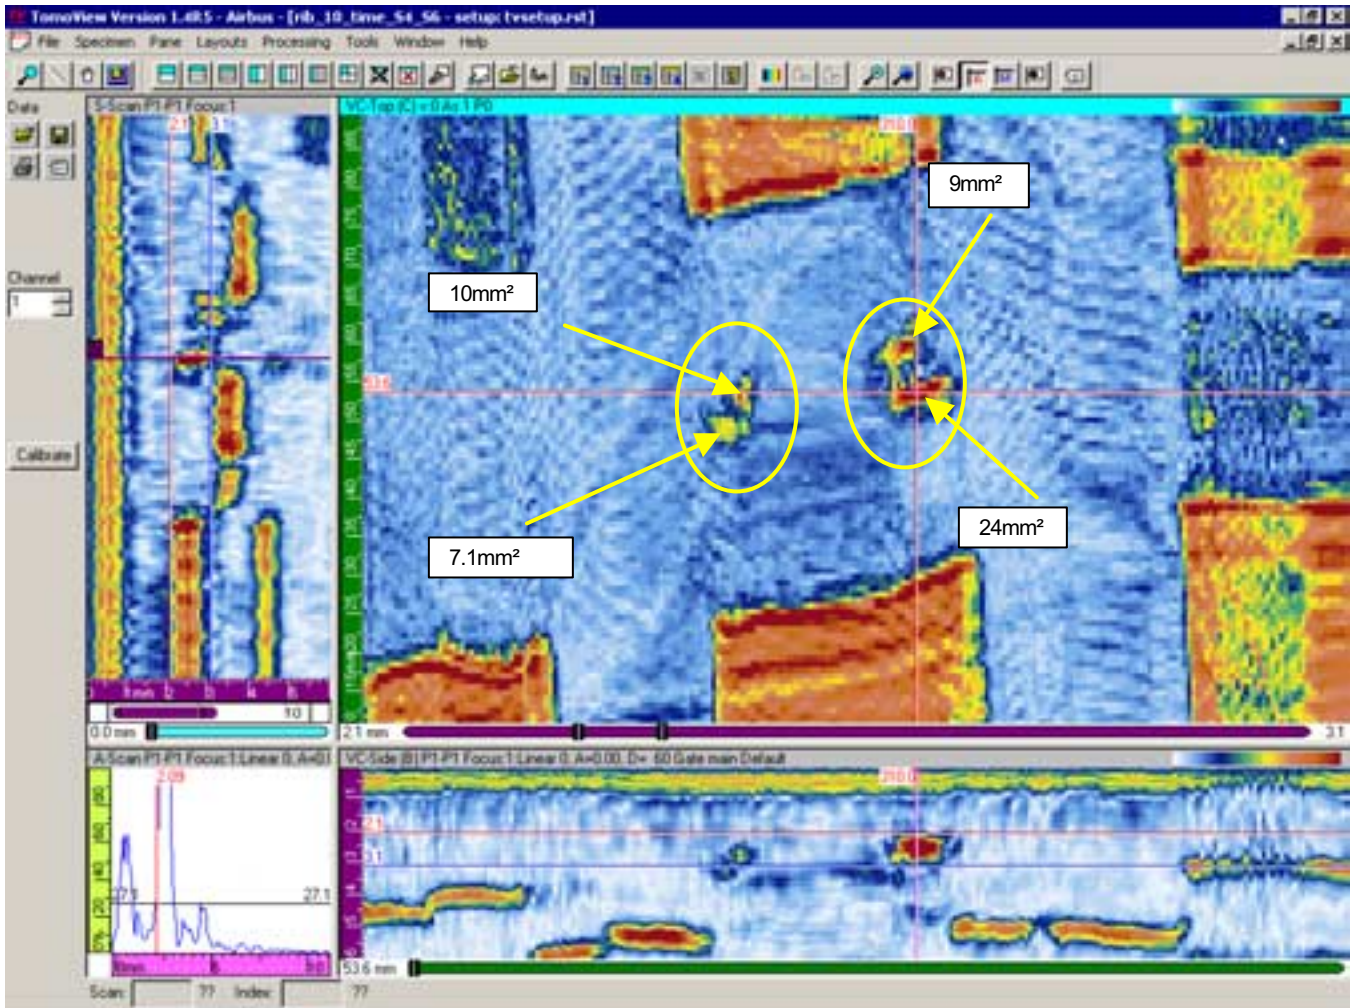
RIB 10 \_ P4 – P5 LH

**NOTE:** The above illustrated area belongs to the quality requirement zone D, which means that a max. extension of de-lamination of 250mm<sup>2</sup> is permissible.

**NOTE:** All above documented indications are below the size to be registered in accordance with the quality requirements.

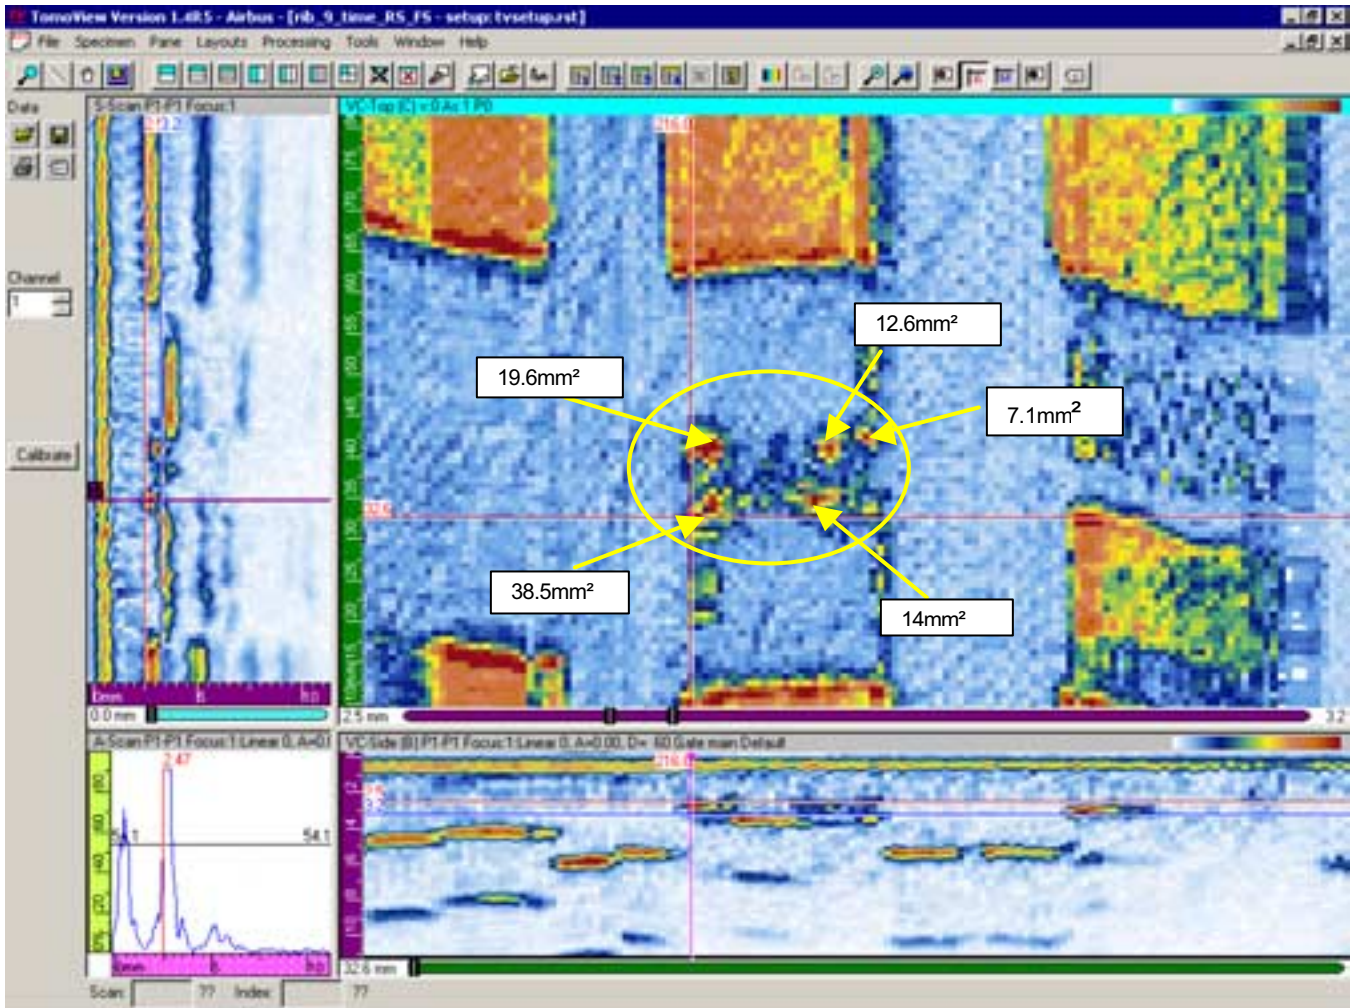
RIB 9 \_ P3 – P4 LH

**NOTE:** The above illustrated area belongs to the quality requirement zone B, which means that a max. extension of de-lamination of 150mm<sup>2</sup> is permissible.

**NOTE:** All above documented indications are below the size to be registered in accordance with the quality requirements.

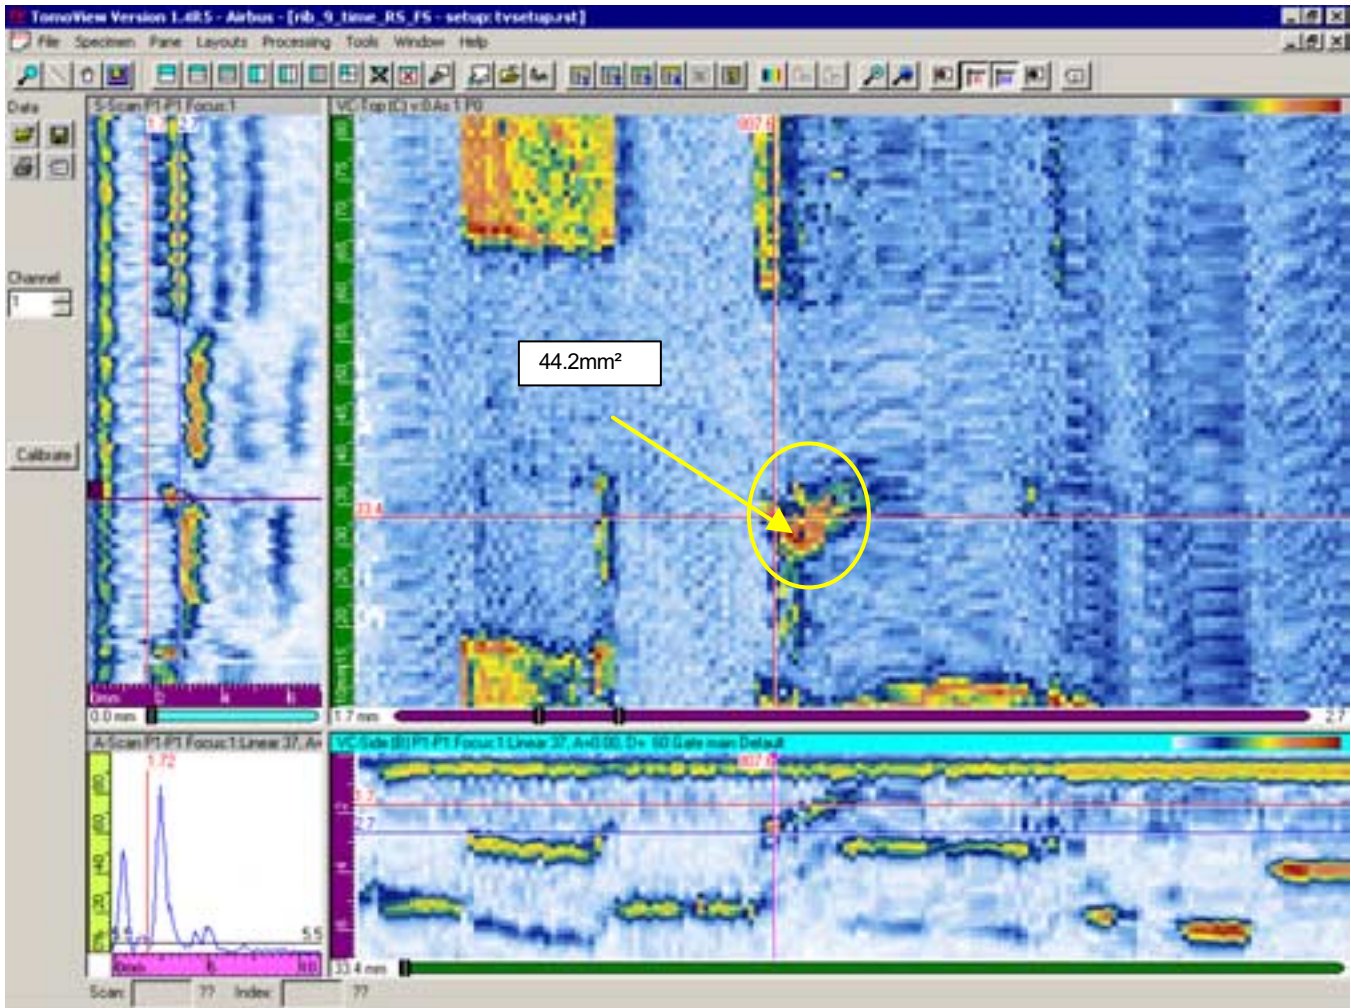
RIB 9 \_ P16 – P17 LH

**NOTE:** The above illustrated area belongs to the quality requirement zone B, which means that a max. extension of de-lamination of 150mm<sup>2</sup> is permissible.

**NOTE:** Above documented indication is below the size to be registered in accordance with the quality requirements.

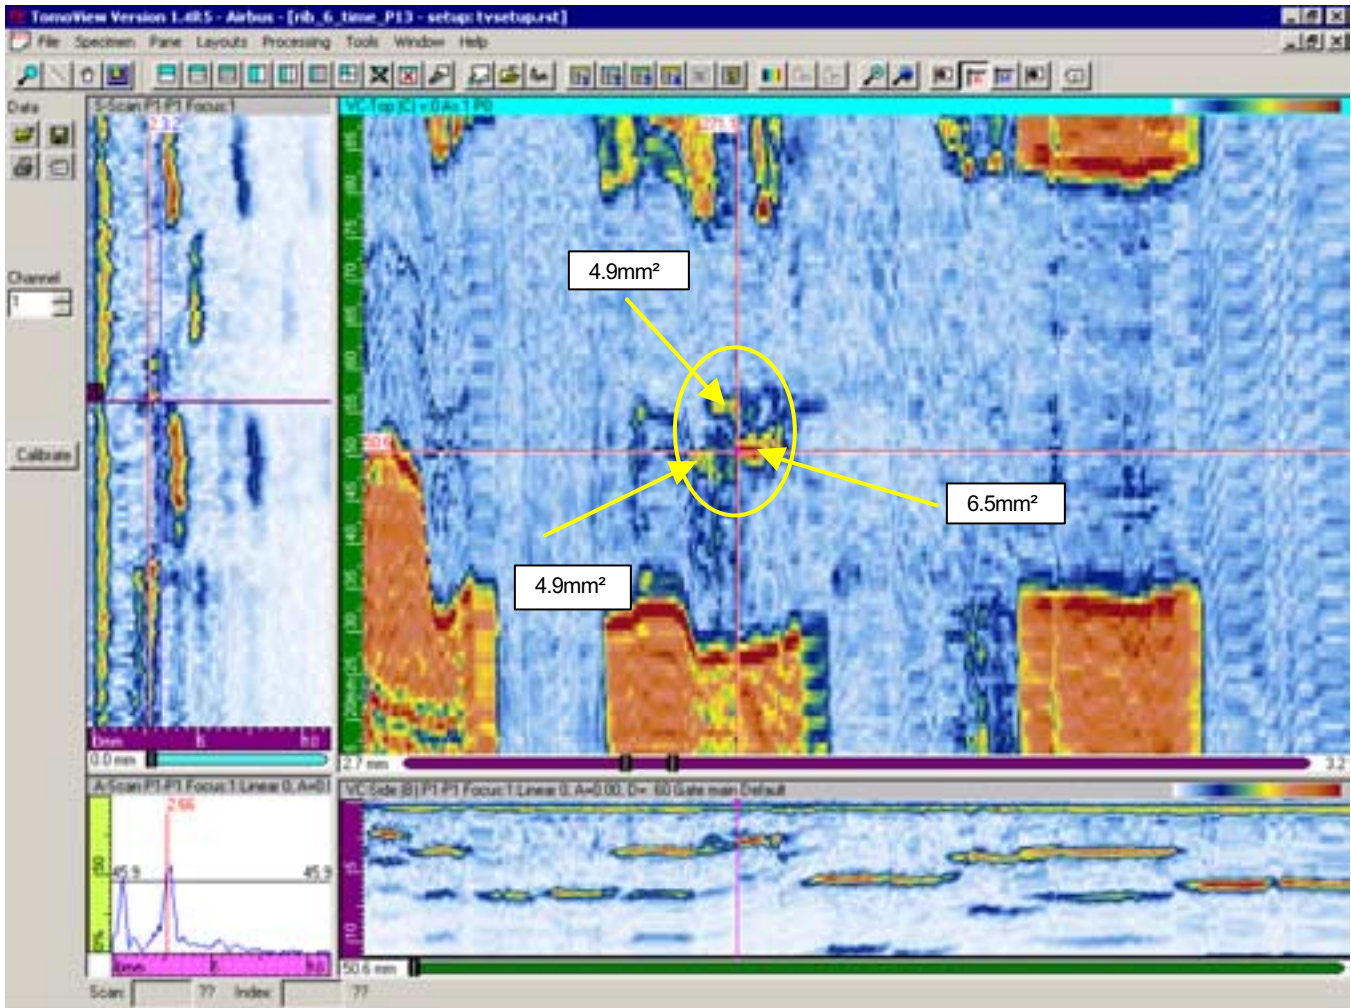
RIB 6 \_ P13 LH

**NOTE:** The above illustrated area belongs to the quality requirement zone B, which means that a max. extension of de-lamination of 150mm<sup>2</sup> is permissible.

**NOTE:** All above documented indications are below the size to be registered in accordance with the quality requirements.

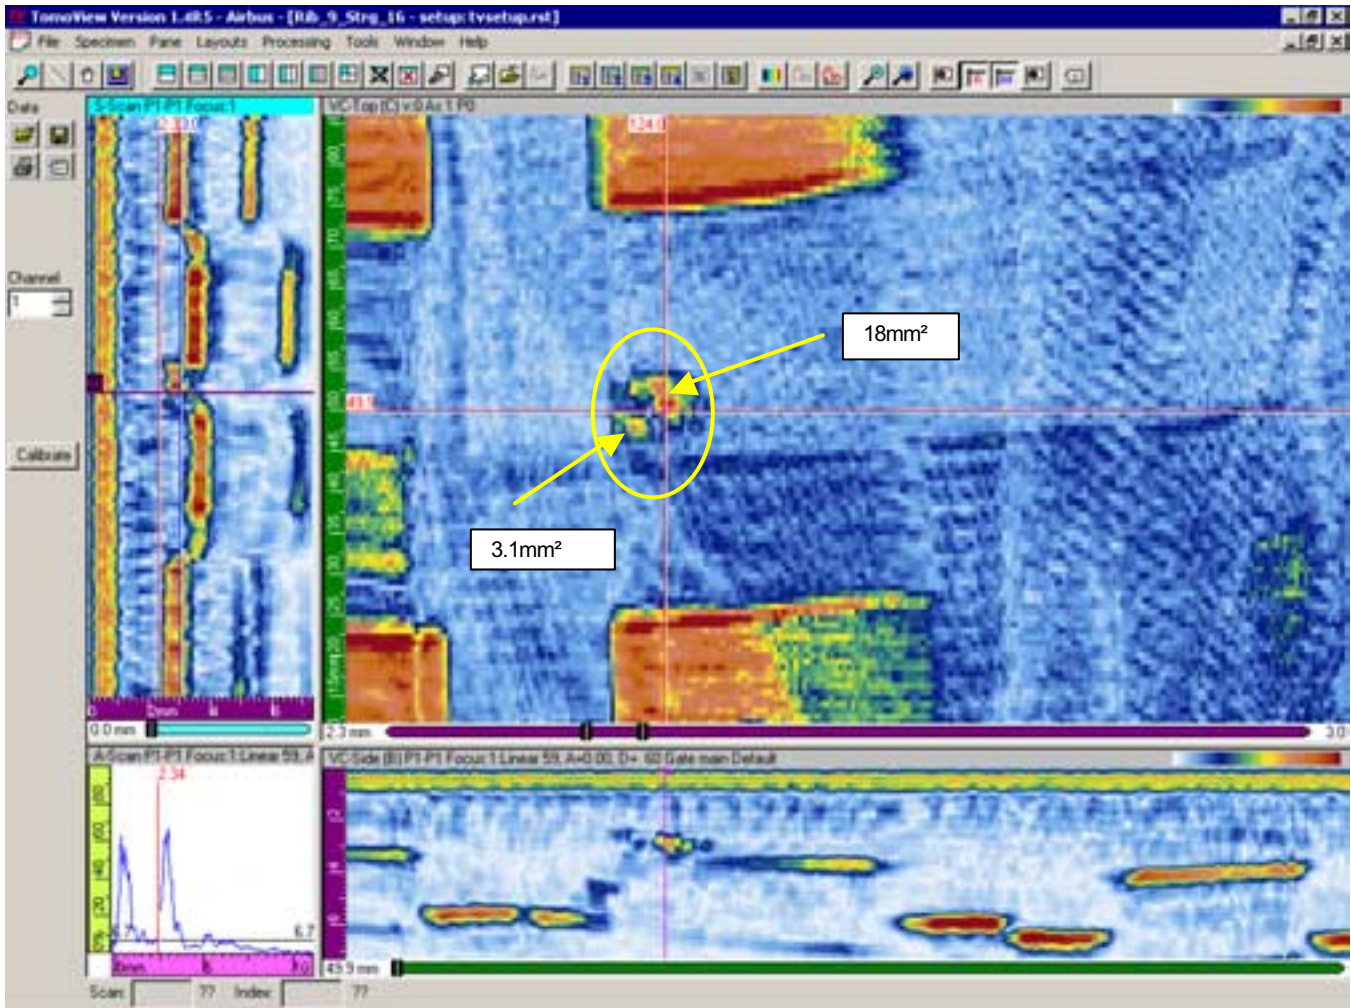
RIB 9 \_ P16 RH

**NOTE:** The above illustrated area belongs to the quality requirement zone B, which means that a max. extension of de-lamination of 150mm<sup>2</sup> is permissible.

**NOTE:** All above documented indications are below the size to be registered in accordance with the quality requirements.

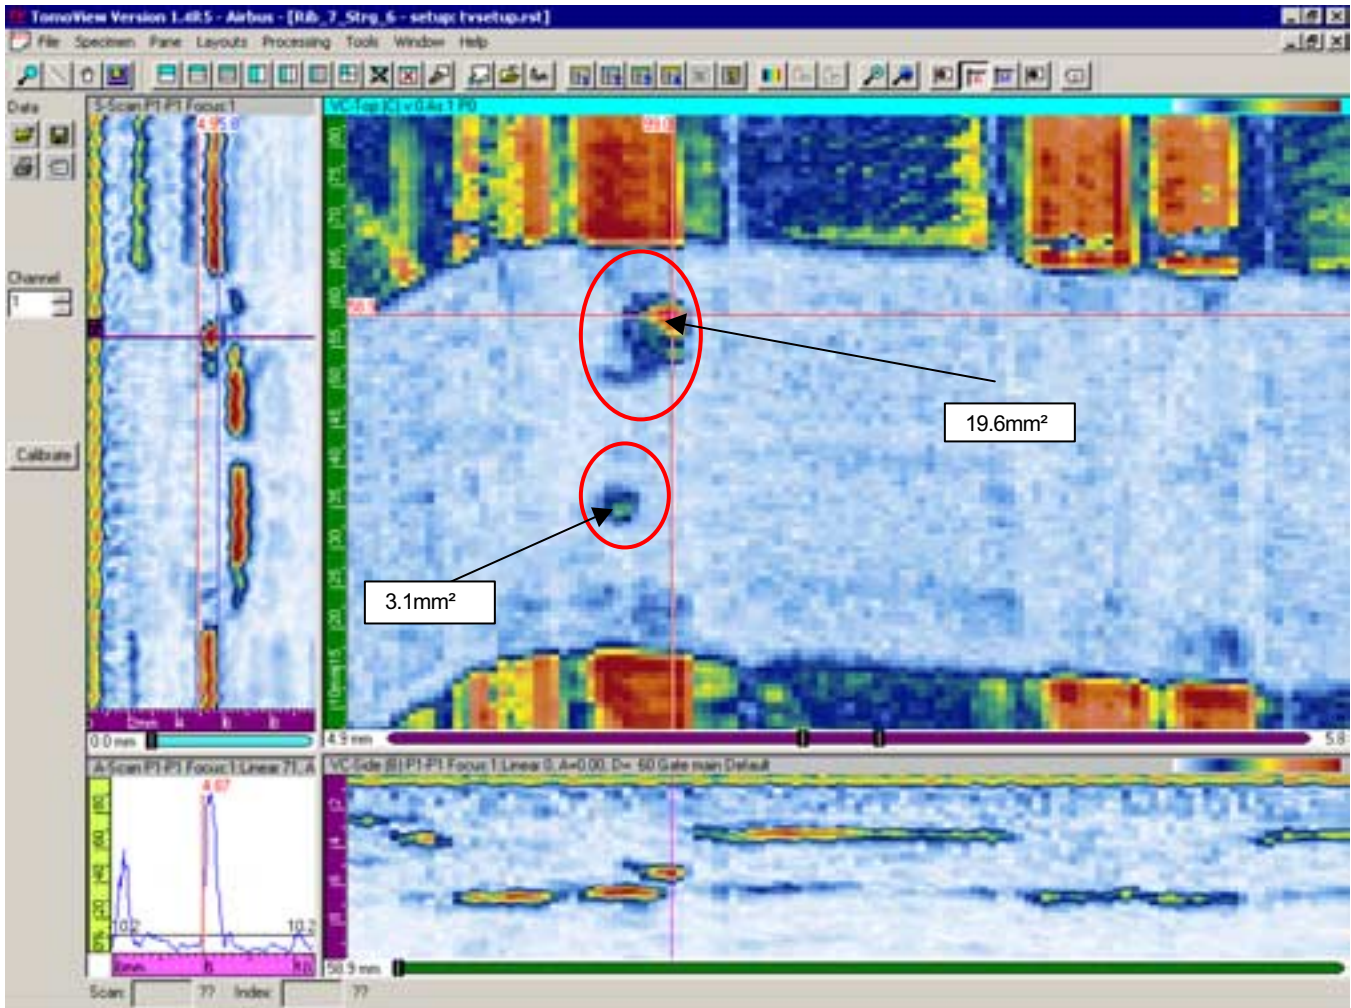
RIB 7 \_ P6 RH

**NOTE:** The above illustrated area belongs to the quality requirement zone D, which means that a max. extension of de-lamination of 250mm<sup>2</sup> is permissible.

**NOTE:** All above documented indications are below the size to be registered in accordance with the quality requirements.

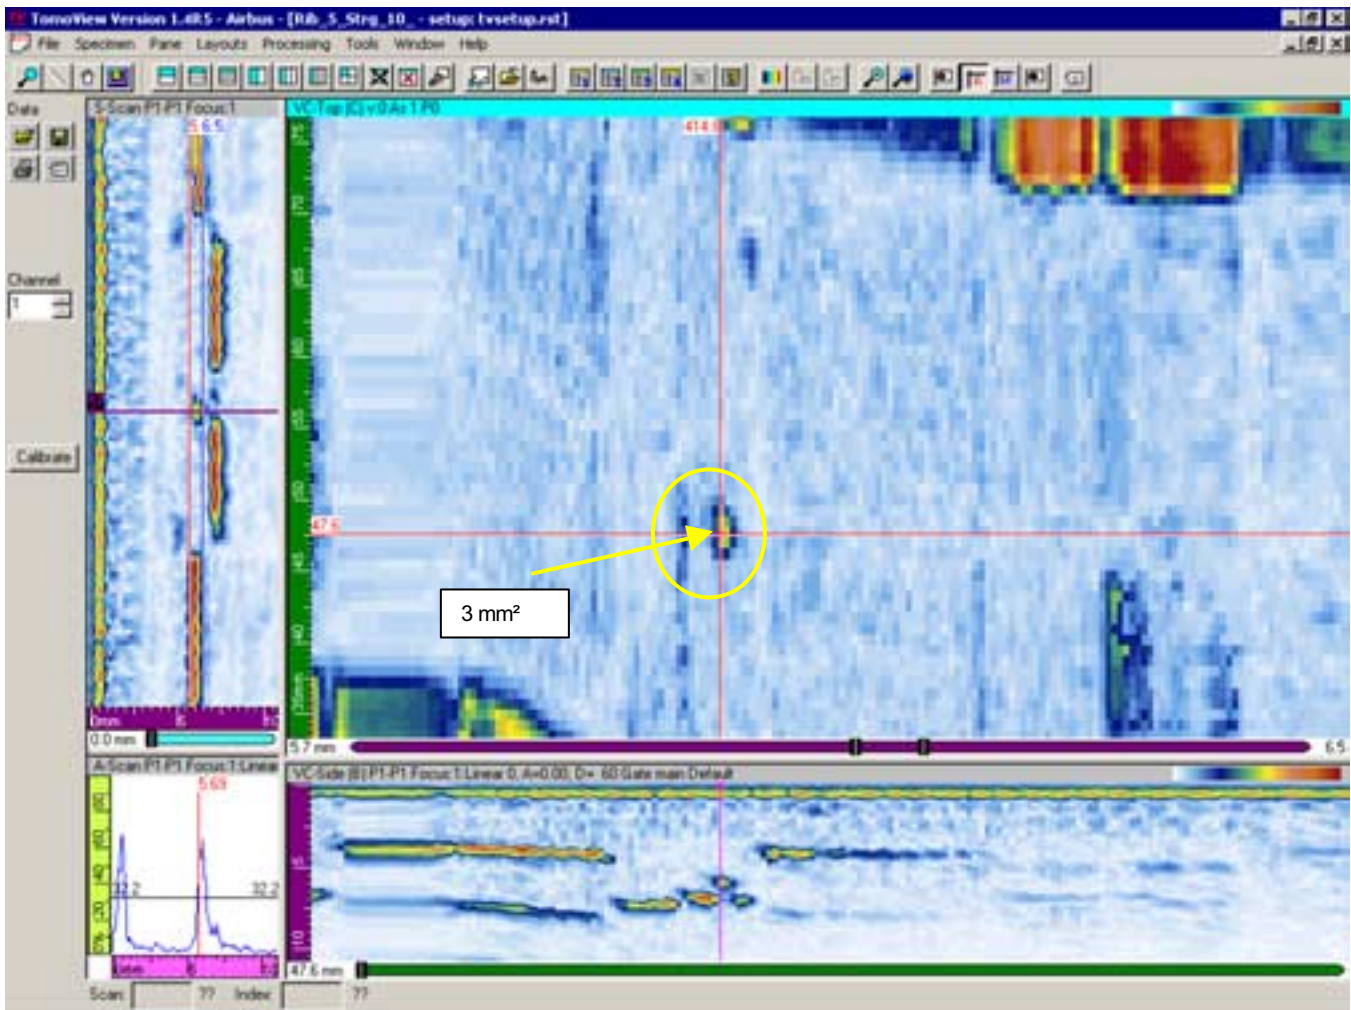
RIB 5 \_ P10

**NOTE:** The above illustrated area belongs to the quality requirement zone B, which means that a max. extension of de-lamination of 150mm<sup>2</sup> is permissible.

**NOTE:** Above documented indication is below the size to be registered in accordance with the quality requirements.
