# NTSB Board Meeting AA Flight 587

## Composite Materials and Wreckage Examination

American Airlines Flight 587  
Belle Harbor, New York  
November 12, 2001

NTSB Board Meeting  
October 26, 2004

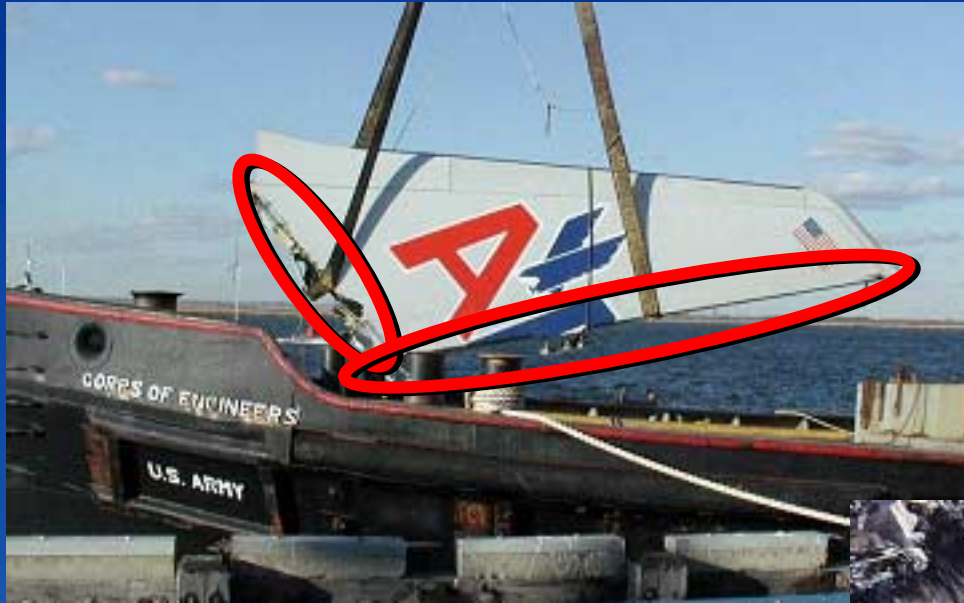
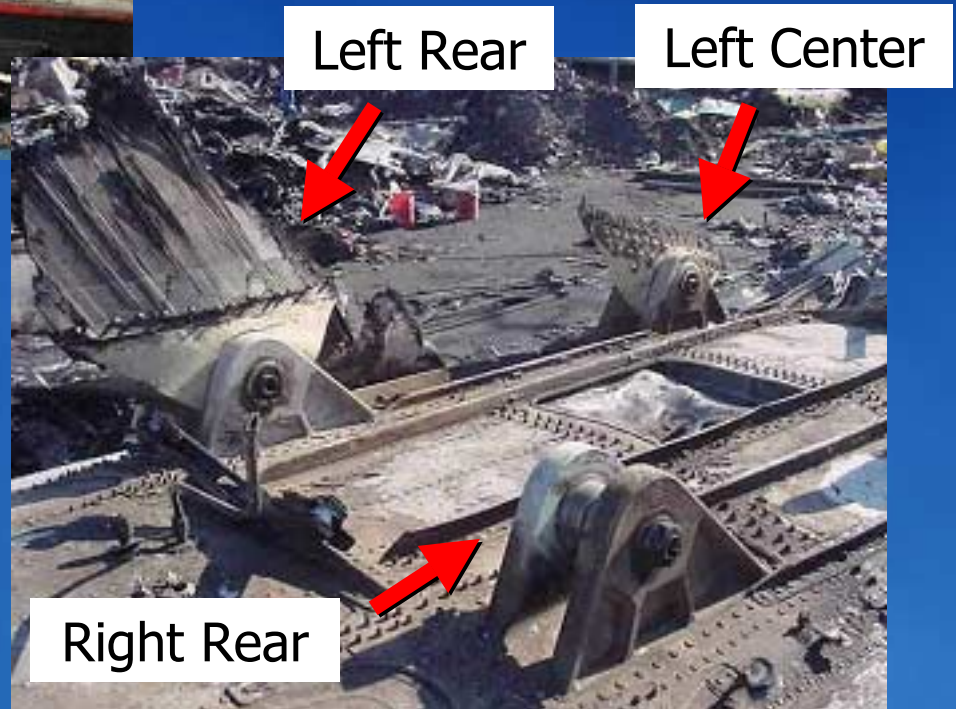
# Visible Damage

Visible damage observed at rudder hinge line and lug locations.

Some lug pieces remained attached to the fuselage.

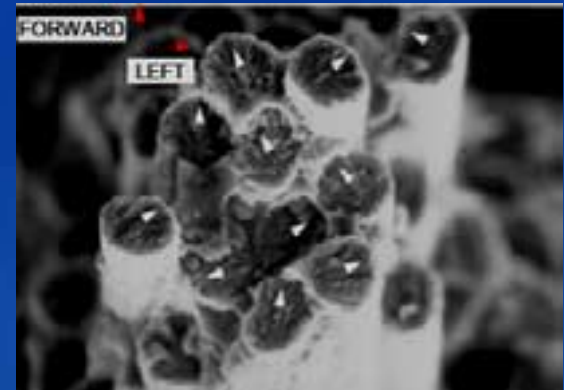
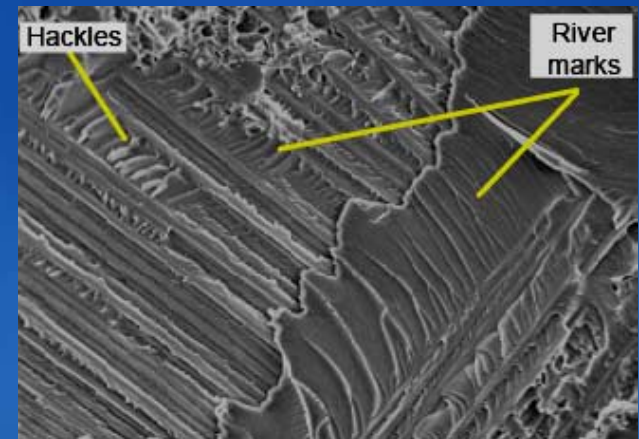
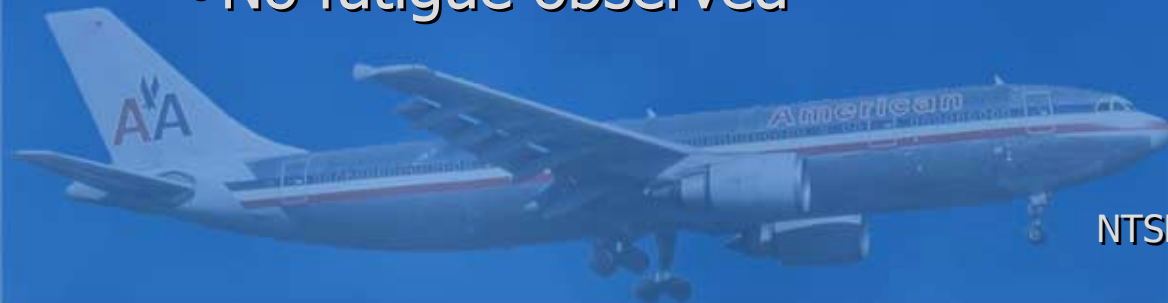
# Fractographic Examination

- Composite fractures examined at high magnification using scanning electron microscopy
- Lug area fractures photographed at more than 300 locations
- Over 500 square inches of crack surfaces examined at high magnification
- No fatigue observed

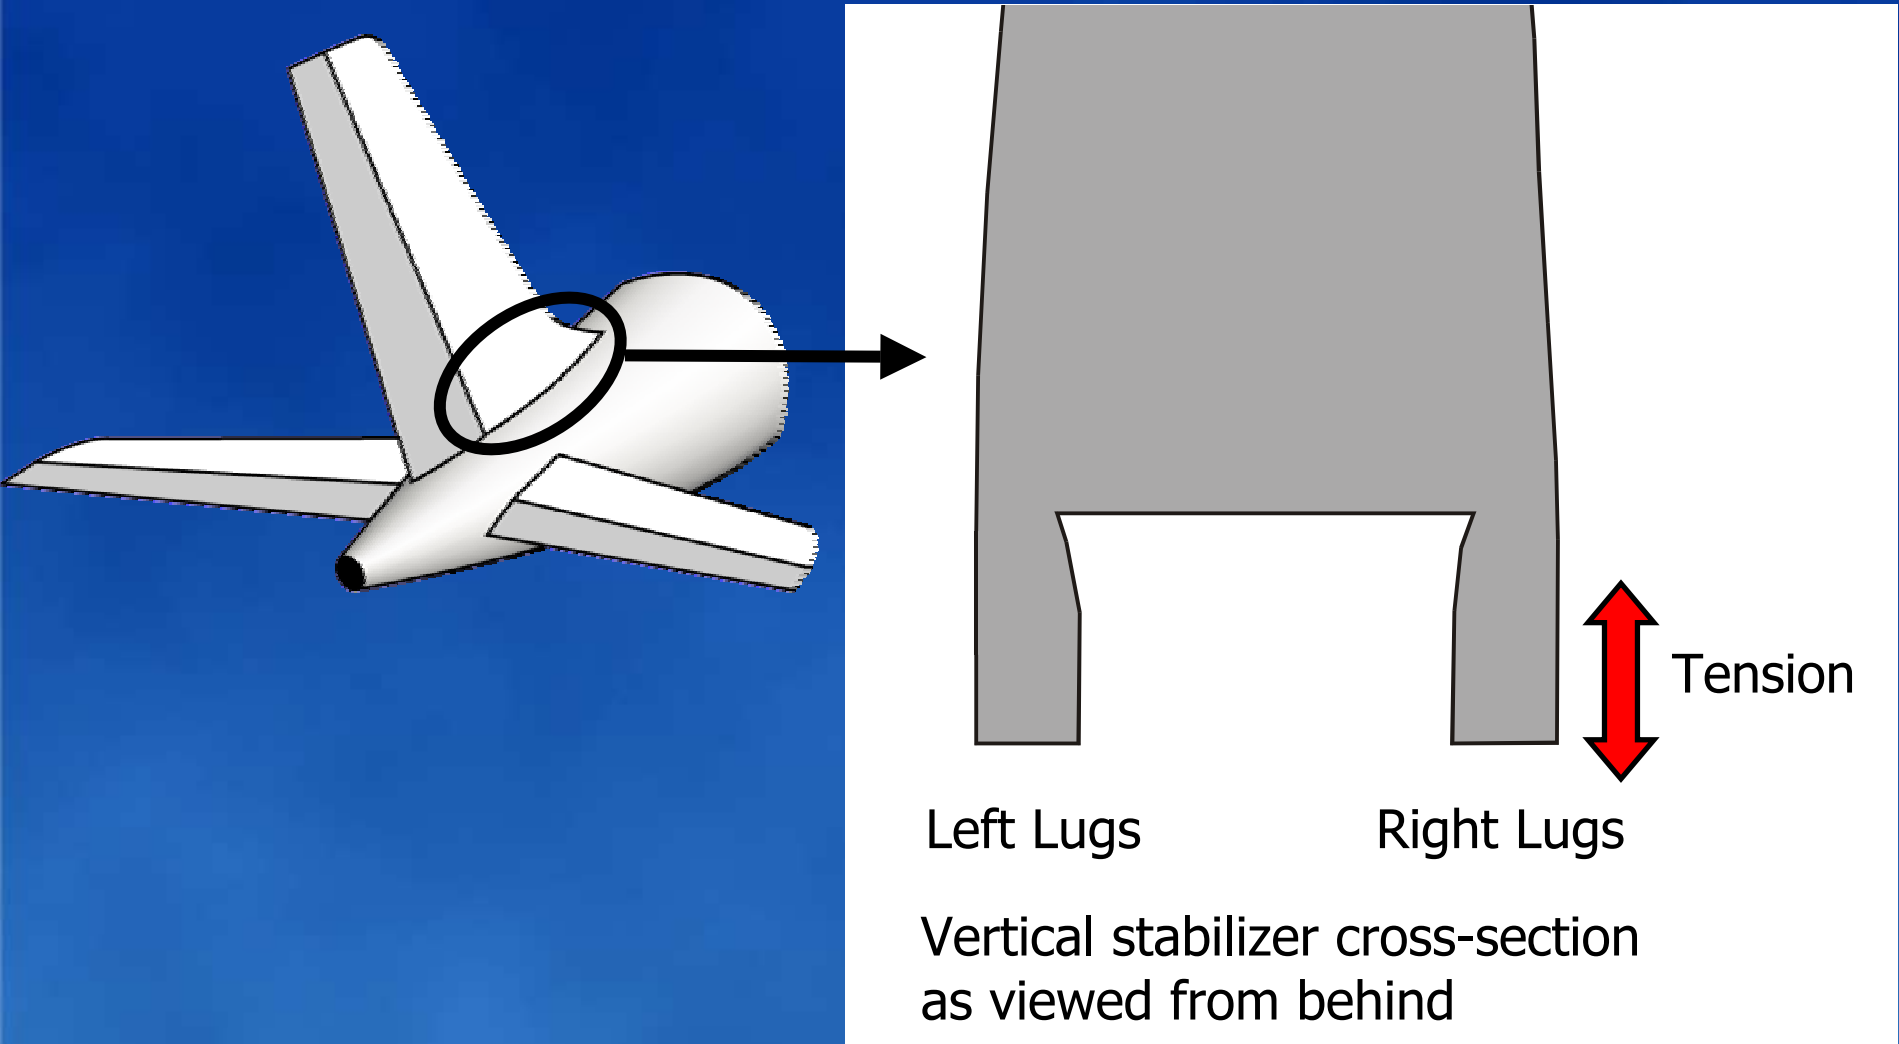
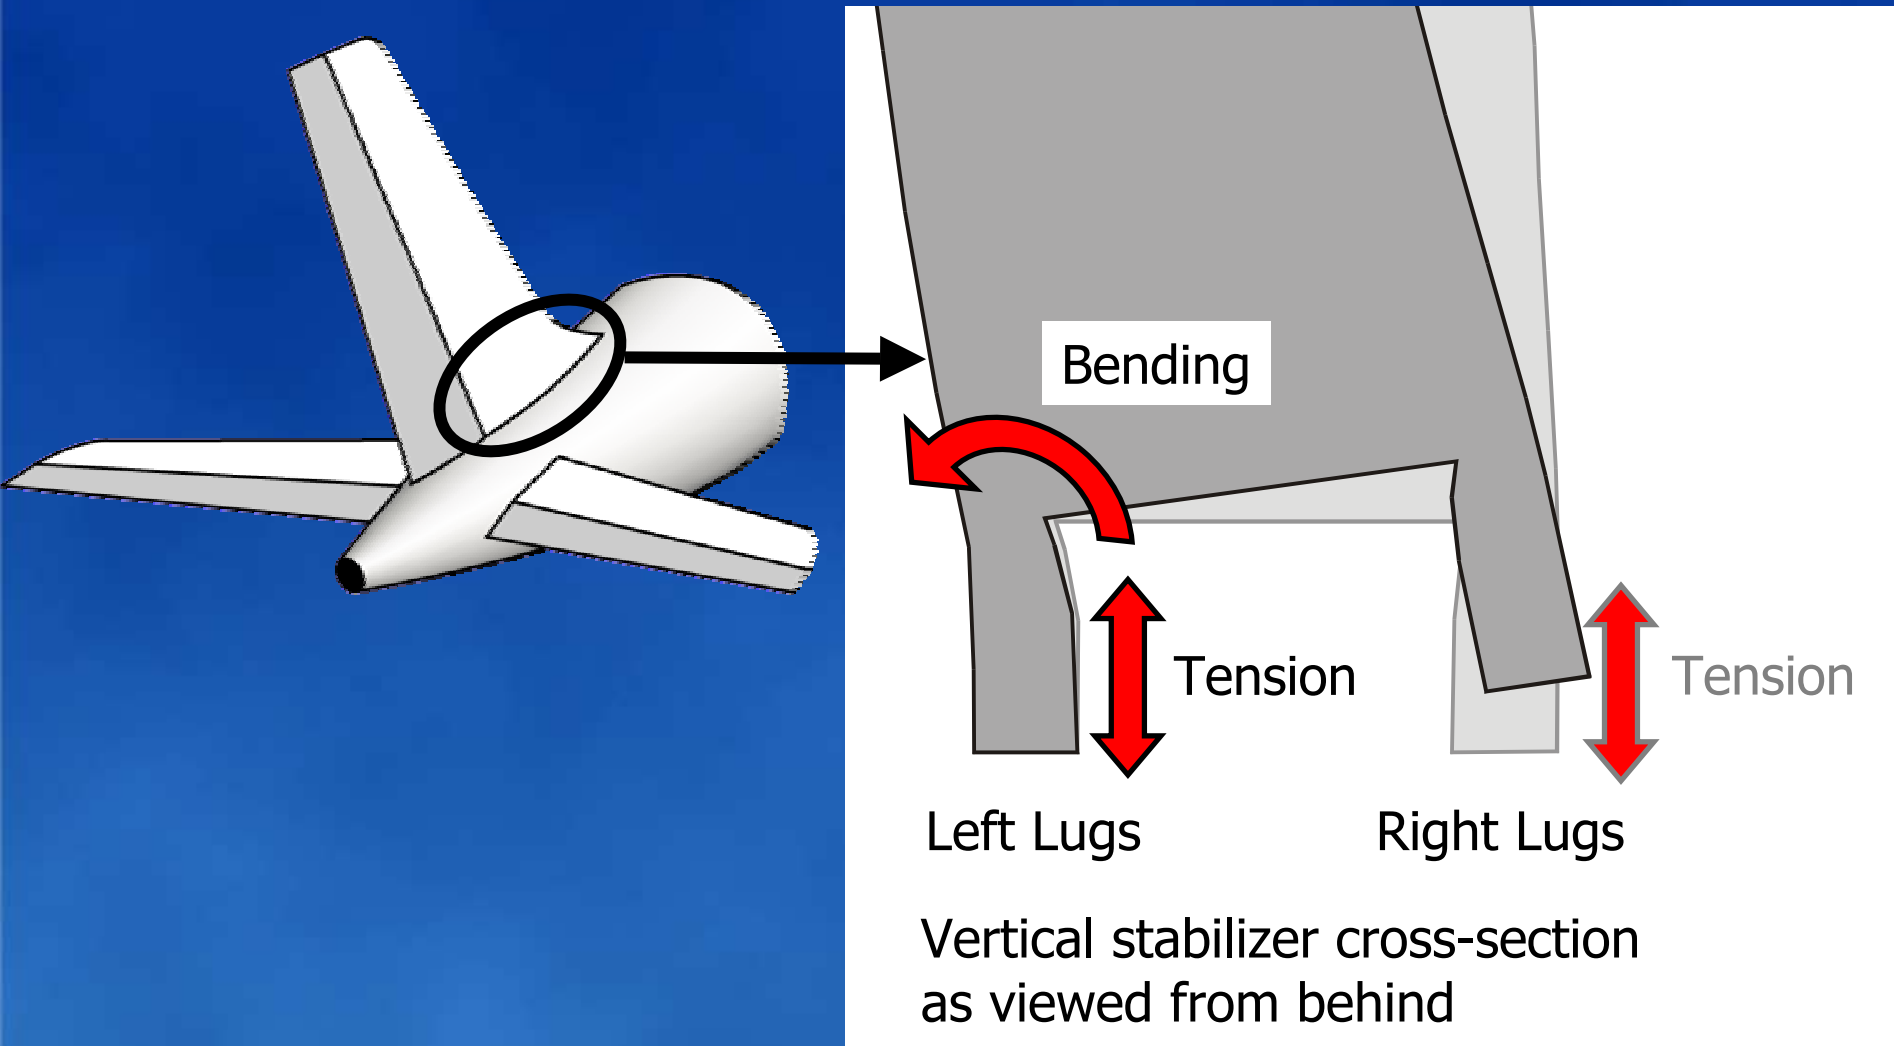
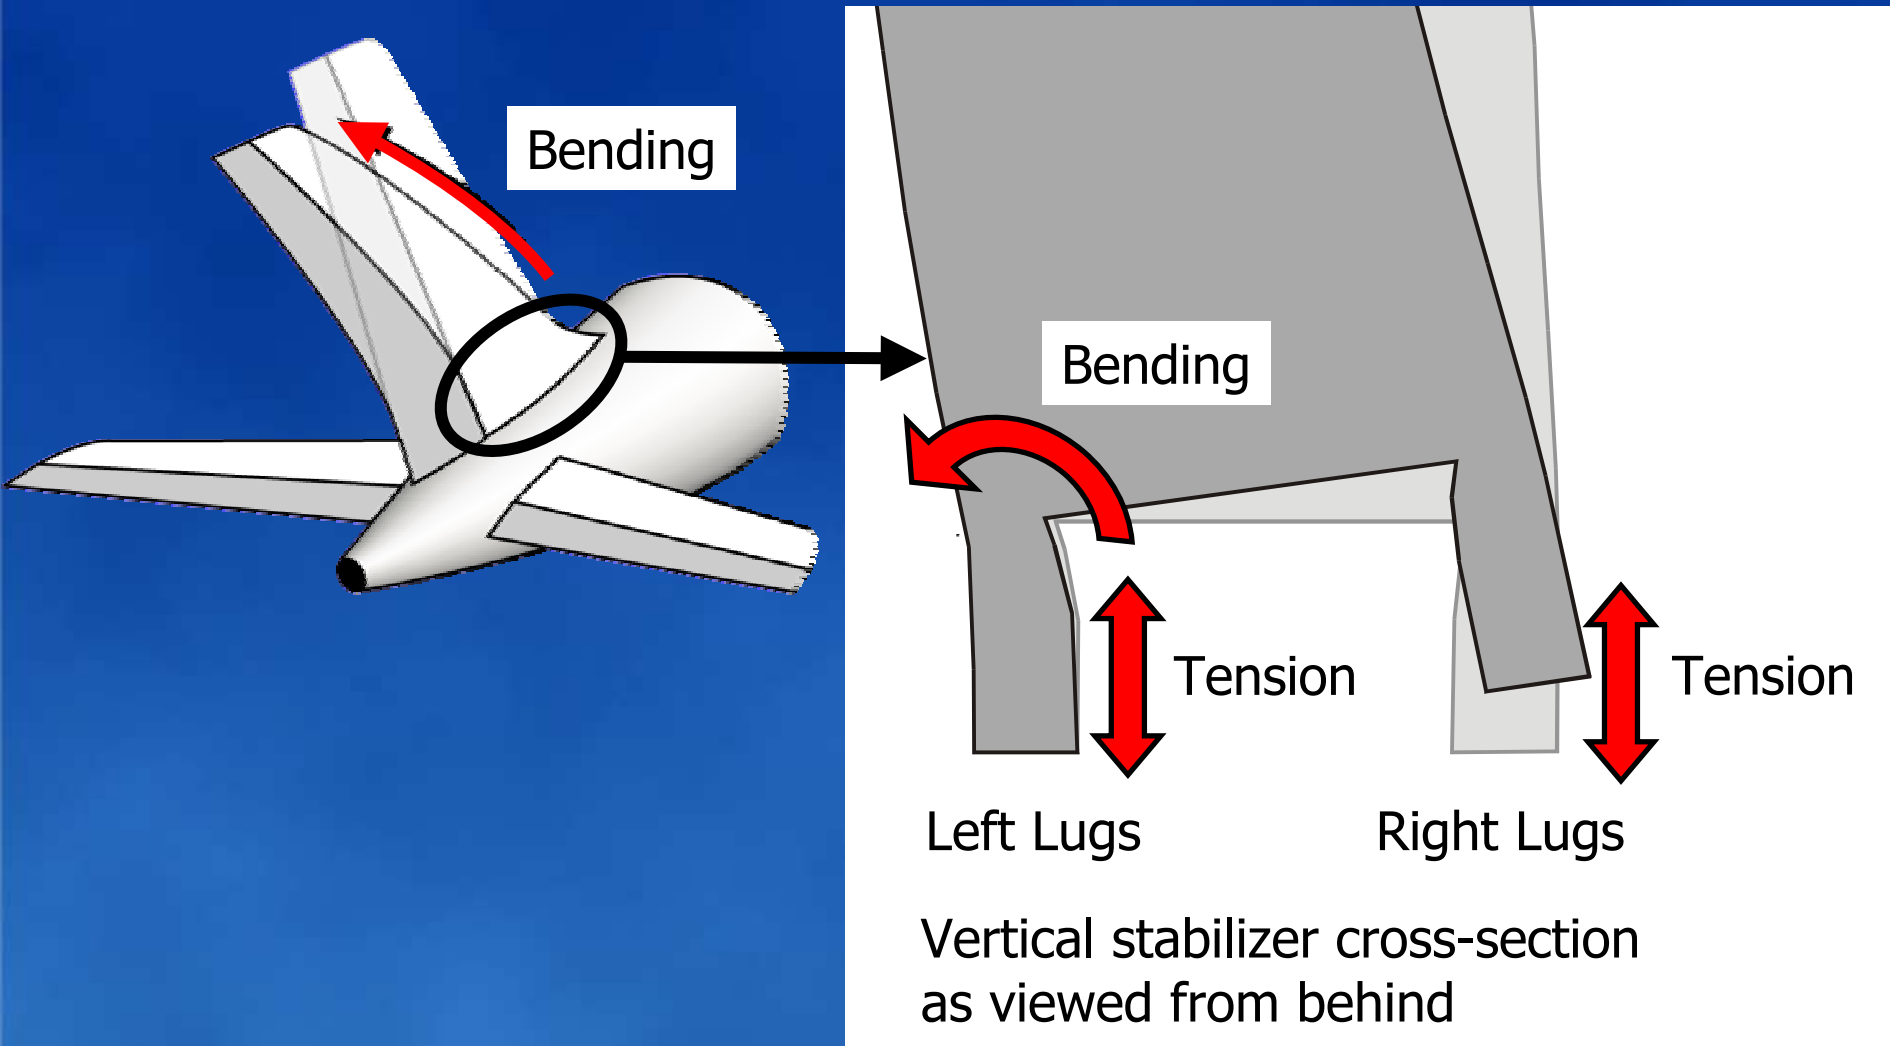
# Fracture Pattern

**Consistent with overload bending to the left**

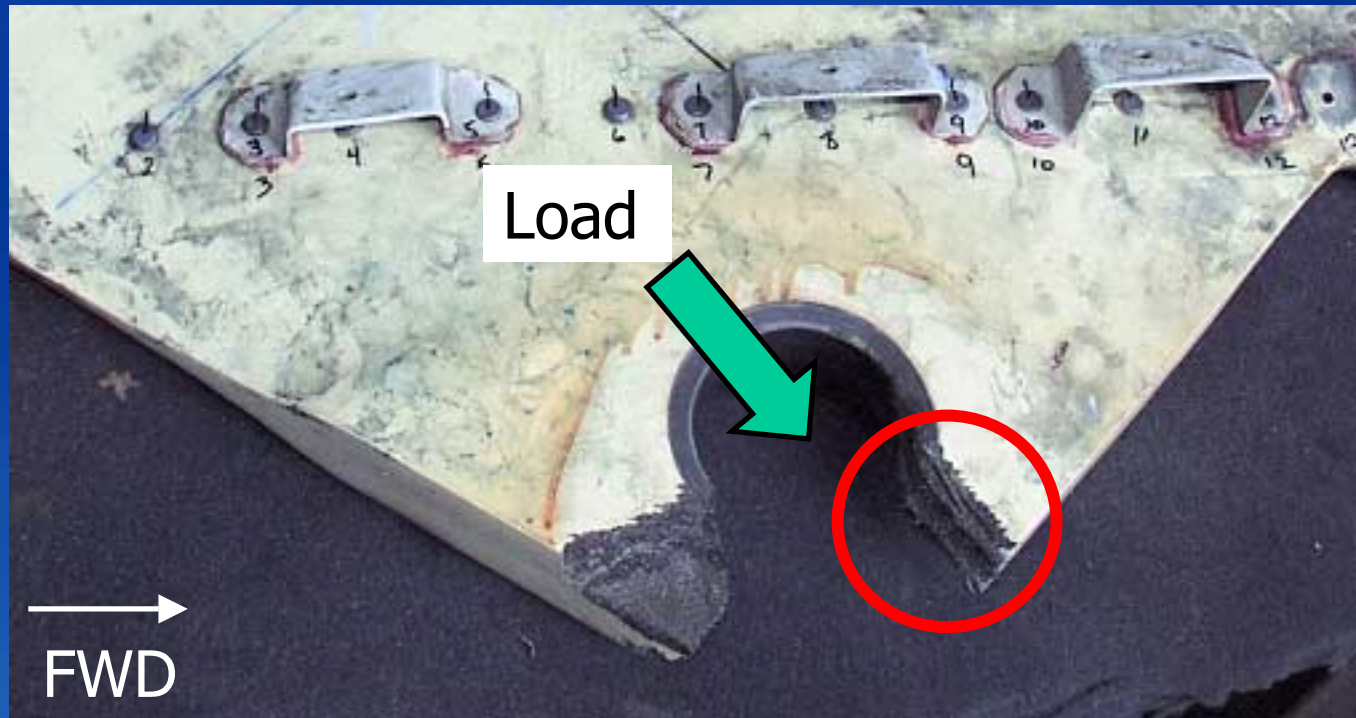
# Right Rear Lug Fracture

- Structural analysis predicted fracture initiation at the location circled in red.
- Structural analysis was consistent with damage observed.

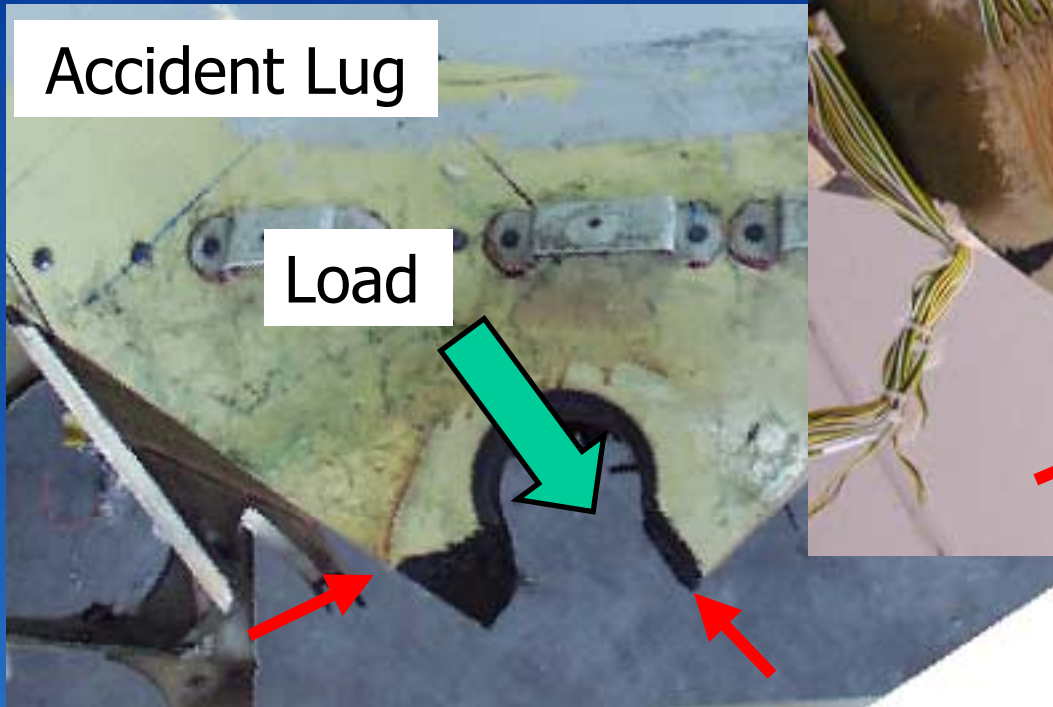
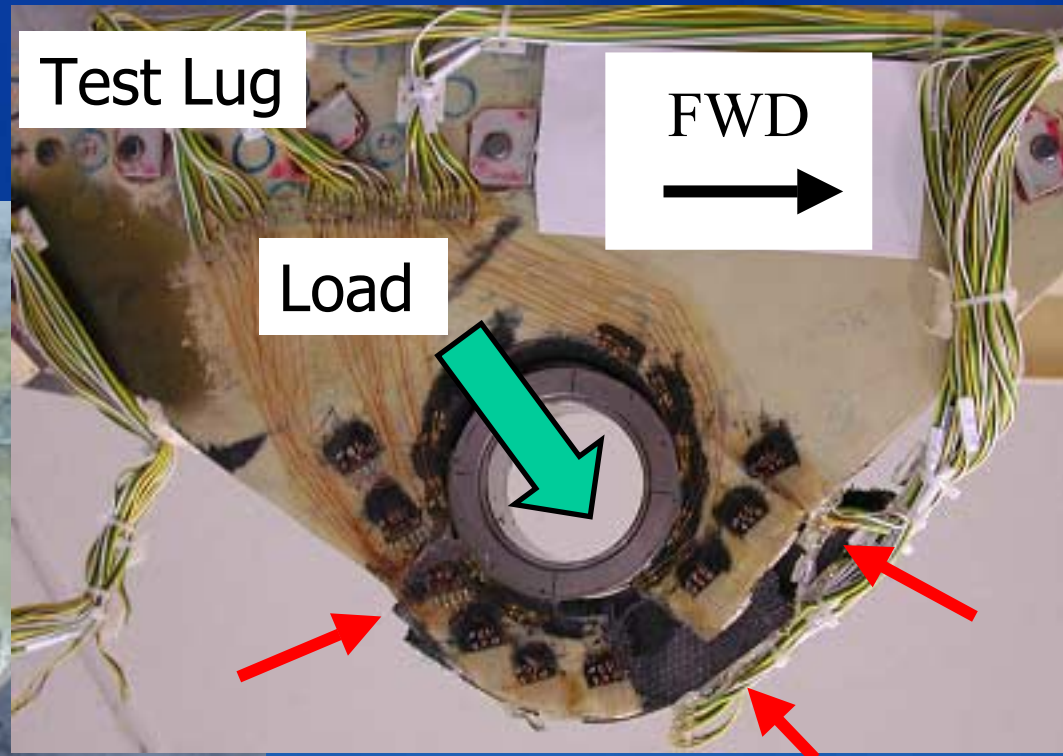
# Lug Tests

Fracture pattern for the accident right rear lug was as expected given the accident loads.
