NTSB Board Meeting AA Flight 587

First Officer's Use of Controls

American Airlines Flight 587
Belle Harbor, New York
November 12, 2001

NTSB Board Meeting
October 26, 2004

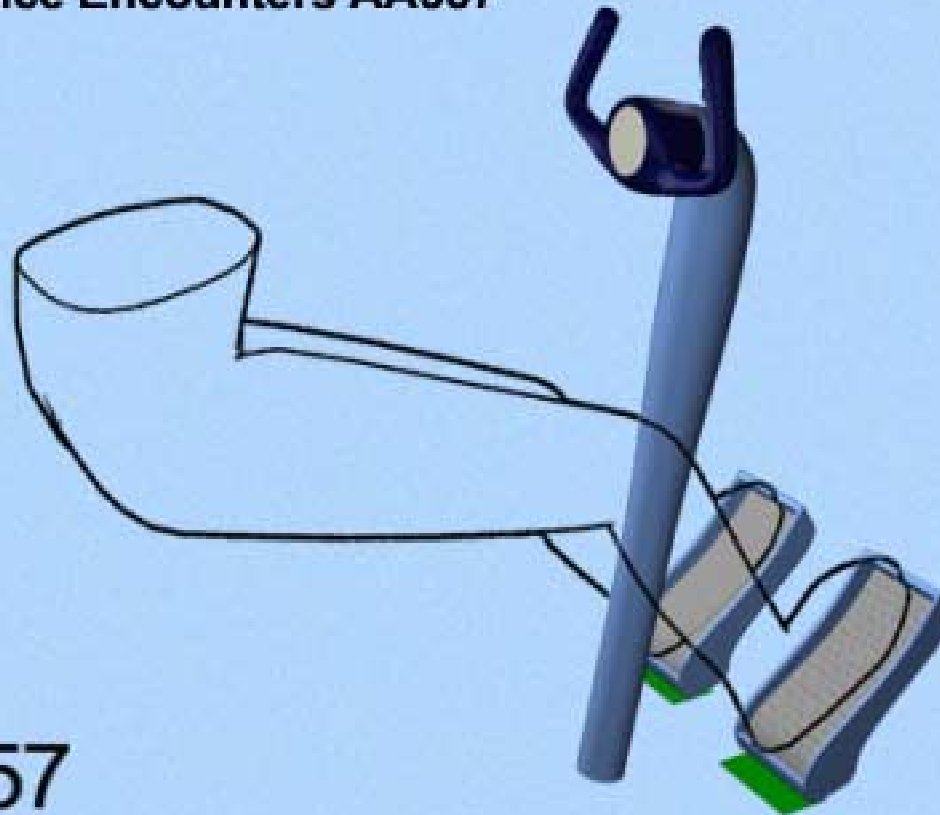
Wake Turbulence Encounters AA587

09 : 15 : 57

HOT-2: "let's go for power please."

CAM: [sound of loud thump]
