Image No.:0512A00782, Project No.: 2005120013

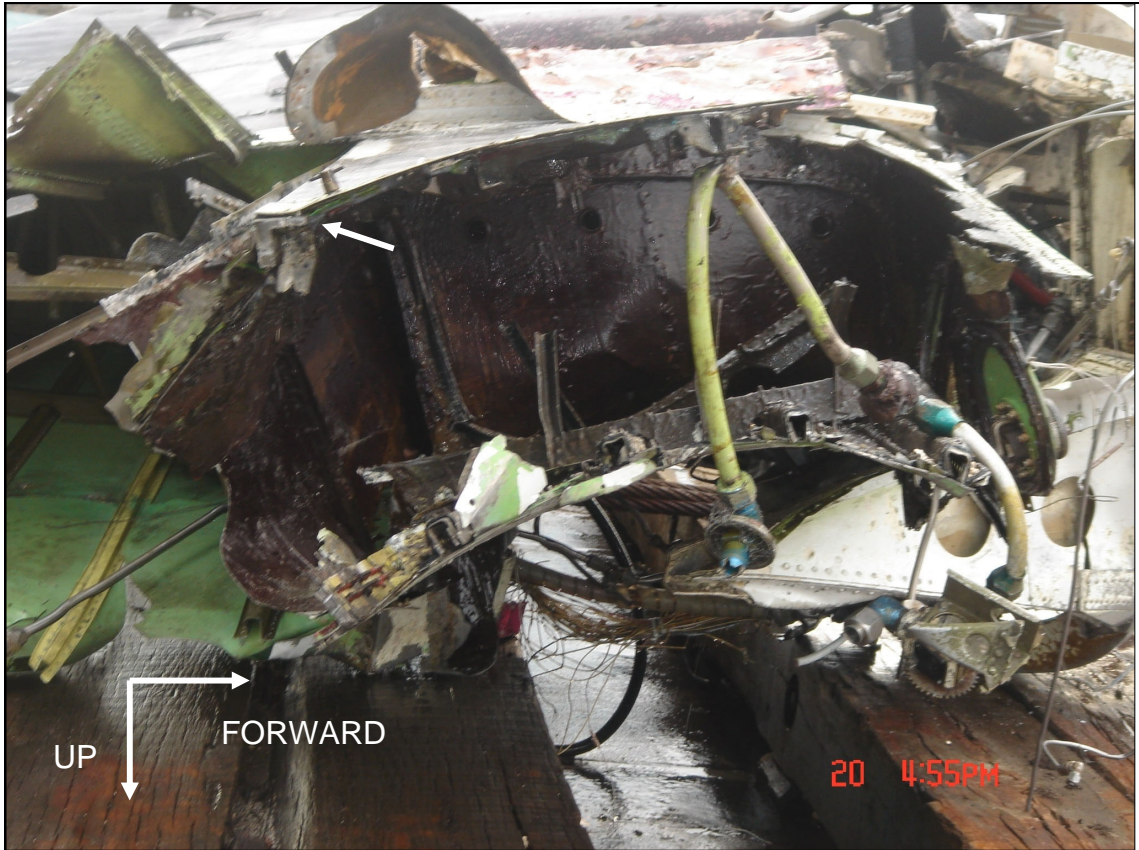
Overall view of the inboard end of the right wing as it was recovered from the water. An unlabeled arrow indicates the lower spar cap of the rear spar where fatigue features were observed.

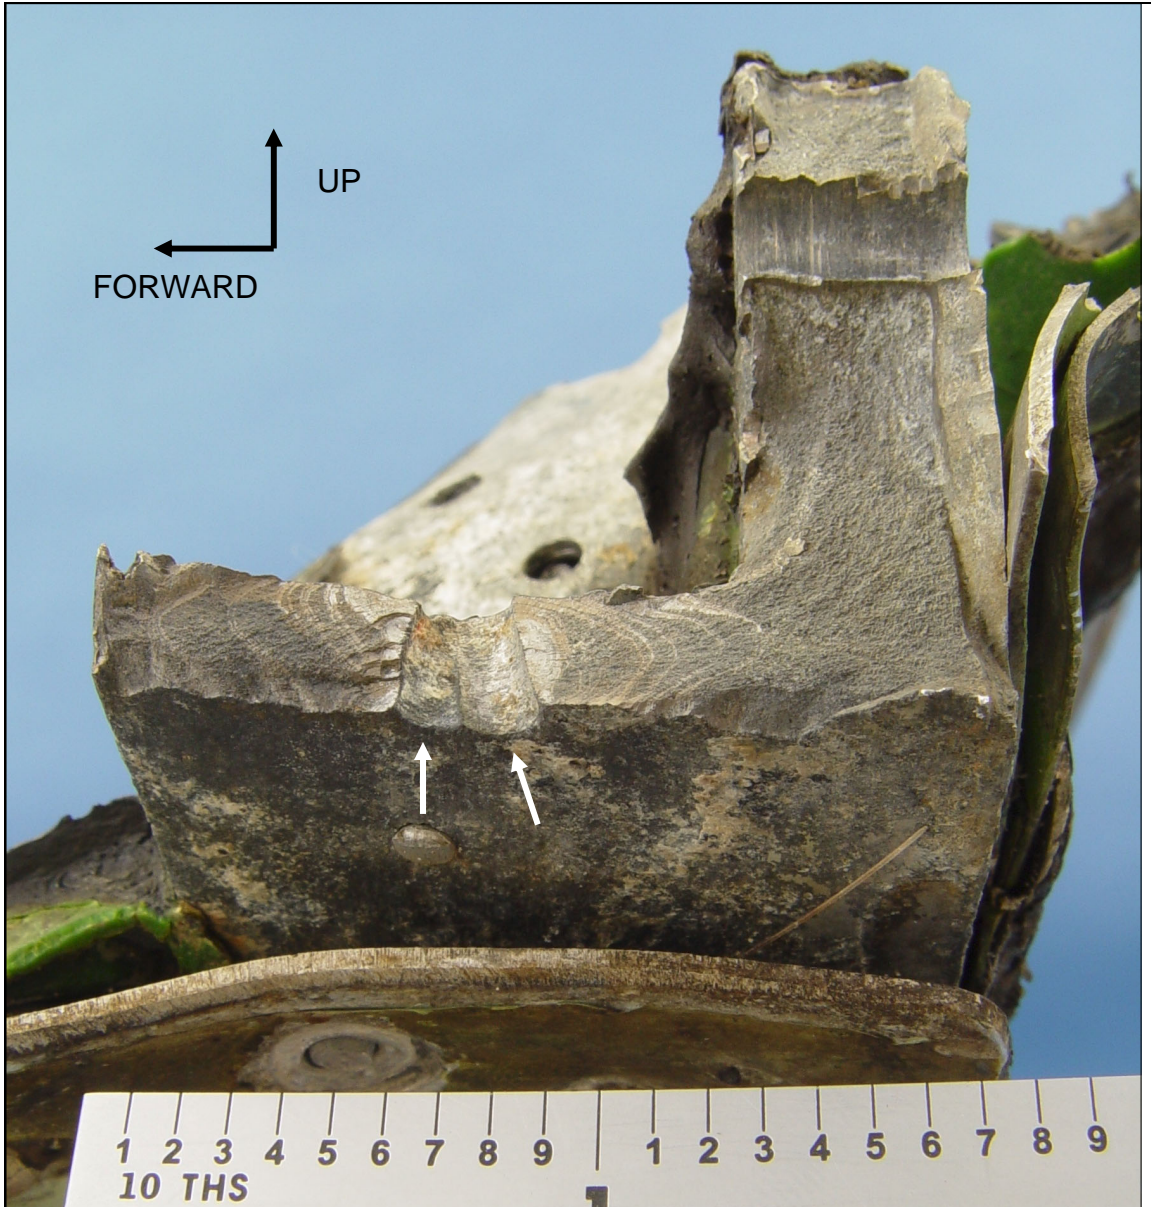
Image No.:0512A00893, Project No.: 2005120013

Closer view of the fracture surface at the inboard end of the lower spar cap of the right wing rear spar. Unlabeled arrows indicate the location of two offset drilled holes.

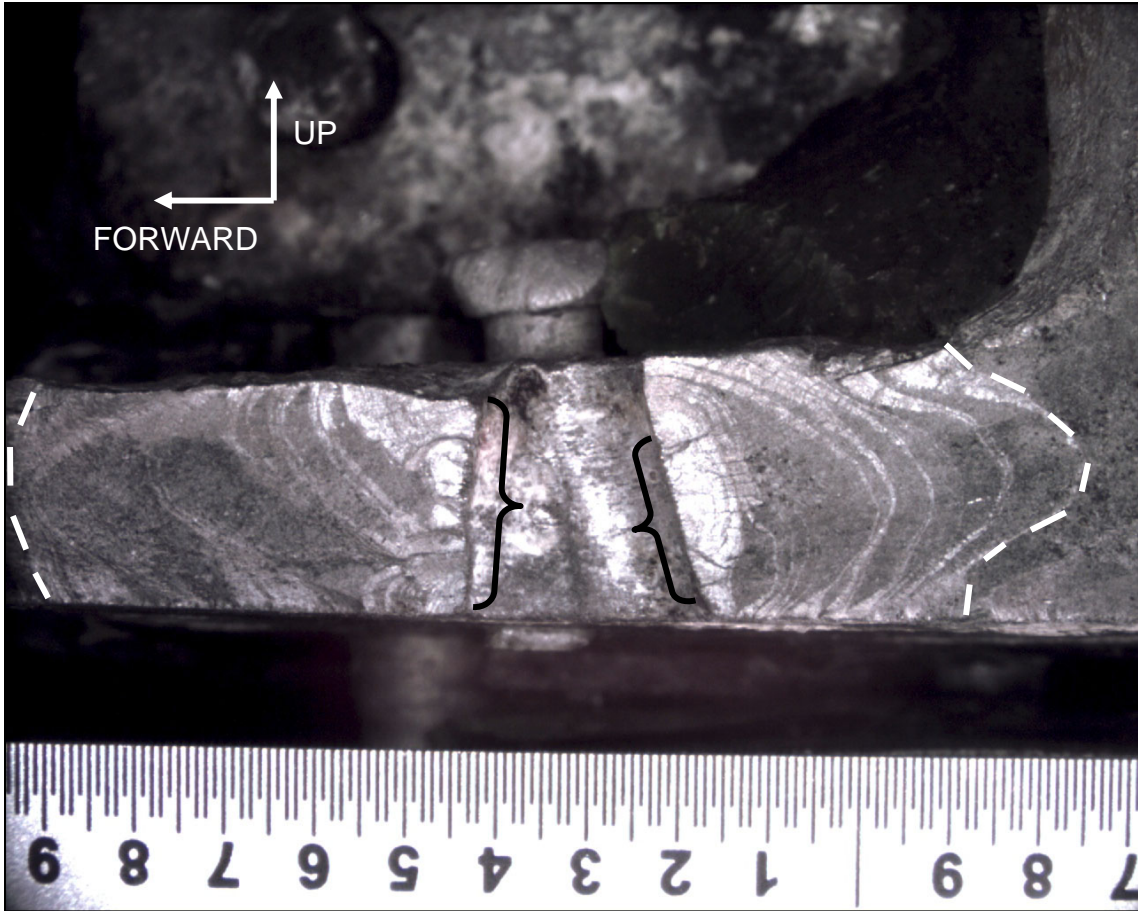
Image No.:0512A00894, Project No.: 2005120013

Closer view of the fatigue region in the horizontal leg of the lower spar cap of the rear spar. Unlabeled brackets indicate fatigue origin areas at the surfaces of the fastener hole, and dashed lines indicate the extent of the fatigue region visible on the fracture surface.
