MEETING

NRC/PG&E/AAR Corp.

April 21, 2004

BLISTERING ON BORAL MATERIAL
IN SPENT FUEL POOLS

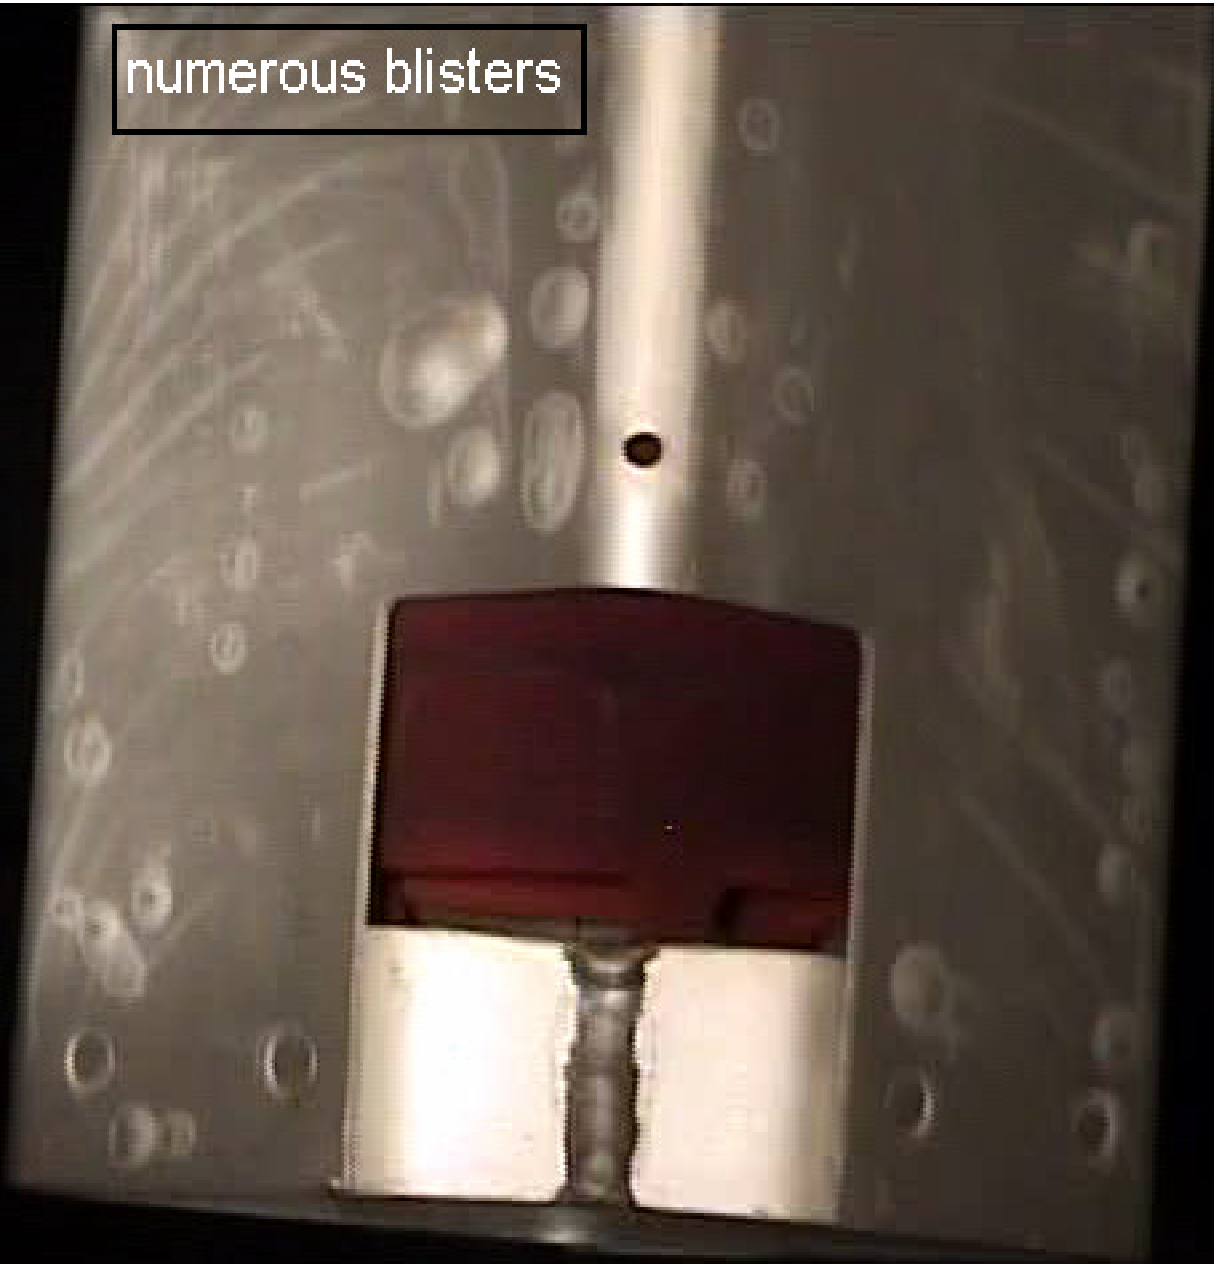
boral can: C-20

numerous blisters

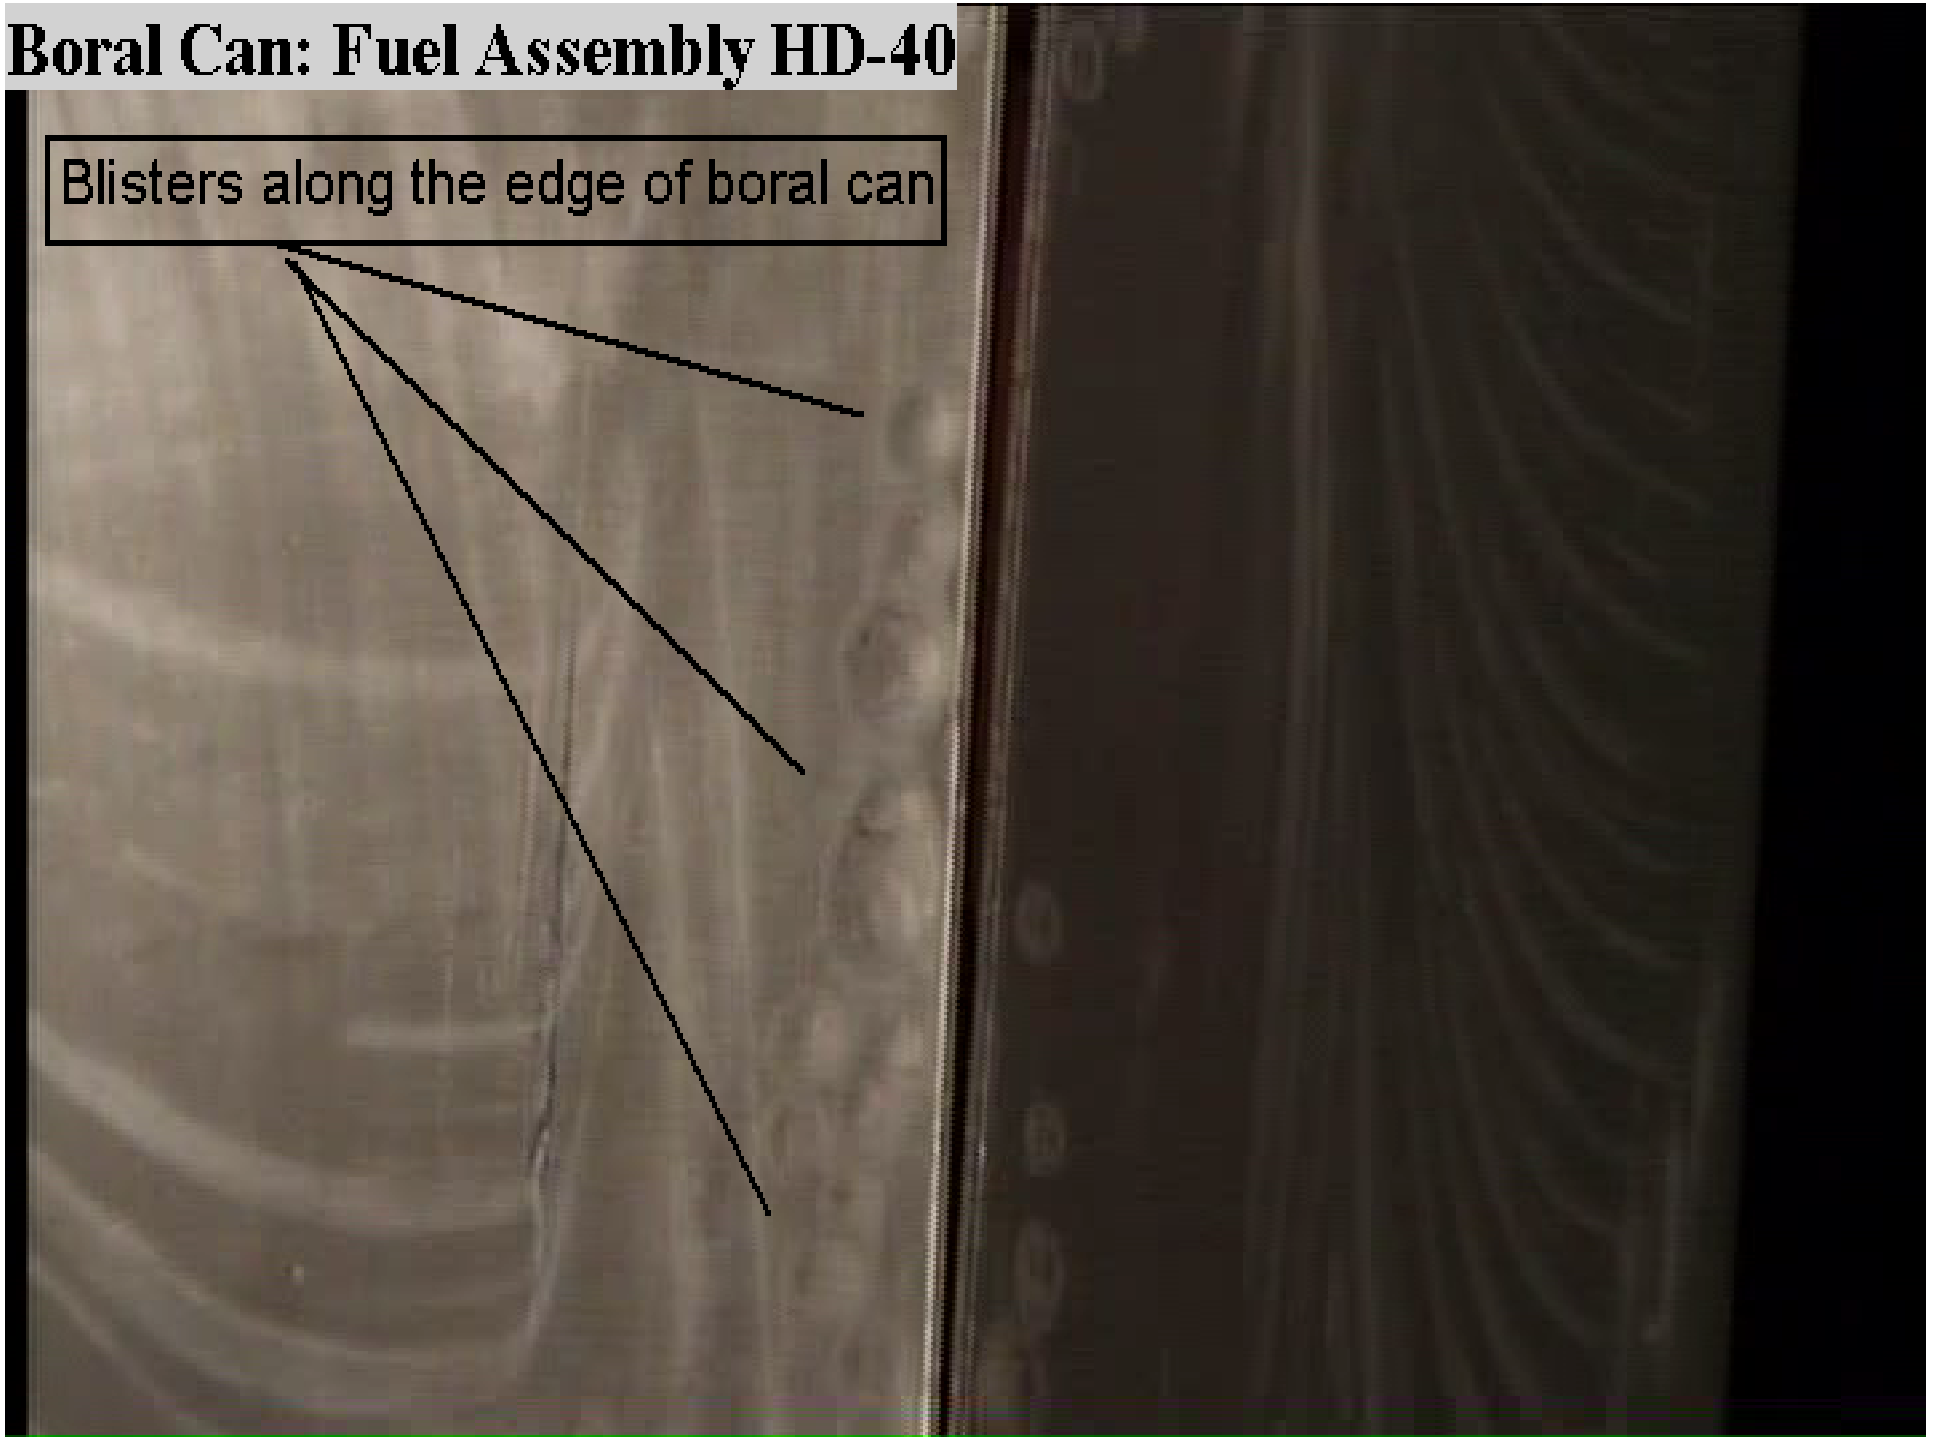
Boral Can: Fuel Assembly HD-40

Blisters along the edge of boral can

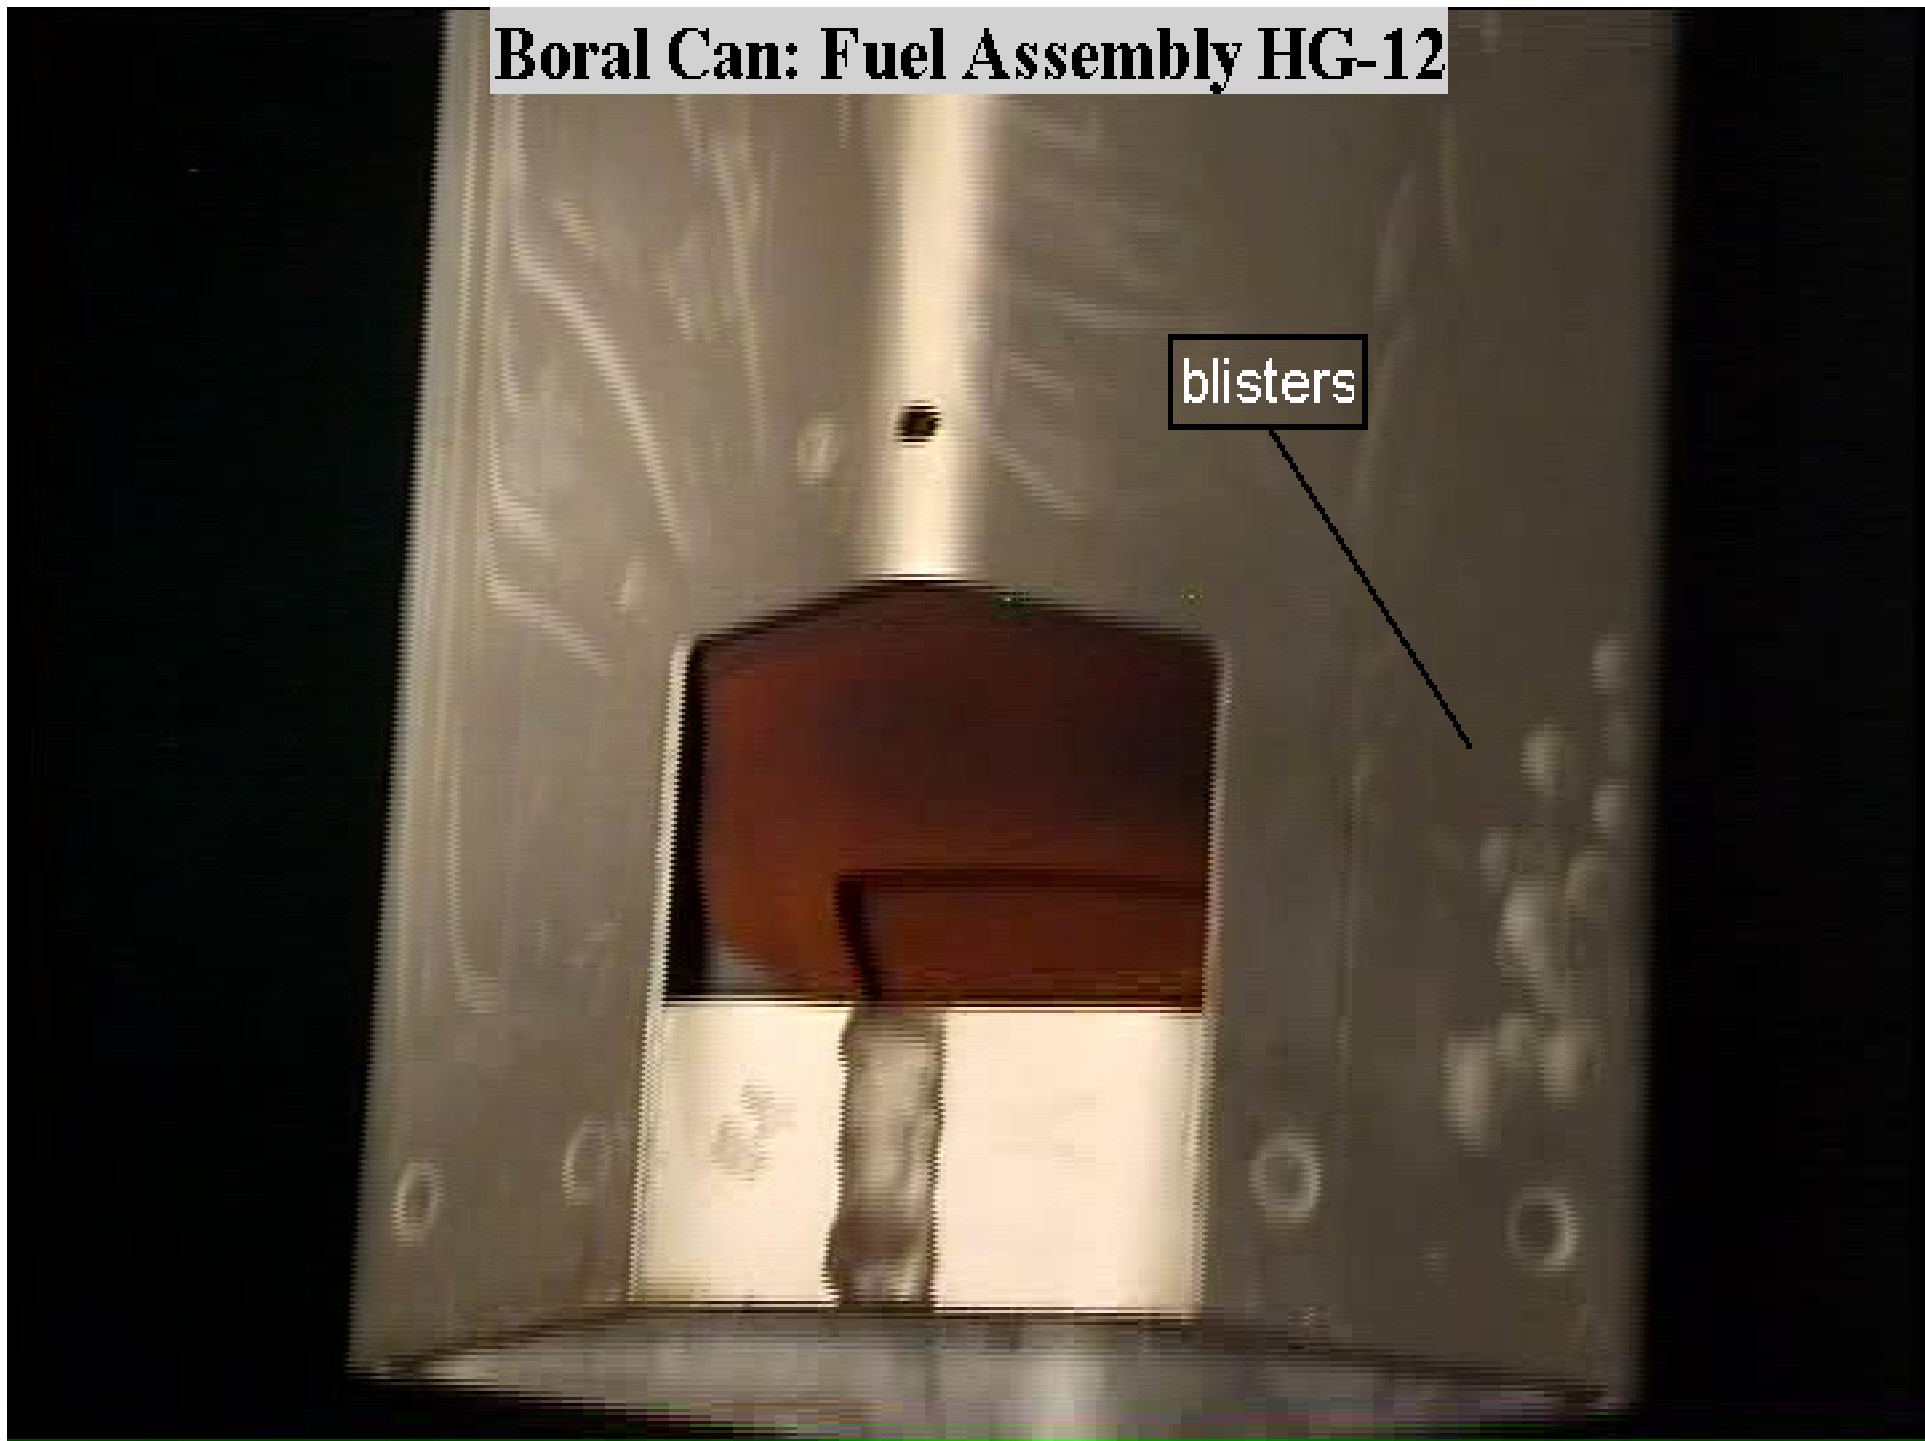
Boral Can: Fuel Assembly HG-12

blisters

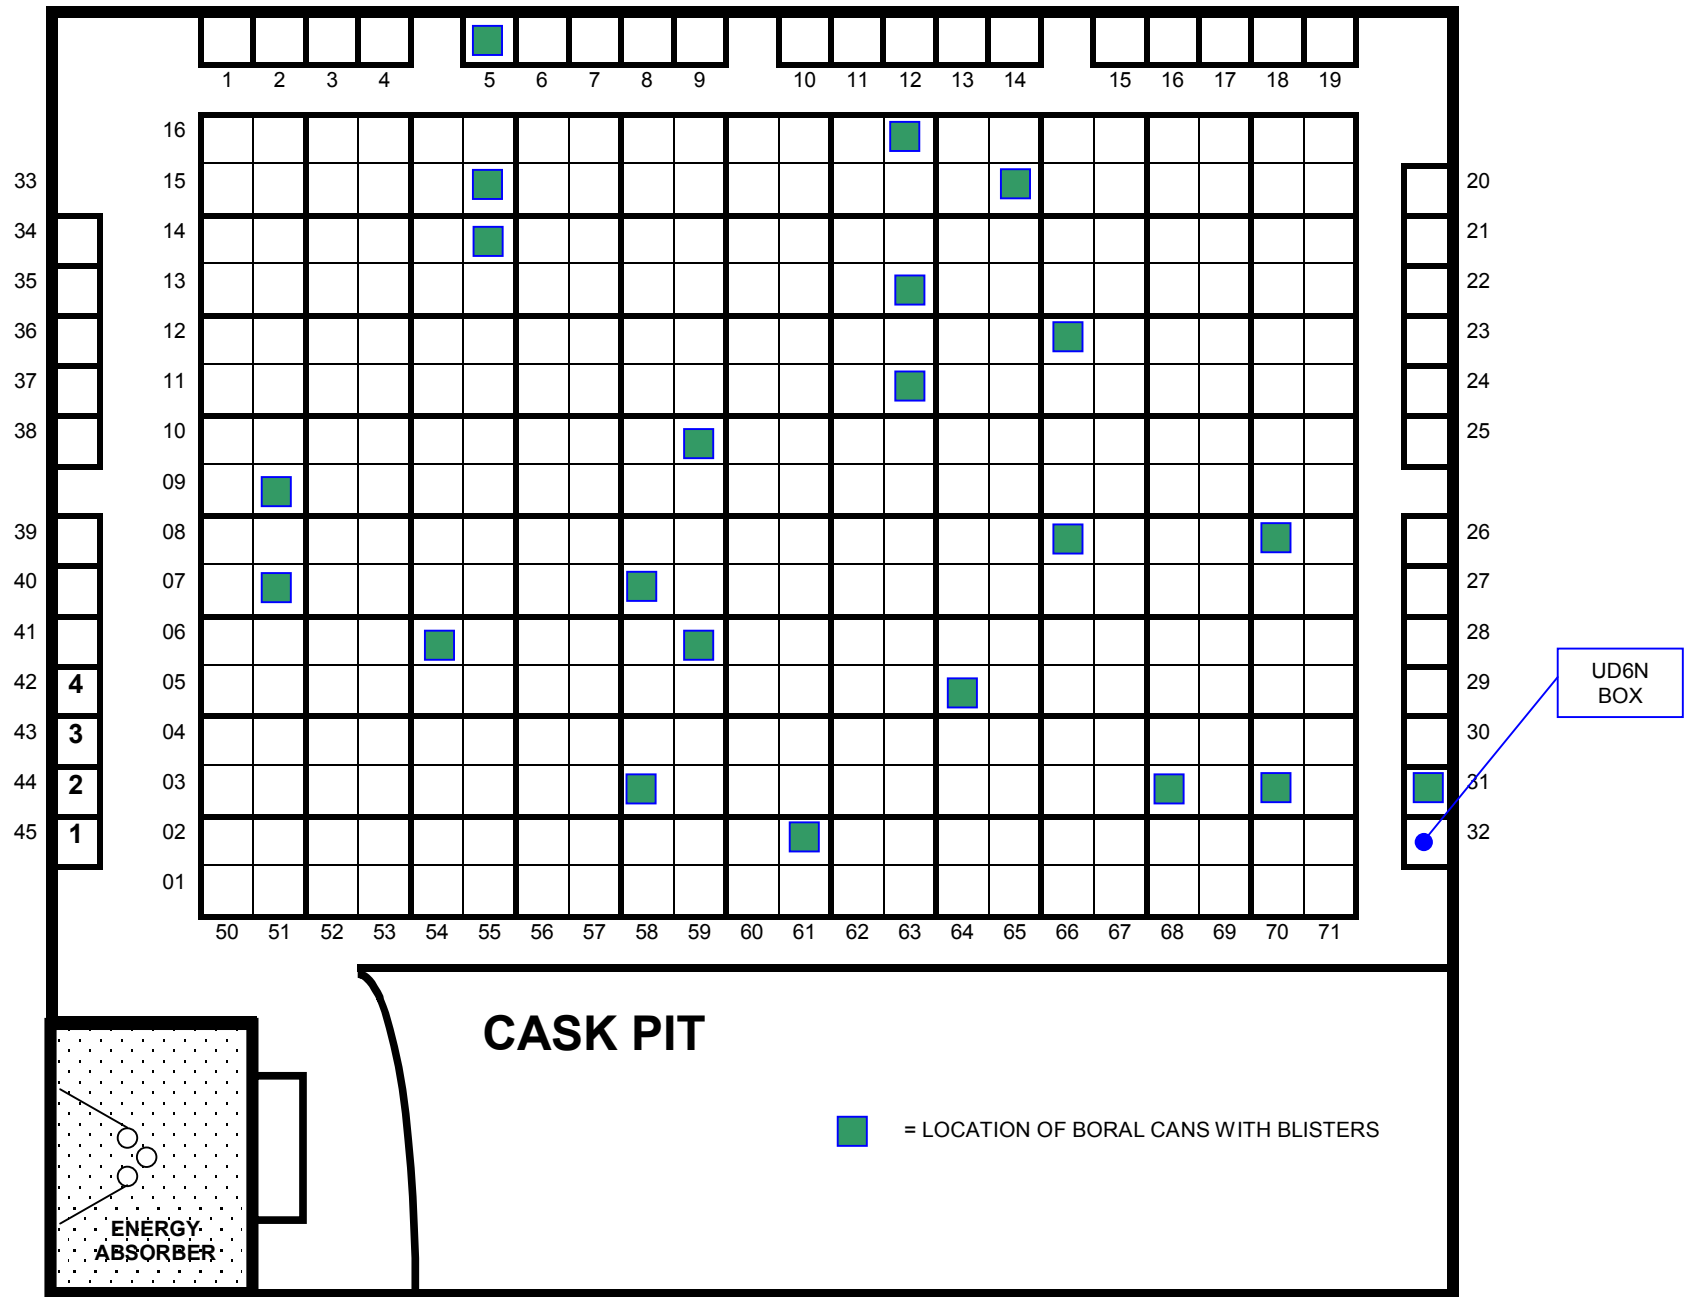
Figure 1. HBPP SPENT FUEL POOL (showing location of Boral cans having blisters)

- 387 Boral Cans Inspected
- 22 individual cans identified with blisters
- Approximately $\frac{1}{2}$ of the blistered Boral Cans have one to two blisters
- The other half of the blistered Boral Cans have more than 10 blisters each
