SECY-03-0036

SUBJECT: REPORT TO CONGRESS ON ABNORMAL OCCURRENCES FOR
FISCAL YEAR 2002

02-1 Reactor Vessel Head Degradation at Davis-Besse Nuclear Power Station in Oak Harbor, Ohio

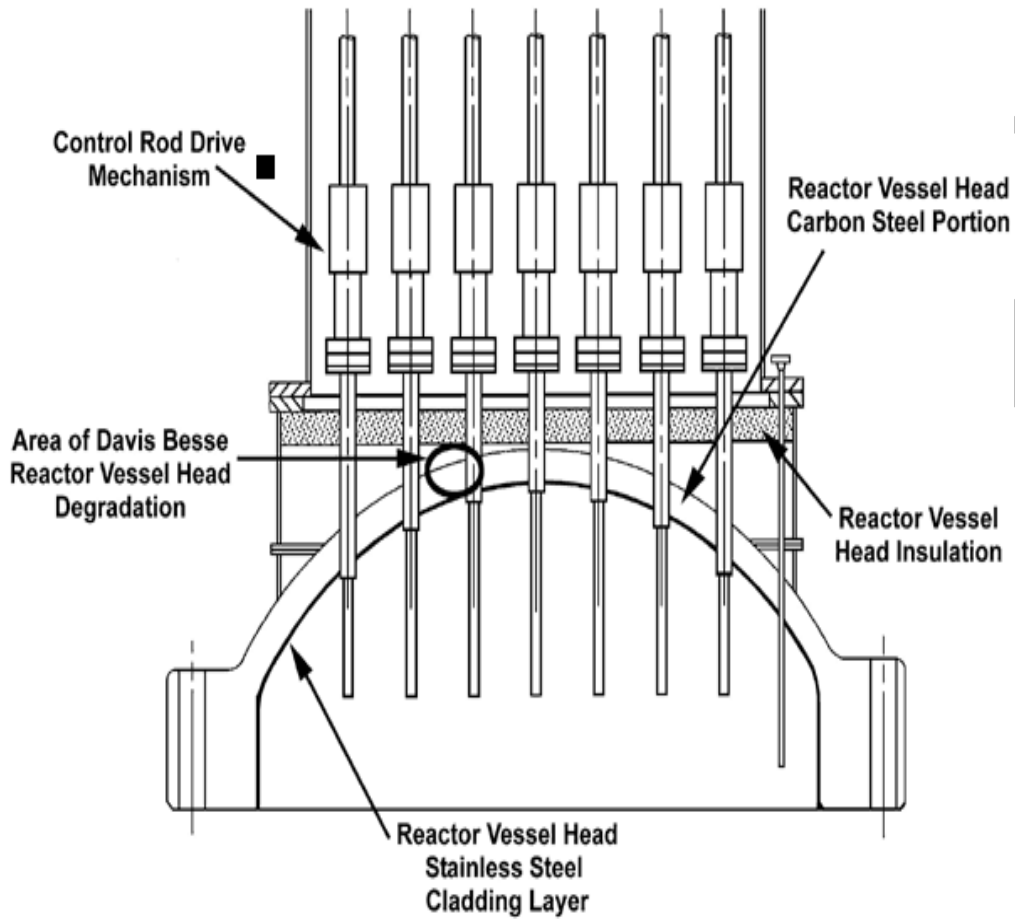
Figure 2. Reactor Vessel Head Degradation Location at Davis-Besse

On February 27, 2002, the licensee notified the NRC that non-destructive examination of CRDM Nozzles 1, 2 and 3 identified that those nozzles contained small through-wall cracks. The licensee decided to repair these three nozzles plus two other nozzles with identified cracks that did not appear to be through-wall. The repair process included machining away the lower portion of the CRDM nozzle to a point above the cracks in the nozzle material. During this activity, CRDM nozzle 3 loosened in the head and on March 6, 2002, the licensee began an investigation to identify the cause. At the same time, activities were underway to remove boric acid deposits from the top of the RPV head caused by leakage of reactor coolant from the cracks and past leaking CRDM flanges. After removing the boric acid deposits, the licensee identified a large corrosion cavity in the head material adjacent to CRDM Nozzle 3 (Figure 2). The cavity was approximately 6 inches in length and four to 5 inches in width. Within this area the 6.63 inch thick low alloy steel head was corroded away leaving only the stainless steel cladding layer on the inside. The remaining cladding layer ranged in thickness from 0.20 to 0.31 inches. Subsequent metallurgical examination of this section of cladding identified a shallow crack approximately 3/8 inch in length. This cladding

layer is designed as a corrosion resistant layer and is not designed to retain reactor operating pressure. In addition to the cavity adjacent to Nozzle 3, a comparatively small cavity was identified adjacent to Nozzle 2. This cavity was approximately 1.75 inches wide, 4 inches long, and 0.25 inches deep.

Cause or Causes — On April 18, 2002, the licensee submitted its Root Cause Analysis Report to the NRC. In this report, the licensee concluded that the most probable technical cause of the RPV head degradation was boric acid corrosion resulting from leakage through a crack in the CRDM penetration nozzle attributable to primary water stress corrosion cracking. Further, this corrosion had occurred over a period of several years. Absent more definitive information, the licensee's technical root cause analysis represents a plausible scenario for the degradation.

Licensee — The licensee elected to replace the damaged head with one procured from the owners of the cancelled Midland nuclear power plant located in Michigan. The licensee has also completed a number of activities designed to identify the management and human performance deficiencies which contributed to the degradation of the reactor vessel head and implemented a series of inspections and evaluations to identify and correct any other potentially problematic plant issues.
