**National Transportation Safety Board
Air Cargo Safety Seminar
Washington, D.C.
March 30, 2004**

**“B-767-300ER Variant Lower Lobe
Cargo ULD Restraint System”**

Problem Statement

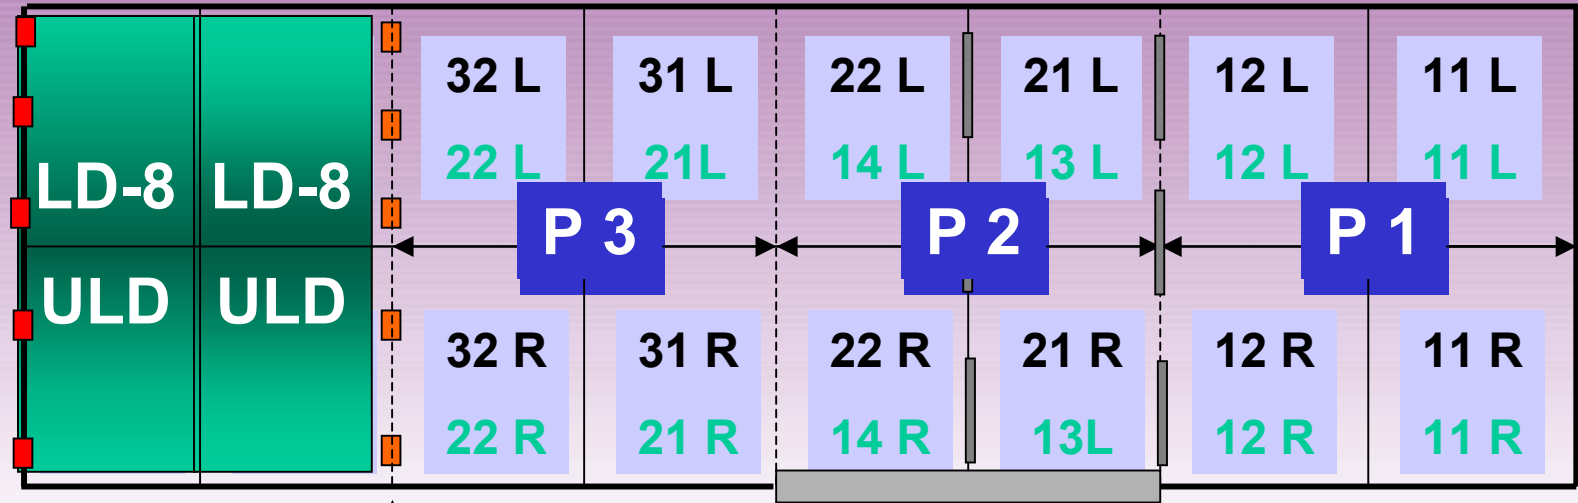
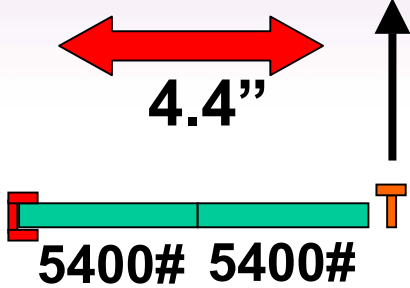
Perceived vs. True Load Shifts

There are only pallet locks between IATA position 22L&R and 23L&R! You must accept a 4.4" gap with a "stack" of only 2 LD-8s, 2 LD-3s, or 4 LD-2s here.

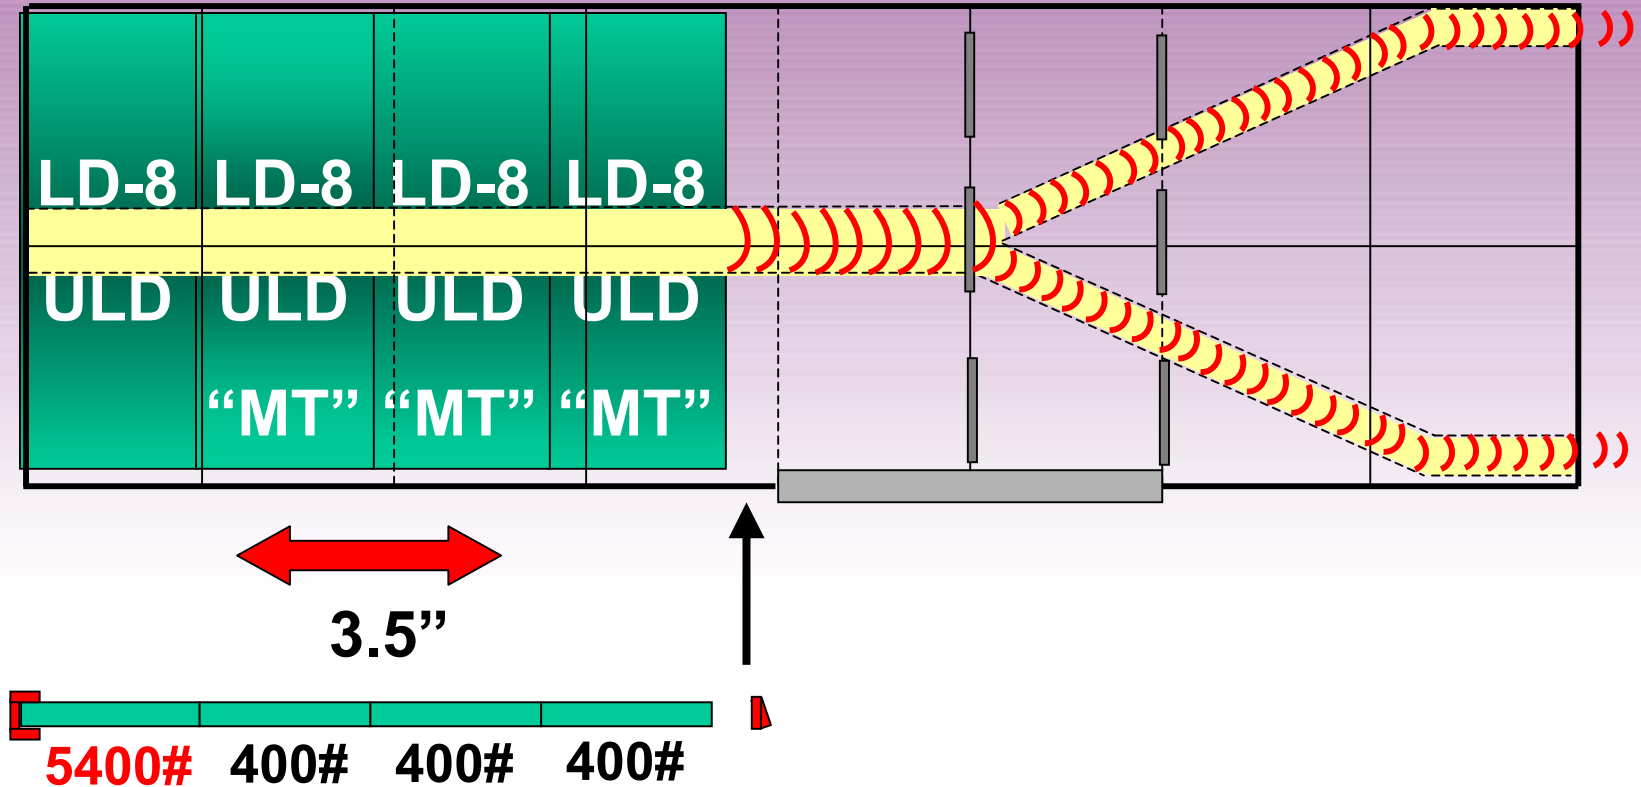
Perceived vs. True Load Shifts

Why does the noise sound like it's coming from directly behind the cockpit? One theory – empty cans act like a bellows...a large ventilation duct below the cargo deck transmits sound waves.

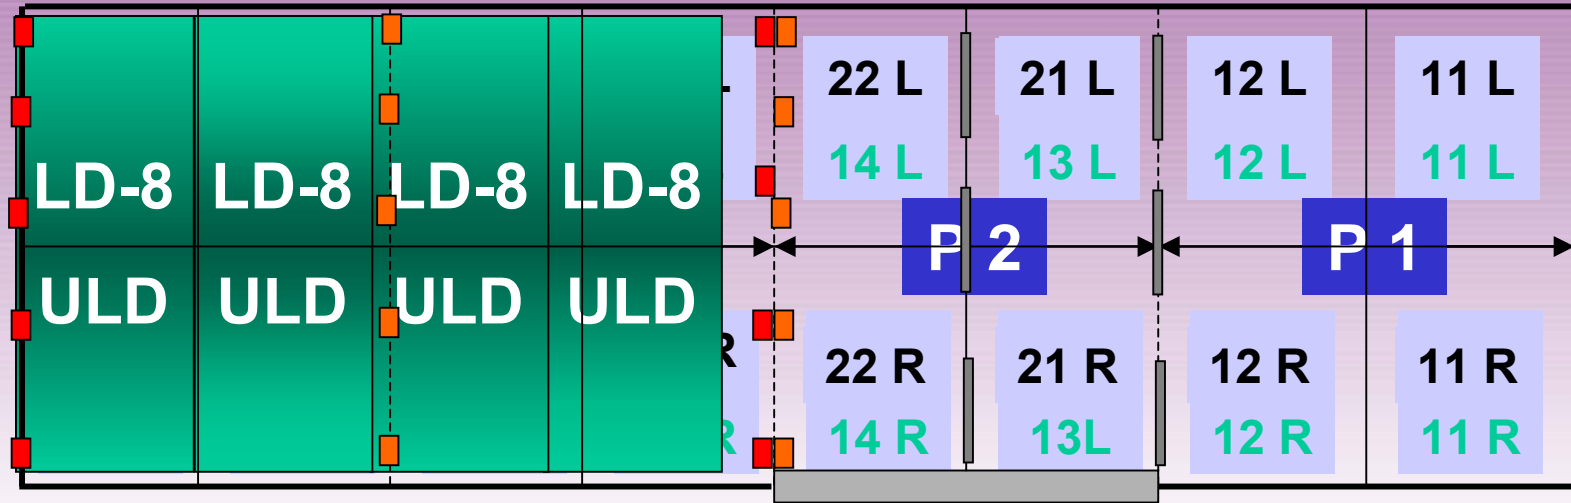
Choices

3.5"

4.4"

In the case of 4 ULDs, it's better to work with a stack of 3.5"

By raising the pallet locks* aft of IATA positions 14L&R & 22L&R you get two large gaps

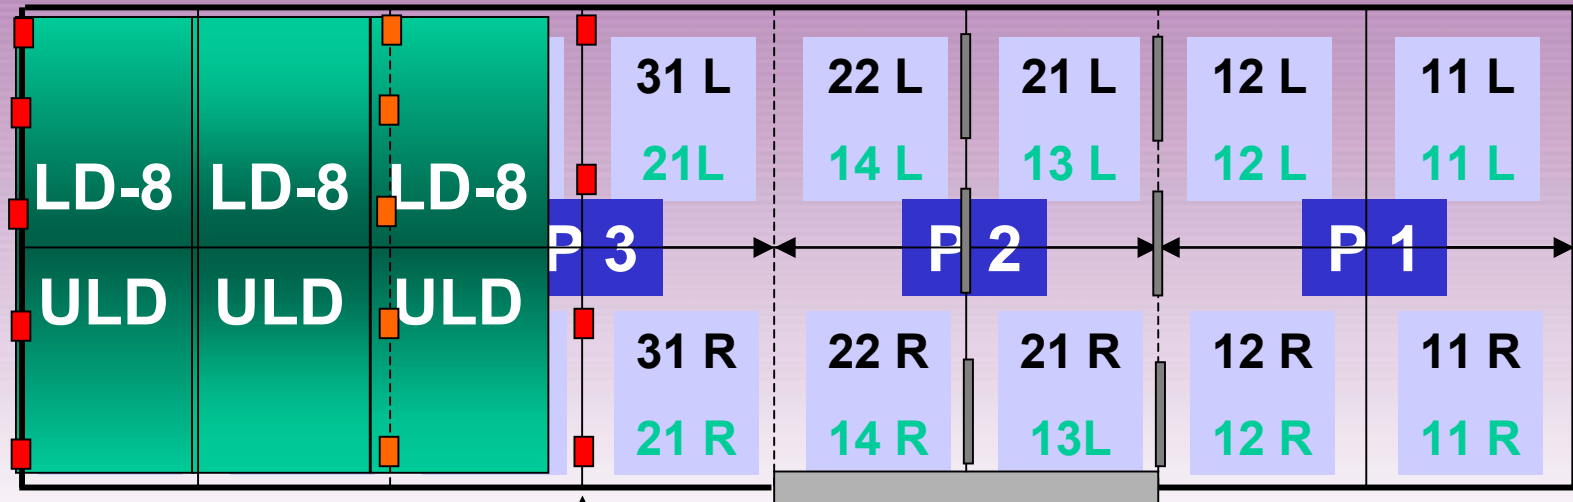
Choices

5.5"

4.4"

0.3"

This is one option but a better one might be...

Raise the pallet locks* aft of IATA position 22L&R to reduce gap

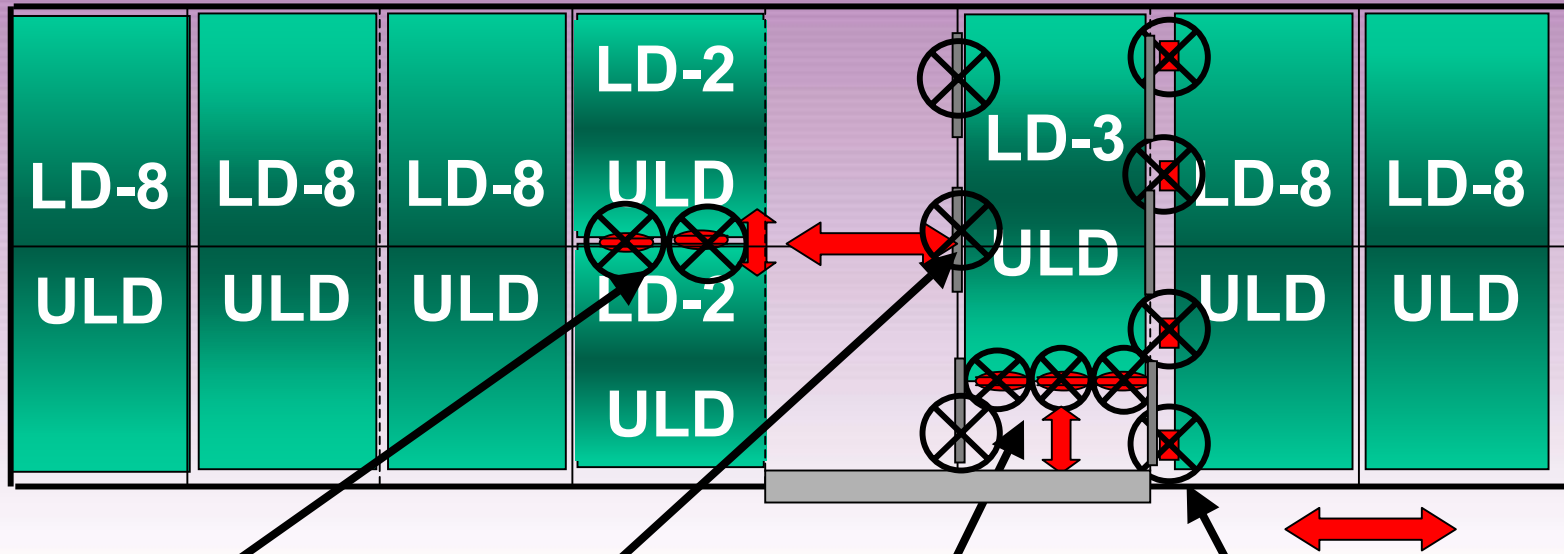
Urban Legends

**“No need”
to raise
Center
Guides on
LD-2...cans
“shingle”
together**

**“No need”
to raise Lateral
Guides in
Forward Door
Position...can in
Position 13L&R
will “float”**

**“No need”
to raise
Auxiliary
Guides on
LD-3...can
will move
laterally**

**“No need”
to raise Partial
Load Stops behind
Position 12L&R
...6” gap between
container and
Lateral Guides**

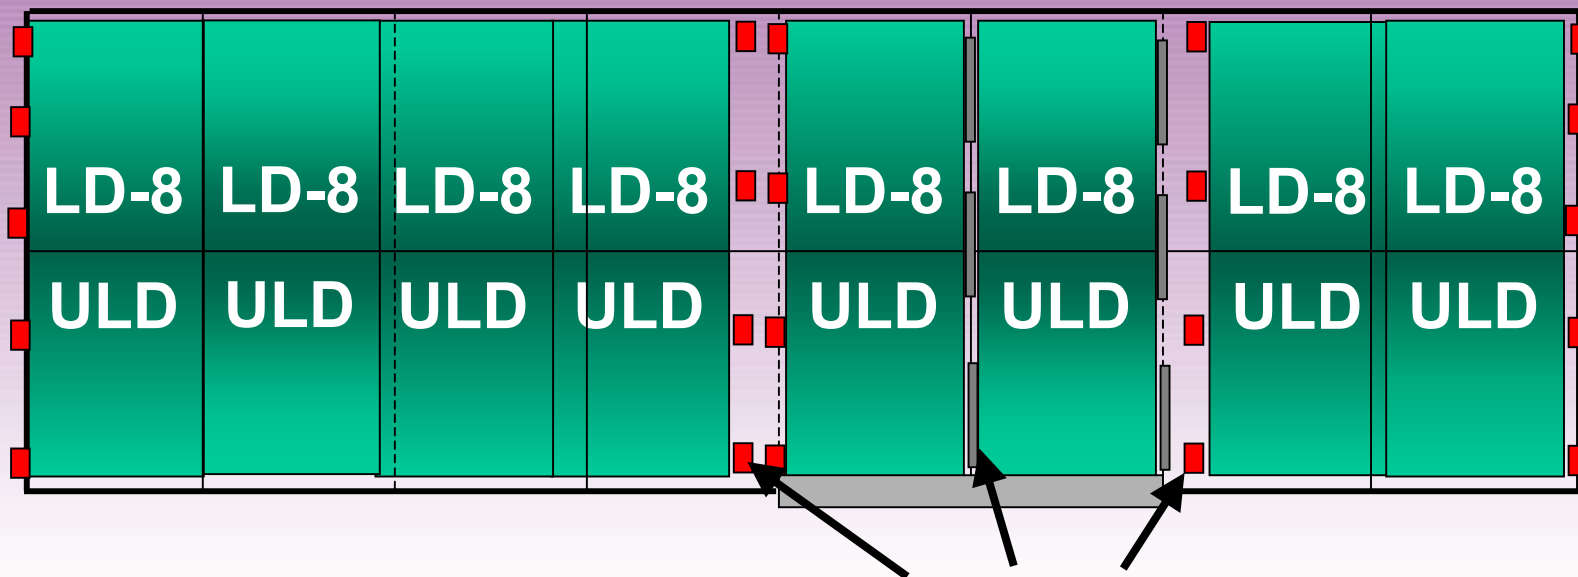
Urban Legend #1

“Please advise the loaders that certain latches need to be set even if the hold is a full fit to reduce gaps, which can cause noise, triggering false alarm load shifts.”

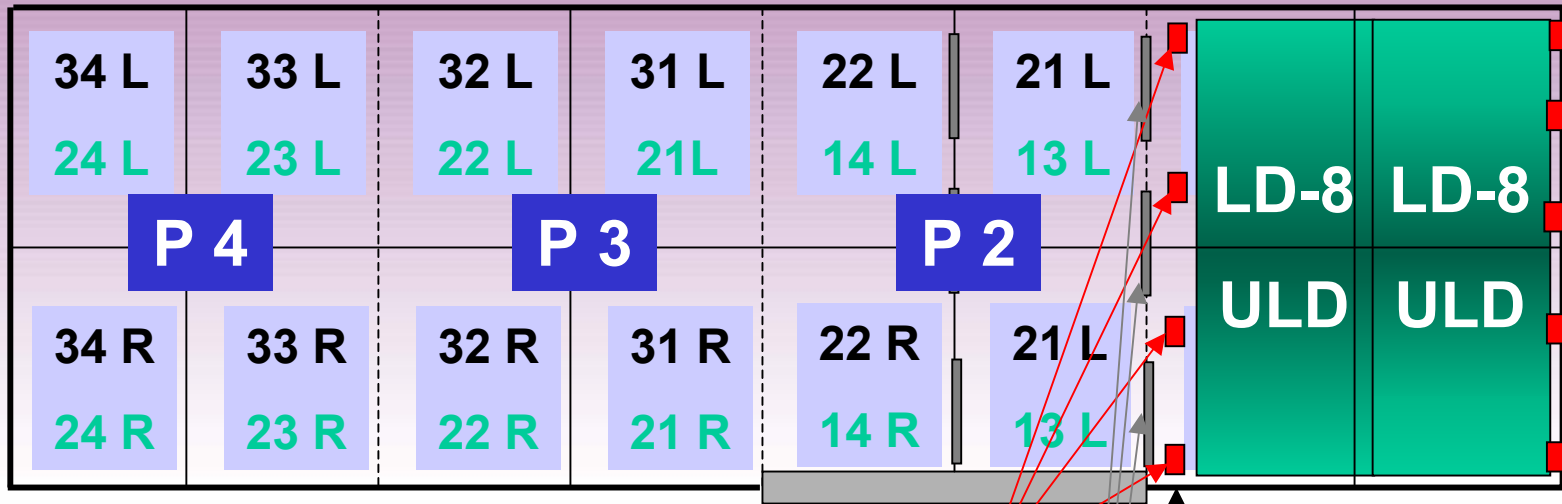
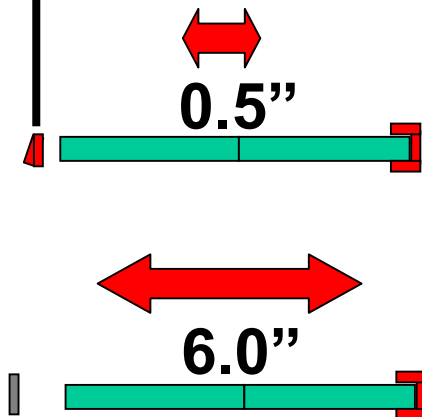
Urban Legend #2

Stack of 2 LD-8s restrained by 4
Partial Load Stops

But if you forget to raise the Partial
Load Stops, you will be depending
on the Lateral Guides!
