Water Operation and Maintenance Bulletin

No. 212

June 2005

Always Brush Your Teeth on a Regular Basis

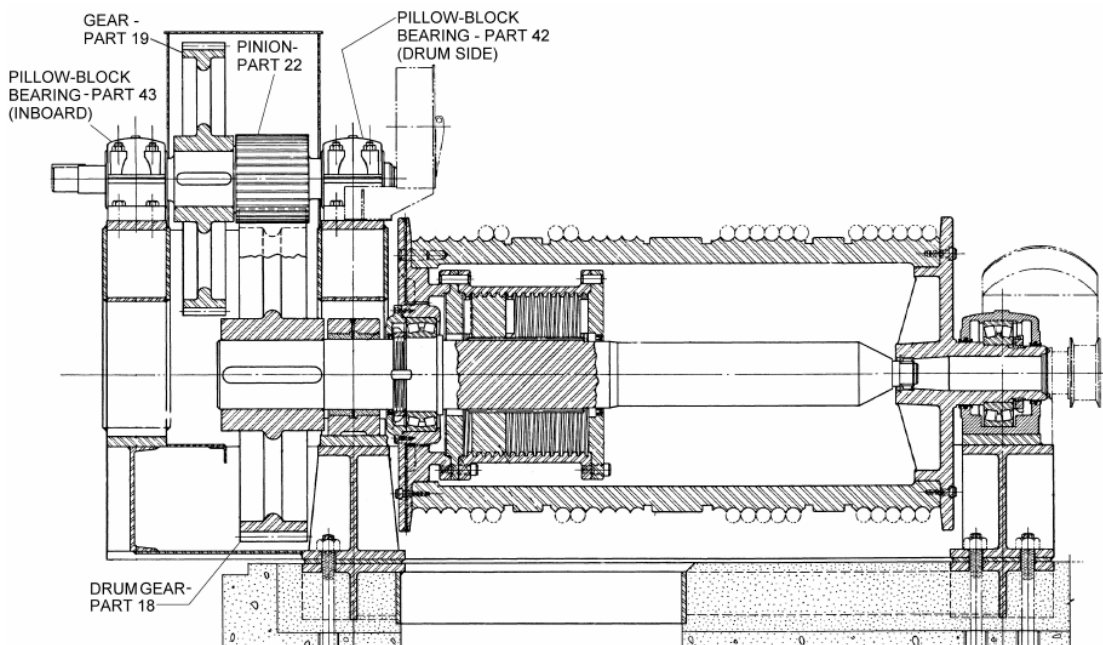
Figure 2.—Section through drum gearing.

During the hoist inspection, it was noted that the two cast housings of the bearings on the pinion shaft, which drives the drum gear, were fractured. The pinion shaft and gear are situated above the drum gear, and the housing of the bearing on the drum end of the shaft (Part 42) and was completely cracked and separated (see figure 2 and photo 1).

The bearing (Part 43 in figure 2) housing on the inboard side of the shaft was severely cracked, but had not completely separated or lifted. It was clear that the bearing housings had cracked from large separation forces generated by the pinion/gear (Parts 22 and 18 in figure 2) mesh. A large amount of bird debris was present in and around the gearing unit. The upper portion or the circumference of the drum gear contained significant amounts of a compressed mixture of bird droppings, feathers, and dirt between the gear teeth (see photo 2).

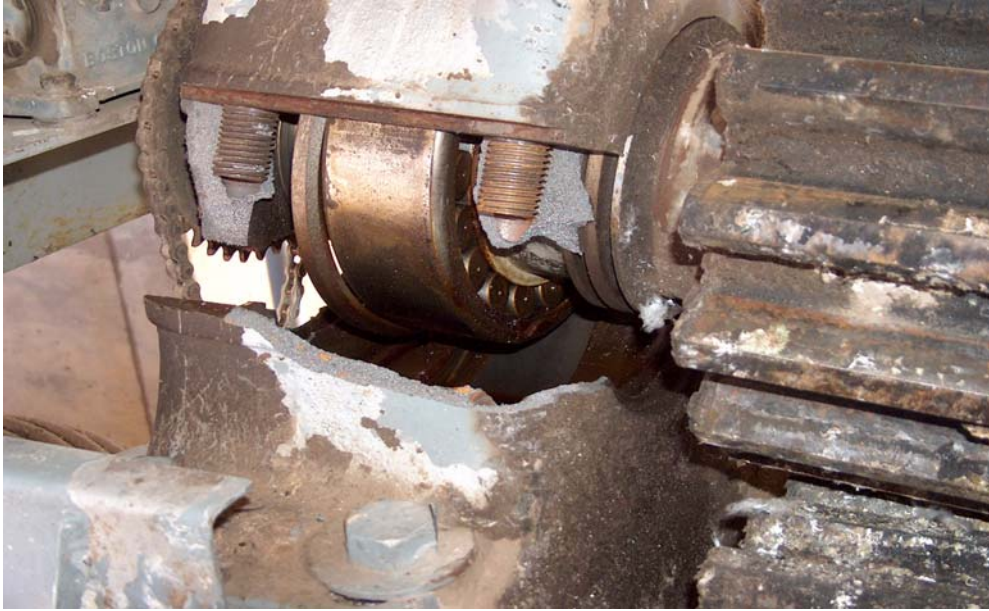
Photo 1.—Fractured casting – pillow block bearing (Part 42).

It was concluded that the debris mixture caused the gear mesh to separate, which fractured the bearing castings. It is likely that most of the buildup of debris that caused this problem occurred over the recent winter months of inactivity.

The bearings were manufactured by SKF in the 1950s and can be replaced with similar models.

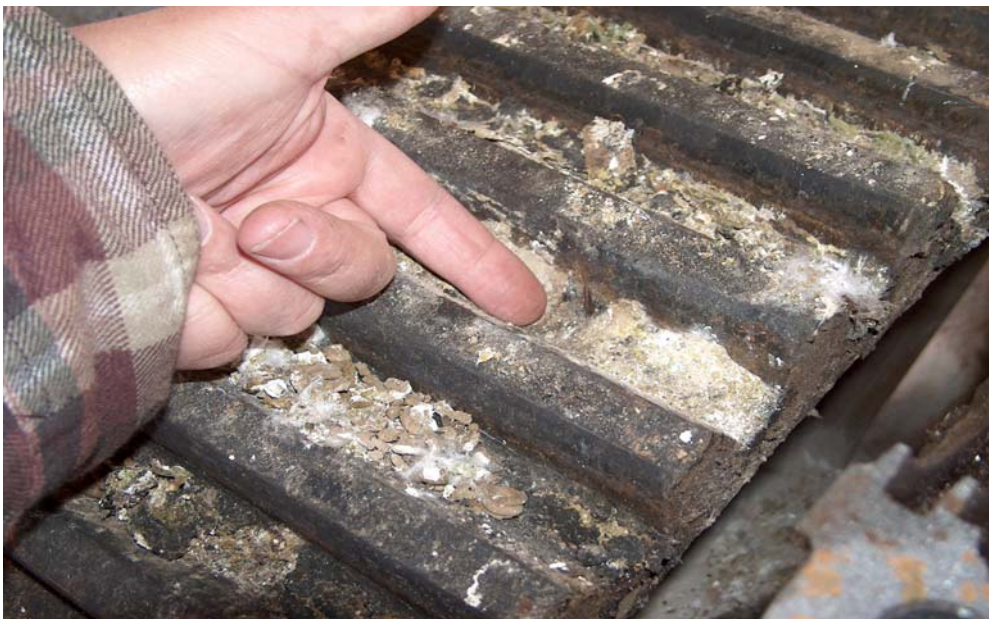
Photo 2.—Debris in gear teeth.

The gear teeth for the pinion/drum gear mesh are 20° stub involute. This type of tooth has a clearance of approximately 1/8 inch (tip of tooth to root of meshed gear). The valley between teeth had been filled with compressed debris, and the design clearance no longer existed. Any additional bearing clearance was exceeded as well. With no room to completely mesh, the gears were forced to separate, which resulted in the upward force on the shaft. The teeth that were packed the fullest with debris were the ones that would have been meshed with the pinion during the beginning of the lifting process, when the bearing housings were fractured.

The gear teeth should be cleaned by power washing, and the screening should be improved to keep birds from inhabiting the gear units. In the future, closer monitoring of the gears should confirm that the problem has not reoccurred.

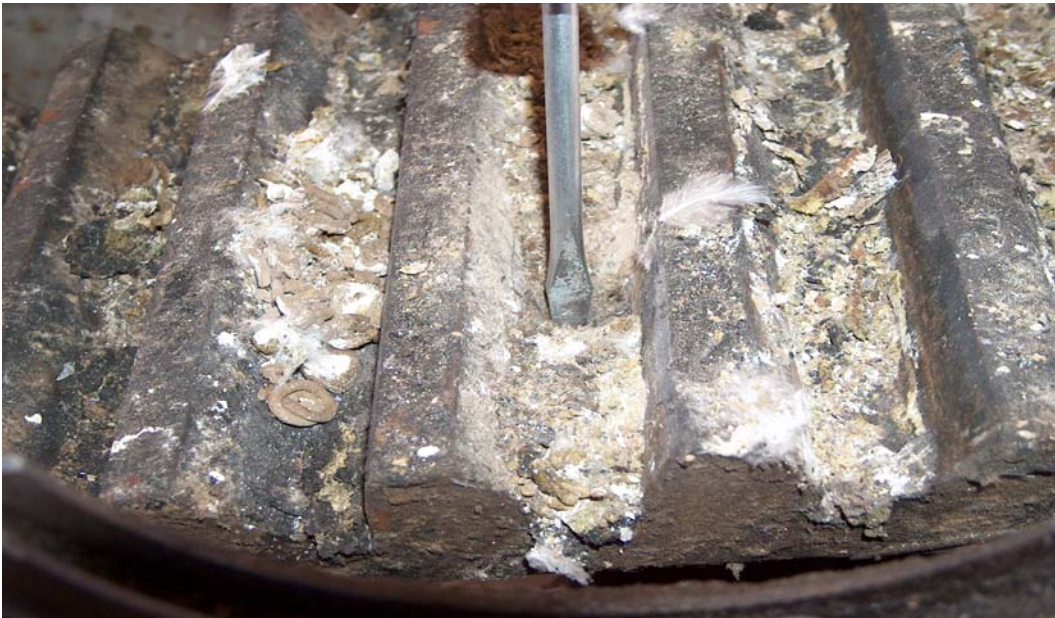
Inspection of the hoist resumed, and the dismantling of the damaged portion of the hoist began. The bearing housing bolts were removed, and the pinion shaft was removed using a small chain hoist that was suspended from the roadway bridge beams. The pinion and drum gear teeth did not show any signs of uneven wear or damage, and no portions of the gear teeth were missing. No rocks or other items were present, other than the bird debris, which would have caused separation of the mesh. Using a screwdriver tip to scrape the bird debris that had accumulated at the gear tooth roots confirmed that the material was extremely hard packed and was, in some cases, up to ½” thick (see photo 3).

Photo 3.—Debris gouged with screwdriver tip.

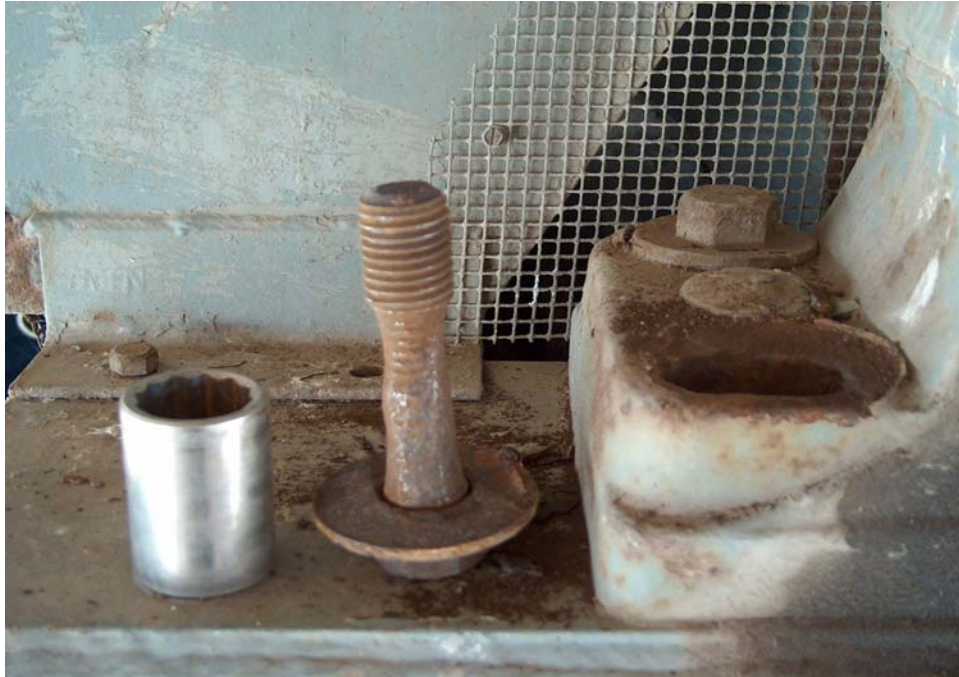
When the bearing bolts were removed, it was noted that the bolt shafts were corroded and had lost a significant amount of diameter between the head and the threads (see photo 4). The bolts are used with steel washers through slotted holes in the base of the bearing castings. The washers are not always positioned to cover the slot completely, allowing water to pool inside of the slots, causing the corrosion of the bolts (see photo 5).

Photo 4.—Bearing bolt corrosion.

The bolts and washers of the bearing housings will need to be replaced. After the bearings are bolted down, the annulus area around the bolts in the slots of the bearing bases should be sealed with caulk to keep water out.

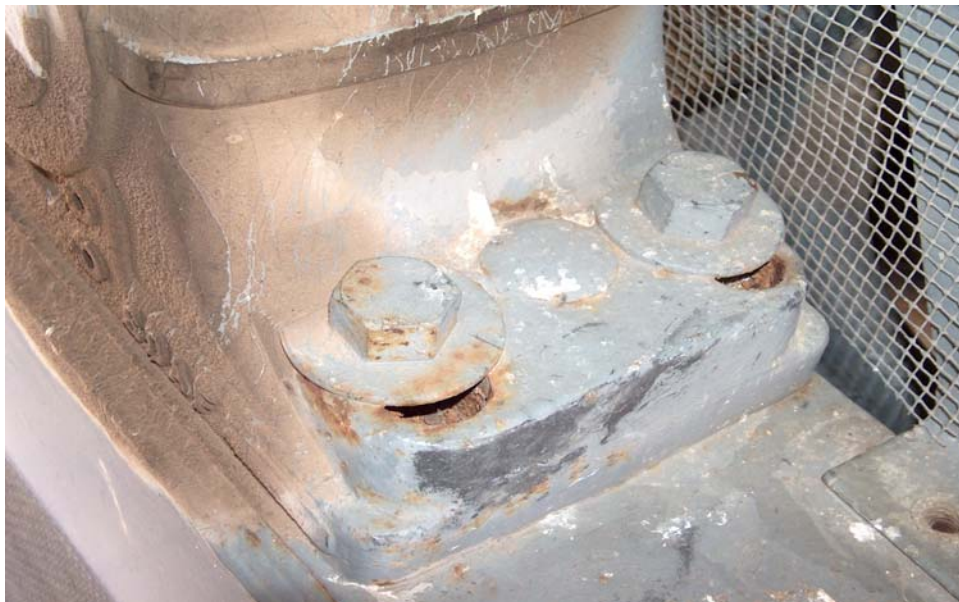
Photo 5.—Slotted holes not covered by washer.
