WATER OPERATION AND MAINTENANCE

BULLETIN NO. 75

MARCH 1971

CONCRETE PIPE JOINT LEAK REPAIR

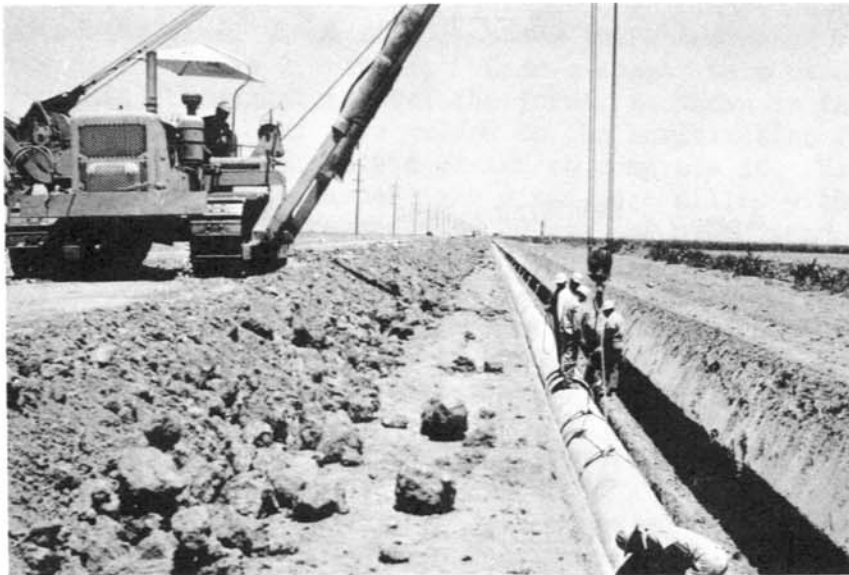
Photograph 1. Photo P805-243-1177 NA

Considerable time and thought has been given to economical methods of repairing concrete pipelines without taking them out of service, and a study aimed at stopping leakage from concrete pipe joints without taking the water out of the pipelines of a distribution system on the Central Valley Project was conducted in 1970. The study was made by the Fresno Construction Office of the Bureau of Reclamation which is responsible for the construction of the many miles of pipelines on the Westlands Water District Distribution System of the San Luis Unit, Central Valley Project, California. Photograph 1 below, shows the installation of a 27-inch pretensioned pipe in a trench that has been excavated to accommodate placement of a 2-inch grout layer prior to the compacted backfill.

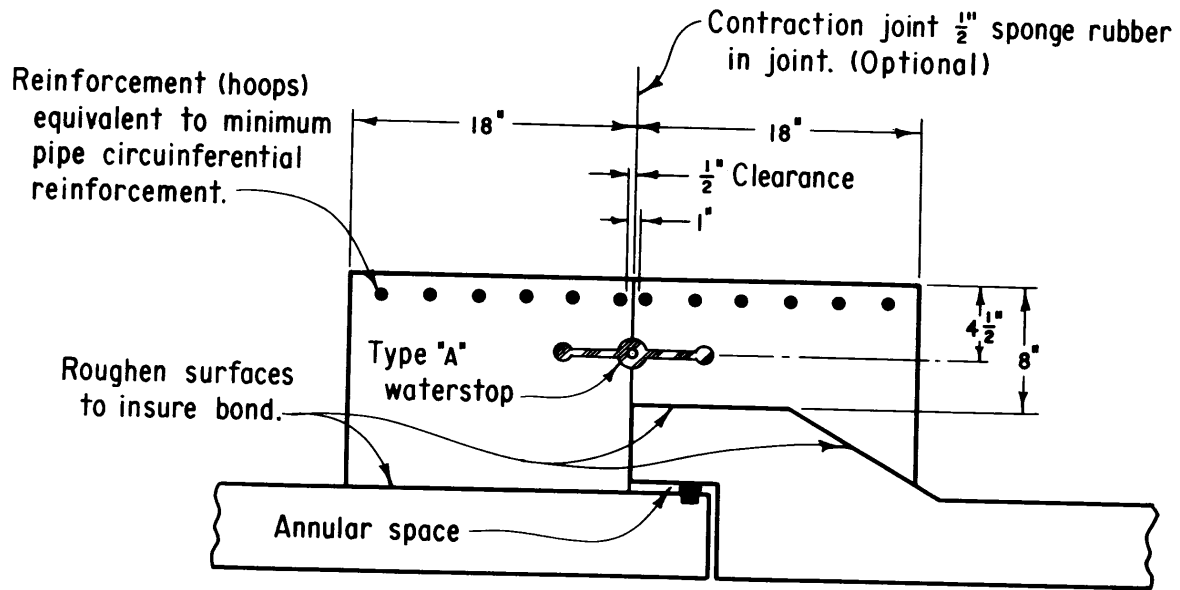
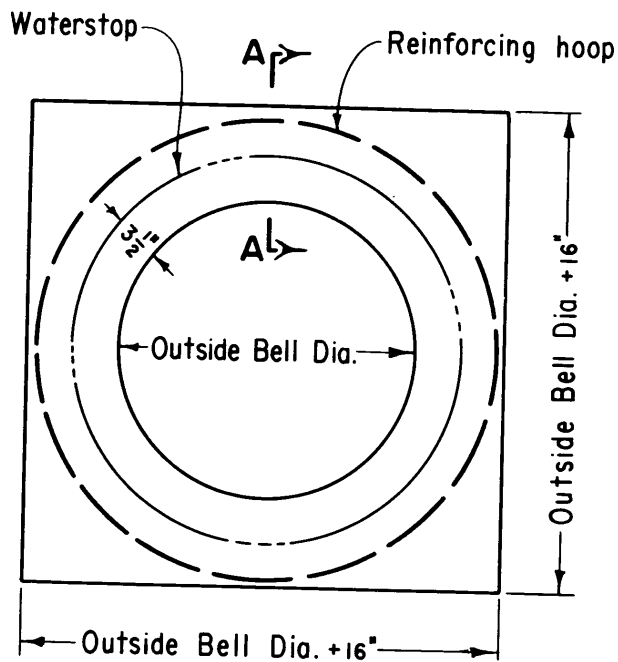
FIGURE 1

Reinforced concrete encasements as shown in Figure 1 on the next page, were being utilized to repair leaking pipe joints. Since this method made it necessary to drain the pipeline downstream and immediately upstream from the leaking joint, there are times when there is serious interference with irrigation schedules. Also the concentrated weight of the concrete encasement on the saturated ground about the joint can cause settlement of the repaired joint and aggravation of the problem at not only the joint under repair, but also at adjacent joints.

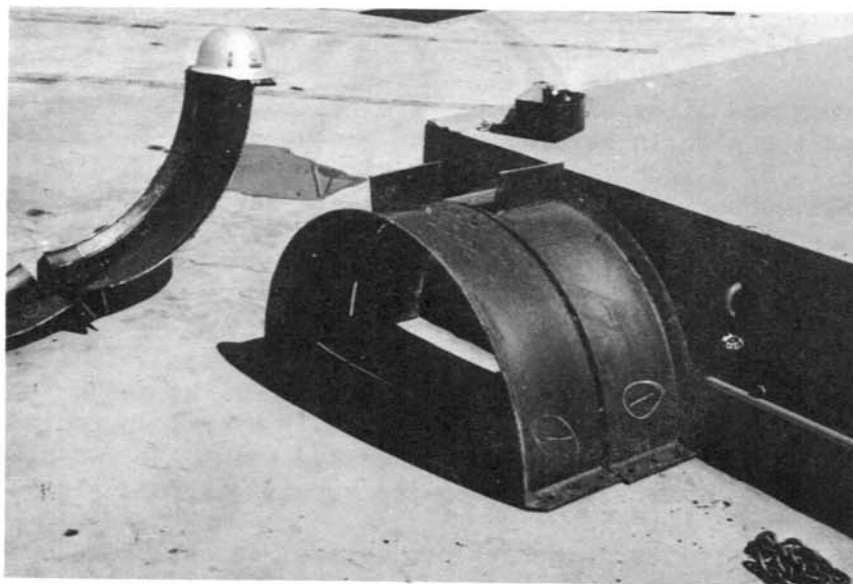
Photograph 2. Photo CN805-243-1167 NA

The first steel ring tested was one that could be clamped about the spigot end of the pipe. This ring is shown in Photograph 2 below, and in the drawing in Figure 2, page 5. "Come-a-longs" were used to pull the ring against the gasket to seal the joint, as shown in Photograph 3 on the next page. Two ears were welded on the semicircular rings in order to draw the ring against the gasket to compress it. With the gasket in place and the ring clamped, the pipes were filled with water and the pressure was slowly increased. At 20 psi the pipe began to leak. The leak occurred between the gasket and the face of the bell. Experimentation indicated that even if sufficient compression of the gasket could be developed to prevent leakage small settlement of the pipe would relieve the pressure on the gasket on one side of the ring enabling a leak to reoccur. This ring was therefore abandoned.

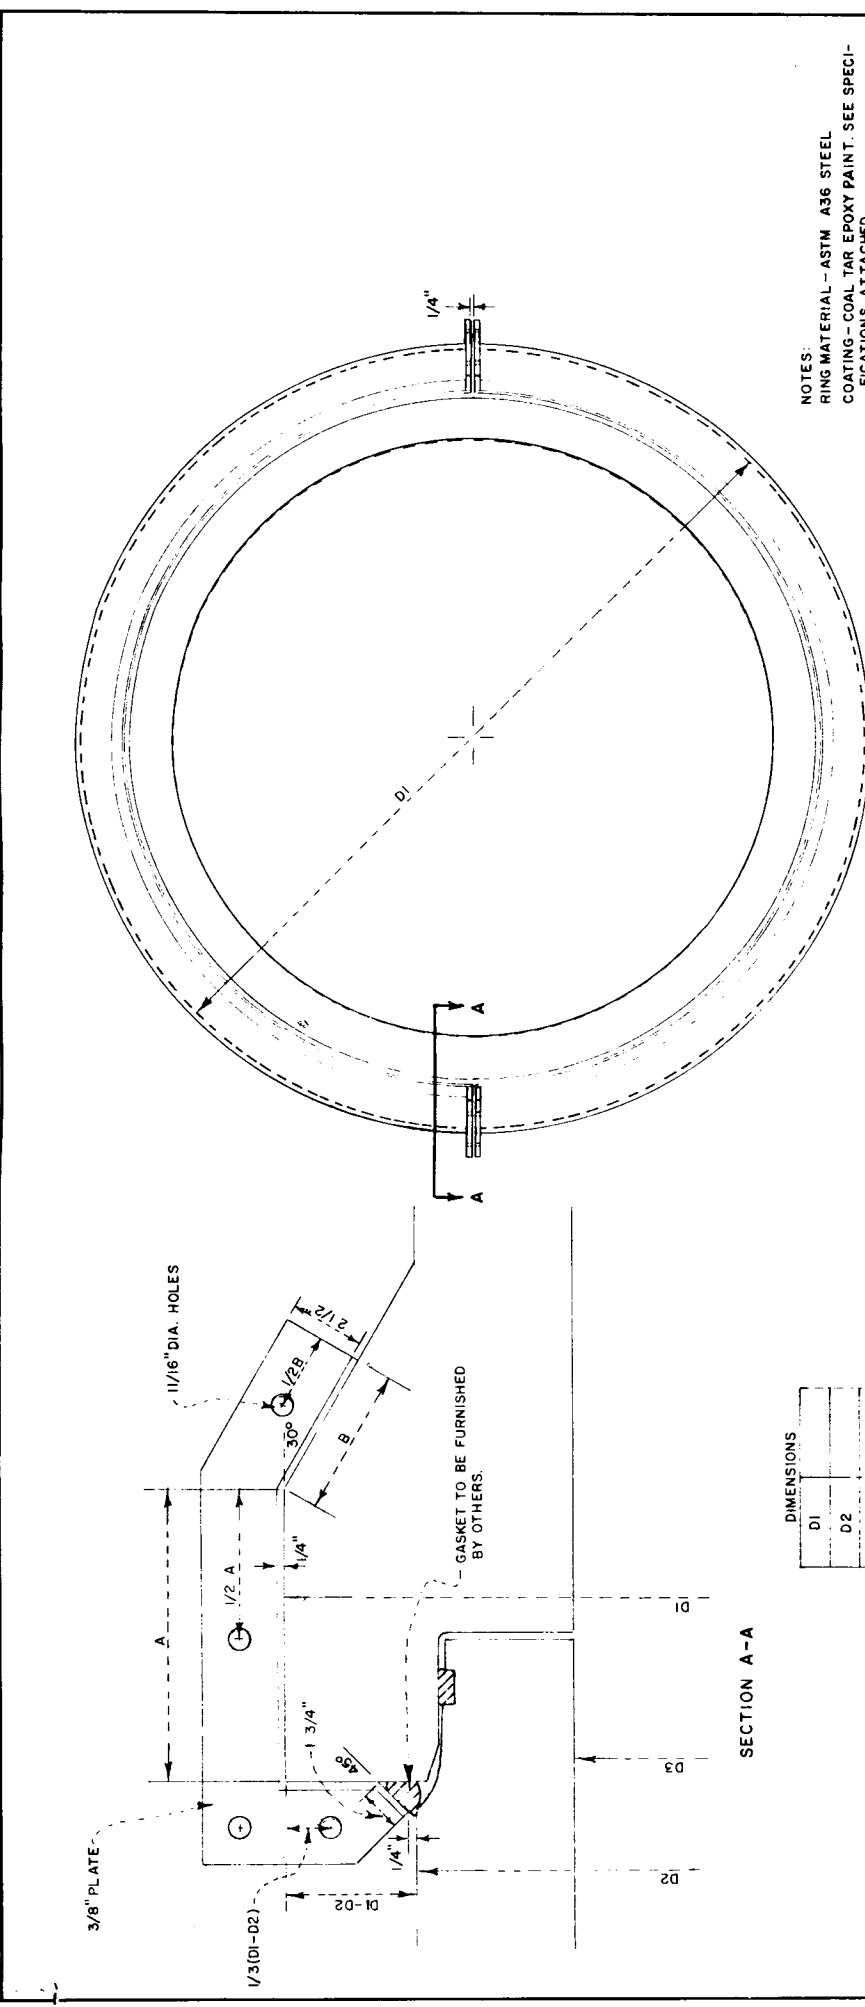
**CONCRETE PIPE STEEL BELL RING
 LEAK REPAIR**

The second ring shown in the drawing in Figure 3, page 7, was then tested. An attempt was made to install the semicircular bell rings, but they dug into and stretched the gasket at the ring connections, Photograph 4, page 9, making it impossible to clamp the ring about the pipe. To remedy this problem, the ring was cut into four 90° pieces for easy assembly. Several views of this four-piece ring are shown in Photographs 5, 6, 7, and 8.

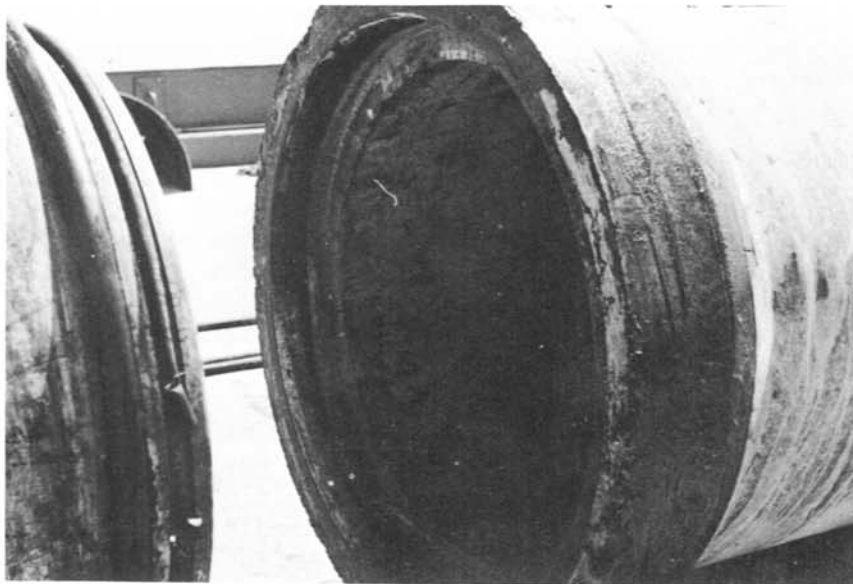
Photograph 9. Photo CN805-243-1172 NA

In making the test, a standard gasket was cut to simulate a leak before the two pieces of test pipe were pulled together, as shown in Photograph 9. Two standard 13/16-inch, and one 1- by 2-inch rectangular-shaped soft rubber gaskets were first tested using the two-piece ring. These failed from extrusion between the repair ring and pipe.

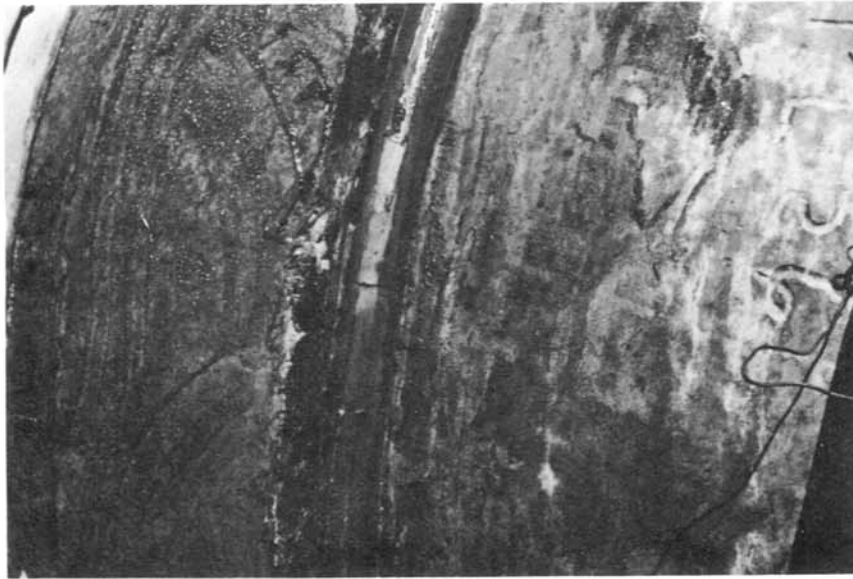
Photograph 10. Photo CN805-243-1176 NA

Because of its excellent cohesive properties, it has been hoped that the soft rubber gasket could be used. In repairing a leak the gasket must be welded together about the pipe, see Photograph 10. The soft

rubber could be pressed together without gluing to form a continuous ring. The 2-inch-diameter soft rubber gasket was tested next. A pressure was raised, the gasket extruded from beneath the ring, Photograph 11 below. At this point the soft rubber materials were abandoned.

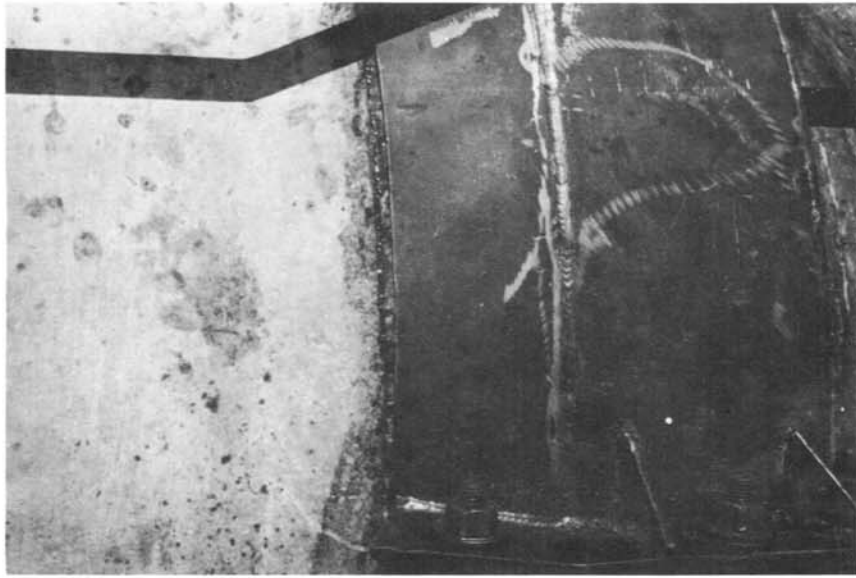
Photograph 13. Photo CN805-243-1187 NA

about the pipe before the tension rods were fastened. The ring was held loosely about the pipe with one bolt in each of its four connections. A pressure of 25 to 30 psi was the maximum pressure that could be developed with the pipe leaking. The ring was gradually tightened about the pipe, Photograph 12, beginning with the set of bolts closest to the shoulder of the bell. This moved the ring back along the bell exerting a lateral and downward pressure on the gasket. The bolts were progressively tightened around the pipe keeping the flanges equi-distant apart. The tightening was continued until the leaking stopped. The pressure on the pipe gradually increased from 25 psi as the ring was tightened to 52 psi at the stoppage of the leak, Photograph 13 on the next page.

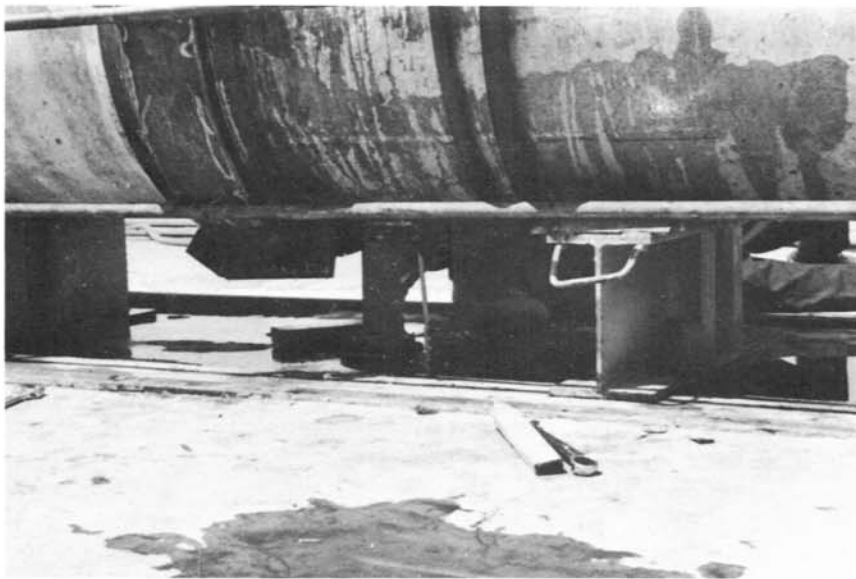
Photograph 14. Photo CN805-243-1188 NA

While the pipe was under pressure, it was jacked up in the middle in order to simulate settlement. The pipes were jacked to the point of maximum deflection; that is, the spigot of the one pipe bore against the bell of the other pipe. As shown in Photograph 14 on next page, no leakage occurred.

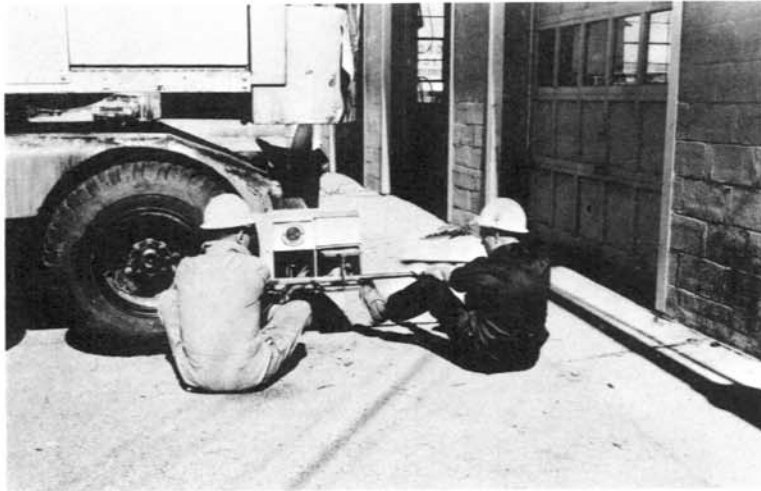
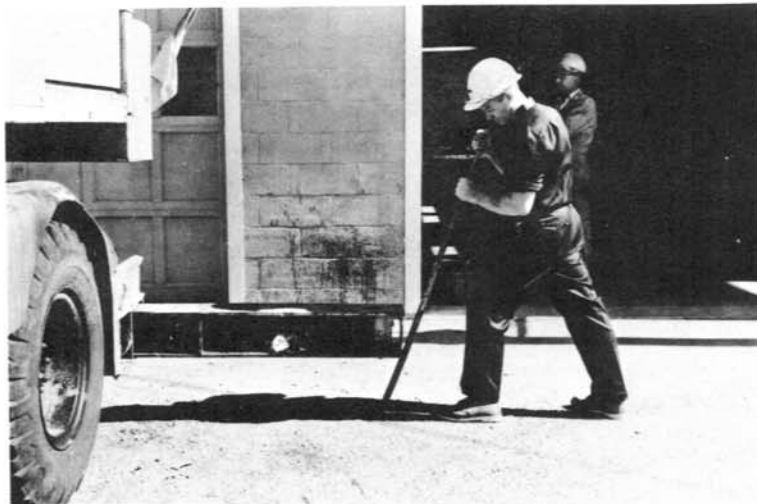
When extending or retracting the outriggers on some older line trucks and truck cranes it requires at least two men to physically move the heavy I-beams into and out of position. Photograph 1 below shows the old method of extending outrigger arms, and Photograph 2 shows how the outrigger arms were retracted.

This is time consuming and hazardous due to uneven ground and the makeshift rigs, jacks, and prybars that are used to free the sticking I-beams in the tubes.
