# ***WATER OPERATION AND MAINTENANCE***

BULLETIN NO. 108

JUNE 1979

***UNITED STATES DEPARTMENT OF THE INTERIOR  
Bureau of Reclamation***

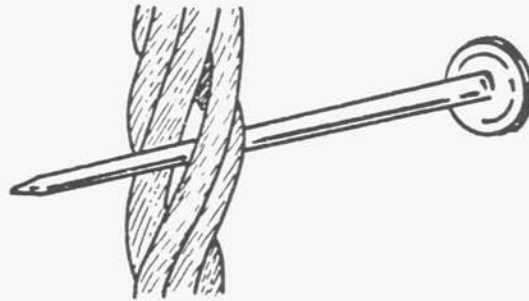
Both boom pendant lines broke under normal operating conditions allowing the boom to fail. Inspection concluded that the lines failed due to severe internal corrosion that was not evident on the surface. In fact, a visual inspection of the surface of the wire rope would have indicated they were in good condition and probably would have passed our crane testing and inspection requirements.

This condition could easily exist on other machines throughout the Bureau that are subject only to visual inspection of the outside surfaces of the rope. Standing lines, such as boom pendant lines, are the most likely to have internal corrosion since they are typically in service much longer than running lines.

To open a rope, insert marlin spike beneath two strands and rotate to lift strands and provide view of interior.

Noticeable rusting, corrosion or pitting of the wires is cause for replacement of the rope. In standing ropes, more than two broken wires in one lay in sections beyond end connections, or more than

one broken wire at the end connection requires the rope to be taken out of service. A wire rope that has grease or dirt packed into the grooves between the strands prevents lubricants from penetrating into the inner core of the rope. Rope in this condition that has been in service for some time will likely show evidence of internal corrosion.
