WATER OPERATION AND MAINTENANCE BULLETIN

No. 203

March 2003

REPAIR OF A LEAKING CONDUIT THROUGH THE SWAN LAKE ARCH DAM NEAR KETCHIKAN, ALASKA

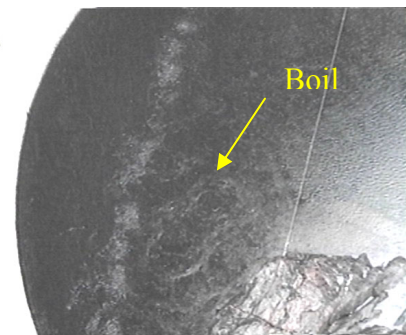
The Swan Lake Dam had been spilling for about 6 weeks between June 15 and July 31, 1999. On August 10, 1999, the on-site project staff noted an unusual increase in flow from the spillway plunge pool and a surface “boil” in the plunge pool at the dam. The KPU operations center was immediately notified, then reported to AEA in Anchorage and the FERC Portland Regional Office, and then the Emergency Action Plan was implemented. AEA contacted Donald E. Bowes, P.E., the FERC Dam Safety Independent Consultant, to perform an inspection of the conditions.

Boil in plunge pool.

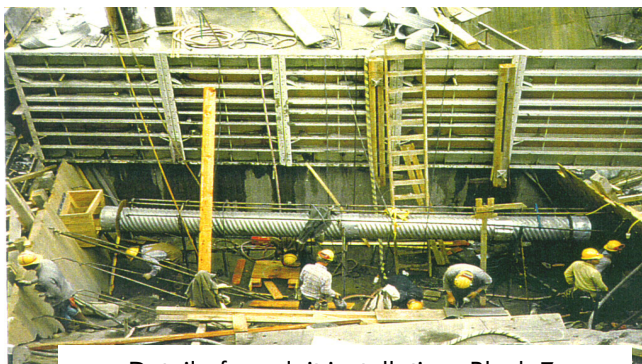
Detail of conduit installation, Block 7, elevation 231.

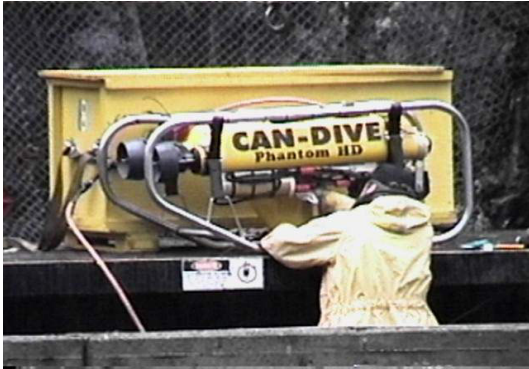
ROV being deployed.

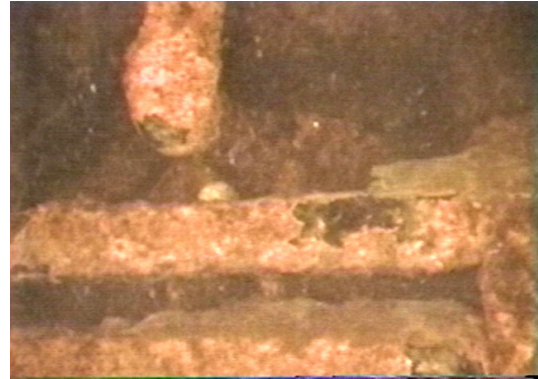
The upstream end of Conduit 4-165 was found to be located in a block-out in the concrete with a flat circular steel plate over the end of the CMP. The steel plate was neither galvanized nor coated to prevent corrosion. As-built documents seemed to indicate Conduit 4-165 inlet block-out had been infilled with concrete.

It was found that back-to-back steel channel walers anchored to foundation concrete with form bolts and a pipe stub held the steel plate against the CMP.

There was a corroded hole and a gap between the plate and the end of the CMP in the upper left-top quadrant into which the leakage was flowing. A significant water velocity could be seen in the video images taken via the ROV.

The upper photograph to the right shows a grout return line above the waler system. The grout line penetrates the steel end plate visible in the top half of the photograph behind the waler.

Conduit 4-165 upstream end, view from mid-height right side of block-out.

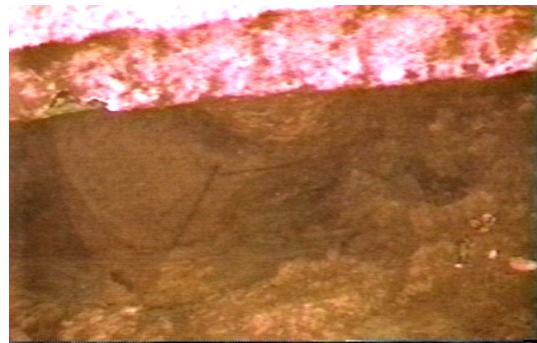
The photograph immediately to the right shows the end plate behind the waler system as viewed from the lower left quadrant of the block-out in the dam foundation.

Conduit 4-165 upstream end, view from left lower side of block-out.

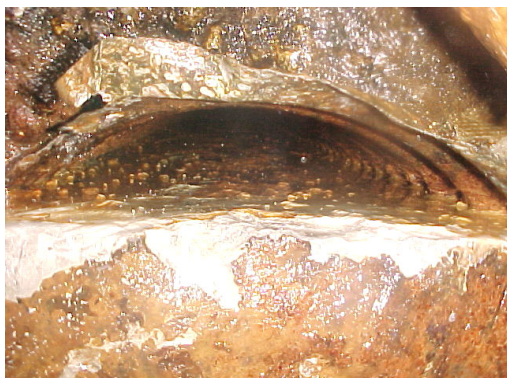
The leakage from Conduit 4-165 was found to be through a void in the cement grout infill about 3 inches high at the CMP crown. The effective cross-section of the void was about that of a 4-inch pipe. Whether the grout void was washed out by the leakage or resulted from settlement of the grout infilling before it set is unknown.

Void in Conduit 4-165, looking upstream.

It is believed that the unprotected conduit extensions within the upstream and down-stream block-outs exposed the conduit to corrosion on the outside. The downstream block-out was only about 6 inches deep, and the conduit extended to the structure concrete surface, exposing the conduit to potential physical damage from boulders in the plunge pool. The void on the inside of the conduit also exposed the pipe wall to corrosion.

It is hypothesized that the extensive period of spill between June 15 and July 31 were of such magnitude that a turbulent flow condition was created in the plunge pool. The turbulent flow may have caused sand, gravel, cobbles, and boulders to impact the exposed downstream end of Conduit 4-165, initiating a rupture of the CMP wall. This likely resulted in loss of integrity in the upstream exposed end of the conduit. The leakage flow through the conduit could have actually initiated any time subsequent to June 15, 1999, when the reservoir began the spill period.

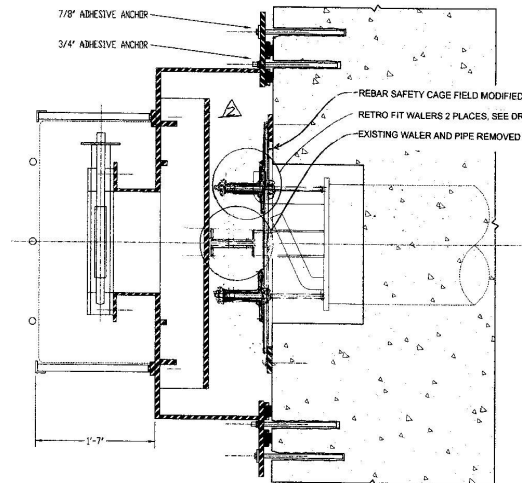
Section through bulkhead in place.

The concept for the leak repair required that divers be able to safely implement the repair and that the flow into Conduit 4-165 be stopped at the inlet with a Leak Closure Bulkhead designed to fit over the existing block-out and waler system holding the steel cover plate on the conduit.

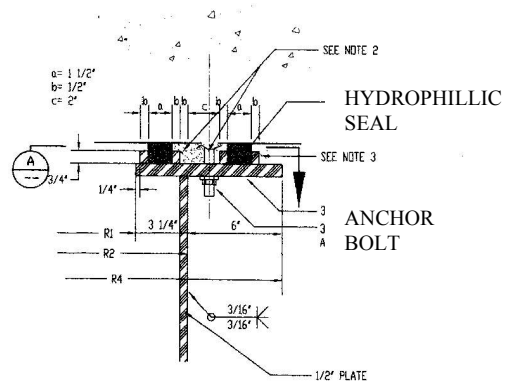
Bulkhead seal detail.

To ensure sealing of the bulkhead to the face of the concrete dam foundation plug, a seal design using two compressible hydrophilic rubber seals in channels at the outer and inner radii of the base seal with a swellable hydrophilic sealant paste between the rubber seals was used. Adeka Ultra Seal was the manufacturer of the hydrophilic seals and paste. The seals were designed to compress 1/2 inch total before the base seal rings contacted the concrete surface. This accommodated minor irregularities in the concrete sealing surface.

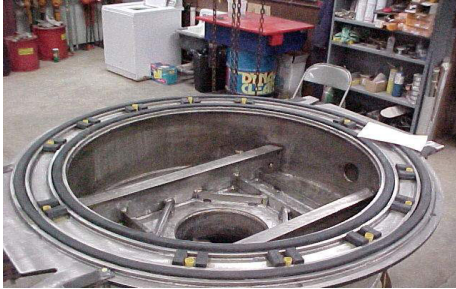
Bulkhead seal system before seals were installed.

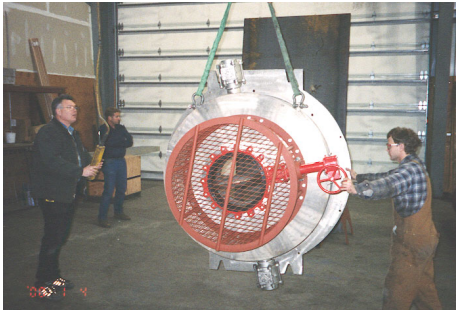
Bulkhead top view, showing 16-inch valve, safety cage, and grout valves.

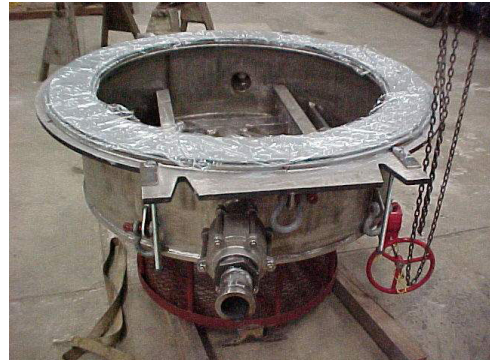
Bulkhead seal system – seals and hydrophilic paste installed.
