Repair Strategy

The Swan Lake Hydroelectric Project is a remote site with steep terrain and a maritime climate. Site access is by floatplane or boat. Access to the reservoir is by road from the project port area. Access to the plunge pool is by a service road in an area above the plunge pool. No road directly leads to the level of the plunge pool. The reservoir fills quickly when there is a storm or high snowmelt runoff. This limits the opportunities for working in the reservoir along the dam and below the dam, as the work sites are affected during spill events by spillway discharges into the plunge pool. Periods of non-spill are relatively short during much of the year. These conditions required a flexible repair strategy to address the non-spill windows that could be as short as 1 or 2 days. In addition, the repair materials and fabricated elements with long-lead time for procurement would require pre-purchase by AEA to provide the maximum flexibility in scheduling the work.

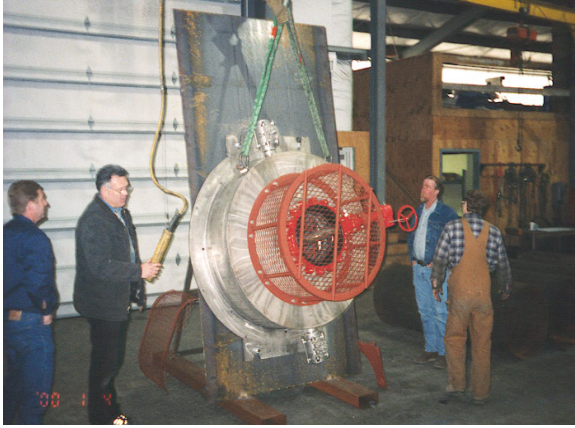
Bulkhead installation demonstration.

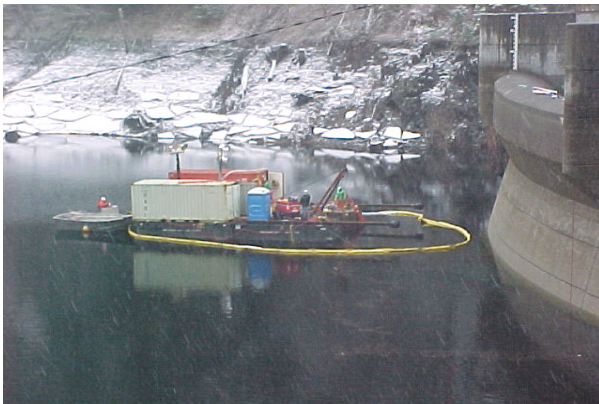
Work barge on station above Conduit 4-165.

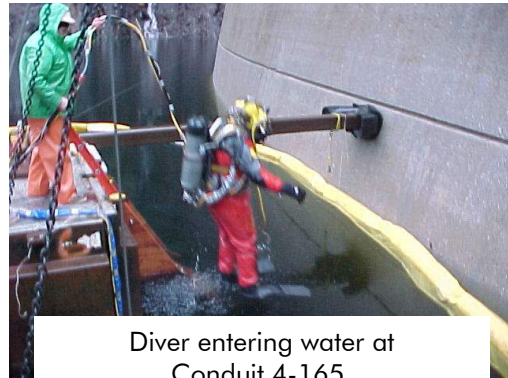
Diver entering water at Conduit 4-165.

The diver inspection of the upstream end of the leaking Conduit 4-165 confirmed that the block-out was 21 inches square and 14 to 16 inches deep, with no concrete backfill. The CMP conduit protruded some 6 inches from the back face of the block-out to within 9 inches from the dam face surface. A 4-inch hole in the upper left quadrant of the CMP provided the leakage inflow source. The divers noted some sort of cement-like infilling below the void in the crown of the CMP. The waler system holding the 3/4-inch circular steel end plate against the end of the 18-inch CMP conduit was found to be shimmed 3 inches out from the dam face, and the walers were measured to be 7-inch channels installed back-to-back. The ROV inspection in September 1999 did not reveal that the walers were set out from the dam face, and that the walers at that time had been estimated to be about 4-inch channels back-to-back.

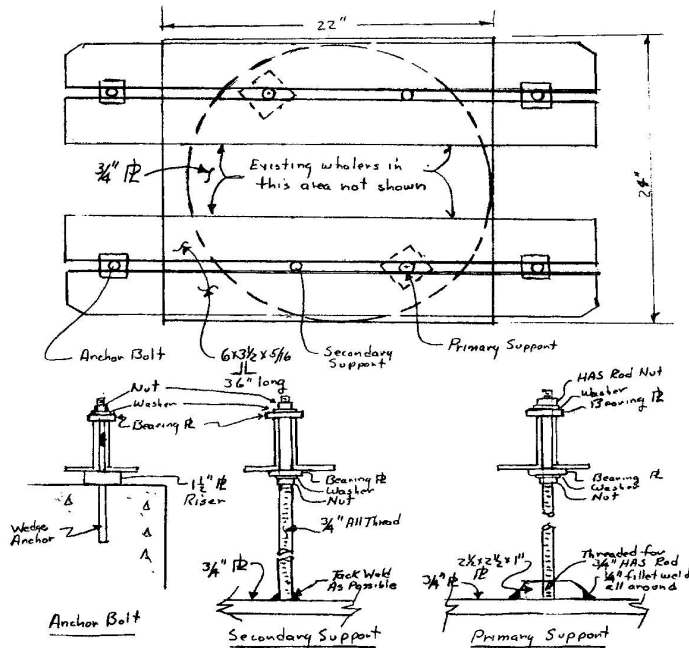
Sketch of field modification to stabilize Conduit 4-165 inlet end plate.

These conditions would not permit installation of the safety rebar cage installation template as fabricated since it would not fit over the walers that extended 10 inches out from the dam face. The safety rebar cage design was modified and re-fabricated on site using straight bars and was installed beneath the existing walers to provide protection to the divers and to maintain the integrity of the bulkhead installation template and centering lugs.

necessary to remove the existing walers before installation of the Leak Closure Bulkhead. A new structural support system was developed to stabilize the 3/4-inch steel end plate on the CMP before removal of the existing walers. The objective of the design was to prevent shifting of the steel end plate that could present a safety hazard to the divers if leakage flow suddenly increased. A new structural support system was designed, fabricated on site, and installed by divers. Once the stabilizing waler system was in place, the existing 7-inch waler and end plate support riser pipe were cut away.

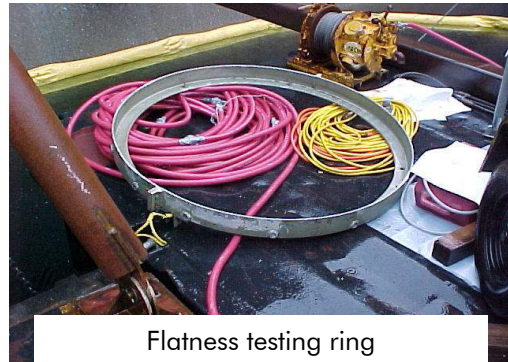
The Leak Closure Bulkhead was to be held in place during grouting by a combination of mechanical and adhesive anchors. Test trials of the adhesive anchor installation as recommended by the manufacturer did not provide satisfactory results; therefore, mechanical anchors were substituted. This required additional holes for mechanical anchors and enlargement of other holes in the seal plate. The concrete surfaces against which the bulkhead would seal was not completely flat and contained some minor surface rock pockets.

Flatness testing ring

The protrusions on the surface were ground off and surface rock pockets were filled with "Splashguard." The surface was checked for flatness using a test ring that comprised a salvaged TV satellite dish antenna base structural ring formed from aluminum channel. Tolerances were achieved, and installation of the Leak Closure Bulkhead over the Conduit 4-165 block-out proceeded as planned.

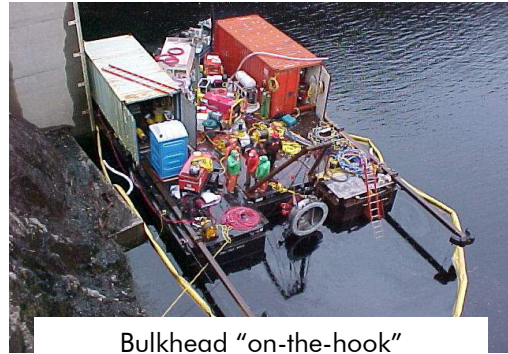
Bulkhead “on-the-hook”

The Leak Closure Bulkhead was suspended from two hoist lines over an “A” frame at one end of the work barge. Using two separate winches, the bulkhead was lowered into position and mated to the previously installed locating pins on the face of the dam using the two separate winches to maneuver the bulkhead onto the locating pins. Threaded rod jackscrews were used to control the movement of the bulkhead to its mating position on the face of the dam. When the bulkhead was in final position, the butterfly flow control valve was closed, and the leakage through Conduit 4-165 was completely stopped.

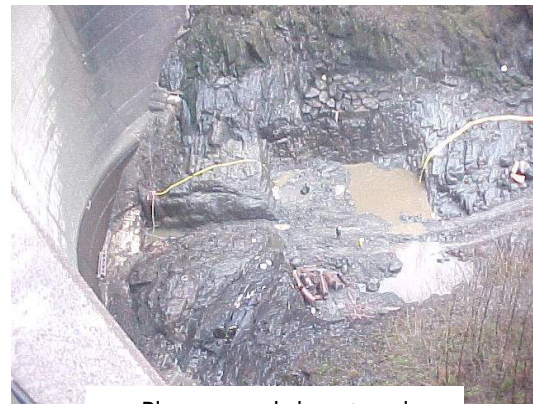
Plunge pool dewatered

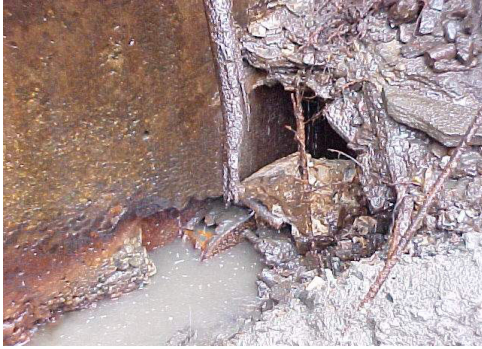
4-165 downstream end revealed.

The block-out in the dam plug concrete was very shallow and had not been backfilled with concrete. The CMP actually protruded beyond the back of the block-out 6 to 8 inches and was flush with the dam foundation concrete face. The conduit had a ragged hole in the upper right quadrant and a void at the crown of the CMP. See the following photographs.

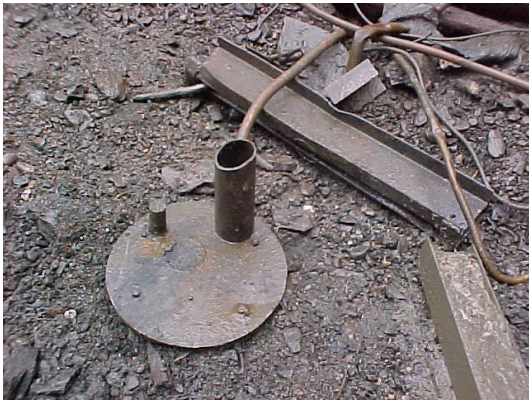
plate was displaced during grouting operations, allowing grout to seep out. The ultimate effect of the upstream leak was that there was a loss of some grout volume from Conduit 4-165.

Original end cap and waler system.

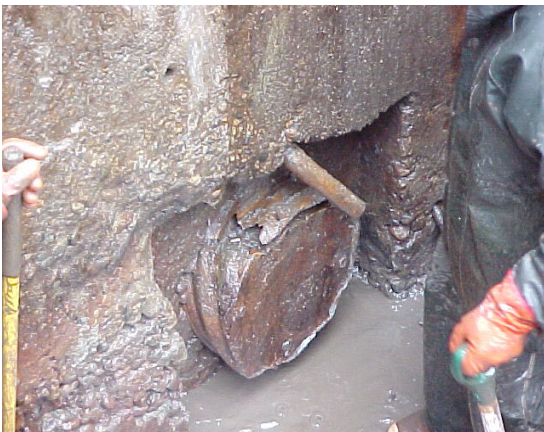
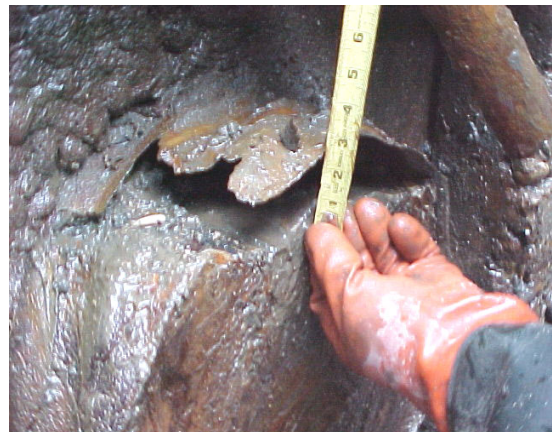
Conduit 4-165 damaged downstream end.

The existing walers and steel end plate were removed, and the damaged conduit wall was removed down to the top of sound grout and replaced with a steel angle-braced steel angle bulkhead and new concrete cap and plug over the CMP with a grout pipe for infilling the void in the conduit.

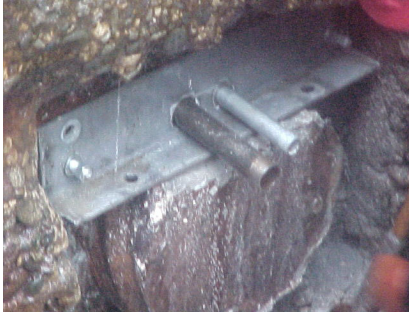
Steel angle bulkhead.

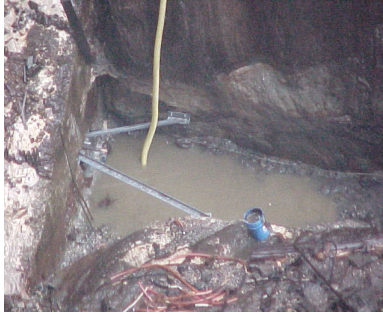
Steel angle bracing of bulkhead.

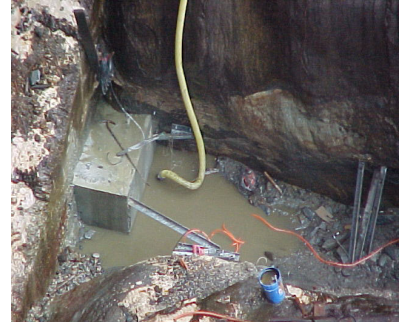
Concrete cap on Conduit 4-165 downstream end.

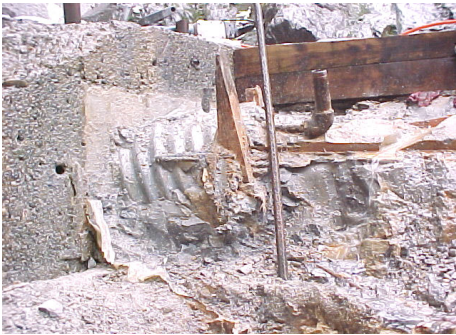
The downstream end of Conduit 3-196 was exposed by careful removal of all weathered waste grout encapsulating the end of the CMP back to the concrete encasement. Close inspection and sounding with a wrecking bar on the top and sides of the exposed end of Conduit 3-196 showed the downstream end of the conduit to be intact, in excellent condition, and completely filled with grout. The steel end plate used for grouting was found to be held in place with wooden stakes and steel braces tied to the upstream concrete.

Conduit 3-196 exposed,
downstream end.

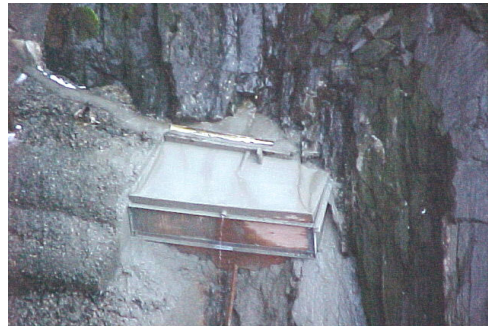
Conduit 3-196 downstream end,
new concrete encapsulation.

A new reinforced concrete encapsulation was constructed to protect the downstream end of Conduit 3-196 from weather and physical damage. The new concrete was tied into bedrock and the rock “nose” immediately downstream with grouted-in rebar dowels. The above photograph (right) shows the encapsulation with formwork still in place. This formwork was later removed.

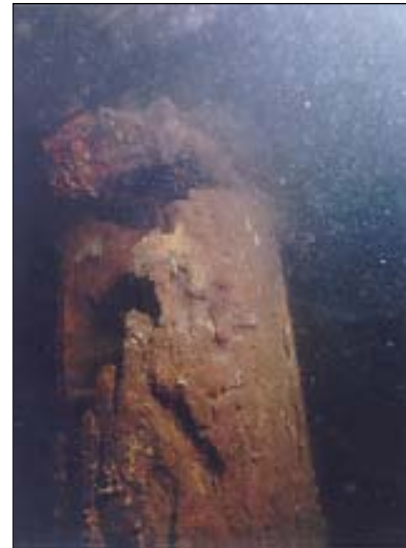
Built in 1933, the pier was constructed during a time when pollution levels were high enough in the harbor where the pier is located to completely prevent marine borers from thriving. Thus, there was no need to treat the wood against biodeterioration caused by borers at the time of construction. However, as pollution levels dropped, obvious Limnoria attack began to manifest itself in the timber. This was documented in previous routine inspection reports, which showed some of the supporting piles taking on an hourglass configuration as their load-bearing capacities gradually diminished with advancing section loss. As Limnoria activity increased, pile diameters shrunk. In assessing if the facility can still function up to its required load-bearing capacity, the owner hired the engineer to perform a structural analysis on the pier and to determine the appropriate repairs necessary to restore the structural capacity of the damaged piles. To accomplish this, the engineer developed the scope of work for an in-depth underwater inspection that would provide the information required to perform the analysis and develop the repair designs. Although the scope did not include destructive core sampling of the timber to evaluate covert deterioration occurring within the piles, it did stipulate that penetration tests using an ice pick in conjunction with hammer strikes had to be performed on 20 percent of the timber piles at 5-foot intervals along their lengths to assess the soundness of the wood and would include those portions located at the mudline. The engineer also required that minor cleaning of marine growth had to be performed where necessary for the inspection diver to carry out the work. According to past inspection reports, the piles were heavily coated with barnacles and other marine organisms.

Timber pile exhibiting severe section loss caused by Limnoria attack.
