WATER OPERATION AND MAINTENANCE

BULLETIN NO. 152

June 1990

**UNITED STATES DEPARTMENT OF THE INTERIOR
Bureau of Reclamation**

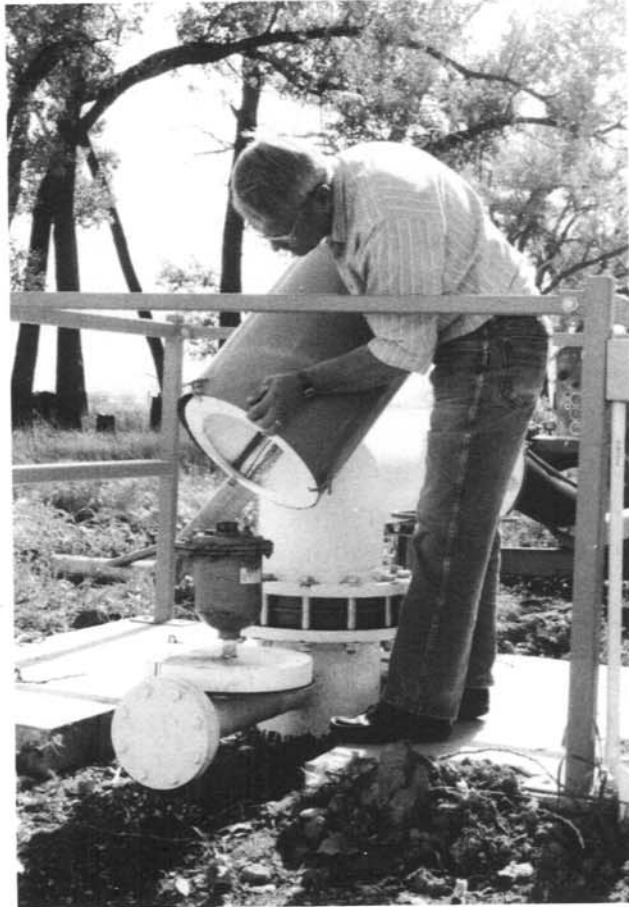
The insulated steel canister does work as evidenced again, this past fall, where the SMRID had approximately 12 valves freeze that weren't provided the canister protection. Not one protected valve froze however. The canisters are left on year round providing protection from early spring frosts as well, adds Renwick.

Technologist, Paul Ewashen, demonstrates how easily an insulated canister can be removed for valve inspection.

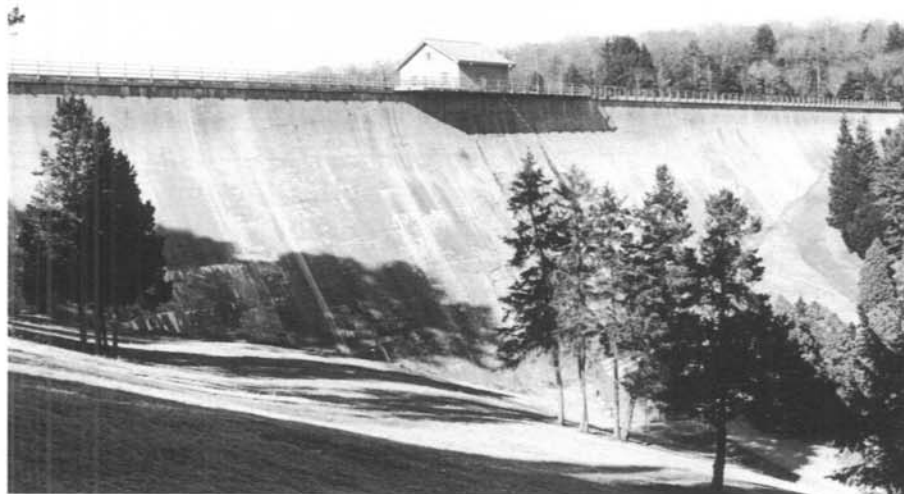
The consulting engineer, Spiegel and Zamencik, Inc., New Haven, Connecticut, found that seepage on the downstream face varied seasonally, with greater quantities of moisture in colder weather. This pattern held even during dry periods, so leakage through the structure rather than dampness from precipitation was the cause. We do not know if waterstops were originally installed in the vertical joints. If they were, they had deteriorated under repeated expansions and contractions.

Freezing and thawing of reservoir leakage on the downstream face, and of ponded water on the crest, was the major cause of the concrete deterioration and spalling. With freeze/thaw damage visible as deep as 6 inches in core samples, a considerable amount of concrete had to be removed prior to resurfacing.

Freezing and thawing of reservoir leakage on the downstream face and ponded water on the crest of Easton Dam caused deterioration and spalling.

After considering several installation methods to seal the vertical joints, we drilled 6-inch-diameter core holes through the vertical construction joint from the top of the dam and filled them with chemical grout. This is a relatively new technique, which the Corps developed and has used with very good results.

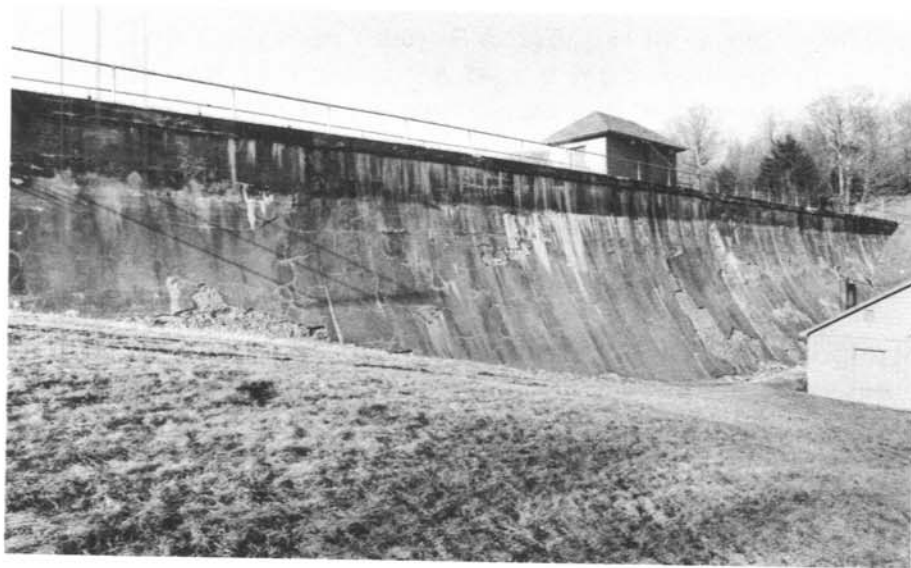
An underwater inspection of the upstream surface found that the vertical construction joints contained a bitumastic filler material apparently used as a waterstop. Deterioration of the concrete edges at the vertical joints was no greater than that of the dam face on either side of the joint.

Precast facing panels will be installed at Means Brook Dam to reduce continued freeze/thaw damage to the original downstream face.

Deterioration was greatest in the top 10 feet — from normal pool elevation to maximum typical drawdown. The apparent cause was freeze/thaw cycling. In two areas, moderately greater deterioration was found in the form of shotcrete lenses from previous repair work, which were ready to spall. No horizontal joints were visible on the dam face.

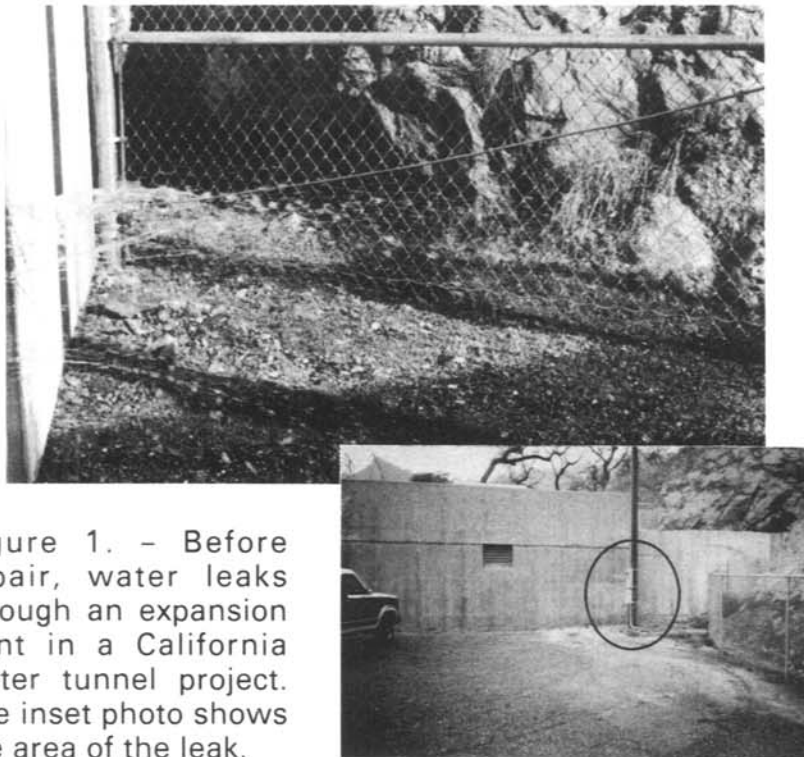
A valve at Pacheco Conduit inlet in California lets workers drain the conduit without draining the 5.3-mile-long tunnel that feeds it. During tests after construction in 1986, however, Bureau of Reclamation engineers found a 125 gal/min leak at the concrete valve structure expansion joint. The leak shown in figure 1 progressed up the joint as the conduit filled.

Figure 1. - Before repair, water leaks through an expansion joint in a California water tunnel project. The inset photo shows the area of the leak.

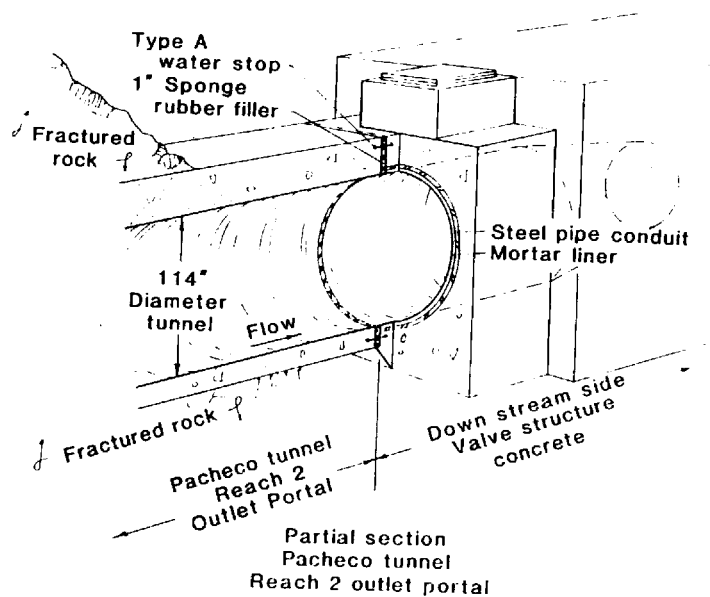
Engineers stopped the tests and partially drained the tunnel to get an inside look at the leaking joint. Although a waterstop had been installed at the joint (figure 2), inadequate concrete consolidation was permitting water to bypass the waterstop. Soundings and visual inspections also revealed two large voids, one at the joint invert and one at the top.

Figure 2. - Expansion joint between the Pacheco Tunnel and a steel pipe conduit includes a 1-inch sponge rubber filler and a waterstop around the joint circumference.

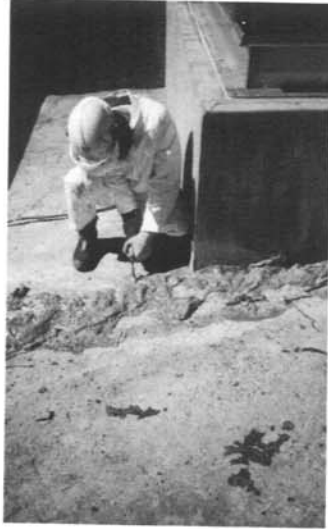
Figure 5. - Excessive resin leakage wastes material. When this happened, the contractor stopped injecting and forced resin-soaked oakum strips into the joint. This contained the foam.
