# **WATER OPERATION AND MAINTENANCE**

**BULLETIN NO. 157**

September 1991

# METHODS FOR THE REPAIR OF CAVITATION DAMAGE TO METAL SURFACES

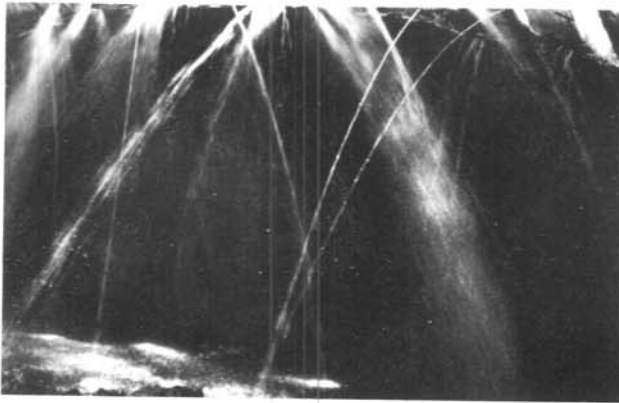
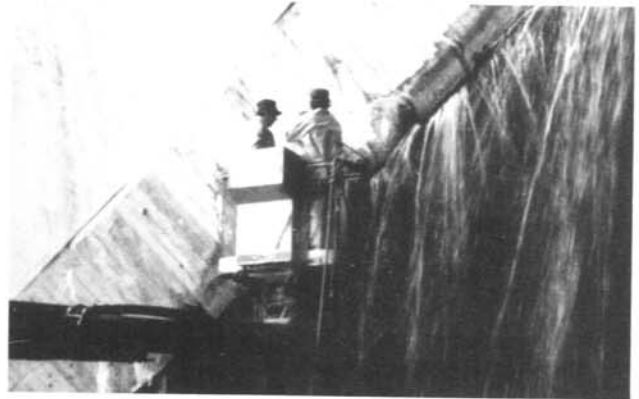
The area between the original and later construction has leaked continuously since filling of the lake because the older and newer concrete did not bond well. Although the dam is safe, we have sought to stop the leaks because of our commitment to water conservation and dam appearance.

At the Lower Colorado River Authority's Buchanan Dam in central Texas, water began leaking from the dam's construction joint after the project was completed in 1937. LCRA has implemented a successful method to stop these leaks. Pipes are installed in holes drilled into the face of the dam to divert water from the joint, as illustrated in the photograph on the left.

With water diverted to the pipes, the flow of water through the joint is reduced, enabling workers to pump foam into the area. In the photograph on the right, pipes to the right of the workers are draining off water while pipes to the left have been pumped full of foam and the leakage stopped. (Courtesy of the Lower Colorado River Authority.)

We drill holes into the face of the dam above the construction joint and insert pipes into the holes to divert water from the construction joint (as shown in the photograph on the left). Next, materials are used to temporarily seal the seam, diverting additional water to the pipes. We then inject a water-activated foam under pressure into each pipe to reach the construction joint, where the foam sets and blocks the leak.

The repair process begins with workers drilling holes into the construction joint, or seam. We use 5/8-inch by 24-inch bits to drill holes approximately 12 inches above the seam. The holes are drilled in a horizontal plane to penetrate almost halfway through the arch, which is 3 to 4 feet thick. As a rule, the greater the water volume, the closer together the holes must be drilled along the seam. Drilling for each hole continues until water flows through the hole. A 3/8-inch pipe is then inserted into each hole and driven in with a hammer to assure a secure fit. Next, a valve is installed on the pipe and left open to permit the flow of water through the pipe, diverting water from the seam.

Lead wool, a material similar to steel wool that bonds to itself when compressed, and oakum, a fibrous material, are used to seal the seam. As the seam flow is plugged, the flow of water through the pipes increases. We have experienced some trouble at this point. Sometimes the water pressure increases and pushes the lead wool and oakum back out of the seam. We have had to install more pipes to counter this condition. When all water has been diverted to the pipes, we begin pumping foam into the seam.

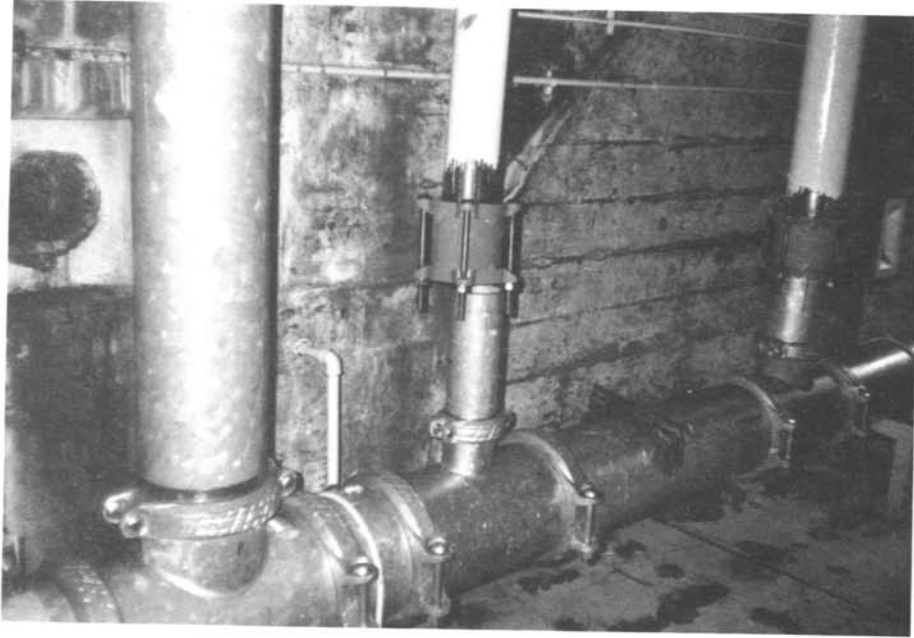
Photo 3. - Unit 5—4-inch sleeve coupling, one of two that came apart. Coupling is typical of all. Note also the unrestrained 6-inch sleeve coupling at the right of the photo. 1/18/91

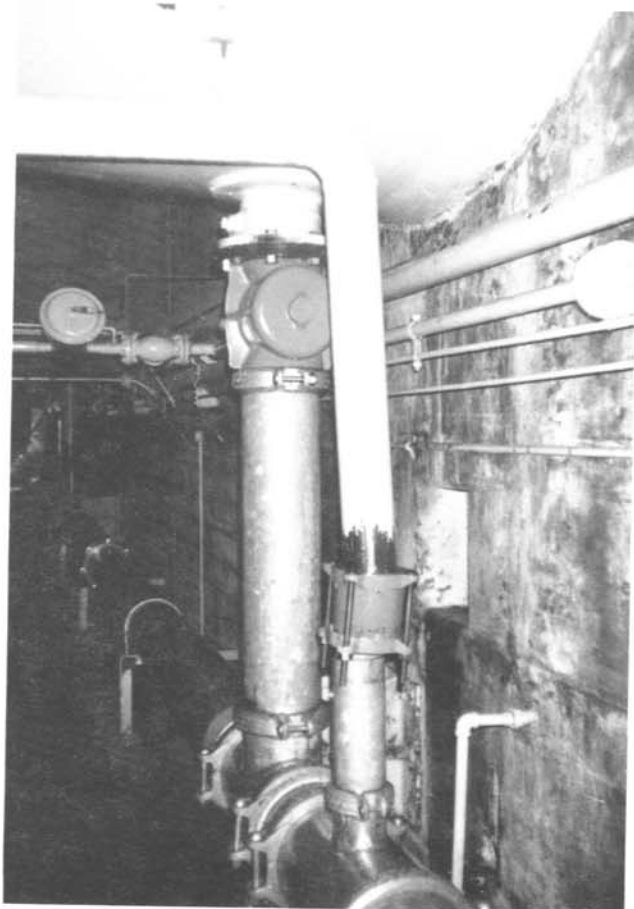
Photo 4. - Unit 5—Same as Photo 3, different view. The 8-inch valve is one of those that had to be turned off under water while high velocity water was coming out of the 4-inch-diameter pipe at the sleeve coupling. 1/18/91

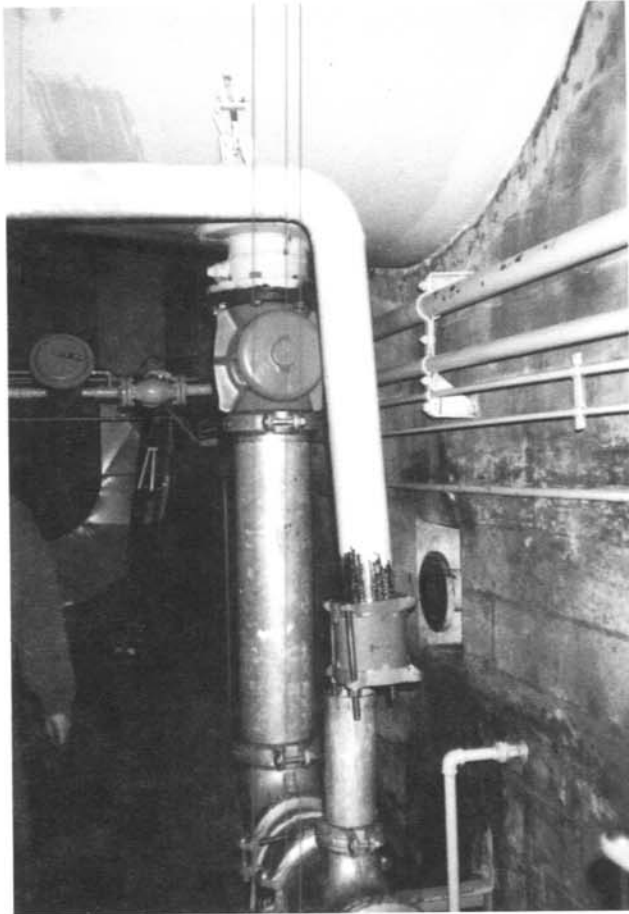
Photo 5. - Unit 6—Second sleeve coupling that separated. Note hanger at elbow does not restrain vertical movement. Vertical restraint was not needed prior to retrofitting because previous pipes had flange coupling at 10-inch pipe. 1/18/91

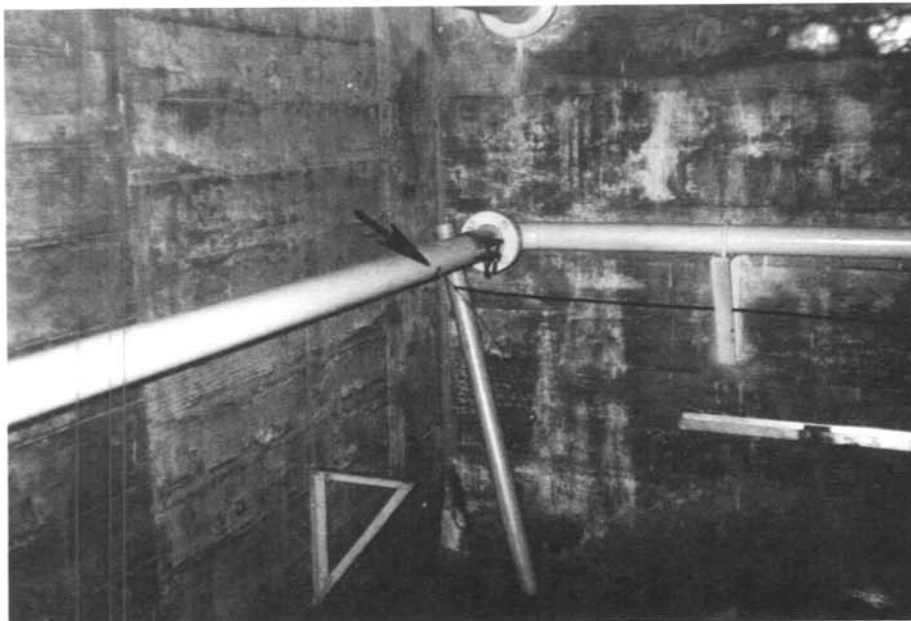
Photo 6. - Unit 5—Arrow points to hole in 3-inch line scheduled for replacement. 1/18/91

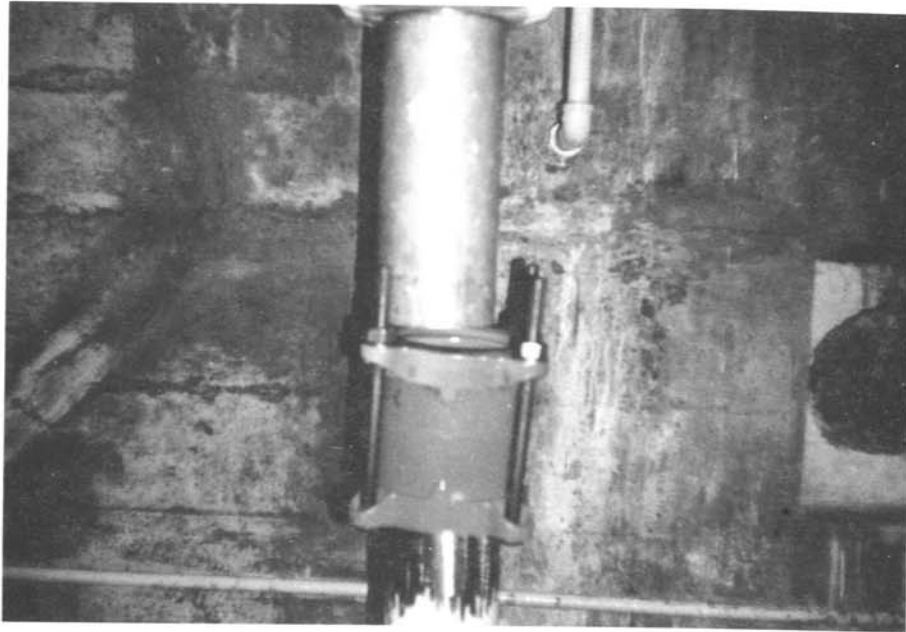
Photo 7. - Unit 5—Closeup of displaced sleeve coupling. 1/18/91

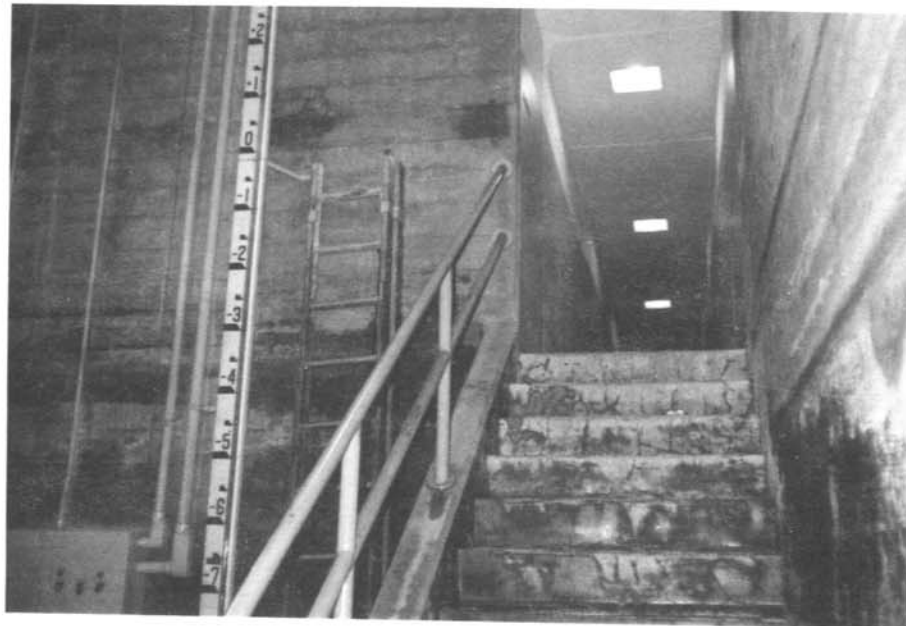
Photo 8. - Unit 5—Water level reached to just above -2 on staff gauge at its highest point. The water level was about 18 inches above the top step in this view. 1/18/91

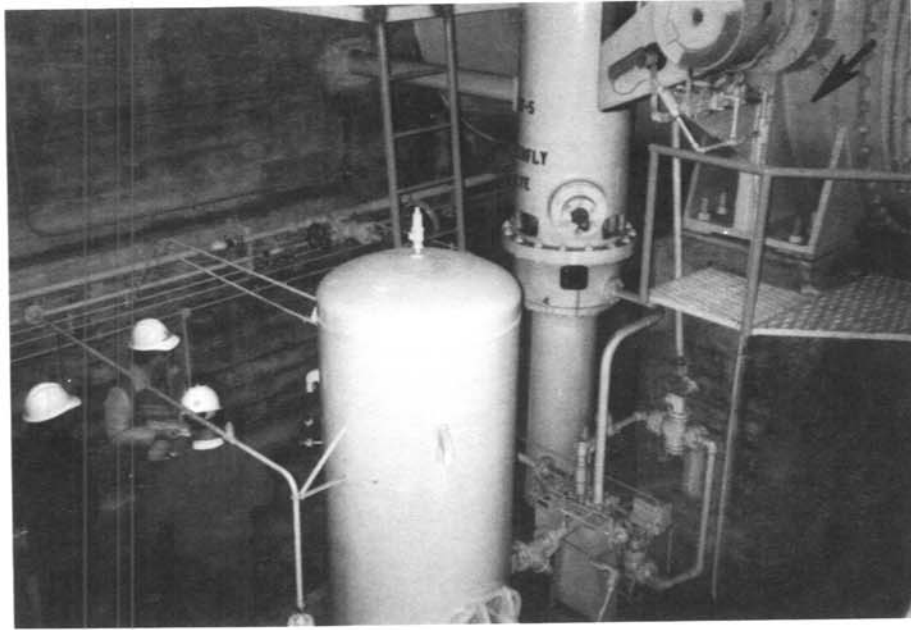
Photo 9. - Unit 5—Arrow points to oil scum line left behind as the water level receded. 1/18/91

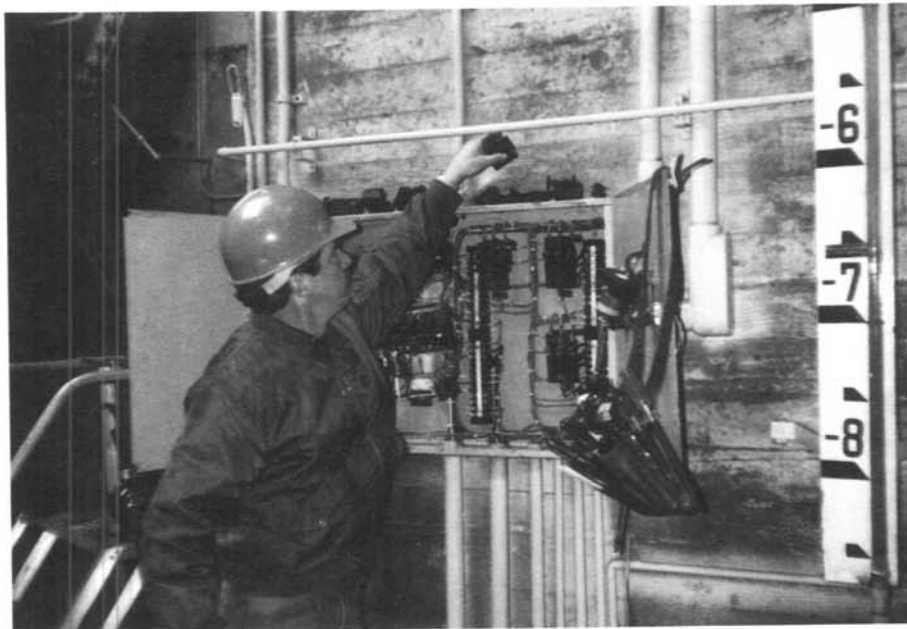
Photo 10. - Unit 4—Cleaning electrical panel that was flooded. 1/18/91

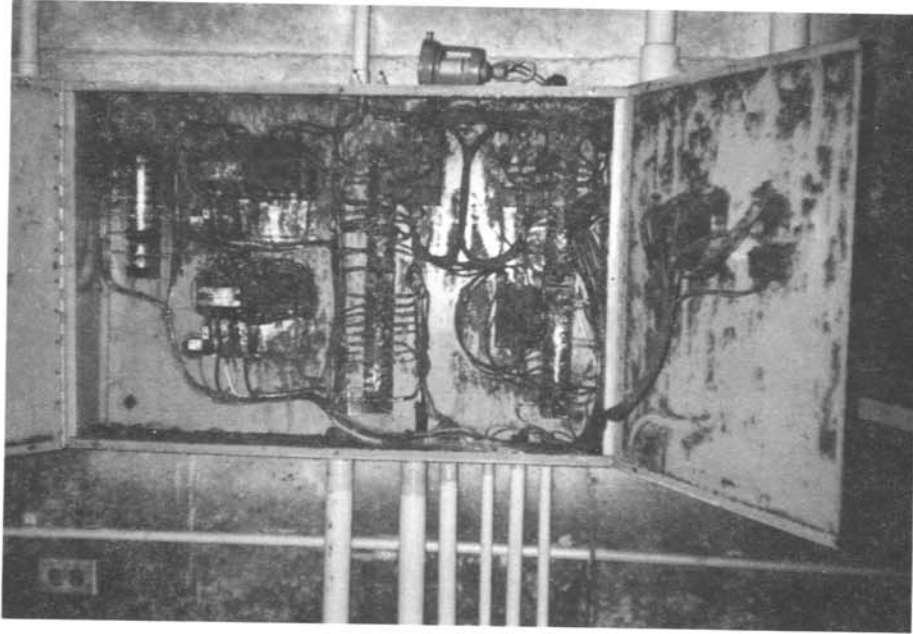
Photo 11. - Unit 2—Flooded electrical panel prior to cleanup. 1/18/91

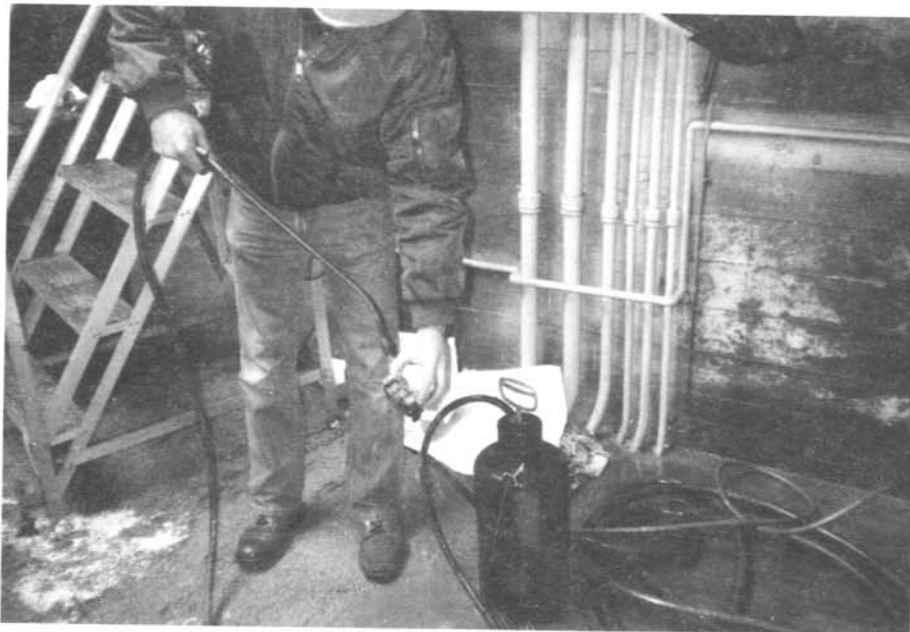
Photo 12. - Unit 4—Cleaning electrical component with water. 1/18/91

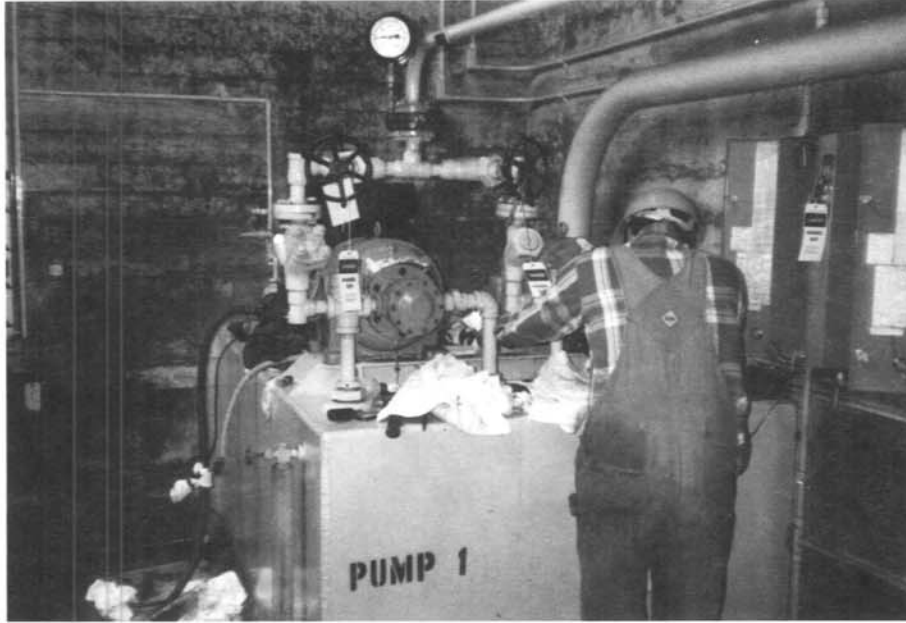
Photo 13. - Unit 4—Butterfly valve hydraulic oil pumps and sump. Motors had to be removed for cleanup and drying. 1/18/91

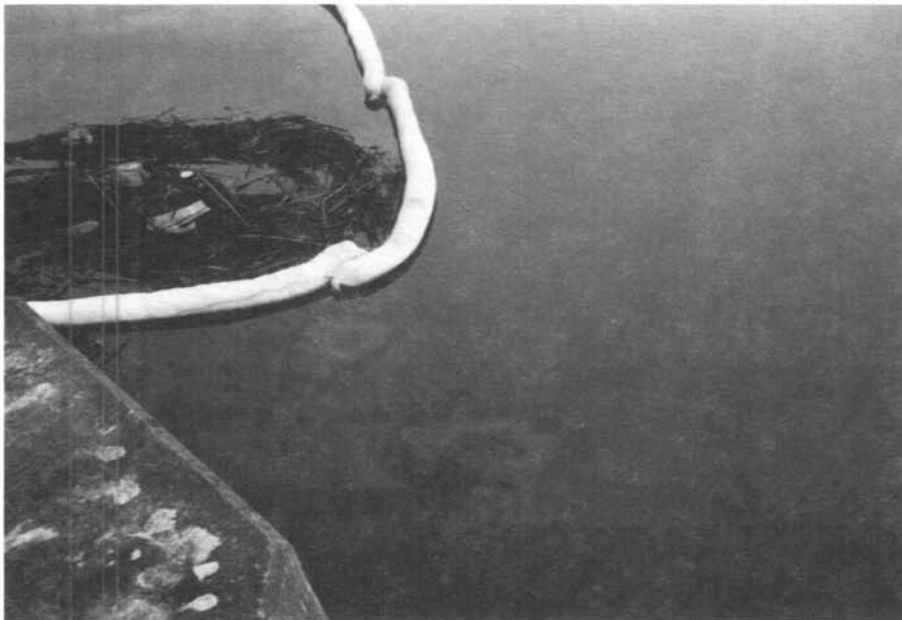
Photo 14. - Intake channel—oil boom, film going under because boom on top of some debris. 1/18/91
