# WATER OPERATION AND MAINTENANCE BULLETIN

No. 181

September 1997

# **CAN FROST HEAVE ON A DRAINAGE CULVERT CAUSE A CANAL BREAK?**

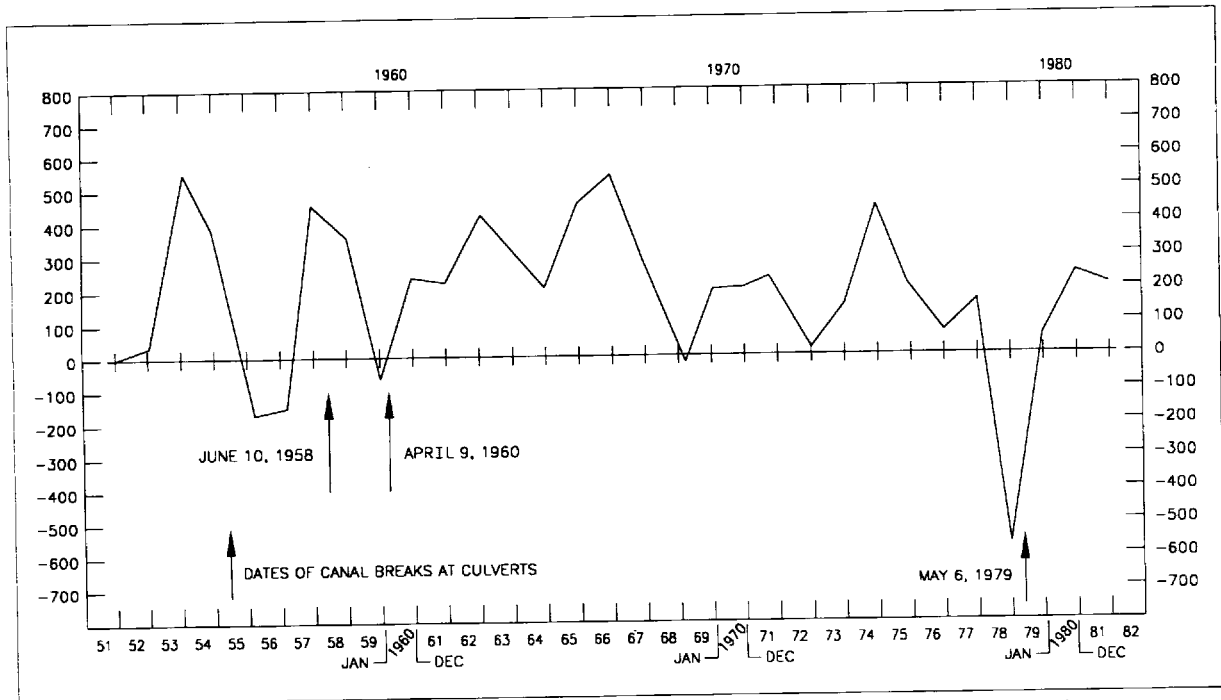
*Figure 1.—Average annual cumulative degree-days for winters of 1951-82 based on air temperatures at Kennewick and Prosser, Washington, and dates of canal breaks at 36-inch-diameter culverts.*

A canal break at a culvert occurred on the Kennewick Main Canal in June 1958 after two unusually cold winters in 1955-56 and 1956-57 during which there were canal breaks not at culverts. Also, there was a canal break at a culvert in April 1960, after one of the colder winters of the 30-year period.

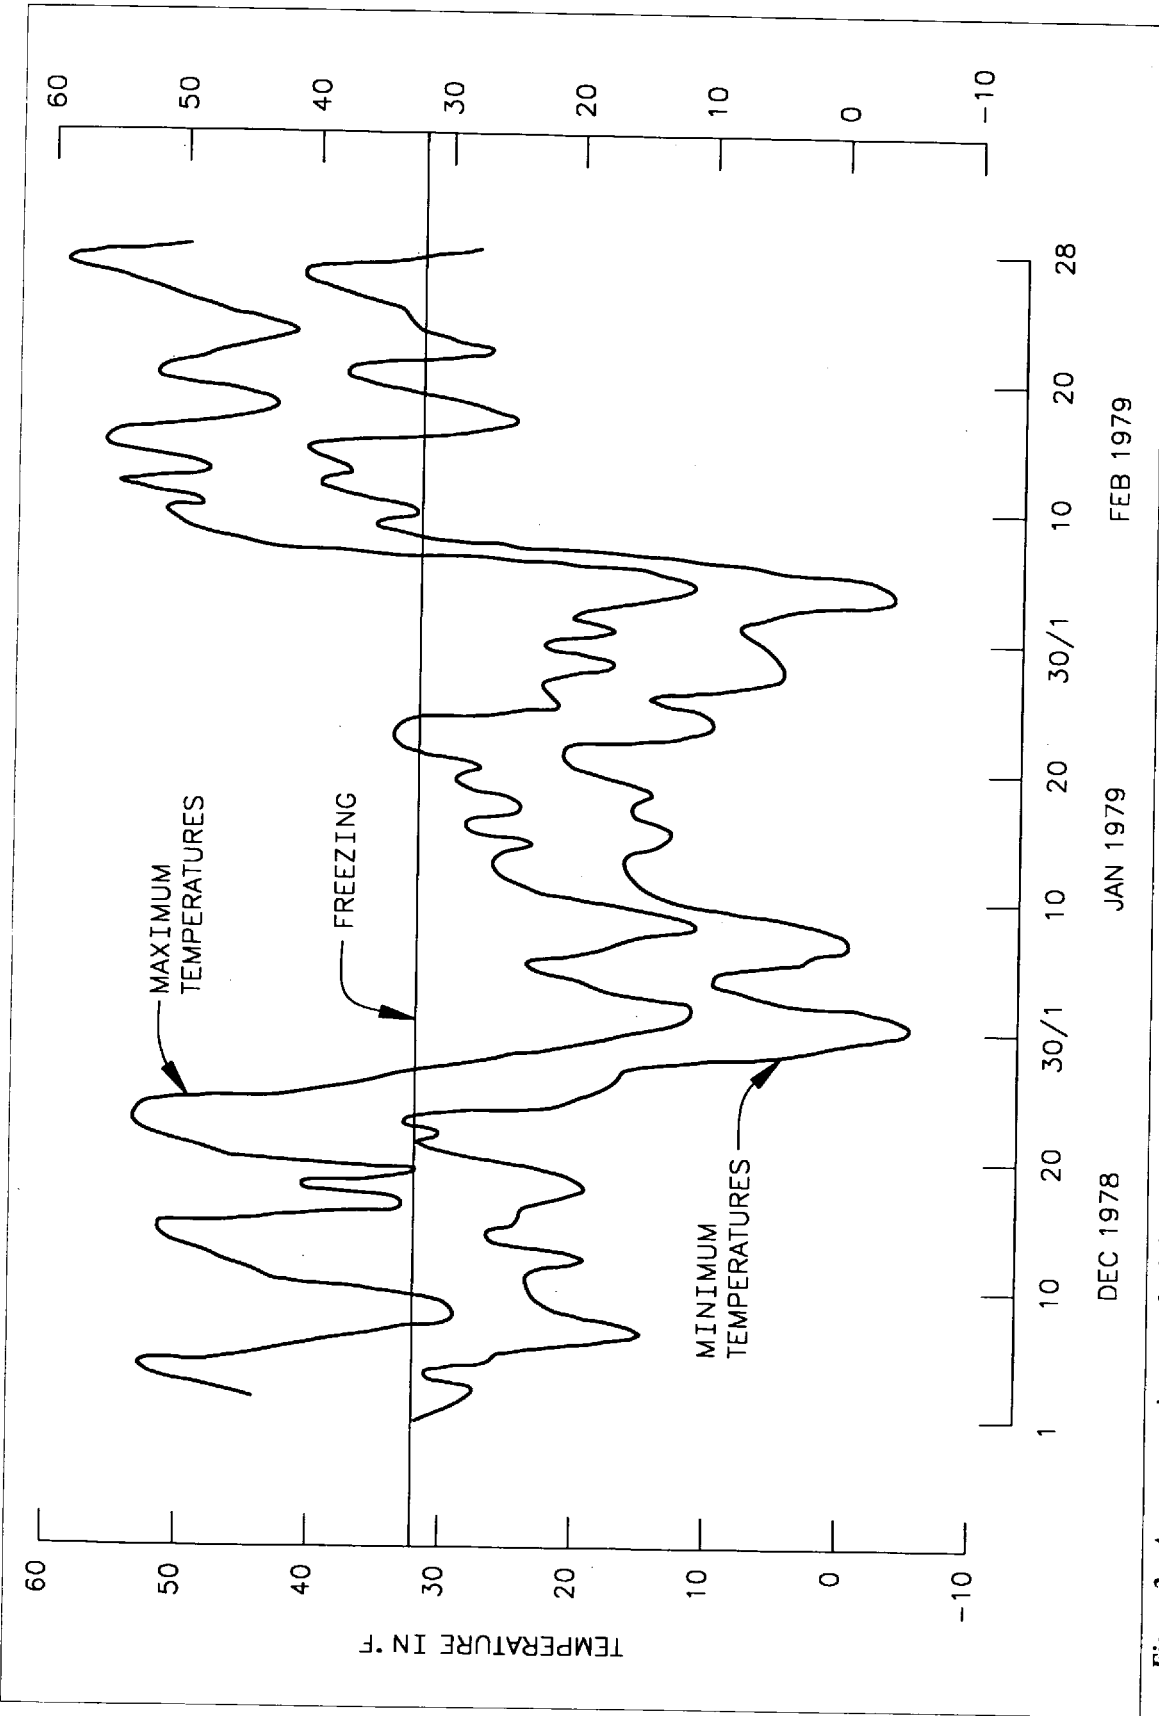
Figure 2 shows that temperatures remained mostly below freezing from about Christmas (1978) into the first week of the following February (42 days). The 1979 Annual Project History for Yakima Project contains references to the very cold winter and to damage to canal structures. On page 11 following mention of the Kennewick Main Canal break is the following: "Sunnyside Valley Irrigation District also suffered a major failure in drop 10 on the main canal when a concrete apron on the bottom of the canal broke up and shifted." On page 169 under the heading of Chandler Canal and Forebay, "very severe cold weather in January with an average of 14  $^{\circ}$ F compared to 27 $^{\circ}$  normal made it impossible to run water. The extreme temperature also had damaging effects on the canal lining. In May, grouting was required in mile 8. In the fall, parts of three liner panels were replaced in miles 2 and 6." From Roza District, "Frost damage to earth sections of the main canal and laterals were repaired by June. These were mostly high water leaks and easily repaired." Also, the following is from the 1979 Annual Project History of the Columbia Basin Project: "There was an unusual amount of snow and cold weather so that the ground was frozen too deep for usual winter construction work. It is felt that the deep frost moved some pipelines enough to break pipes, resulting in numerous washouts in the spring."

Figure 2.—Average maximum and minimum air temperatures for winter of 1978-79, based on records from Kennewick and Prosser, Washington.

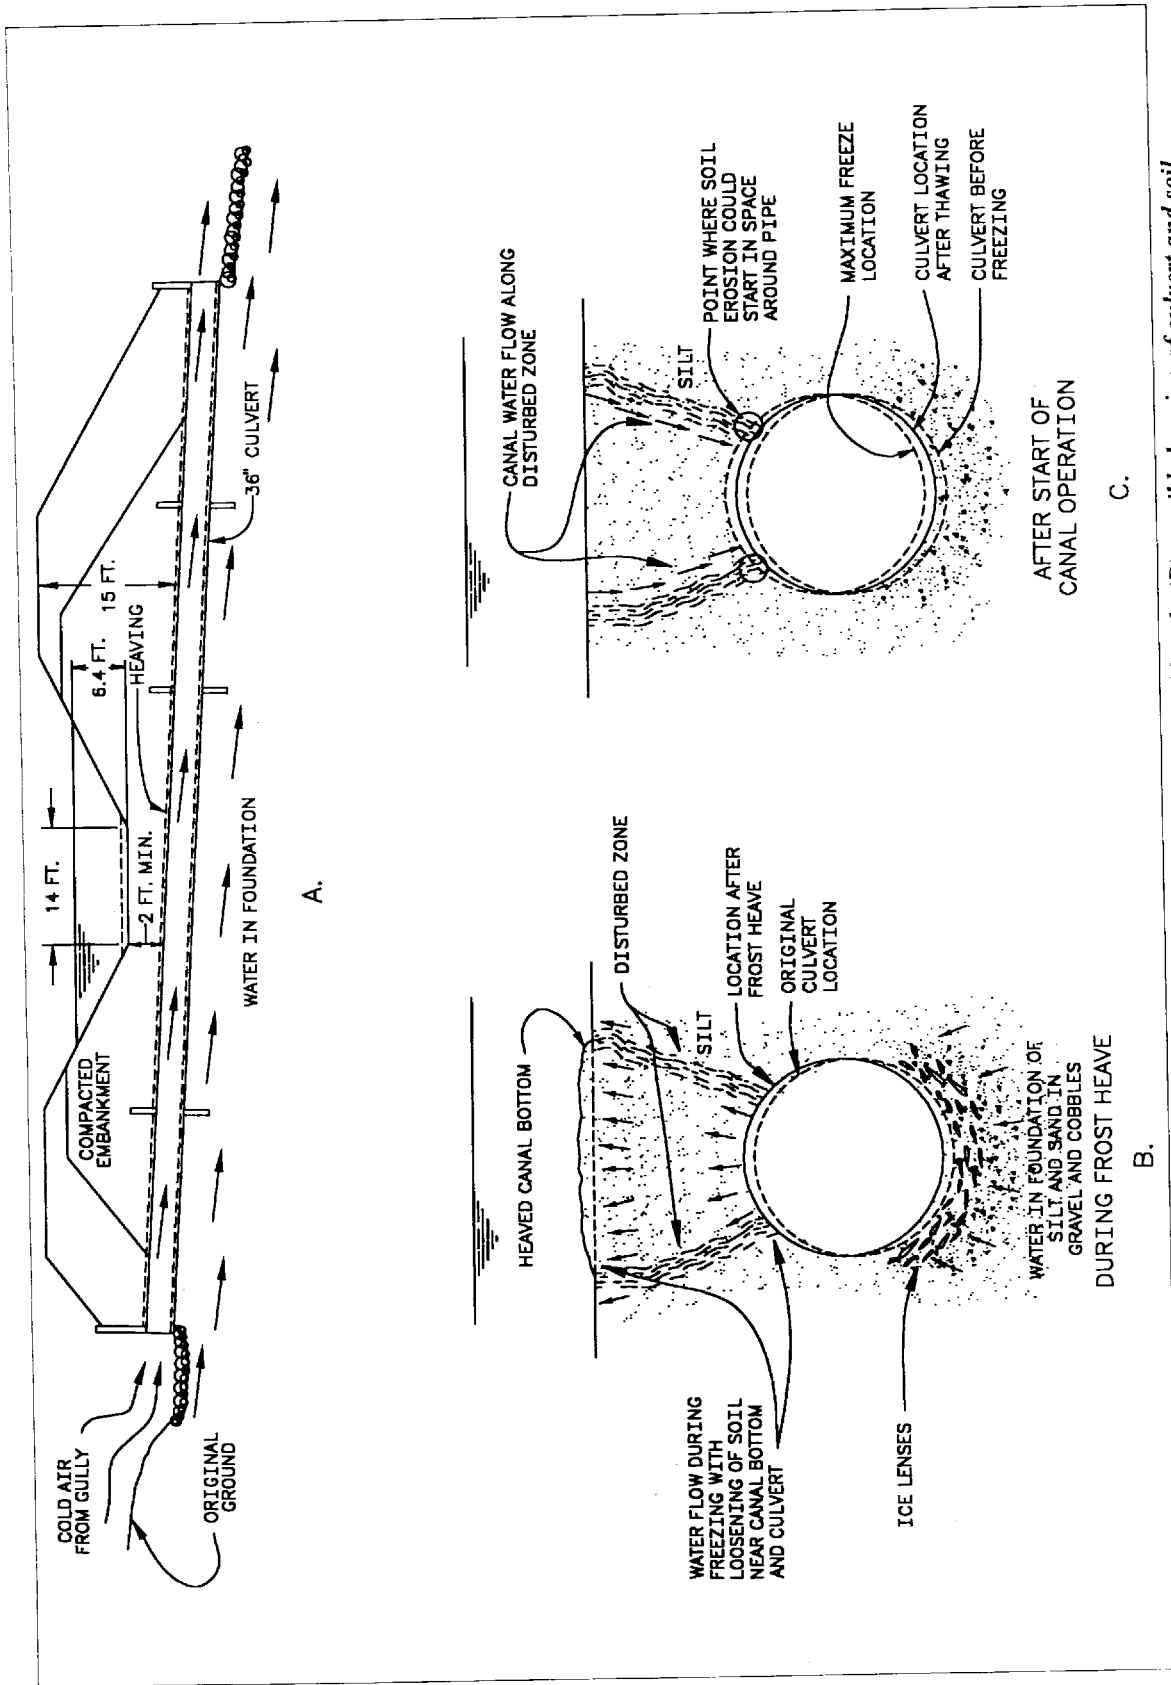
Since cold air is heavier than warm air, it would settle in the drainage area and flow down the gully into the culvert (figure 3A). This would provide a continual supply of cold air flowing through the culvert conducting heat from soil embankment and foundation. From a chart of frost penetration for different soil types [1, figure 16], it is estimated that for the winter of 1978-79, when the air freezing index was about 712, the soil under bare-ground conditions in a level area would freeze to a depth of about 2.5 feet in silt, and the presence of any gravel particles would cause it to freeze deeper than that. With a supply of water in the foundation, ice lenses would build up around the pipe (figure 3B), and this could cause very high pressures. Tests have shown (figure 4) that, for a silt, such pressures can build up to over 50 lbf/in<sup>2</sup>. This is over three times the pressures that would result from the weight of culvert and 16 feet of embankment over it. Thus, forces from frost action could lift the culvert even under the embankment where collars are located. After thawing in the spring, the culvert

Figure 3.—(A) Canal and culvert cross sections at site of May 6, 1979, canal break; (B) possible heaving of culvert and soil by frost action; (C) possible mode of erosion after start of canal operation.

soil surface. This could provide disturbed shear planes where water, after the canal was placed in operation, could flow through the soil and start a piping action into voids around the pipe (figure 3C).

Closing one end of a culvert pipe would stop the flow of cold air. Heat from the soil surrounding the culvert would then reduce freezing in the soil/culvert contact area. Where extremely cold spells are rare, as in the Kennewick Canal area, selected culverts could be temporarily closed by snow, plastic sheeting, or other measures; this would allow an increase in the flow of water to break through the temporary culvert barrier. This preventive measure would be especially important in areas where a canal washout would cause significant damage.

A properly designed and maintained flexible canal lining placed over a culvert would prevent piping of canal water through any fracture zones down to the pipe. Some short lengths of lining were added over selected culverts on the Kennewick Canal. However, such a lining would not prevent a possible culvert washout during a heavy rainfall if there were spaces around the pipe. If exploration showed voids, soil could be removed and recompact. A slurry grout of soil might also be effective in filling voids formed by the frost heave action.

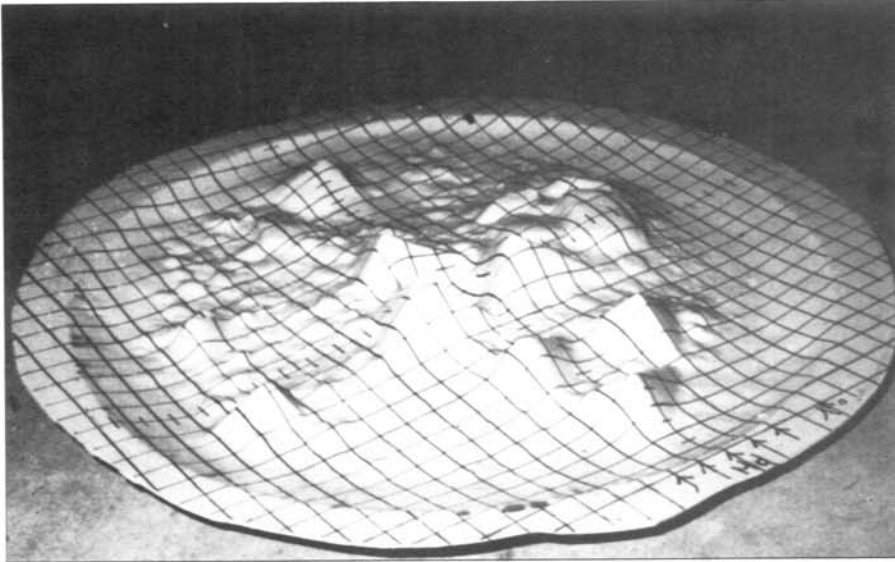
Various types and thicknesses of geomembranes were tested to determine their conformability, burst resistance, and puncture resistance in the presence of a very rough substrate (figure 1). Samples of membrane were placed in a pressure vessel that was sealed and pressurized to a maximum pressure of approximately 150 psi (1 MPa). Samples of membrane that did not rupture during pressurization were subjected to the maximum pressure for 24 hr. The specimens were then removed from the pressure chamber and inspected. A sample of reinforced polyvinyl chloride (PVC) after testing is shown in figure 2. Obviously, the membrane conformed to the very irregular substrate without puncturing.

*Figure 2.—Condition of the reinforced PVC after a sustained load of 150 psi (1MPa) for 24 hr.*

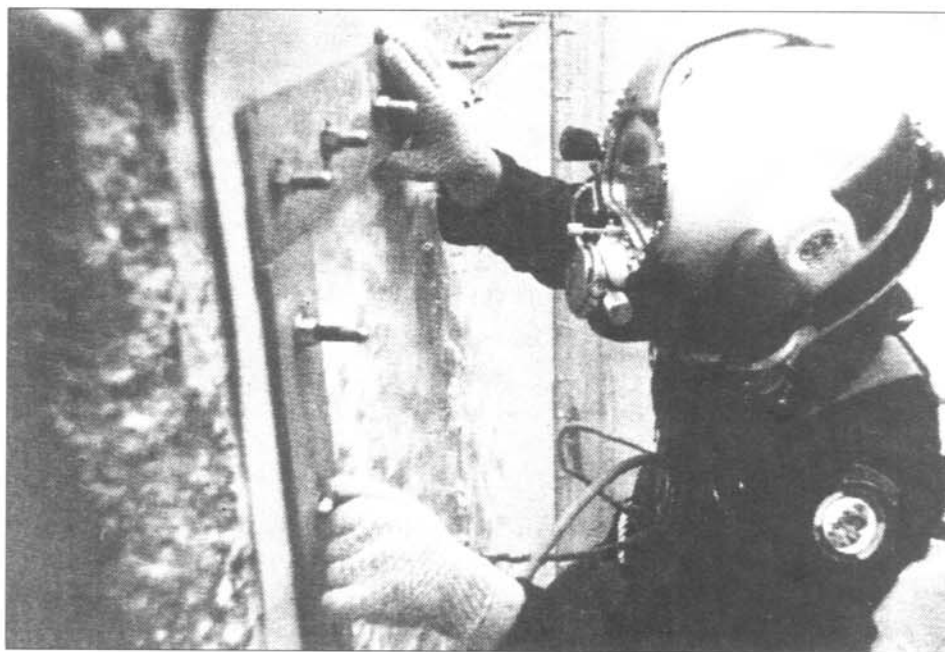
After all of the bolts were tightened, water was evacuated from behind the membrane using a hydraulic ejector. The combined effort of the pressure depression behind the membrane and the water depth resulted in a hydrostatic head of approximately 40 ft (12.2 m) of water. Two weeks after the vacuum was shut off, the membrane remained tightly conformed to the wall (figure 8), indicating that seepage through the repair system was extremely slow. During one of the underwater installations, five anchor bolts that used a combination of two-part epoxy and a glass-encapsulated resin cartridge were used. These five bolts loosened as the nuts were tightened. Failure was later attributed to the installation technique.

*Figure 8.—Membrane tightly conformed to the substrate.*

The system was tested to determine the effect of the defective bolts. As the ejector evacuated water behind the membrane, the membrane conformed tightly against the wall. With the ejector shut off, the membrane remained tightly conformed for approximately 2 hr. With the suction reapplied, divers were able to locate a small leak near the defective bolts by injecting dye into the water near the bolts. The defective bolts were removed and replacement bolts were installed underwater. When the nuts were tightened, an efficient seal was achieved. This installation demonstrated that the system is repairable as well as constructible.

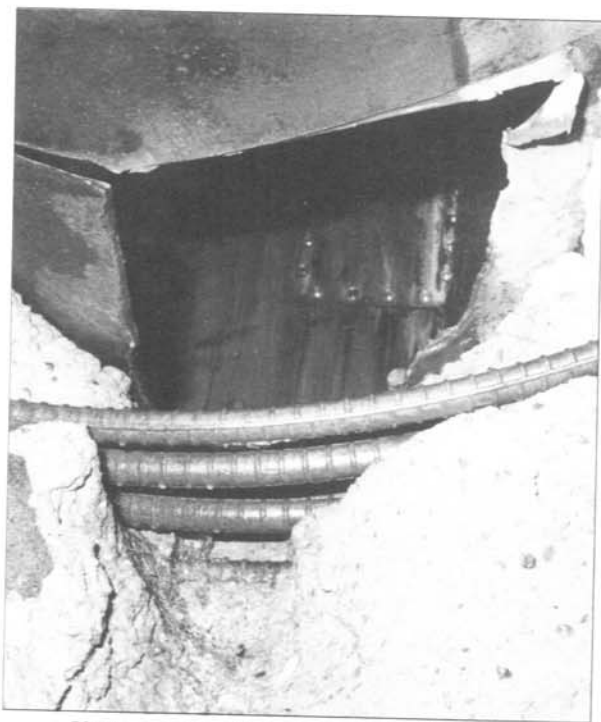
*Upward view of the hole in the #2 hollow jet bypass tube.*

Before that target was reached, an alarm sounded at approximately 6:00 p.m. on Saturday, June 21, 1997. Flooding within the powerplant was taking place, resulting in a powerplant shut-down and a rapid drop in flows from 8,600 cfs to about 4,000 cfs.

When crews arrived at the dam, there were six inches of water on the main floor of the powerplant, and an additional three to four feet of water on the level below. The releases from the bypass tubes were decreased by half as crews worked to determine which tube was leaking.

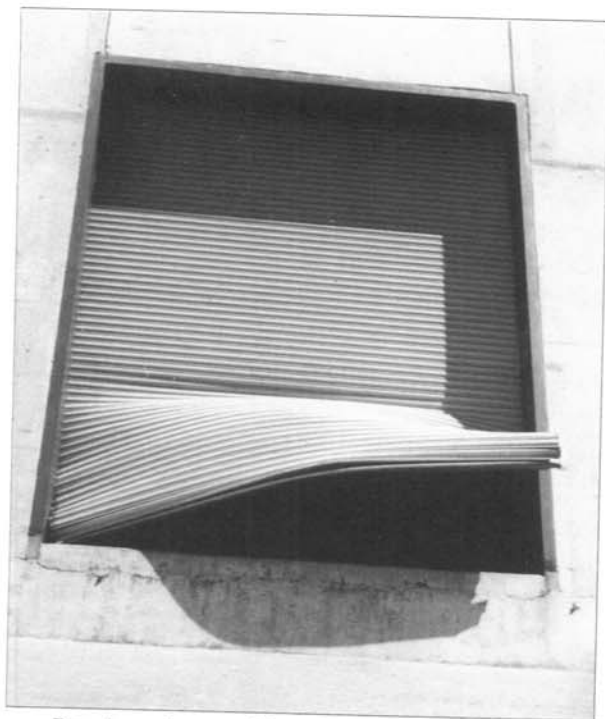
*Bay door damaged by water pouring through the hole in the outlet tube.*

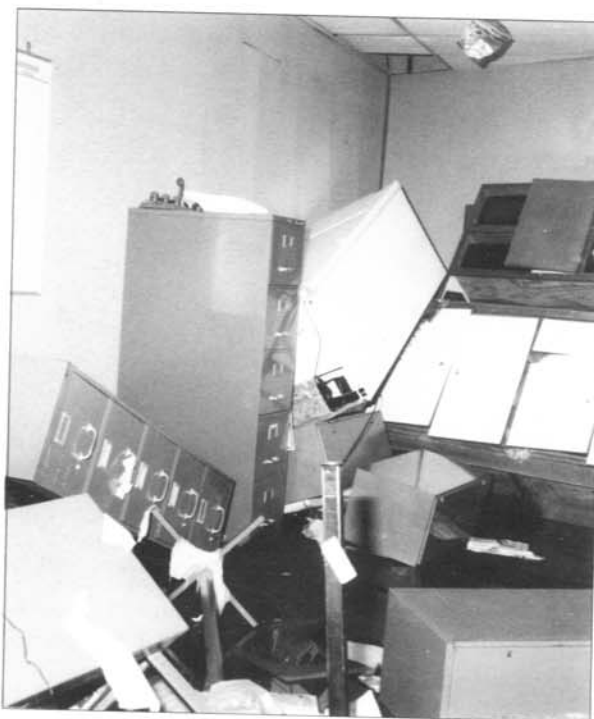
*Heavy file cabinets, refrigerator, and other office furniture and equipment "rearranged" in an office area damaged by water.*

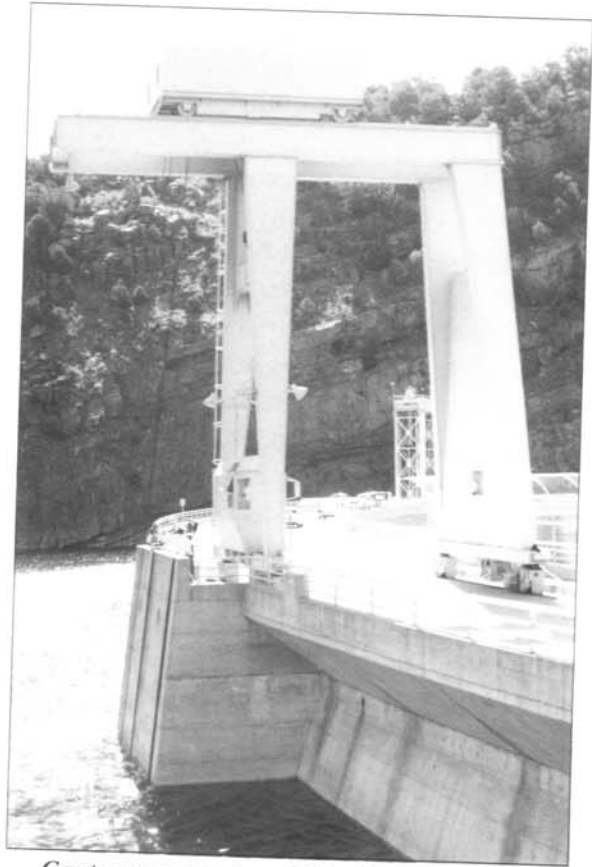
*Gantry crane on top of Flaming Gorge Dam used to place the bulkhead gate in front of the opening to the damaged bypass tube.*
