National Transportation Safety Board

CONCLUSION

The joint bars at the east end of the rail plug fractured under the previous train or as the accident train passed over the joint, and after the joint bars fractured, the rail itself also fractured and broke away, causing the train to derail.

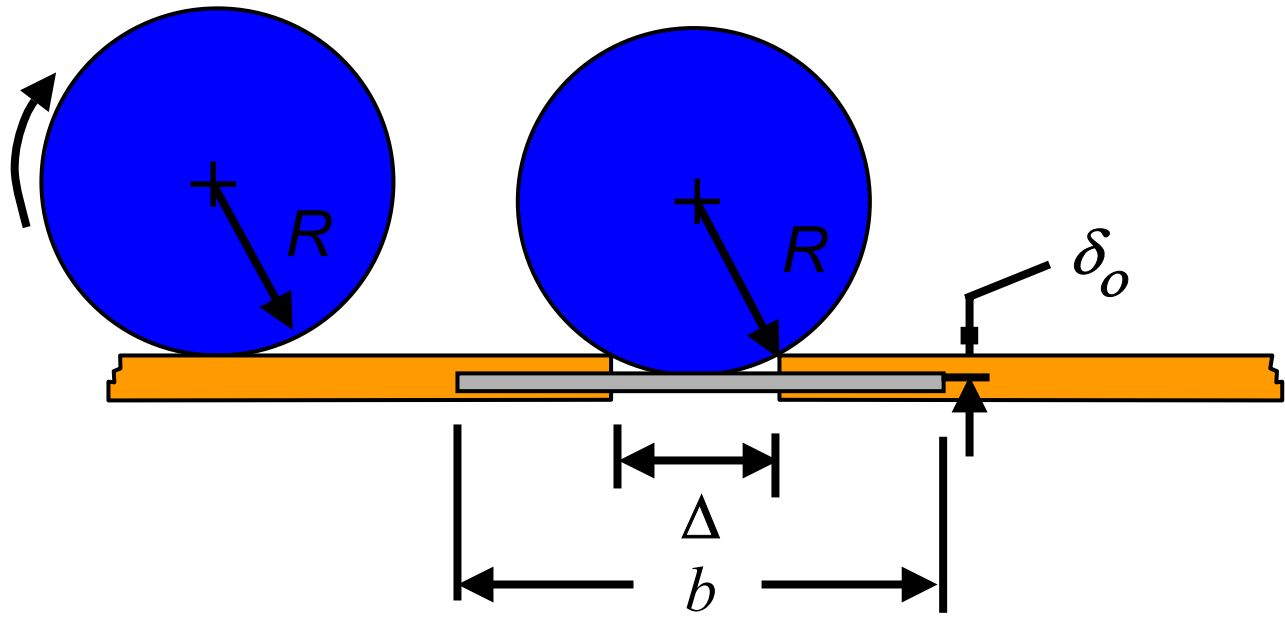
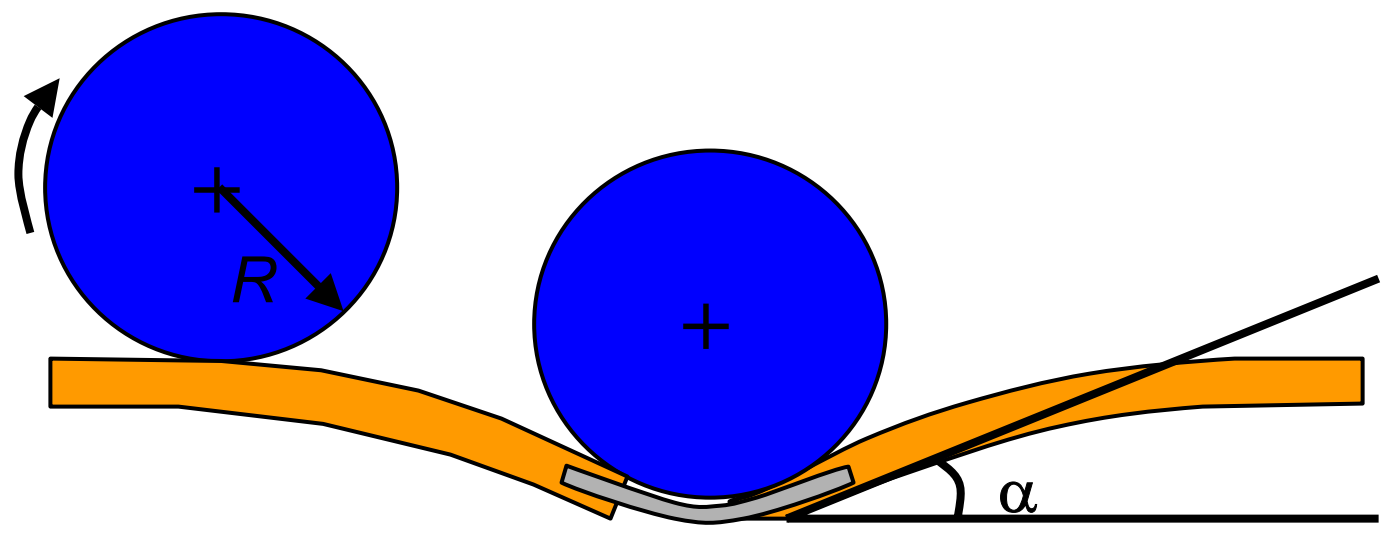
Under Torqued Bolts

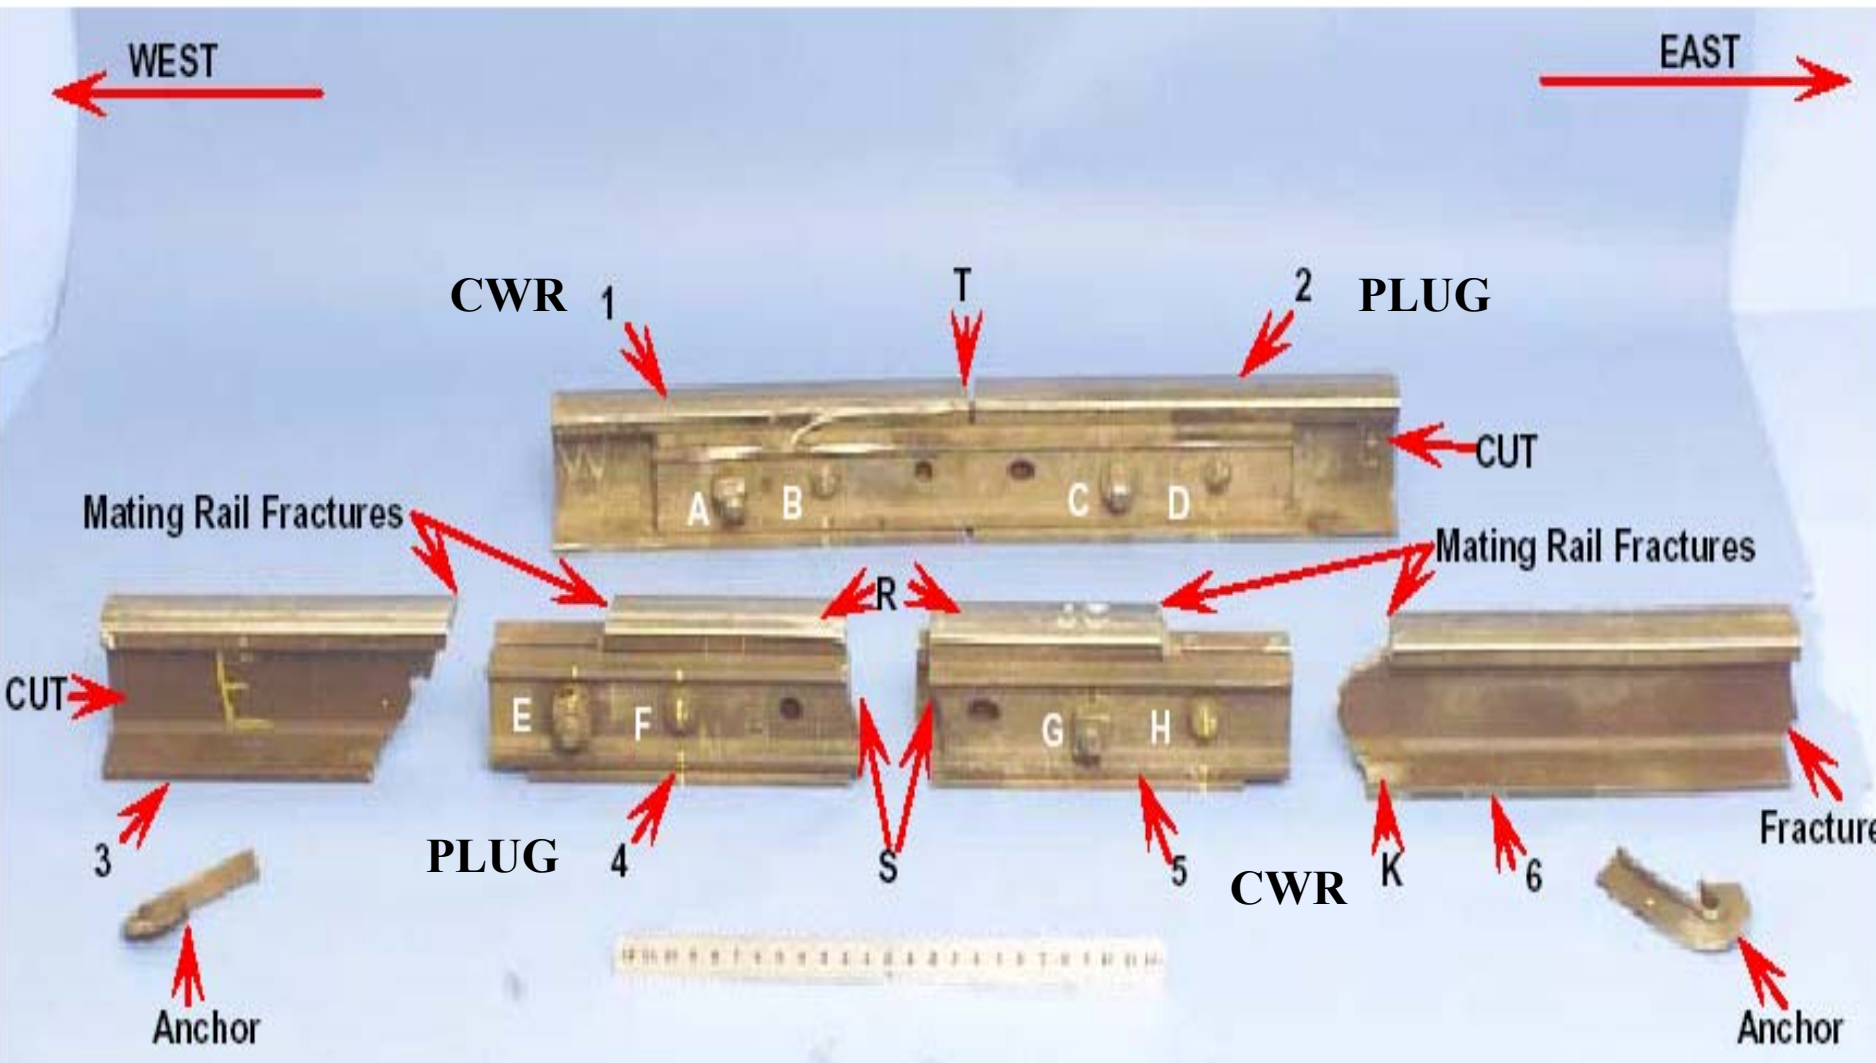
Figure 10. Recovered pieces of rail and joint bars from the north side of the track. Arrows "S" indicate the location of the fracture on the pair of joint bars from the east end of the rail plug. Arrows "R" indicate the joint between rail pieces 4 and 5. Arrow "T" indicates the joint between rail pieces 1 and 2.

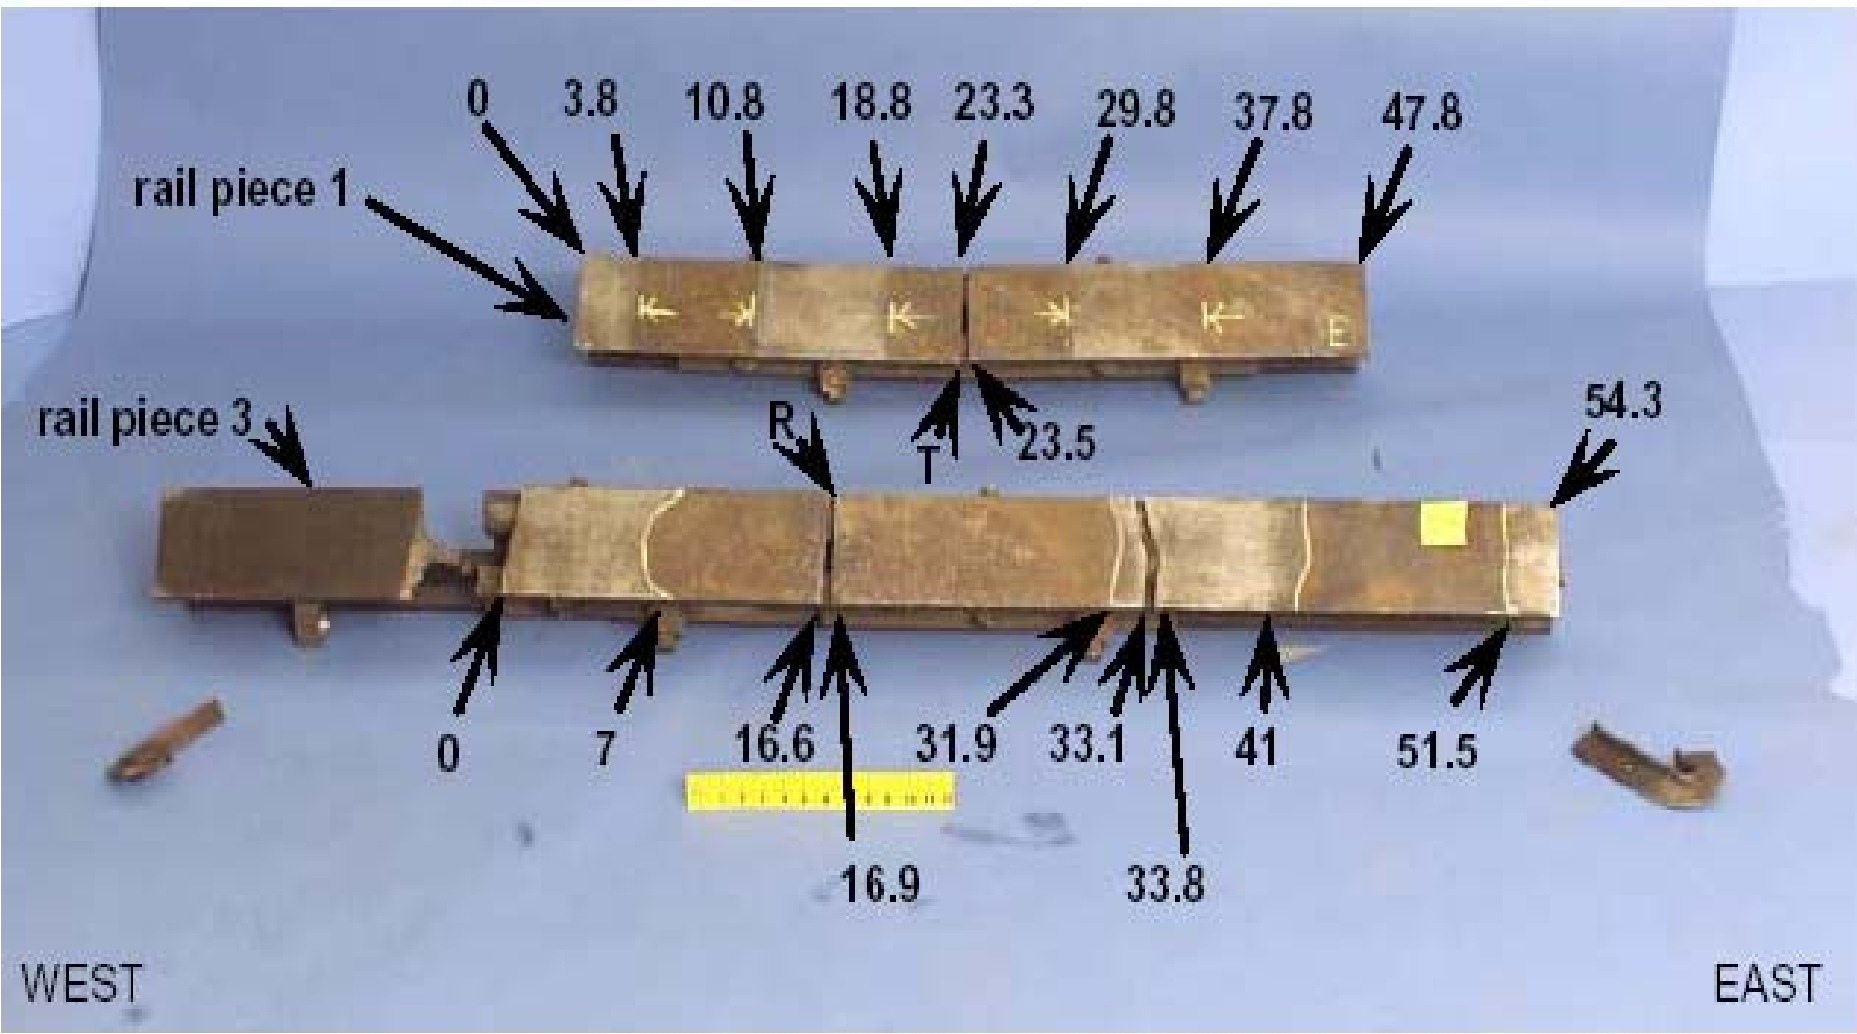
Figure 9. Underside of the recovered pieces of rail from the north side of the track. Pieces placed as they were before they were fractured. The numbers indicate the distance in inches from the “0” arrows.

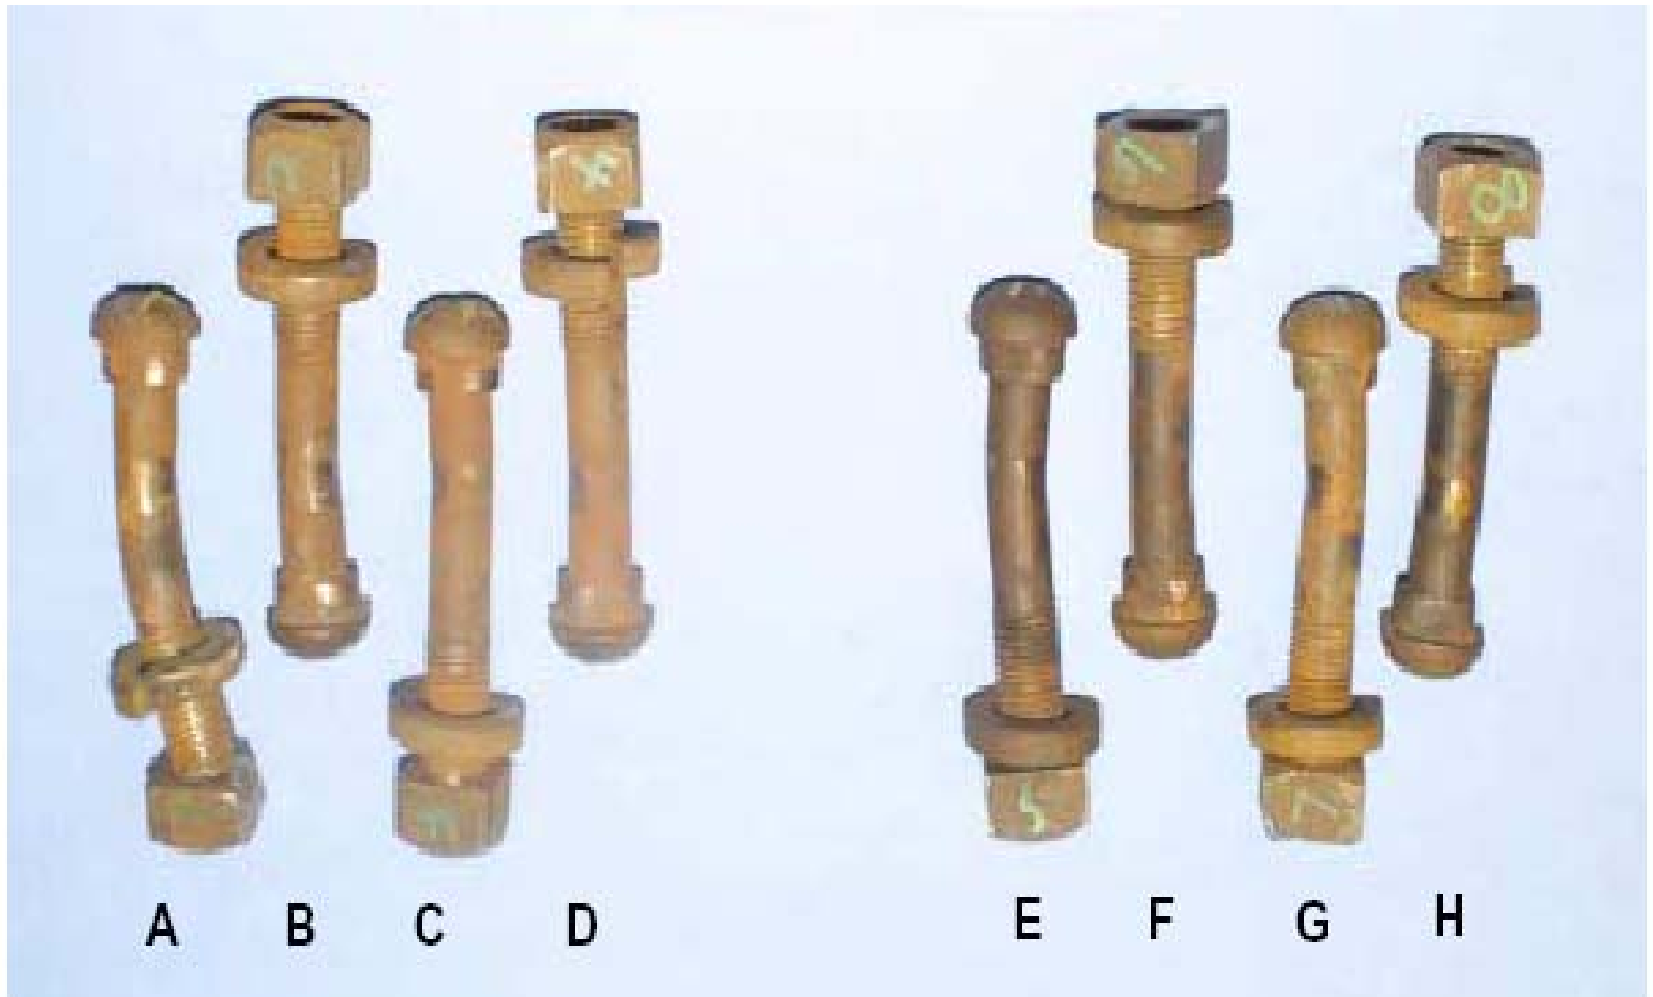
Figure 13. The eight bolts that fastened the joint bars. The disassembled bolts, washers, and nuts are positioned as they were when in place. Note that the shank portion of the bolts that are bent away from their rail joints. West is on the left side of photograph.

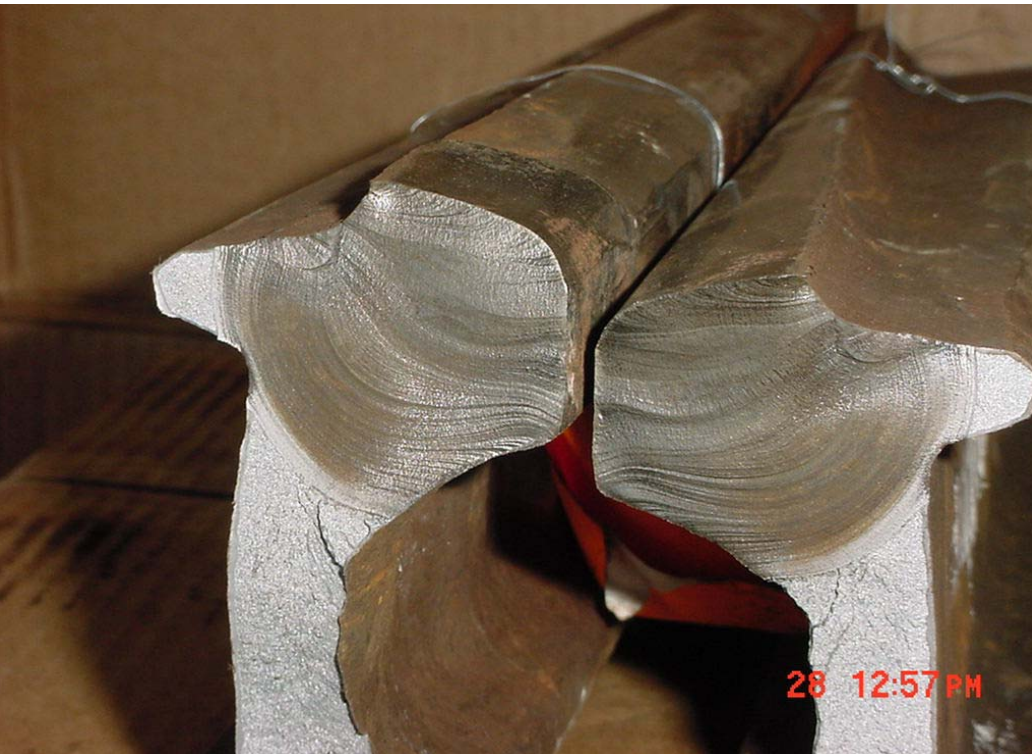
Post-accident “missed defect”

The bar on the left, two halves of same bar, shows fatigued area very similar to fatigued area of accident bars (2).
