National Transportation Safety Board

Safety Recommendation

Date: February 19, 1999

In reply refer to: A-99-10 and -11

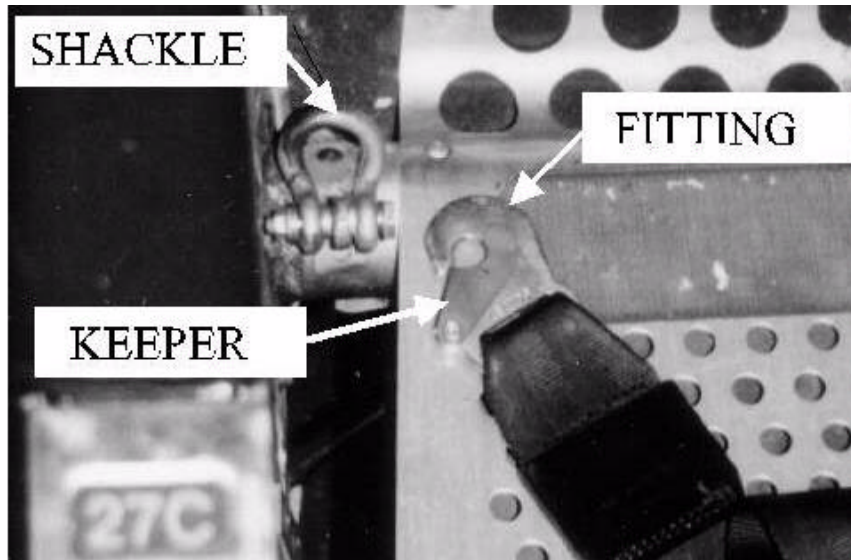
Figure 1.—Seatbelt Assembly

The second safety issue that the Safety Board has identified in its investigation of the flight 1340 accident involved two passenger seatbelts that released at their seat attachments during the airplane’s impact with the ground. The seatbelts on the aisle side of seats 25C and 27C remained buckled but became unhooked at their seat shackles. The passenger in seat 25C was not injured; he stated that he noticed that his seatbelt had separated (at the seat attachment) when he reached down to unbuckle it. However, the passenger in seat 27C reported minor injuries; he stated that his seatbelt released during the airplane’s second impact. After his seatbelt released, he pitched forward to the left, and struck the seat in front of him.

Both seatbelt assemblies are of a design commonly used in commercial airplanes. The seatbelt assembly consists of the standard release buckle, webbing, and an attachment fitting with a spring clip keeper at each end of the belt (see figure 1). The attachment fitting clips over a shackle that is bolted to the seatframe.

During the investigation of the American Airlines flight 1340 accident, Safety Board investigators examined the seatbelt shackles at seats 25C and 27C. In contrast to the CAMI findings in the earlier detachments, both shackles were found to move freely in the vertical direction, and the torque values for each shackle bolt did not exceed the recommended torque limits of 65- to 90-inch pounds. The Safety Board was unable to determine why the seatbelts became unhooked from the shackles at seats 25C and 27C.

The Safety Board is concerned that the current seatbelt fitting with a spring clip keeper that clips over a shackle does not provide enough assurance that the seatbelt will remain fastened to a seat during turbulence or during an emergency landing. The Safety Board is also concerned that operators may not be aware of this unsafe condition and that appropriate corrective measures have not been taken to alert operators and to prevent this condition from occurring. Thus, the Safety Board believes that the FAA should reexamine the design of seatbelts installed on passenger seats on air carrier, air taxi, and commercial airplanes to determine the reason some have become unhooked from their seat attachments during turbulence or a hard landing and establish a suitable means of ensuring that the seatbelts remain attached to their shackles during all modes of flight.

Reexamine the design of seatbelts installed on passenger seats on air carrier, air taxi, and commercial airplanes to determine the reason some have become unhooked from their seat attachments during turbulence or a hard landing and establish a suitable means of ensuring that the seatbelts remain attached to their shackles during all modes of flight. (A-99-11)
