National Transportation Safety Board

Safety Recommendation

In reply refer to: A-99-4

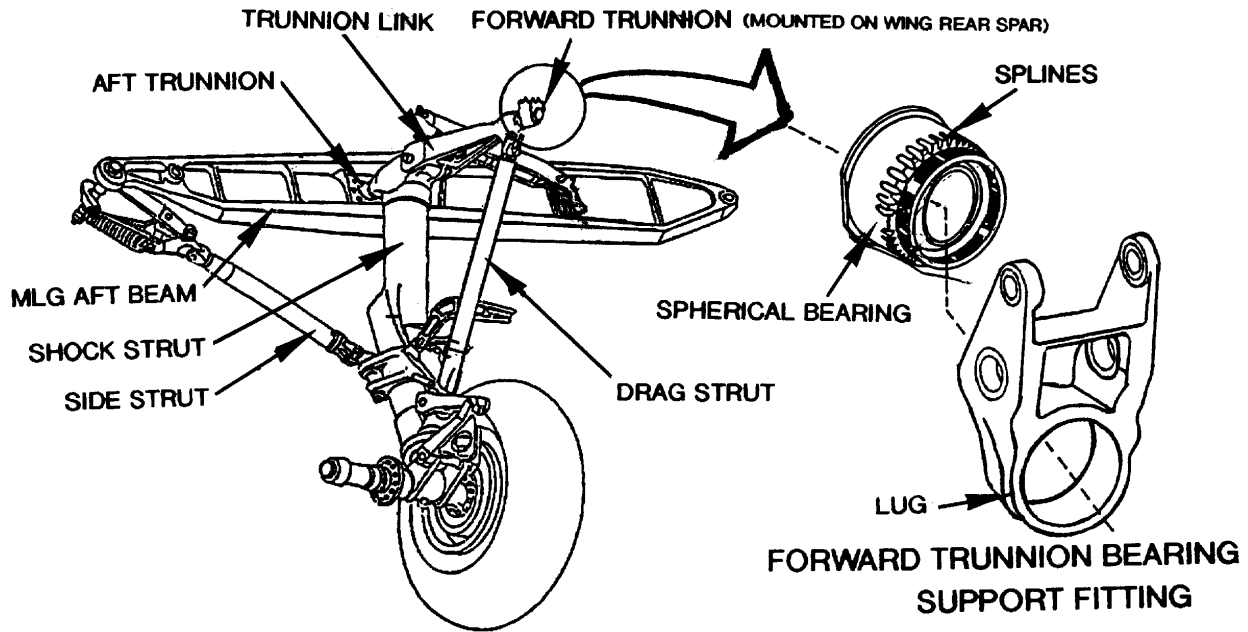
Figure 1. Boeing 727 Main Landing Gear Assembly

The right MLG was original equipment that had accumulated 44,554 flight cycles and 50,861 flight hours in 28 years and 6 months of service. Postaccident examination of the airplane by the National Transportation Safety Board revealed that the right MLG forward trunnion bearing support fitting lug had fractured and that postfracture loads on the fitting had spread the fracture faces apart by bending the outboard side of the lug.

The right MLG of the B-727 is a conventional, two-wheel landing gear with three support points: the forward trunnion, the aft trunnion, and the side strut (see figure 1). A trunnion link is mounted between the shock strut and the rear spar. The aft end of the trunnion link is pinned to the shock strut, and the forward end pivots in a spherical bearing mounted in the forward trunnion bearing support fitting.¹ The spherical bearing has external splines that are used for locking the bearing assembly and retaining it within the support fitting lug. The splines contact a portion of the inner surface of the lug, leaving the gaps between the splines exposed to possible corrosion. The trunnion bearing support fitting is a round housing made from 4330M steel. The inner bore of the housing has chrome electroplating, which is the bore's primary means for corrosion protection. The fitting is mounted on the rear spar of the wing with high-strength bolts.

Examination of the trunnion bearing support fitting at the Safety Board's materials laboratory revealed corrosion at the forward edge of the fitting's lug in many of the exposed areas between the bearing splines. Fatigue cracking emanated from two locations within a severely corroded area, and intergranular stress corrosion cracking (SCC) stemmed from the fatigue cracking. This corroded area was 0.15-inch wide by 0.37-inch long by 0.07-inch deep. The fracture was caused by a combination of fatigue cracking and SCC.

Require operators of all Boeing 727 series airplanes to (1) conduct periodic ultrasonic inspections of the main landing gear (MLG) forward trunnion bearing support fittings for corrosion, cracks, and stress corrosion cracking; (2) repair or replace these fittings if they are cracked or corroded; and (3) ensure that a proper moisture barrier is applied on new or existing MLG forward trunnion bearing support fittings to minimize corrosion. (A-99-4)
