National Transportation Safety Board

Safety Recommendation

Date: February 3, 1999

In reply refer to: A-99-5 through -7

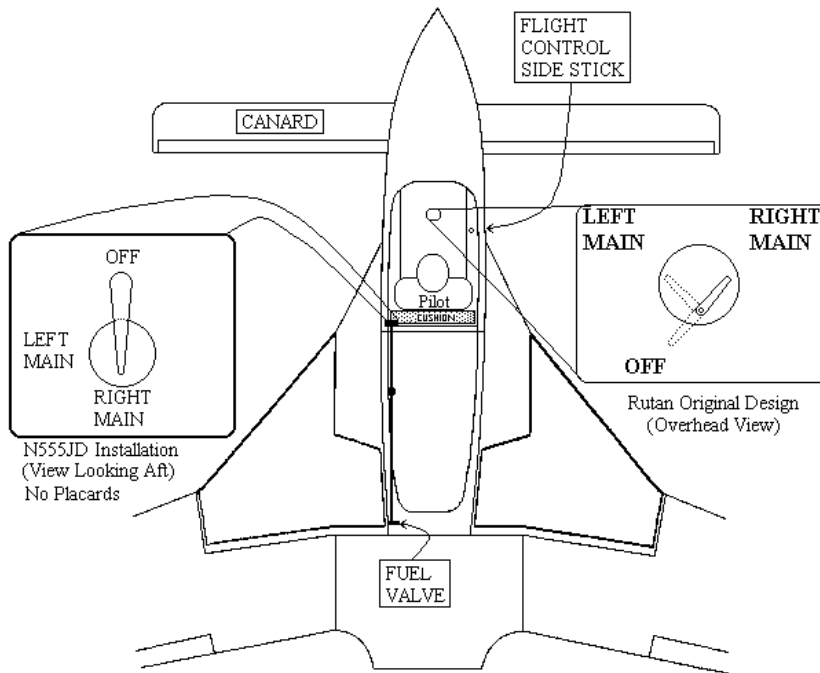
Figure 1—Comparison of fuel selector handle locations in Long-EZ

The amateur builder of N555JD modified the fuel system design by locating the fuel selector handle on the left side of the bulkhead that forms the front cockpit seat back. It was positioned approximately behind the front-seat pilot's left shoulder (see figure 1). The builder also changed the orientation of the handle so that upward selected "Off," right selected the left tank, and downward selected the right tank. The corresponding 3-position fuel selector valve was installed inside the rear cockpit on the front of the engine firewall just behind the rear seat and was connected to the selector handle via two torque tubes and a universal joint. The selector handle was about 4 feet forward of the fuel selector valve. No placard or marking existed (nor was it required) on the fuel selector handle base that would have indicated to the pilot its operating position. Further, as has been stated, the sight gauges were not marked to quantify the amount of fuel in the tanks.

N555JD vs. Original design

The flight control side sticks in both cockpits were installed in armrests on the right side of the cockpits, measured about 6 inches high, and were similar in function to a conventional control stick. During the postaccident investigation, simulation by Safety Board staff showed that the front-seat pilot in the accident airplane would have had to loosen his shoulder harness, completely release the flight control stick, turn in his seat, and stretch to his left when reaching over the left shoulder with his right hand to change the position of the fuel selector handle on the accident Long-EZ airplane. The Safety Board investigator, in every simulation, inadvertently applied right rudder when turning his body and reaching for the fuel selector handle. This finding concerned the Safety Board because the design change that moved the fuel selector handle introduced a safety hazard in N555JD. On the basis of the accident circumstances and witness accounts, the Board concluded that the accident pilot probably inadvertently applied right rudder while manipulating the fuel selector, precipitating the loss of control that preceded the accident.

The Safety Board is concerned that the pilot of N555JD, who had minimal¹³ pilot-in-command experience in the accident airplane, may not have been adequately familiar with the operating positions of the unmarked fuel selector handle. This is of special concern because in its modified location and orientation, the fuel selector handle’s operating positions would have been less intuitively obvious than if it had been installed as originally designed. Also, demonstrations indicated that the fuel selector handle was out of the accident pilot’s view and in an awkward position that a pilot of similar height as the accident pilot (5’ 10”) could not operate without releasing the flight control stick. An interview with the checkout pilot revealed that he

Amend FAA Order 8130.2C to specify that, before the issuance of special airworthiness certificates, experimental, amateur-built airplanes should be inspected for needed placards and markings on cockpit instruments and for the appropriate placement and operation of essential system controls to ensure that they provide clear marking, easy access, and ease of operation. (A-99-5)
