National Transportation Safety Board

Safety Recommendation

In reply refer to: A-99-9

On October 12, 1997, about 1728 Pacific daylight time, an experimental category, amateur-built Adrian Davis¹ Long-EZ airplane, N555JD, crashed into the Pacific Ocean near Pacific Grove, California. Air traffic control communications indicated that the airplane had departed from the Monterey Peninsula Airport's runway 28L about 1712, and the pilot performed three touch-and-go landings and departed to the west moments before the accident. Witnesses reported that they heard engine popping and a reduction in engine noise before the accident. The pilot made no distress calls. The pilot was killed, and the airplane was destroyed.

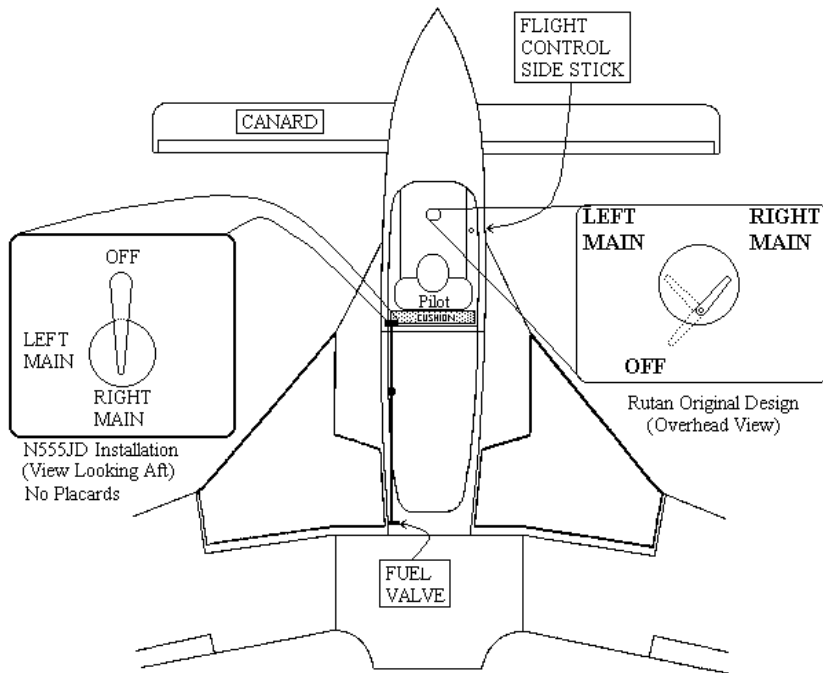
The amateur builder of N555JD modified the fuel system design by locating the fuel selector handle on the left side of the bulkhead that forms the front cockpit seat back. It was positioned approximately behind the front-seat pilot's left shoulder (see figure 1). The builder also changed the orientation of the handle so that upward selected "Off," right selected the left tank, and downward selected the right tank. The corresponding 3-position fuel selector valve was installed inside the rear cockpit on the front of the engine firewall just behind the rear seat and was connected to the selector handle via two torque tubes and a universal joint. The selector handle was about 4 feet forward of the fuel selector valve. No placard or marking existed (nor was it required) on the fuel selector handle base that would have indicated to the pilot its operating position. Further, as has been stated, the sight gauges were not marked to quantify the amount of fuel in the tanks.

Figure 1—Comparison of fuel selector handle locations in Long-EZ

N555JD vs. Original design

The flight control side sticks in both cockpits were installed in armrests on the right side of the cockpits, measured about 6 inches high, and were similar in function to a conventional control stick. During the postaccident investigation, simulation by Safety Board staff showed that the front-seat pilot in the accident airplane would have had to loosen his shoulder harness, completely release the flight control stick, turn in his seat, and stretch to his left when reaching over the left shoulder with his right hand to change the position of the fuel selector handle on the accident Long-EZ airplane. The Safety Board investigator, in every simulation, inadvertently applied right rudder when turning his body and reaching for the fuel selector handle. This finding concerned the Safety Board because the design change that moved the fuel selector handle introduced a safety hazard in N555JD. On the basis of the accident circumstances and witness accounts, the Board concluded that the accident pilot probably inadvertently applied right rudder while manipulating the fuel selector, precipitating the loss of control that preceded the accident.

The Safety Board is concerned that the pilot of N555JD, who had minimal¹³ pilot-in-command experience in the accident airplane, may not have been adequately familiar with the operating positions of the unmarked fuel selector handle. This is of special concern because in its modified location and orientation, the fuel selector handle’s operating positions would have been less intuitively obvious than if it had been installed as originally designed. Also, demonstrations indicated that the fuel selector handle was out of the accident pilot’s view and in an awkward position that a pilot of similar height as the accident pilot (5’ 10”) could not operate without releasing the flight control stick. An interview with the checkout pilot revealed that he

Establish, in conjunction with the Federal Aviation Administration and the Aviation Insurance Association, a cooperative program that strongly encourages pilots transitioning to unusual or unfamiliar amateur-built, experimental category airplanes to undergo formalized, type-specific transition training similar to that provided to pilots of some advanced, experimental, amateur-built airplanes. (A-99-9)
