# National Transportation Safety Board

Washington, D.C. 20594  
Safety Recommendation

Date June 13, 1997

In reply refer to: A-97-38 through -40

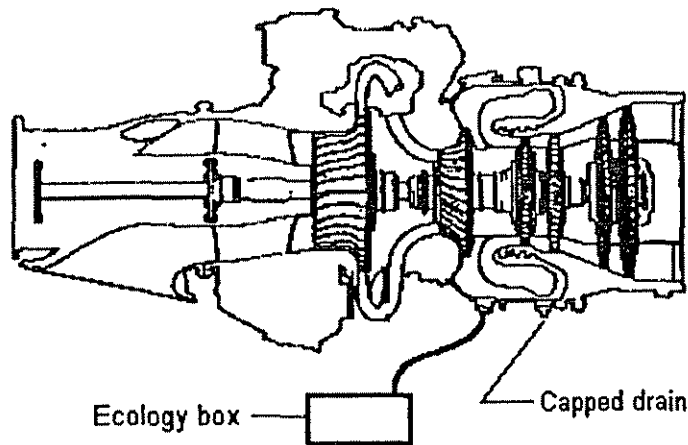
The PWC PW100 series turboprop engine gas generator case has two drain plugs, one each at the forward and rear of the case, at the 6-o'clock location,<sup>1</sup> to drain the unburned fuel from the fuel manifolds that has drained back through the lowest fuel nozzles into the gas generator case. These drains are intended to prevent internal fires or hot starts. Each drain plug has a "finger" seal, which closes to prevent any air leakage whenever the case is pressurized. After engine shutdown, the finger seal opens when the internal pressure in the case returns to ambient levels. The gas generator case has the two drain plugs to accommodate the installation requirement for the case drain line for the various airplane model installations.<sup>2</sup> One drain plug is connected to a drain line routed to the "ecology" tank,<sup>3</sup> and the other drain plug is then capped to prevent fuel leakage into the nacelle.

On the EMB-120, the forward drain plug has the drain line to the ecology tank and the aft drain plug is capped. During the disassembly of the engine, it was noted that the forward drain plug had the drain line that would have been routed to the ecology tank. But the aft drain plug did not have the cap attached, and the threads of the plug were not damaged. Thus, the Safety Board concluded that the cap had not been installed before the engine failure.

Therefore, when the engine failed and shut down because of the oil-fed fire, the unburned, residual fuel in the fuel manifolds would have drained back through the fuel nozzles into the gas generator case and then out through the drain plugs at the bottom of the case. Because the airplane was climbing in a nose-high attitude, the fuel would have drained rearward through the aft drain plug and onto the deck under the engine, rather than through the forward drain into the ecology tank. Although the deck area under the engine also has an overboard drain located in the forward part of the engine bay, the fuel would have flowed aft because of the airflow through the nacelle and the nose-up climb attitude. The fuel could have then been ignited by the heat from the hot exhaust pipe in the aft section of the engine nacelle.

Issue an airworthiness directive to require an immediate one-time inspection of all Pratt & Whitney of Canada PW100 series turboprop engines to ensure that the gas generator case drain line and the plug are correctly installed. (Class I, Urgent Action) (A-97-38)
