NATIONAL TRANSPORTATION SAFETY BOARD
WASHINGTON, D.C.

ISSUED: NOV 9 1984

SAFETY RECOMMENDATION(S)

A-84-116 through -122

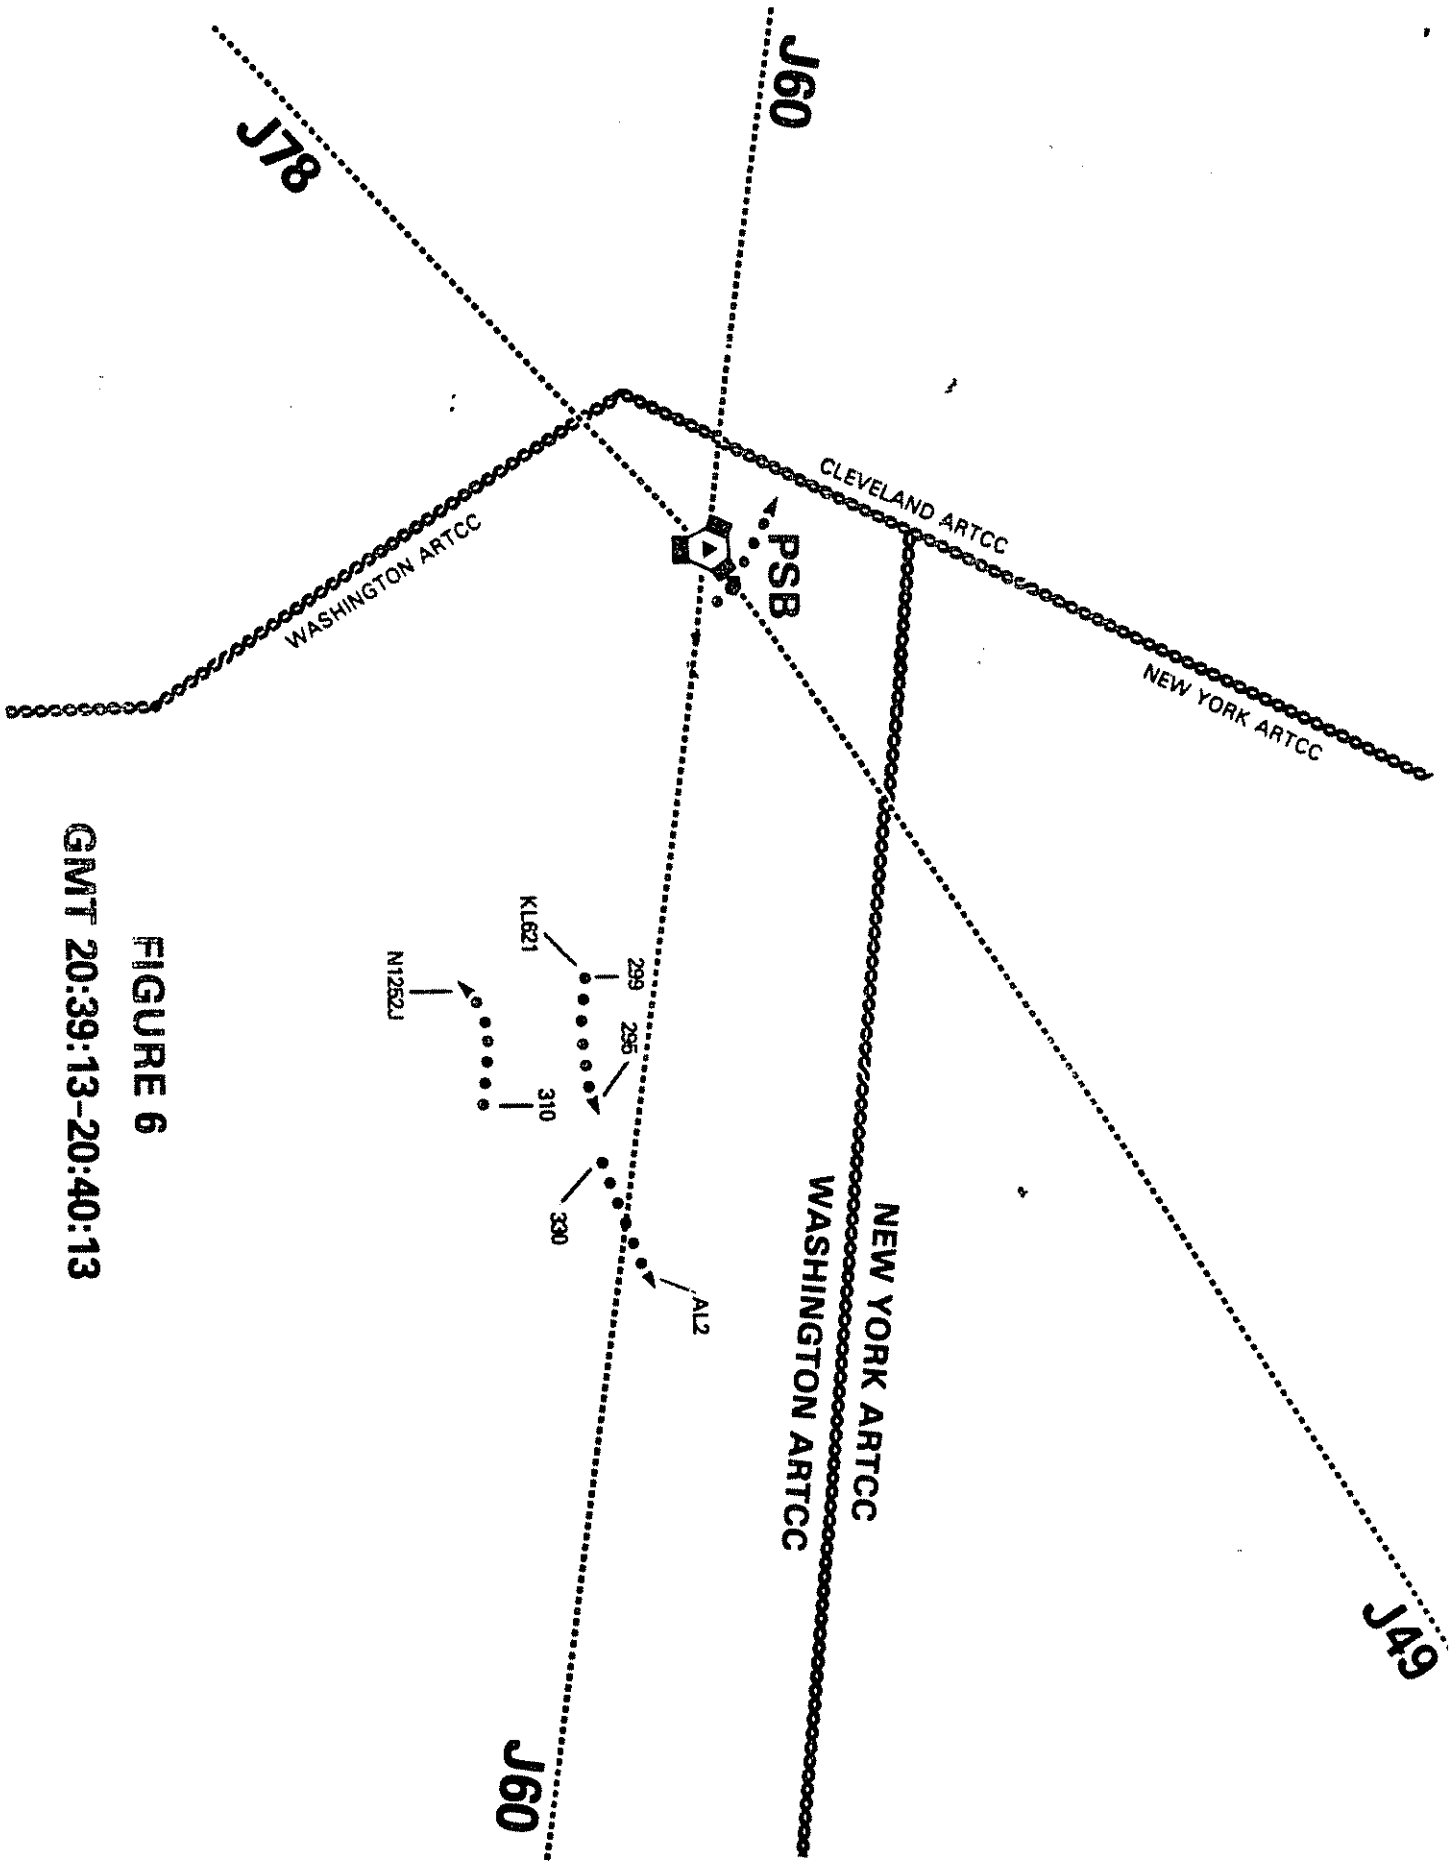
FIGURE 6

The East Texas sector radar controller noted that KLM 621 had started a left turn toward UAL 1009, and he immediately directed UAL 1009 to enter an emergency climb to FL 320. KLM 621 and UAL 1009 came within 1 nmi horizontally and 750 feet vertically of each other. As KLM 621 continued to turn to the left, it headed directly toward NW 157 and then toward the corporate jet, N1252J, both of which remained at FL 310. Noting this, the New York ARTCC Milton sector controller issued further emergency clearance to KLM 621 to descend to FL 290. KLM 621 and NW 157 passed within 1.8 nmi horizontally and 580 feet vertically and KLM 621 and N1252J passed within 3.4 nmi horizontally and 1,400 feet vertically. The flightpaths of these aircraft as determined from an analysis of the FAA ATC radar recordings are shown on figures 2 through 6.

GMT 20:39:13-20:40:13

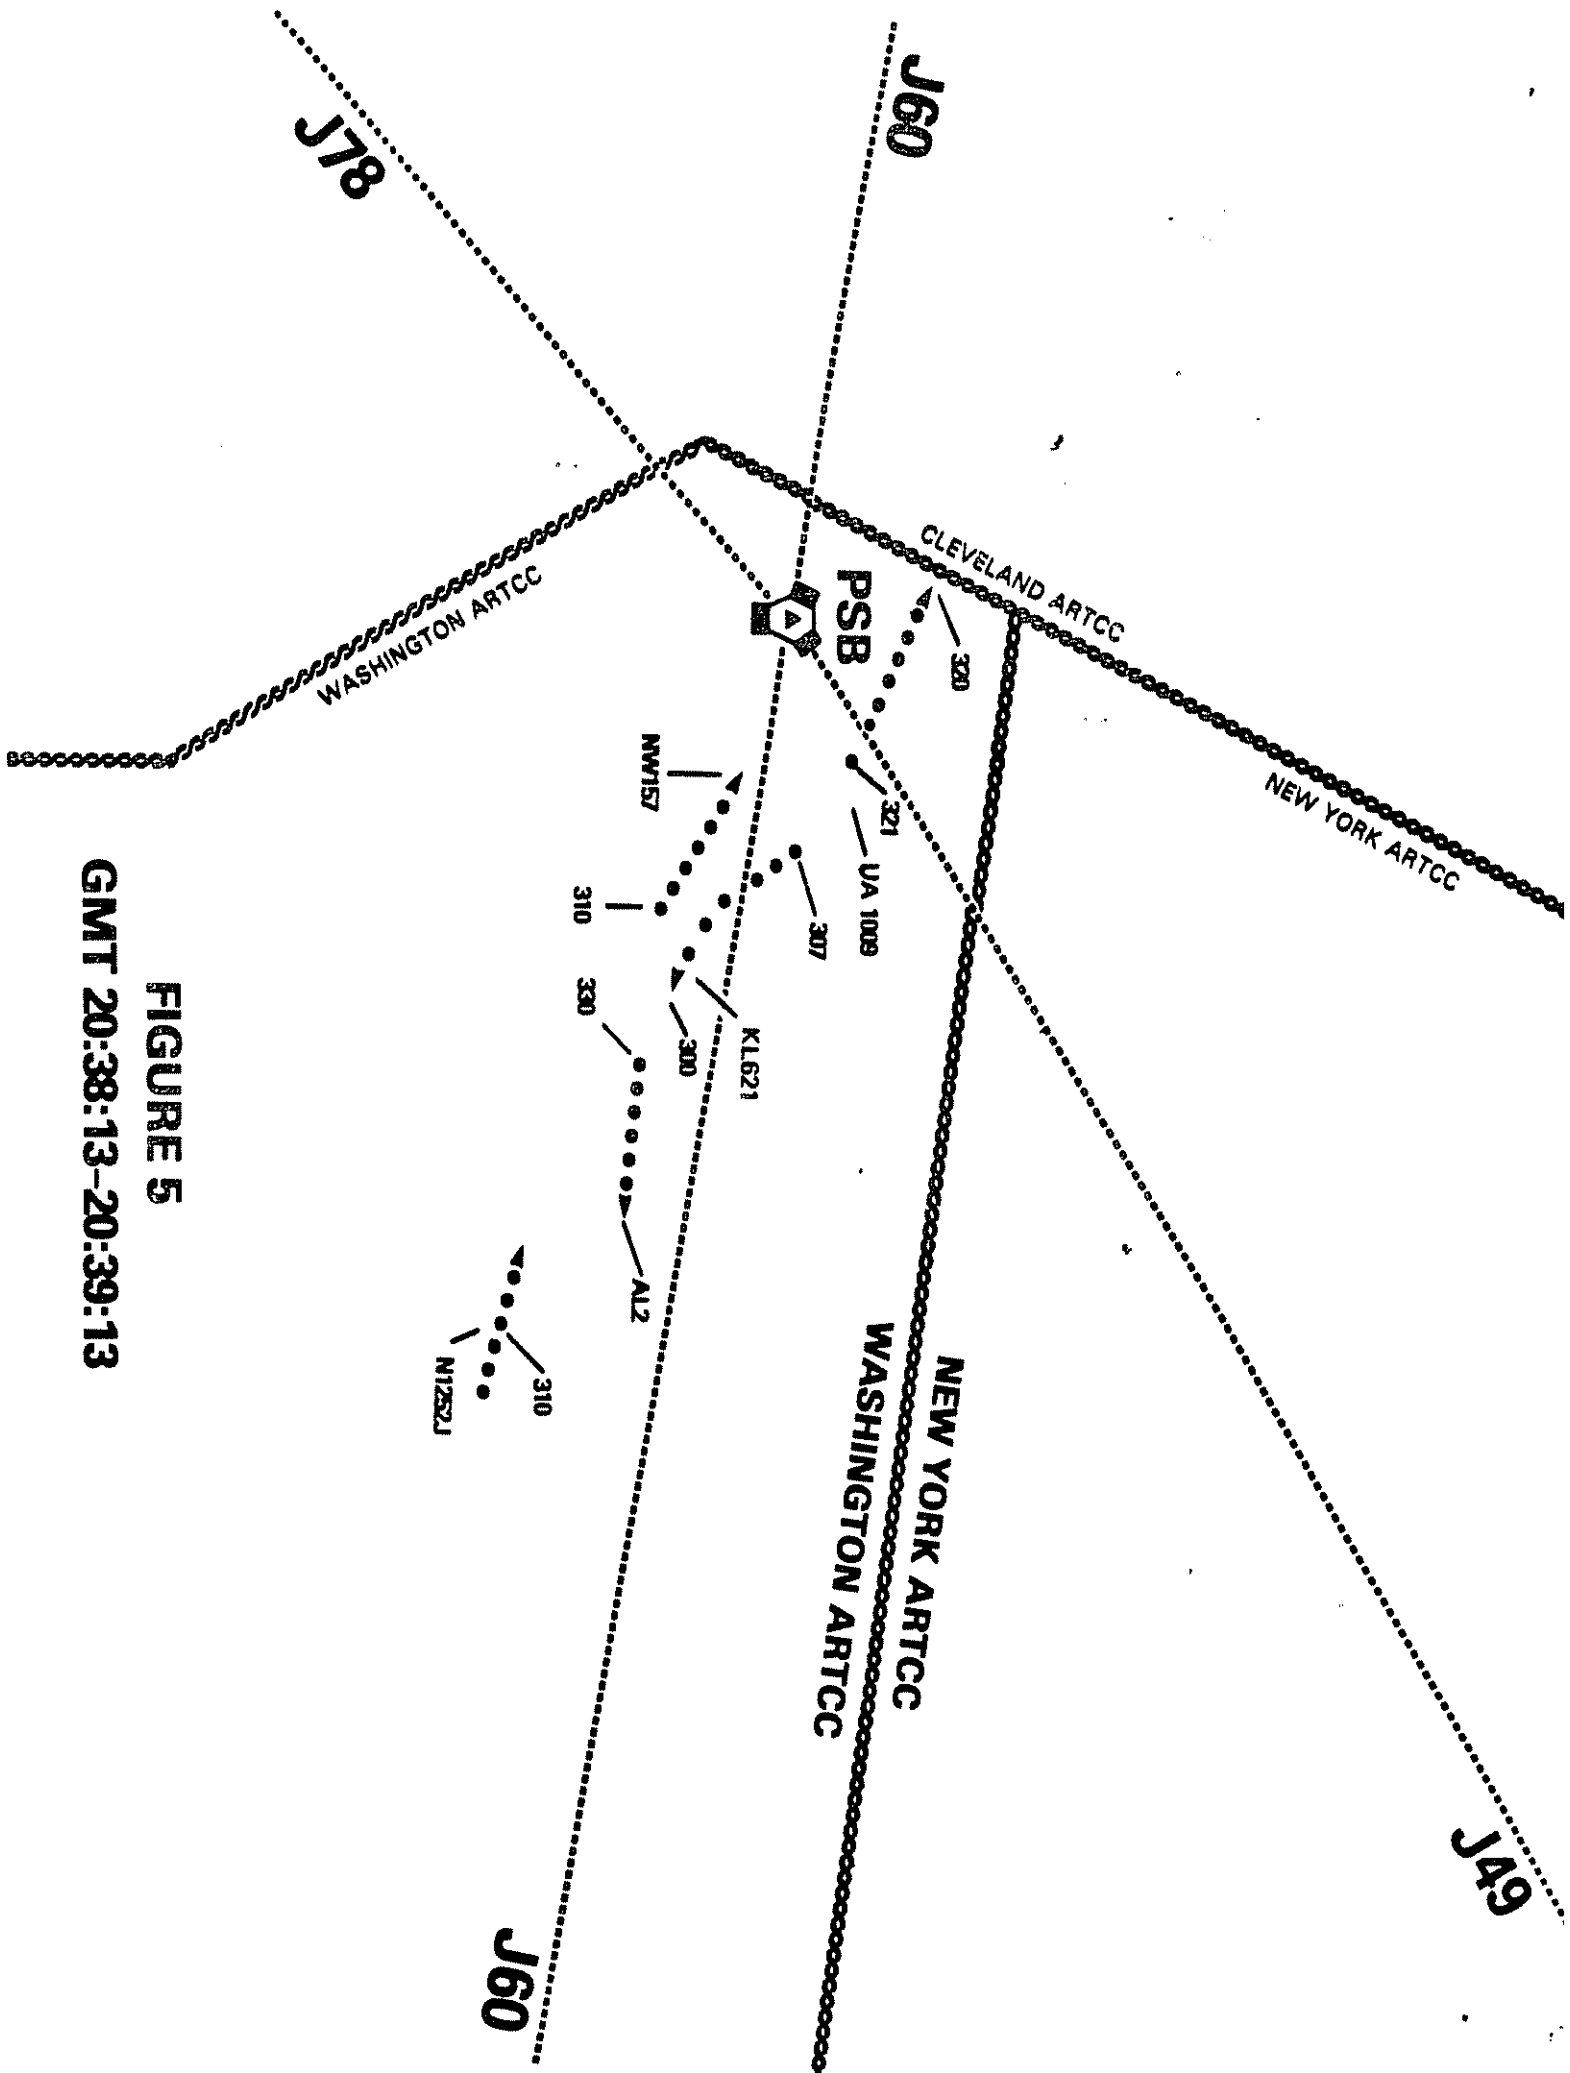
FIGURE 5

GMT 20:38:13-20:39:13

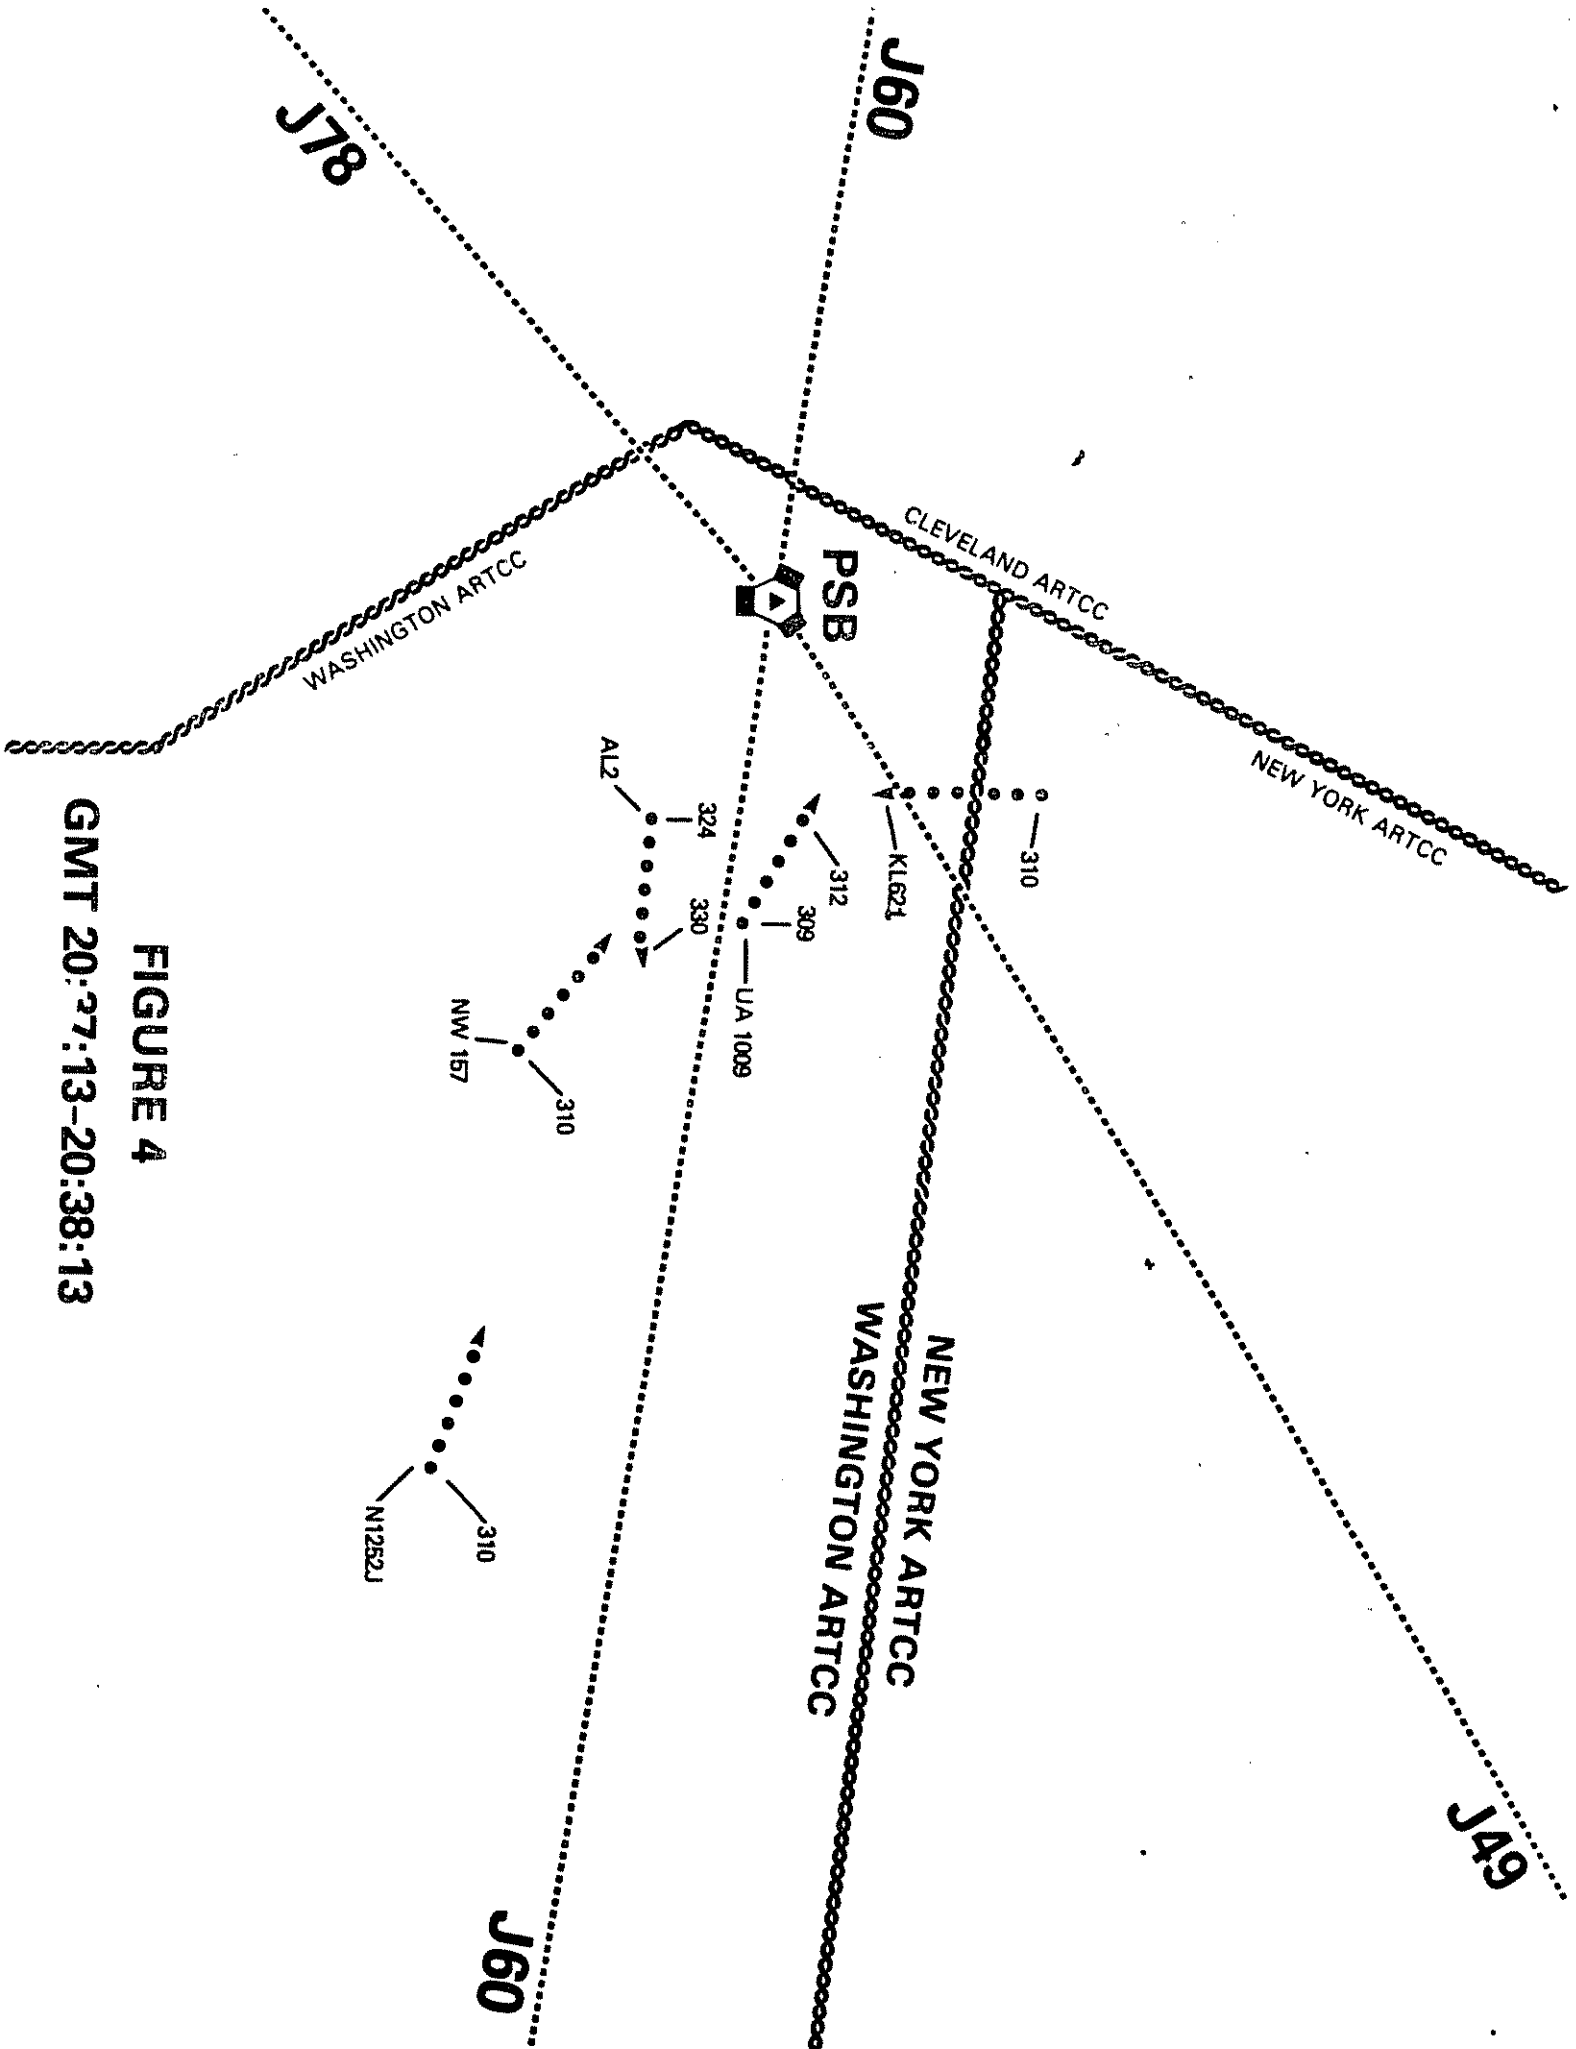
FIGURE 4

GMT 20:27:13-20:38:13

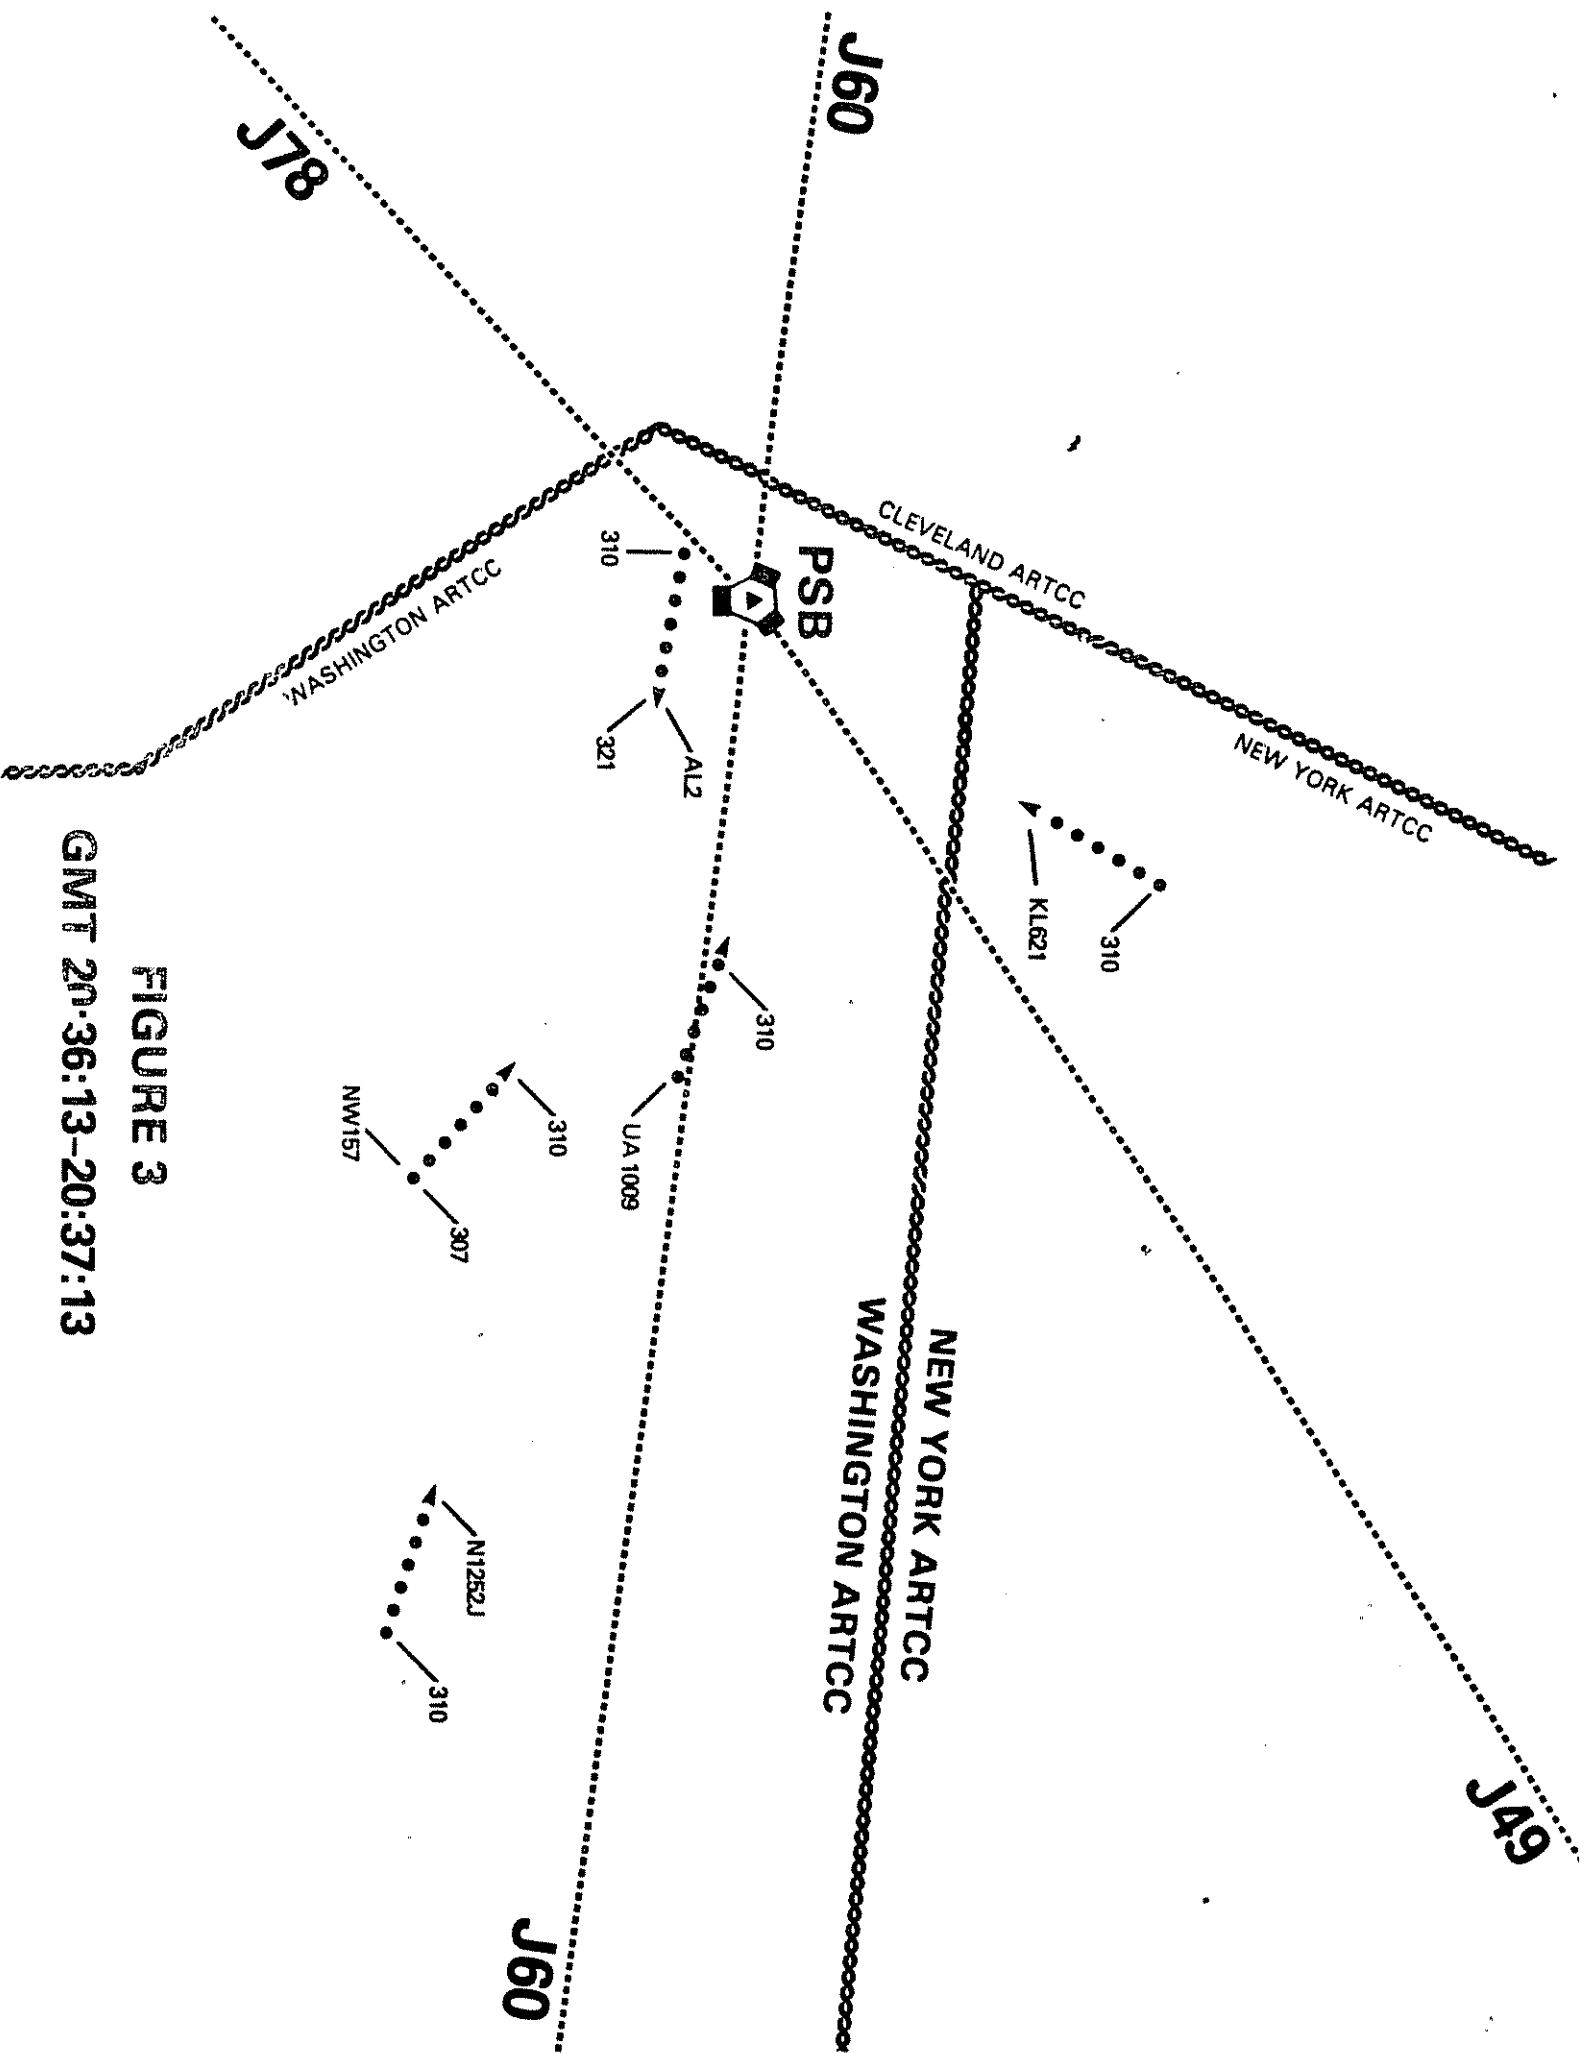
FIGURE 3

GMT 20:36:13-20:37:13

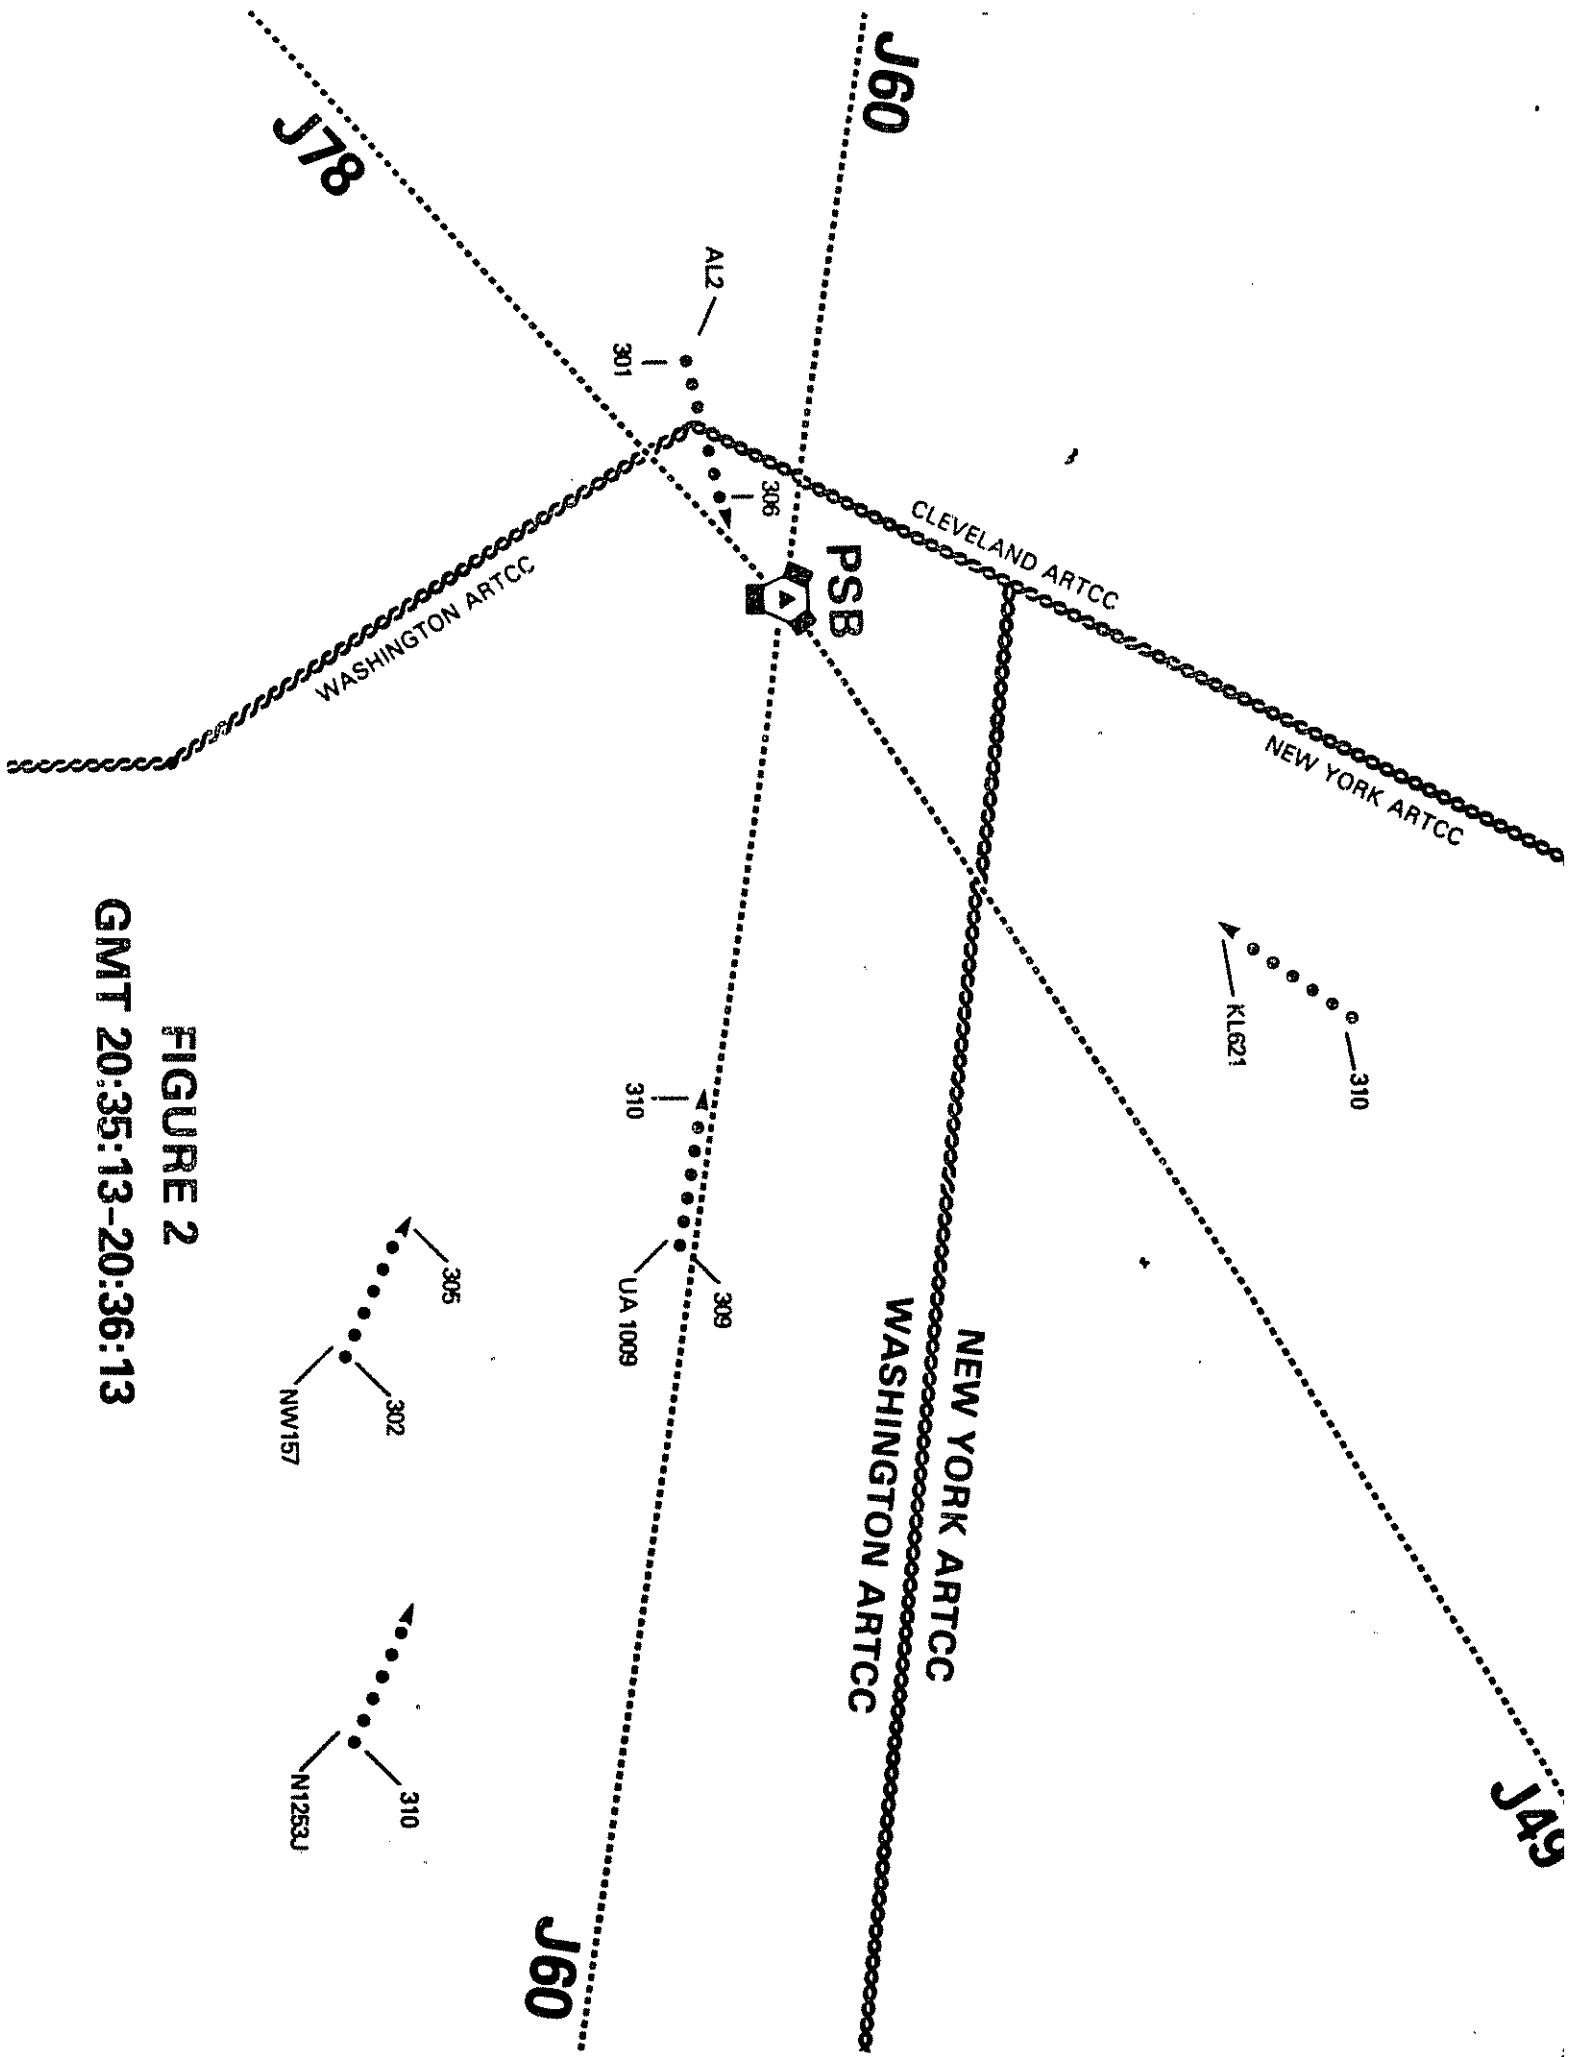
FIGURE 2

GMT 20:35:13-20:36:13

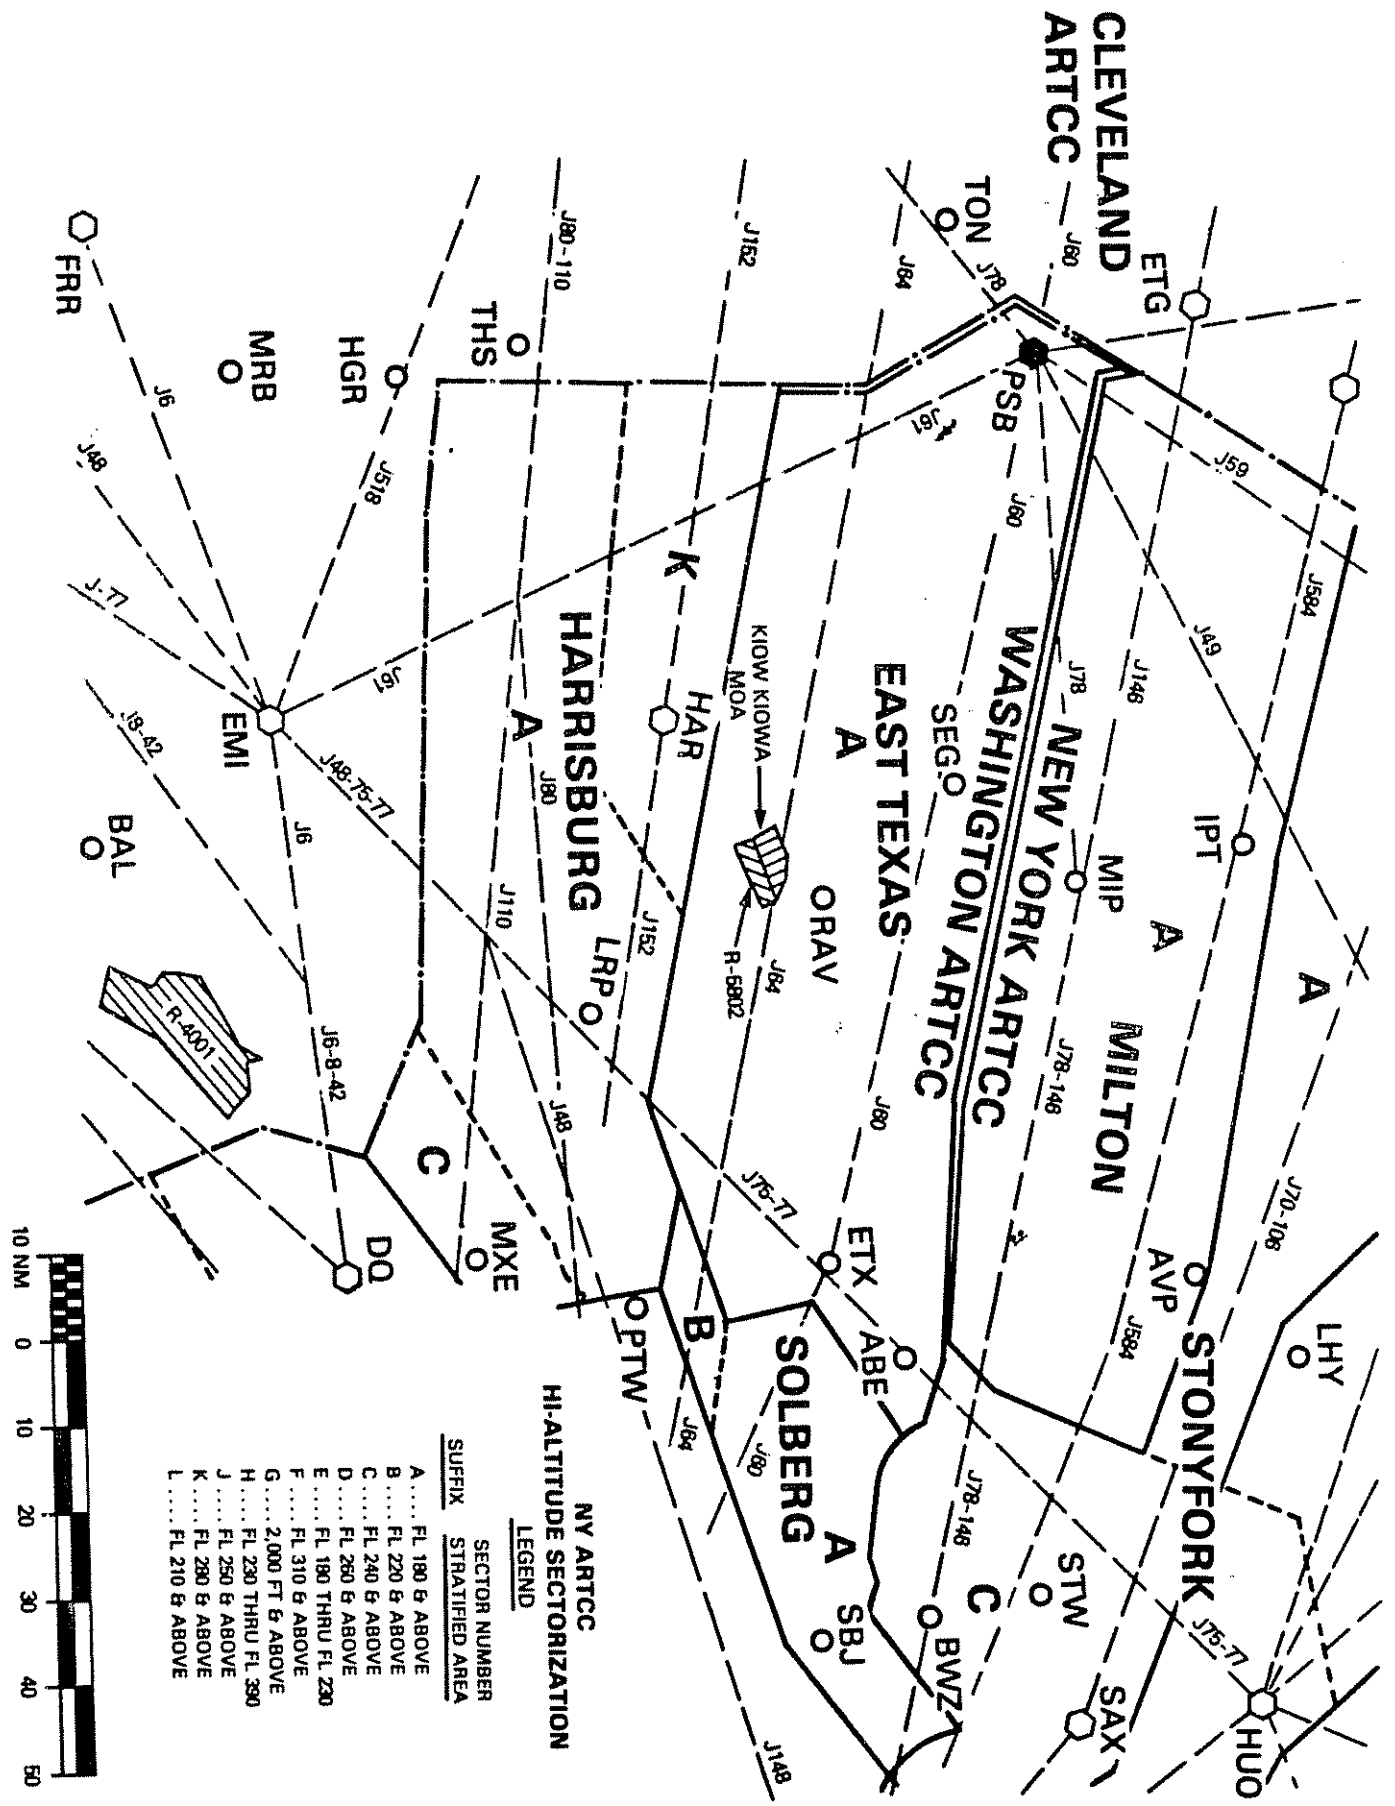
FIGURE 1

About 1635, 1/ KLM Flight 621 (KLM 621), a Boeing 747, operating from Amsterdam, the Netherlands, to Atlanta, Georgia, was proceeding southwest at flight level (FL) 310 2/ toward Philipsburg. The flight was in airspace controlled by the Milton high altitude sector of the New York Air Route Traffic Control Center (ARTCC) and was approaching the boundary where it would enter airspace controlled by the East Texas high altitude sector, which is a part of the Washington, D.C., ARTCC. This boundary between the Milton sector and the East Texas sector is about 8 nmi north of Philipsburg. (See figure 1.)
