National Transportation Safety Board

Safety Recommendation

Date: December 29, 1995

In reply refer to: A-95-149 and -150

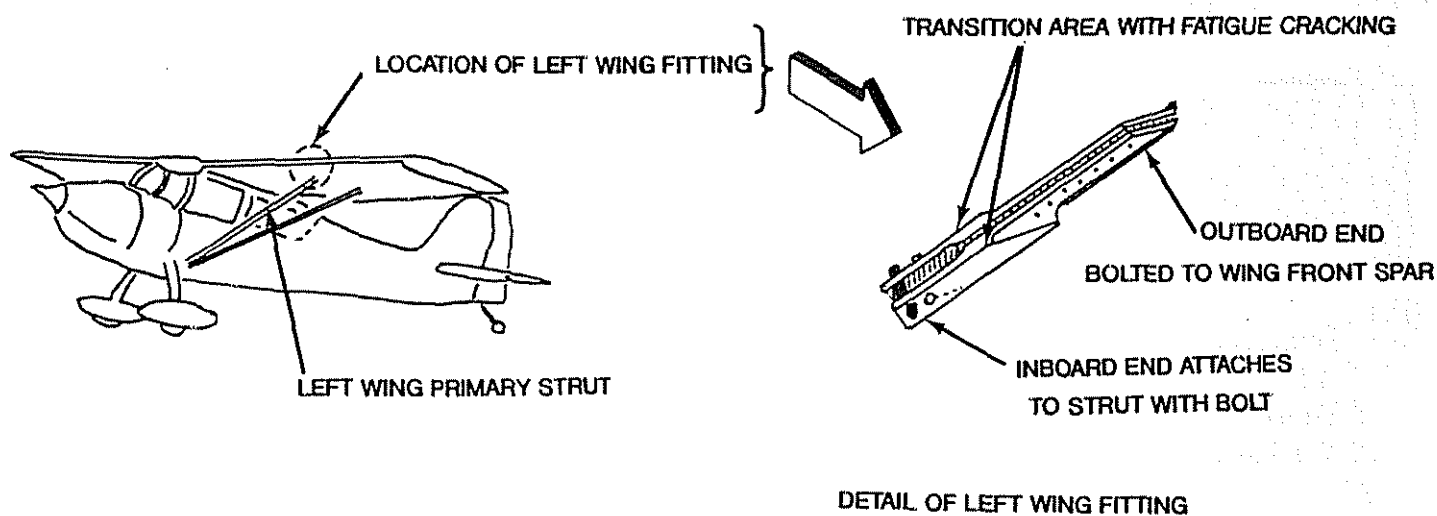
Figure 1. Location of fatigue cracking on the wing fitting for the left wing primary strut.

Examination of the fractures through the two legs of the forward fitting showed that fatigue cracking progressed almost all of the way through the aft leg and about 25 percent of the way through the forward leg. The Safety Board's investigation revealed two factors that contributed to the initiation of the fatigue cracking: scratches in the forward fitting and operation of the airplane in an abusive manner.

Initiation of the fatigue cracking in the wing fitting was from multiple locations in one of a series of small, sharp scratches in the forward edge of the shorter portion of the aft leg, in the area where the leg begins the transition to the inboard configuration. The scratches were about 0.010 inch deep and were oriented vertically across the thickness of the shorter portion of the leg. Independent secondary cracks were found in three of these scratches. The Safety Board has not determined the source of the scratches, but they may have been created during the manufacturing process. The area that contained the scratches was in the transition area of the fitting, an area that is blended after removal of excessive material. It is possible that the scratches were not entirely removed during final sanding and polishing of the surface at this time. Other manufacturers have previously made the same models now made by American Champion. However, the previous manufacturers only made these airplanes with wooden spars and different (steel) wing fittings for the lift strut. For this reason, wing fittings on airplanes made by previous manufacturers are not of concern.

Require that the wing fittings for the primary struts on all American Champion 8KCAB model airplanes with more than a specified minimum number of operating hours receive an immediate one-time inspection for scratches, using magnified visual inspection, and for cracks, using an appropriate nondestructive inspection method such as dye penetrant inspection. Fittings with scratches or cracks should be removed from service before further flight. (Class I, Urgent Action) (A-95-149)

Require that the wing fittings for the primary struts on American Champion 8KCAB model airplanes not previously inspected and on all American Champion 8GCBC, 7GCBC, and 7ECA model airplanes be inspected for scratches, using magnified visual inspection, and for cracks, using an appropriate nondestructive inspection method such as dye penetrant inspection, within a reasonable time period. Fittings with scratches or cracks should be removed from service before further flight. (Class II, Priority Action) (A-95-150)
