National Transportation Safety Board

Safety Recommendation

Date: August 25, 1995

In reply refer to: A-95-84 and -85

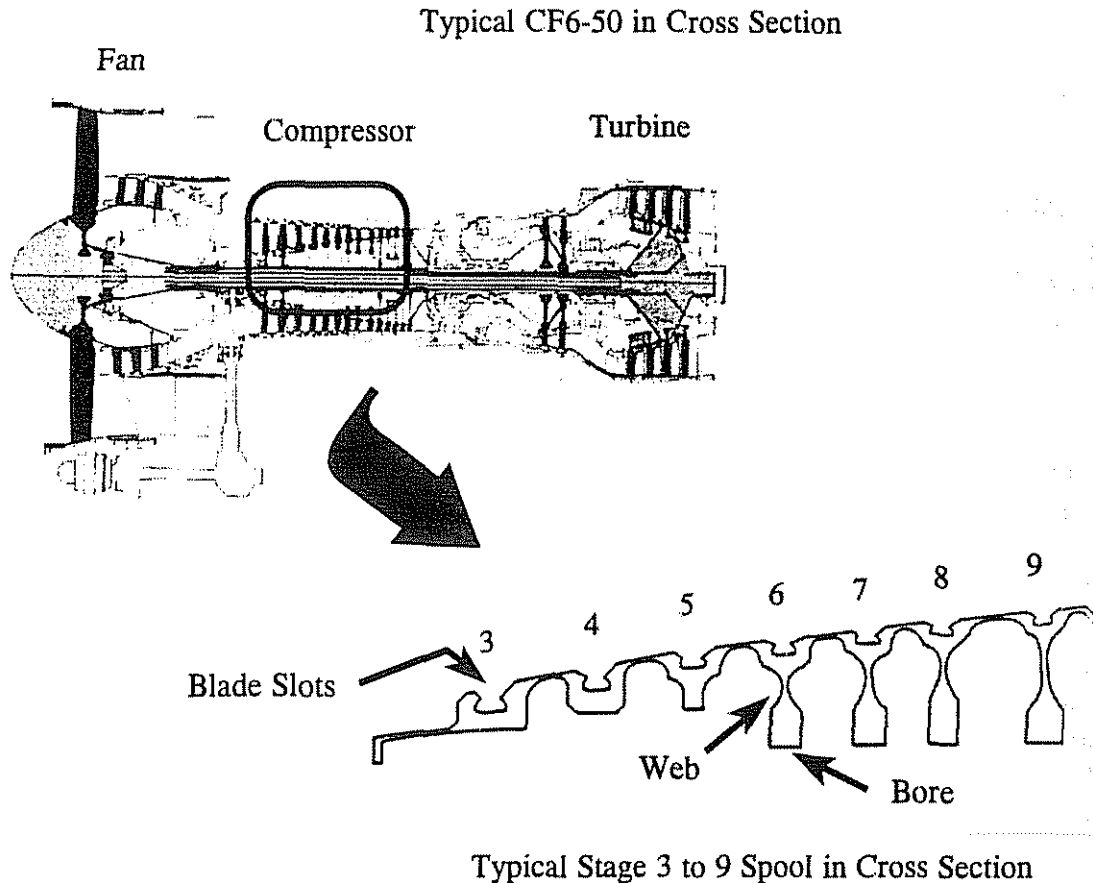
On April 10, 1995, during a takeoff roll at Cairo, Egypt, an Egypt Air Airbus Industrie A300B4 airplane equipped with General Electric CF6-50C2 engines sustained an uncontained separation of the stage 3 through 9 high pressure compressor (HPC) rotor spool in the No. 1 engine, serial number (S/N) 528-305 (see illustration). The crew rejected the takeoff, stopped the airplane on the runway, and ordered an emergency evacuation of passengers. A small fire along the underside of the HPC in the left engine was reported to the crew of the A300B4 by the crew of another aircraft. Although there was no fire warning indication in the cockpit, the crew executed ground fire procedures, which included discharging of a fire bottle into the No. 1 engine. The small fire under the left wing was subsequently extinguished by ground personnel. One passenger sustained a minor injury in the course of exiting the aircraft via the emergency slide. The remainder of the 264 passengers, 9 flight attendants, and 3 pilots reported no injuries.

The metallurgical examination revealed that the failure of the HPC rotor spool was caused by a fatigue fracture in the stage 6 disk. The fatigue cracking initiated from a nitrogen stabilized "hard alpha"⁴ inclusion located on the aft side of the disk web. After initiation, the crack propagated on a radial plane forward through the web thickness in both inboard (towards the disk bore) and outboard (towards the rim) directions until it had reached a critical size of about 1.54 inches. The estimated number of fatigue striations on the fracture is approximately equal to the number of flight cycles on the spool. Assuming that each striation represents one flight cycle, the

crack began propagating very early in the service life, perhaps with the application of the first cycle of stress.
