NATIONAL TRANSPORTATION SAFETY BOARD  
WASHINGTON, D.C.

SAFETY RECOMMENDATION(S)

H-83-35 through -37

Figure 1.—Examples of inadequate traffic safety features on highway bridges over the NEC in three different States.

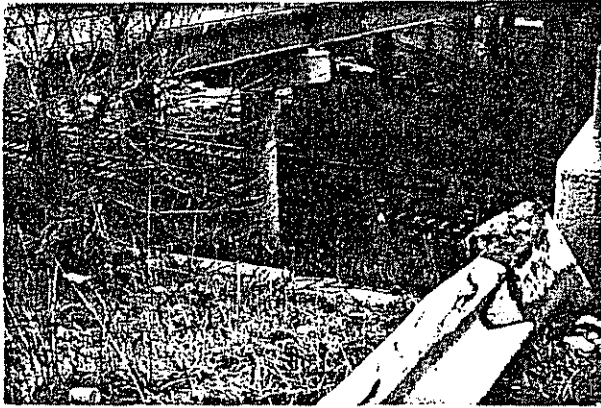
A. The approach guardrail is on a principal arterial. Speed limit is 45 mph. Average daily traffic in one direction is 40,000, 8 percent of which is trucks. The average height of the guardrail was 20 inches. There are 72 trains daily with a maximum speed of 105 mph (120 mph in the future), using the tracks below.

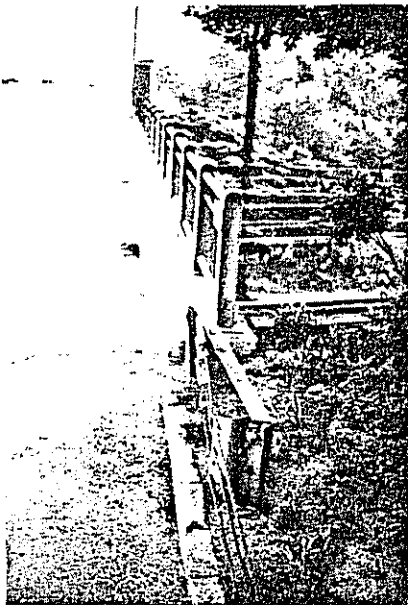
B. The approach guardrail is on Interstate 95. The maximum posted speed is 55 mph. The average daily traffic in one direction is 45,000, 13 percent of which is trucks. None of the traffic safety features are satisfactory. The top of the cable guardrail is 22 inches above the pavement; it is not attached to the bridge, and the bridge rail is the panel discontinuous type. There are 78 trains daily with a maximum speed of 45 mph (55 mph in the future) using the tracks below. (Note: This bridge is on a toll road and Federal money is not available for correction of the indicated hazards.)

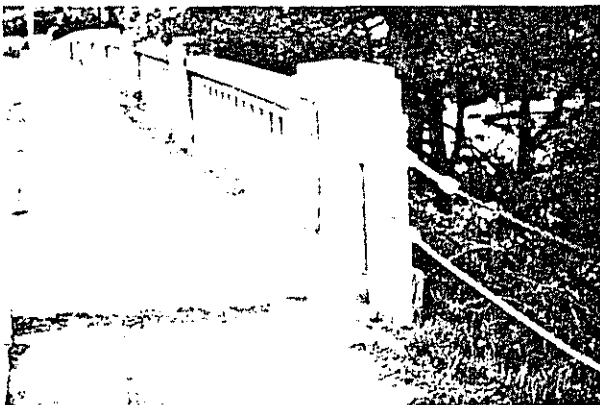
C. The approach guardrail is on a major arterial. Speed limit is 40 mph. Average daily traffic is 17,000. None of the traffic safety features are satisfactory. The two cables are mounted on concrete posts at a minimum of 17 inches above the bridge sidewalk. There are 31 trains daily with a maximum speed of 79 mph (100 mph in the future), using the tracks below.
