NATIONAL TRANSPORTATION SAFETY BOARD
WASHINGTON, D.C.

Log P-223

SAFETY RECOMMENDATION(S)

P-83-10

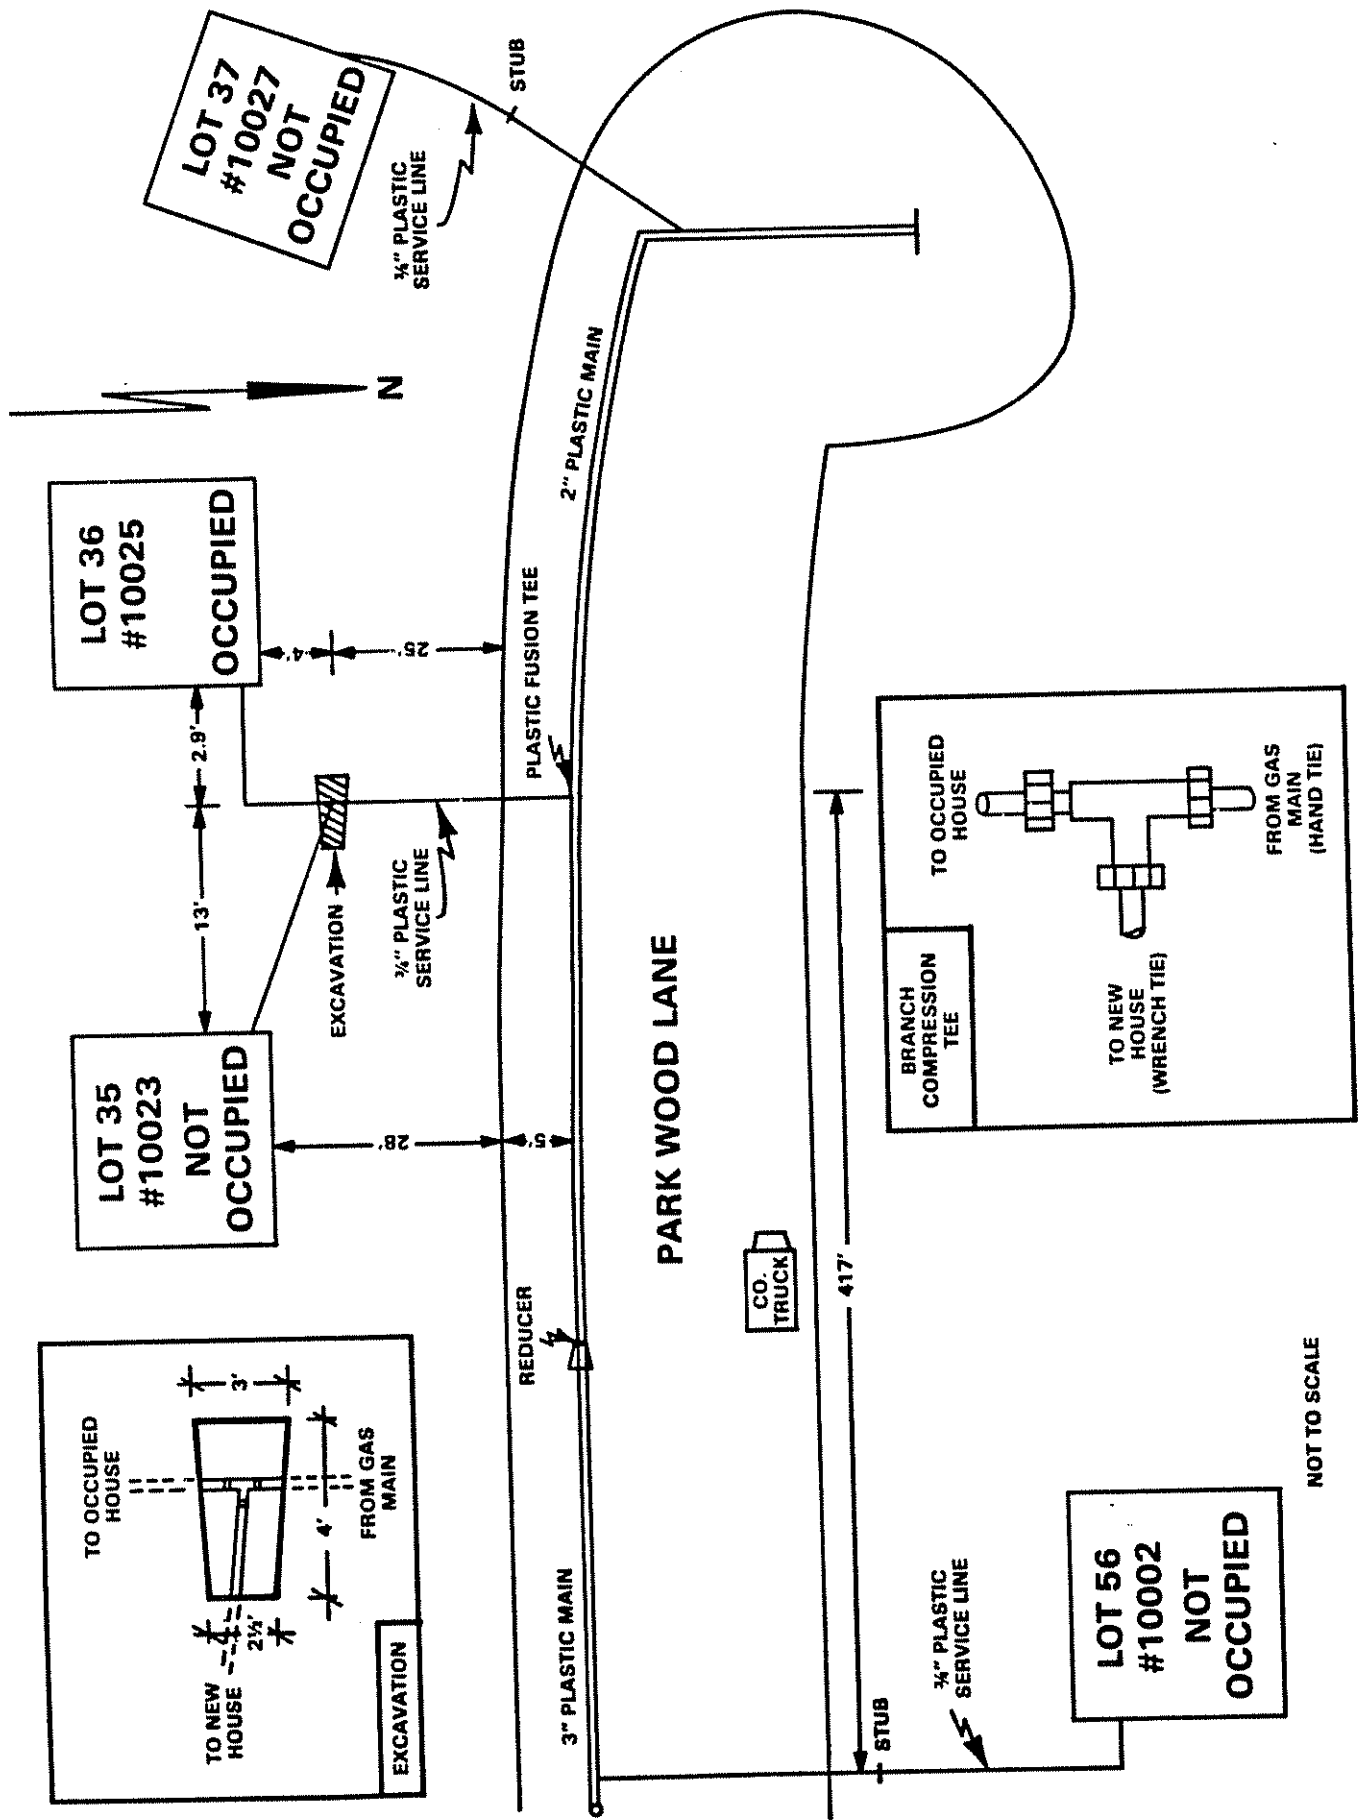
FIGURE 1. PLAN VIEW OF ACCIDENT SITE

About 10:30 a.m., the crew arrived at the work site and connected the service line for residence No. 10027 (see figure 1) to an existing service line stub. After making this connection, the crew was to install a branch service line to residence No. 10023 from the service line connected to the house next door, No. 10025. Using hand tools, a hole 30 inches deep was excavated to expose the plastic service line. The service line was cut, and the end of the service line segment which contained gas under pressure was sealed with a cap. The installation required that a branch tee connection be installed in the service line to No. 10025 to allow No. 10023 to be served from the same service line. A check of the service truck disclosed that the appropriate compression tee was not available at the job site; by radio, the crew leader called the foreman and advised him that a branch tee was needed. While waiting for the requested fitting, the crew began work at residence No. 10002.

After removing the crew mechanic from the excavation, the crew leader and helper mechanic noticed that the compression tee was partially installed. One downstream connection was completed; the other downstream connection had been made, but the retaining nut was only hand-tight. The upstream connection had not been made, and the cap had been removed from the portion of the service line under pressure. Company

Notify its member companies of the circumstances of this accident and urge them to emphasize to their supervisory personnel the need for strict adherence to established company safety procedures. (Class II, Priority Action) (P-83-10)
