Log R40 DOT 973C Rec R-73-13 and 14
UNITED STATES OF AMERICA
NATIONAL TRANSPORTATION SAFETY BOARD
WASHINGTON, D.C.

ISSUED: April 25, 1973

SAFETY RECOMMENDATION R-73-13 & 14

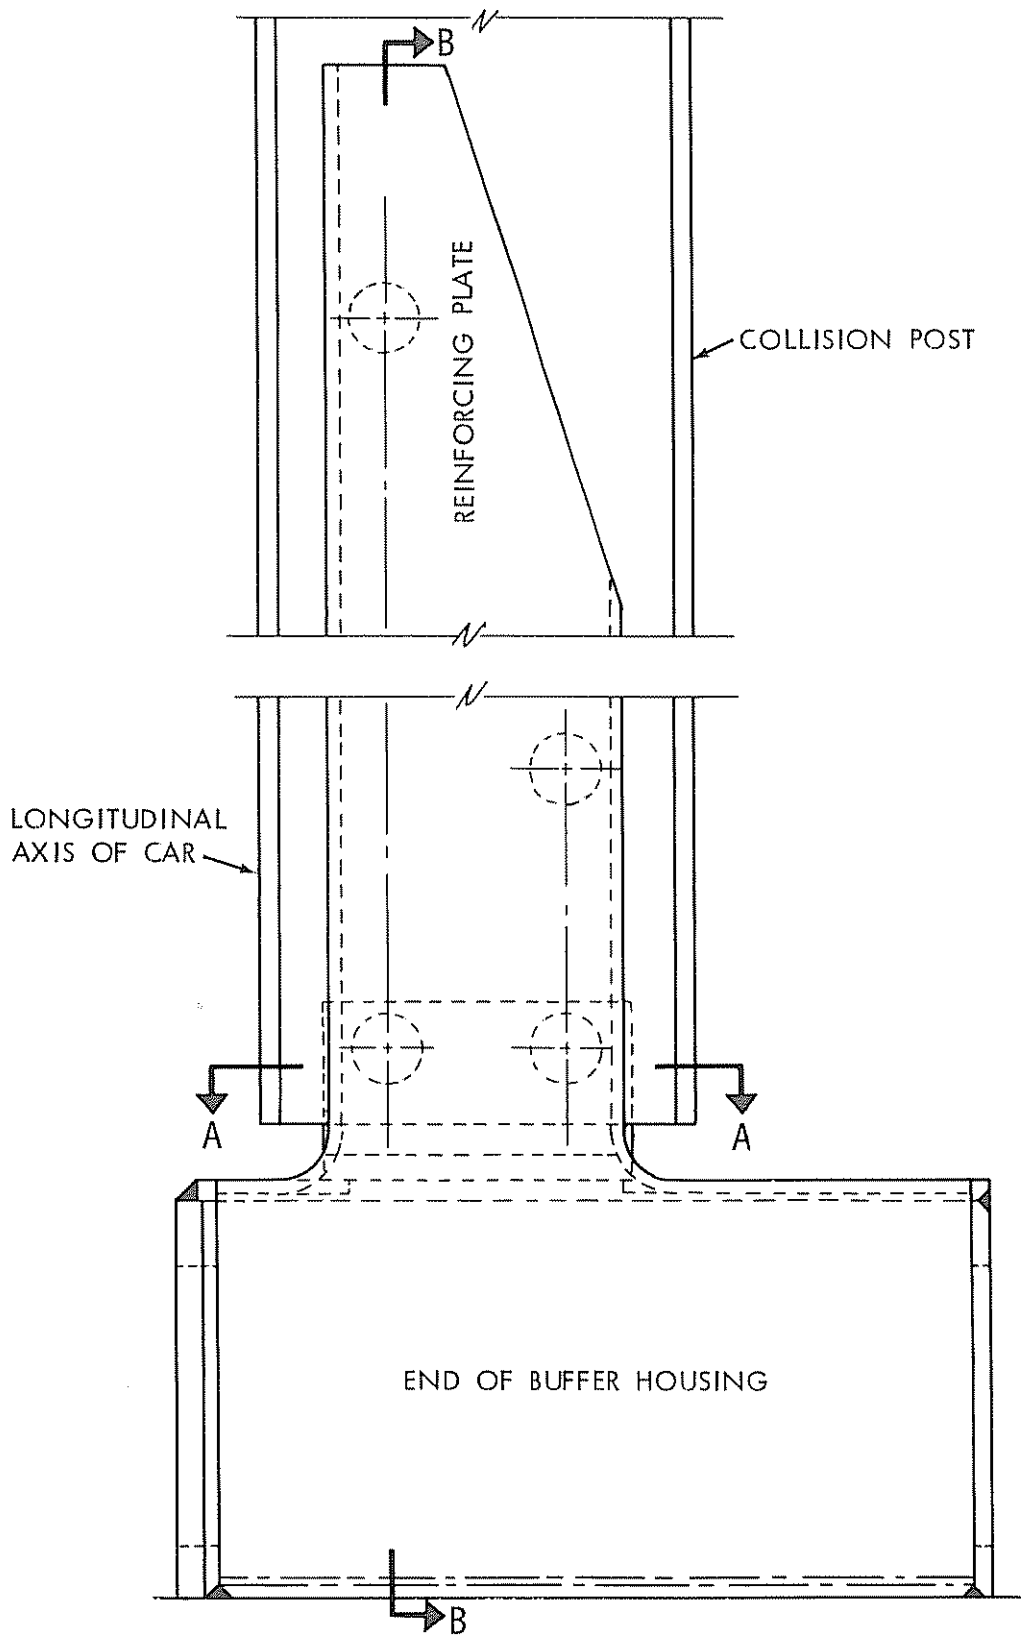
ELEVATION OF COLLISION POSTS
 ILLINOIS CENTRAL GULF RR CAR NO. 1509
 Figure 1

It was disclosed at the hearing that there was incomplete fusion in about 75 percent of the weld attaching one collision post to the underframe. The collision post was secured to the underframe by a 1/2-inch-thick attachment plate, the bottom edge of which was beveled at a 45° angle for welding purposes. The depth of the bevel was only 5/16th of an inch instead of the full 1/2-inch thickness of the plate as originally designed and shown on the drawing. The

depth of the bevel did not provide access to permit welding over the full ½-inch thickness. In addition, only 25-percent fusion was achieved in the accessible area.

The possibility of not achieving a good weld with full penetration was quickly determined during the construction of the cars by the production department of St. Louis Car Division. The bevel was reduced in depth and an additional weld adjacent to the weld in the beveled area was added in an effort to compensate for any deficiencies of penetration. This effective design change was not, however, changed on the drawing. These factors are illustrated by the attached sketches based upon exhibits in evidence. The added weld is visible in this exhibit.

The added weld did not solve the problem. First, as can be seen in the sketch, the added weld material was distant from the location at which it could add to the strength of the weakest section. This section was limited by the 5/16-inch bevel. Second, the poor fusion at the weakest section could not be corrected by metal added to the outside of the plate.
