National Transportation Safety Board

Safety Recommendation

In reply refer to: A-94-167 through -169

Chandler Evans (CECO)
Model MFP261
MAIN FUEL PUMP

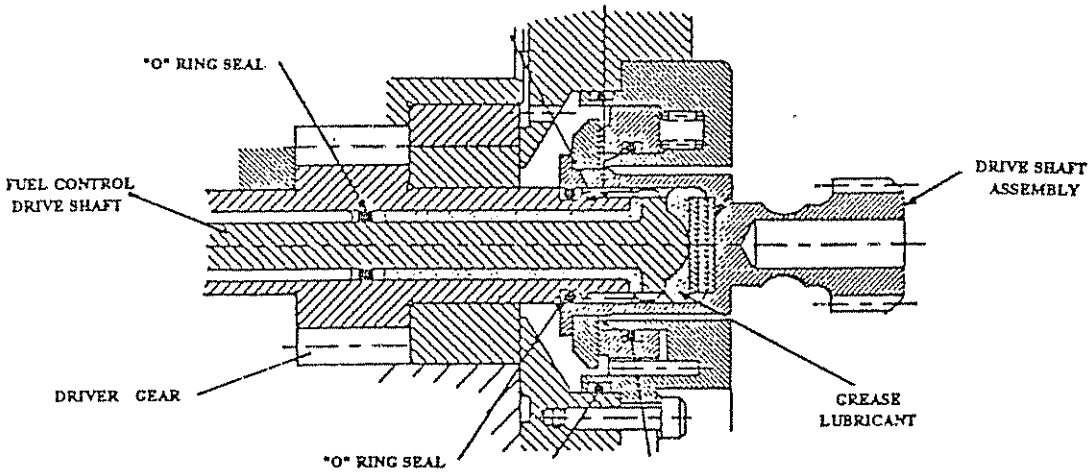
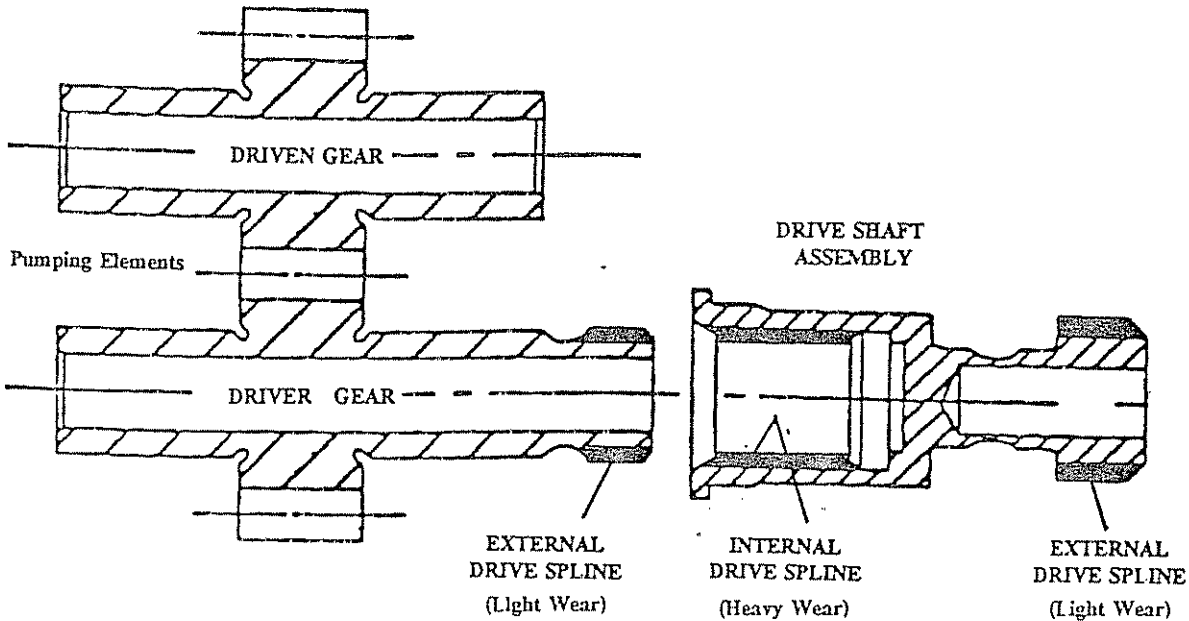
FUEL PUMP DRIVE
(CROSS SECTION)

Examination of the disassembled pump at the Safety Board's materials laboratory revealed that the internal splines on the fuel pump main driveshaft had worn to the point that the external splines of the fuel pump driver gear could be rotated freely within the internal splines. The portion of the driveshaft internal splines that engages the fuel control driveshaft external splines was not worn. The drive faces of the external splines of the fuel pump driver gear had lost a small thickness of material due to wear. The greater amount of wear on the internal splines of the driveshaft is consistent with the lower hardness of this component, when compared to the relatively high hardness of the nitrided case on the external splines of the fuel pump driver gear. Despite the loss of a relatively small amount of material, the drive faces of the external splines on the driver gear were rough where they had contacted the driveshaft splines, and each external spline contained what appeared to be a gaping crack along the length of the spline, about midway between the spline root and crown. The location of these cracks corresponded to the crowns of the internal splines on the driveshaft.
