National Transportation Safety Board

Safety Recommendation

In reply refer to: A-94-190

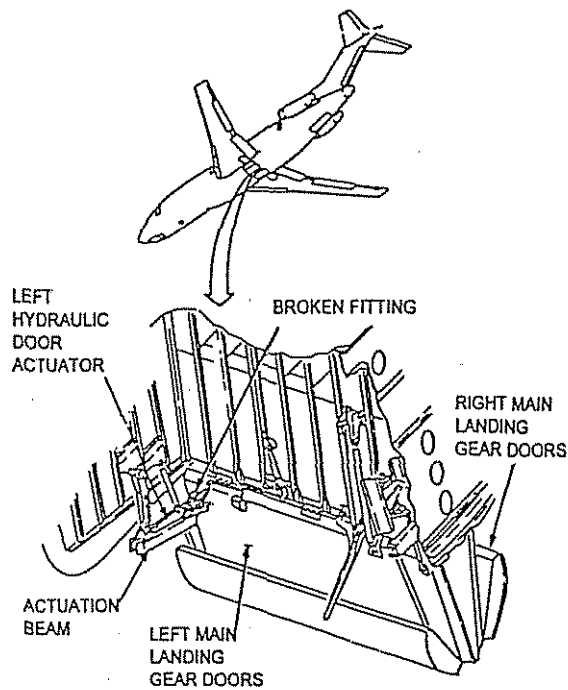
DOOR COMPONENTS

On April 2, 1994, about 1439 eastern standard time, a Boeing 727-243, N59412, operating as Continental Airlines flight 1447, landed at Orlando International Airport with the left main landing gear partially extended. The airplane came to rest on the left wing leading edge slats, trailing edge flaps, wing tip, nose tires, and right main landing gear. None of the nine crewmembers or 141 passengers were injured. Examination of the airplane revealed that the left main landing gear was in the wheel well, resting on the main landing gear door. A broken door fitting was found lodged in the door hinge area.

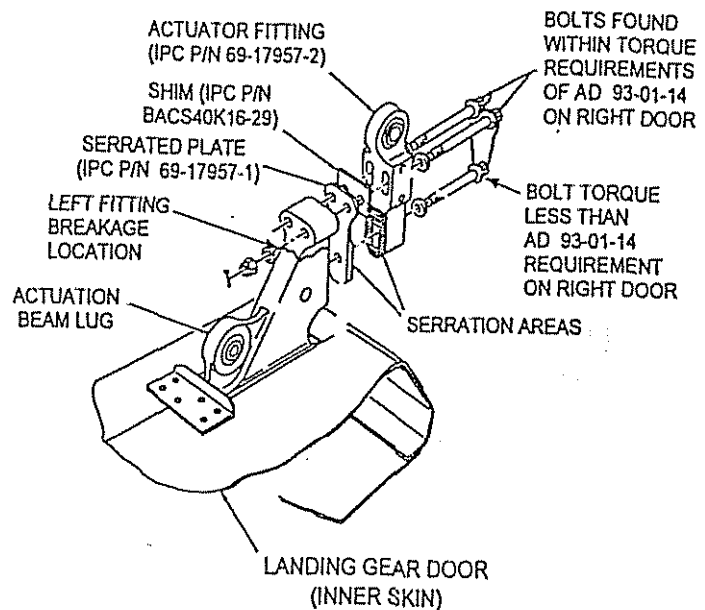
FITTING ASSEMBLY

The left main landing gear door fitting assembly laminated shims were removed and found degraded. The rectangular shims were distorted in shape, the individual plies were shifted, and the bolt holes were elongated. Degradation of the shims prevented a determination of their thickness prior to the incident.

At the Safety Board's laboratory, investigators found that loosening the single outboard bolt and not filling the shim pocket caused the left steel fitting and serrated plate on the damaged serrations at the base of the fitting pocket to pivot. Pushing the walls of the pocket toward each other caused separation of the serrated surfaces near the single outboard bolt.

Because of the damage to the left door fitting assembly, the serviceable right door actuator fitting assembly was also examined. The right fitting single outboard bolt was found to have slightly less than the required torque. Evidence of fretting was seen at the edges of the fitting teeth and light could be seen between the aluminum fitting and the serrated plate. Shims removed from the right door fitting assembly were found to be distorted, with bolt hole elongation and shifting of the laminated plies. The shims in the right door fitting had degraded to the point of extruding from the assembly.

Serration damage seen in the left fitting, fretting residue found in the right fitting, extrusion of shim material, and shifting of plies indicated that the fitting assemblies had not been stable before the incident. Insufficient torque of the fitting bolts and loss of shim material may have loosened the actuator fitting bolts.

The Safety Board's materials laboratory examined the broken aluminum left actuator attachment fitting and found a low cycle-high stress fatigue failure. Fatigue striations indicated that at least 13,000 progression cycles¹ preceded the failure of the door fitting after the crack had

Revise Airworthiness Directives 90-02-19 and 93-01-14, applicable to Boeing 727 main landing gear door actuator fitting assemblies, to reduce the current inspection intervals, thereby improving the potential for identifying loose bolts and cracks in the aluminum fittings. The revision should also require inspection of the laminated shims within the assembly for reduction of thickness and degradation and require continued periodic inspections until an alternative design is available. (Class II, Priority Action) (A-94-190)
