National Transportation Safety Board

Safety Recommendation

Date: April 22, 1994

In Reply Refer To: P-94-1 through -3

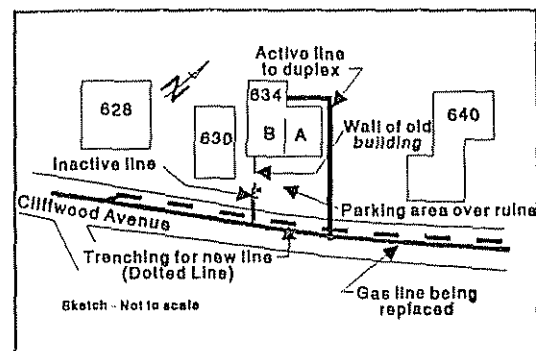
The NJNG had hired a contractor to replace the bare steel main on Cliffwood Avenue with a plastic main (figure 1). The contract included removing and replacing the service lines to 628 and 630 Cliffwood Avenue with plastic piping. The project did not require that excess flow valves (EFVs) be installed on the new gas service lines.

Figure 1. Sketch of the work area.
