# National Transportation Safety Board

## Safety Recommendation

**Date:** February 3, 2006

**In reply refer to:** A-06-4 and -5

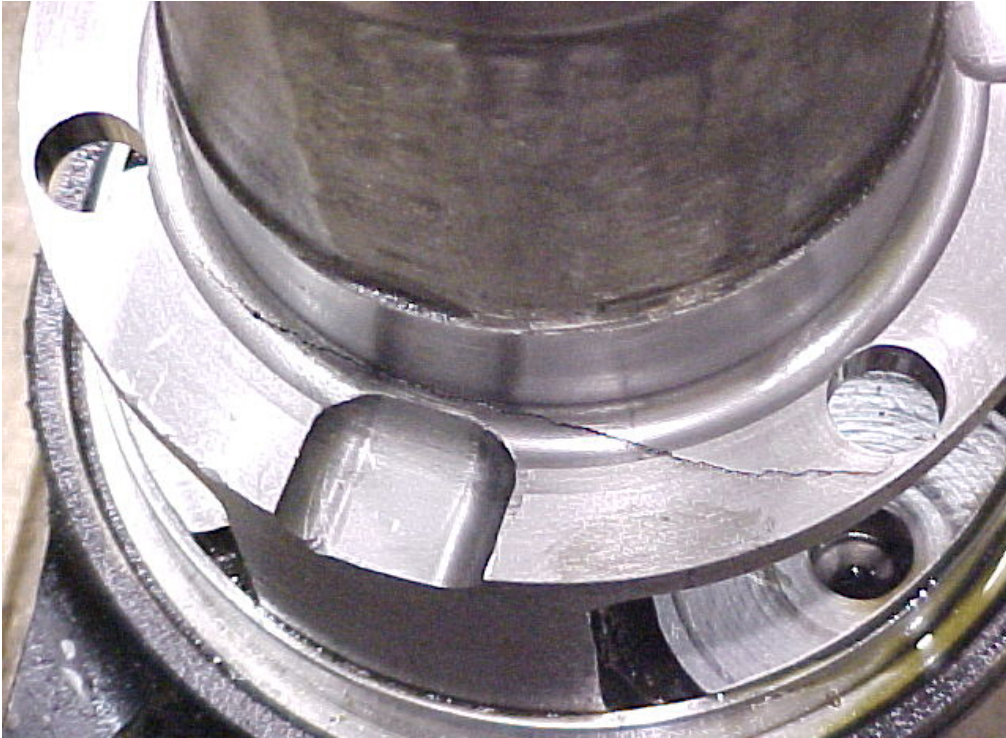
Figure 2. Cracked P-23 wheel hub assembly.

The USAF became aware of numerous instances of cracked P-23 cast iron hub assemblies and began monitoring these cracks in late 1996/early 1997. They noted that the cracks

typically occurred in the wheel hub assembly's stub axle. Initially, the identified cracks did not result in complete failure or separation of components. However, in early 1998, the USAF became aware of an instance in which a cracked hub assembly actually resulted in separation of a P-23 hub assembly.

As a result of its concerns regarding 12 documented wheel hub assembly cracks that occurred between January 1997 and March 1998,<sup>6</sup> the USAF began an engineering analysis, including extensive laboratory testing, to determine the cause of the cracks and to identify criteria for a redesigned wheel hub assembly. Also in March 1998, the USAF issued a "restriction notice" for all P-23 vehicles. The notice stated that although the 8-wheel drive P-23 vehicle would likely remain stable in the event of a single wheel hub assembly separation, the USAF was concerned that the separated pieces would present a hazard to ARFF personnel, flight line crews, and other personnel or objects near the vehicle when a separation occurred. Therefore, the notice restricted P-23 vehicles to speeds no greater than 30 miles per hour (mph) during emergency operations, and no greater than 15 mph for all nonemergency operations. In addition, P-23 training operations were restricted to mission essential/currency training. Further, the notice required all operators to conduct visual inspections of each of the P-23's 8 hub assemblies after any use of the vehicles.

As a result of these concerns, the Safety Board believes that the FAA should issue a CertAlert<sup>12</sup> to all Airport Certification and Safety Inspectors and operators of airports certificated under 14 CFR Part 139, describing the potential hazards with the existing P-23 hub assembly. The CertAlert should emphasize the need for inspection of the P-23 hub assemblies after any use of the vehicles, the retention of inspection results, and the timely replacement (upon availability of safe and reliable replacement assemblies) of all existing P-23 hub assemblies. In addition, the CertAlert should emphasize that FAA Airport Certification Inspectors must ensure that affected airports can still meet 14 CFR Part 139 response time requirements when ARFF personnel are restricted to operating P-23 vehicles at speeds less than 30 mph during emergency operations, and less than 15 mph for all nonemergency operations (as indicated in the USAF restriction notice).

The replacement of existing P-23 wheel hub assemblies with safe and reliable assemblies would eliminate the risks of fracture and possible injury during operation and allow the P-23 to travel at higher speeds during emergency operations to expedite response. Therefore, the Safety Board believes the FAA should require all airports that use P-23 ARFF vehicles to install a redesigned wheel hub assembly on all P-23 vehicles in the timeliest manner possible upon availability of suitable replacement assemblies.

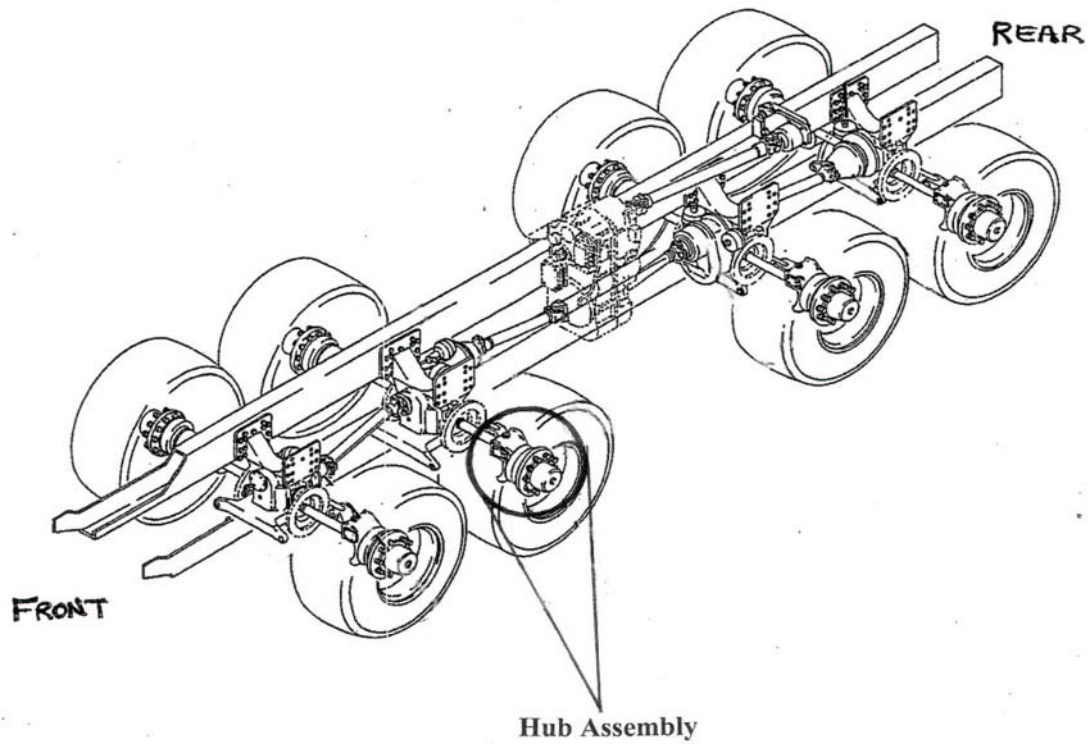
Figure 3. Diagram of the 8-wheel assembly on the P-23, with a hub assembly location shown.

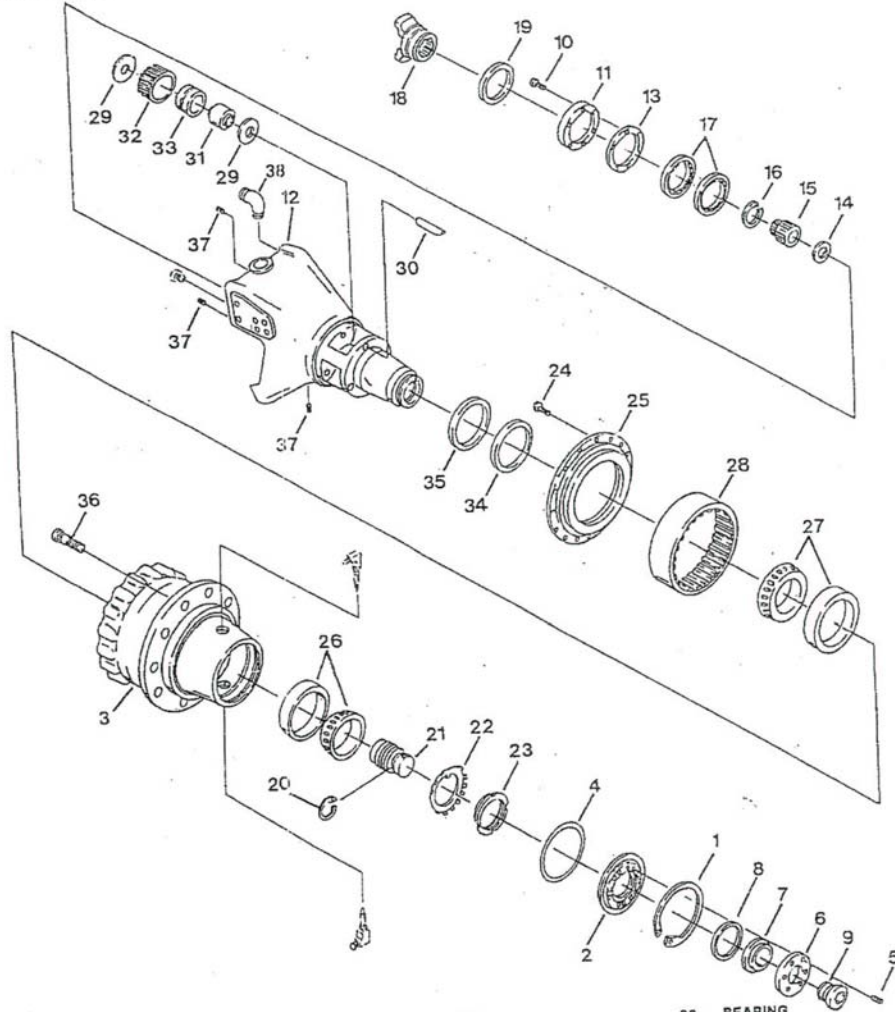
Figure 4. Diagram of the P-23 wheel hub assembly, with components identified.

<sup>6</sup> According to the restriction notice, 5 of the 12 documented hub assembly cracks involved cracked stub axles (#12 on figure 4), another 2 involved stub axles that cracked the castings in the lower suspension mounting ear (lower part of #12 on figure 4), and 5 involved stub axles that cracked inside the hub housing (#3 on figure 4).
