National Transportation Safety Board

Safety Recommendation

In reply refer to: A-06-53

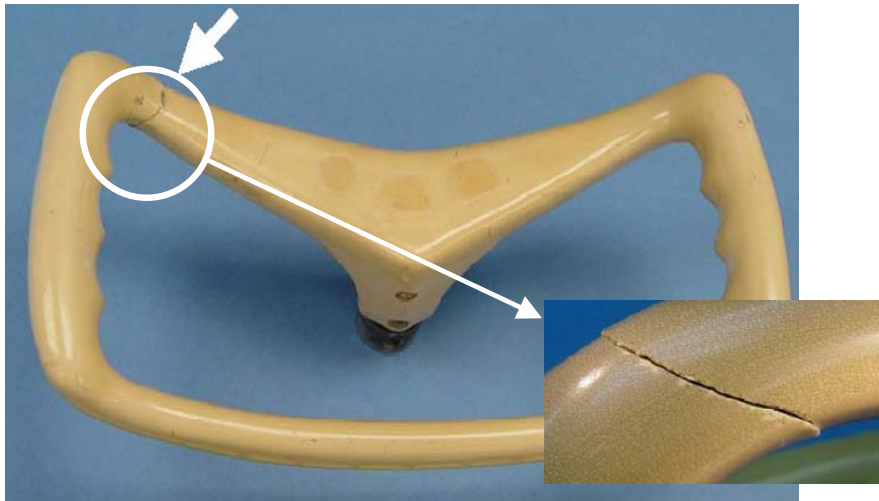
Both control wheels from the accident airplane were sent to the National Transportation Safety Board's Materials Laboratory for examination. The pilot's hard plastic (acrylic) control wheel, part number (P/N) 0513166, was fractured near the upper left corner where the handle adjoins the crossbar (see figure 1). The examination of the fracture surface revealed smooth crack arrest markings, as well as bands of slightly different colors, which are indications of fatigue cracking. Some surface discoloration and crazing were also evident, indicating the effects

of age. Discontinuities of the fracture surface revealed that the fatigue cracking originated at several locations. The location of the fracture, which propagated through about 95 percent of the cross-section, indicated that the fatigue crack propagated as a result of tensile stress from the repetitive force of the pilot manipulating the control wheel forward and aft. The copilot's control wheel showed no evidence of similar fatigue cracks.

Figure 1. Control wheel fracture

The fracture locations on the control wheels from the accident airplane and the Cessna 210 were consistent with the typical operation of the aircraft during maneuvers such as takeoff and landing, in which the pilot's left hand holds the control wheel while the pilot's right hand operates the throttle. In this mode of operation, repetitive stresses would generally occur at the location of the fractures—in the corner between the crossbar and the handle on the left side of the control wheel.

Require recurrent inspection of part number 0513166 series control wheels in applicable Cessna airplanes for cracks, with specific emphasis on the inside upper corners where fatigue cracking has been found and replacement of the control wheels if any cracks are detected. (A-06-53)
