# National Transportation Safety Board

## Safety Recommendation

**In reply refer to:** A-06-6

### **P-23 Wheel Hub Assembly Issues**

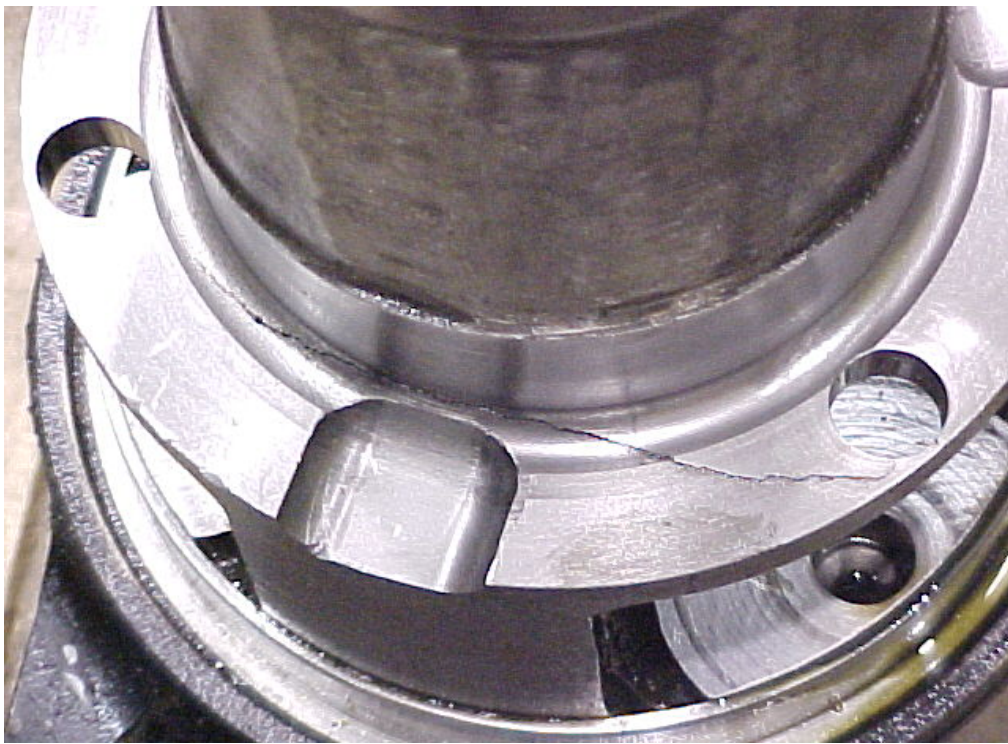
Figure 2. Cracked P-23 wheel hub assembly.

The USAF became aware of numerous instances of cracked P-23 cast iron hub assemblies and began monitoring these cracks in late 1996/early 1997. They noted that the cracks

typically occurred in the wheel hub assembly's stub axle. Initially, the identified cracks did not result in complete failure or separation of components. However, in early 1998, the USAF became aware of an instance in which a cracked hub assembly actually resulted in separation of a P-23 hub assembly.

As a result of its concerns regarding 12 documented wheel hub assembly cracks that occurred between January 1997 and March 1998,<sup>6</sup> the USAF began an engineering analysis, including extensive laboratory testing, to determine the cause of the cracks and to identify criteria for a redesigned wheel hub assembly. Also in March 1998, the USAF issued a "restriction notice" for all P-23 vehicles. The notice stated that although the 8-wheel drive P-23 vehicle would likely remain stable in the event of a single wheel hub assembly separation, the USAF was concerned that the separated pieces would present a hazard to ARFF personnel, flight line crews, and other personnel or objects near the vehicle when a separation occurred. Therefore, the notice restricted P-23 vehicles to speeds no greater than 30 miles per hour (mph) during emergency operations, and no greater than 15 mph for all nonemergency operations. In addition, P-23 training operations were restricted to mission essential/currency training. Further, the notice required all operators to conduct visual inspections of each of the P-23's 8 hub assemblies after any use of the vehicles.

Despite these efforts, USAF personnel continued to observe stub axle failures, and their replacement wheel hub assembly stock was diminishing. The original manufacturer of the wheel hub assembly (Timoney Technology) provided the USAF with replacement stub axles made of stronger cast iron. However, these enhanced wheel hub assemblies also experienced failures. As a result, in February 2002, the USAF contracted with another developer/manufacturer (the Nevada Automotive Test Center [NATC]) to redesign and then manufacture the entire modified hub assembly. In June 2002, the USAF issued an updated P-23 restriction notice in which it cited continuing wheel hub assembly problems (with as many as 150 such failures documented) and required P-23 operators to continue to observe the speed and training restrictions and the visual inspection requirement cited in the March 1998 restriction notice. Because the failures continued to occur, the updated restriction notice informed P-23 operators that the enhanced wheel hub assemblies received from Timoney were considered only an interim solution. USAF personnel have indicated that the NATC-designed enhanced wheel hub assemblies may be available in early 2006.

Issue an advisory notifying all firefighting communities about the potential hazards with the P-23 aircraft rescue and firefighting (ARFF) vehicle hub assembly, and the eventual necessary replacement of the hub on the P-23 ARFF vehicle. (A-06-6)
