National Transportation Safety Board

Safety Recommendation

In reply refer to: A-98-112

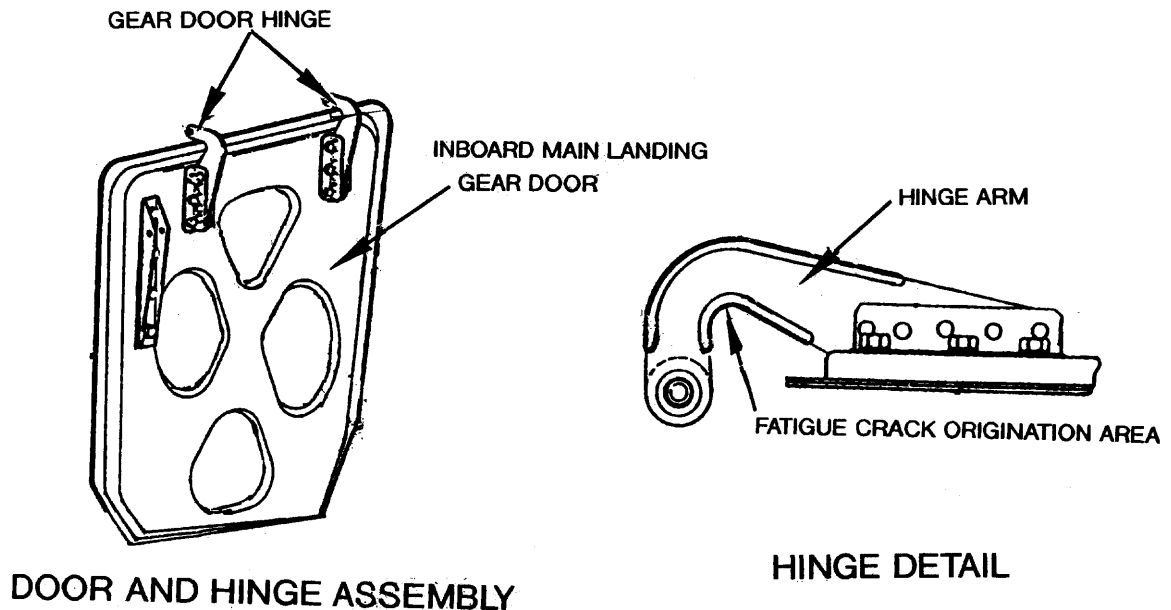
Figure 1. Piper PA-31 Main Landing Gear Door Assembly

Before landing, the pilot attempted to lower the landing gear; however, the landing gear did not extend normally, and the landing gear unsafe light illuminated in the cockpit. During a subsequent low pass over the airfield, ground personnel confirmed that the left MLG was not extended. Postincident examination revealed that a forward hinge on the left MLG inboard door had broken and disabled the door, preventing the gear from extending fully.

The National Transportation Safety Board's materials laboratory examined the fracture surfaces of the broken hinge. The examination revealed a fatigue crack that had emanated from multiple origins at the tip of the forged flash¹ on the inside curve portion of the hinge arm (see

figure 1). The arm is subjected to cyclic loading during service, and the forging flash is a high-stress region of the hinge.

Require Piper PA-31 operators to conduct repetitive inspections for cracks of all Piper part number 47529-32 main landing gear (MLG) inboard door hinge assemblies until they are replaced by an improved MLG inboard door hinge assembly that is not prone to similar failures. (A-98-112)
