National Transportation Safety Board

Safety Recommendation

In reply refer to: A-98-113 through -118

On June 18, 1998, a Swearingen SA226-TC Metroliner II airplane,¹ Canadian registry C-GQAL, operated by PropAir, Inc., crashed after the left wing separated during an attempted emergency landing at Mirabel Airport, Montreal, Quebec, Canada. The flight was operating as a charter from Montreal to Peterborough, Ontario, Canada. The airplane had departed from Montreal's Dorval Airport and was climbing through 12,500 feet when the flightcrew reported a loss of hydraulic pressure and a fire on the left side of the airplane. The pilot then shut down the left engine and declared an emergency. The flightcrew lost control of the airplane at low altitude during the final approach for landing. The airplane was destroyed, and the two flightcrew members and all nine passengers were killed.

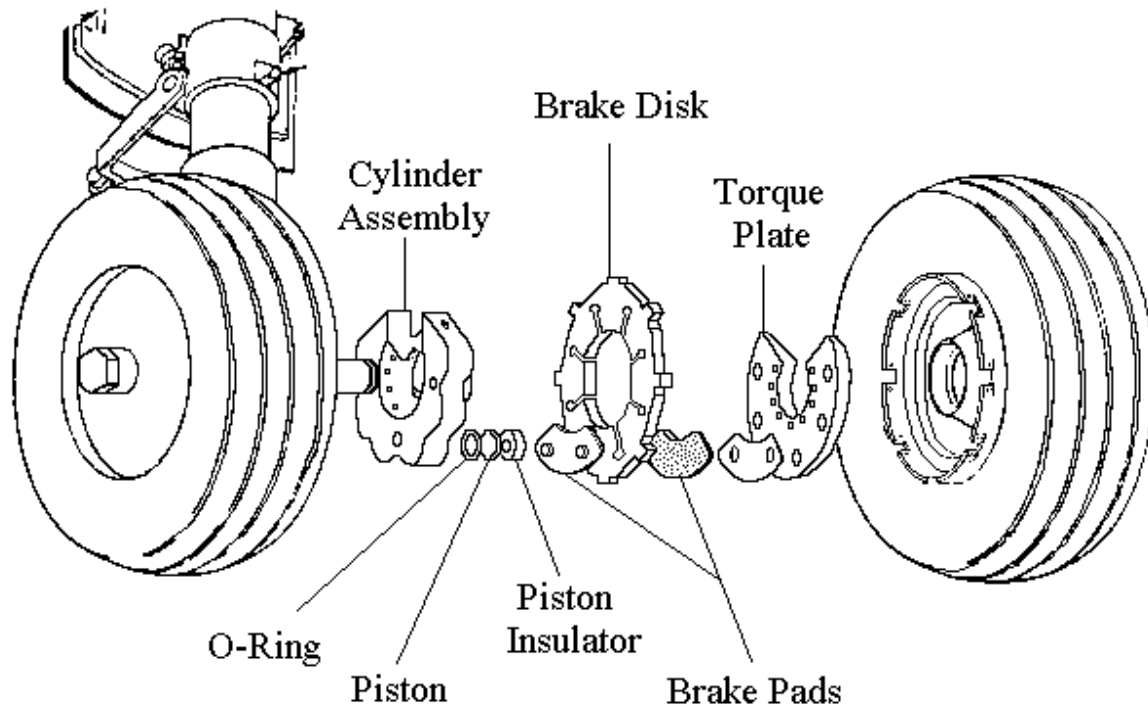
Figure 1. B.F. Goodrich 2-1203 Disk Brake Assembly

The airplane involved in the Montreal accident was equipped with B.F. Goodrich part number (P/N) 2-1203 wheel brake assemblies (see figure 1).² The left wheel well included the

² The B.F. Goodrich P/N 2-1203 series brake assembly is a floating-type, single-disk assembly. The steel disk has smooth sides, expansion slots, and tangs around the outer diameter. The tangs are keyed into the wheel so that both rotate together. The disk floats in and out of the wheel to prevent binding during brake application. The cast-aluminum alloy housing, which is bolted to the landing gear strut, has six cylinders, aluminum alloy pistons, and O-rings to prevent leakage. Each piston is protected from the brake pad by an asbestos piston insulator to minimize heat transfer from the disk to the piston. During brake application, hydraulic fluid is forced into the cylinder, and the piston pushes against the insulator, movable brake pad, disk, and opposing brake pad and torque plate to clamp the rotating disk. The airplane involved in the Montreal accident had the original design P/N 2-1203 wheel brake assembly. Subsequent P/N 2-1203 brake assemblies have suffixes of -1 through -4.

hydraulic and fuel lines and fittings, and a burned rubber fuel crossover line. Witness marks on the inside of the brake cylinders and on the outside of the piston insulators indicated that the pistons were cocked within their respective cylinders. Most of the brake pads were worn unevenly, exposing the base metal. The piston insulators and brake disks were also worn unevenly; however, the wear on the disks was within the minimum thickness requirements specified in the airplane's maintenance manual. Although the airplane's main and brake hydraulic systems had a placard specifying MIL-H-83282, analysis of the fluid in both systems revealed a mixture of MIL-H-83282 and MIL-H-5606 hydraulic fluids.⁴ The mixed fluids had a flash point of approximately 237°F.

The investigation thus far indicates that the flightcrew applied the right rudder during the takeoff roll probably to compensate for a dragging left wheel brake and then raised the landing gear, with overheated brakes, into the left wheel well. Although the precise cause of the wheel well fire has not yet been determined, the investigative findings indicate that the ensuing fire in the left wheel well may have been caused by either (1) leaking low flash point brake system hydraulic fluid from a brake cylinder or (2) leaking fluid from damaged lines in the wheel well from an exploding tire coming in contact with and being ignited by the hot brake disk. The fire became hotter as additional flammable liquids from the brake, hydraulic, and fuel systems were introduced. This fire likely led to the wing failure. Leaking brake cylinders could have been caused by the cocked pistons, which appear to have resulted from the combined effects of excessive and uneven brake pad wear, uneven disk wear, and unevenly worn piston insulators on the outboard brake.

Require B.F. Goodrich to develop and implement a process for identifying and eliminating excessive uneven wear on all B.F. Goodrich part number 2-1203 series wheel brake assemblies used on Fairchild/Swearingen SA226 and SA227 series airplanes. (A-98-114)
