National Transportation Safety Board

Safety Recommendation

Date: November 30, 1998

In reply refer to: A-98-122 through -124

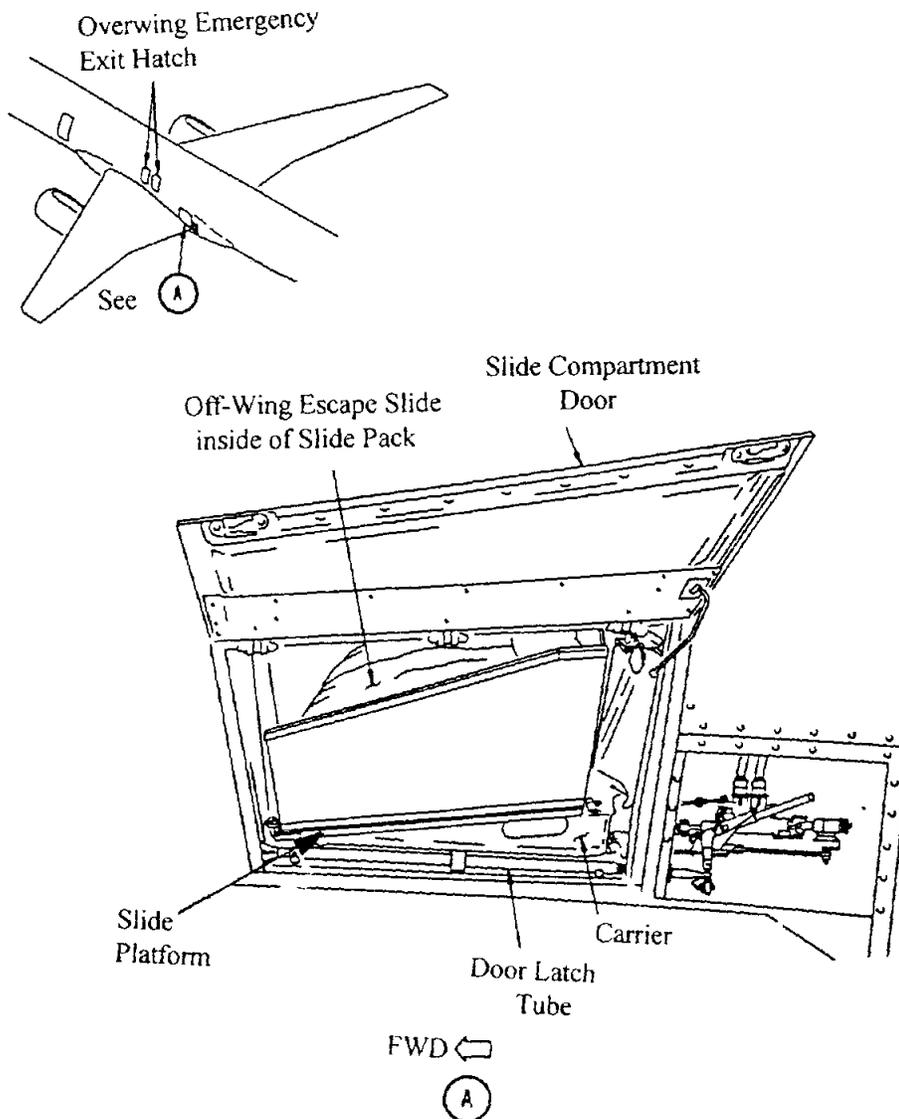
Figure 1.—B-757 Off-Wing Escape Slide Assembly

After the airplane landed, a Delta Airlines mechanic performed a walk-around inspection. During the inspection he saw that the left off-wing emergency escape slide had separated from the airplane, the left side of the fuselage aft of the slide was damaged, the slide was missing, and the restraining hook that mounted to the slide platform was broken, which allowed the platform to over-rotate, causing damage to the wing and fuselage (see figure 1). The slide carrier, the platform, and the door latching tube remained with the airplane. Further inspection found significant damage to the left side of the fuselage aft of the trailing edge of the left inboard flap.

During its investigation of the B-757 off-wing escape slide, the National Transportation Safety Board found that Delta Airlines had performed a replacement of the left off-wing emergency escape slide 2 days before the incident. The two mechanics who replaced the slide stated that it was the first time they had replaced a B-757 off-wing slide. The mechanics stated that they referred to the B-757 maintenance manual, sections 25-65-00 and 25-65-01, and the placard on the inside of the maintenance access door while they replaced the slide.¹ One mechanic maneuvered the round yellow actuator handle that secures the off-wing emergency slide door within the slide compartment (see figure 2), and the other mechanic held the slide door closed (by sitting on the wing and pressing on the door with both his feet.) The mechanic who manipulated the round yellow actuator handle said it was difficult to ensure that the handle was in the full-

down position, stating that “it took several attempts to move the actuator handle to the latched position.” The mechanics stated that after the door was latched one mechanic ran his finger around the door to ensure it was closed, and then both mechanics checked the EICAS in the cockpit to ensure that the door was closed. One of the two mechanics said that he had received instructions on how to replace the slide about 4 or 5 years ago during a 2-week B-757 initial maintenance training class that provided instructions on all B-757 systems. The other mechanic had not yet received training on the B-757 off-wing escape slide replacement during his 3 months of employment at Delta.

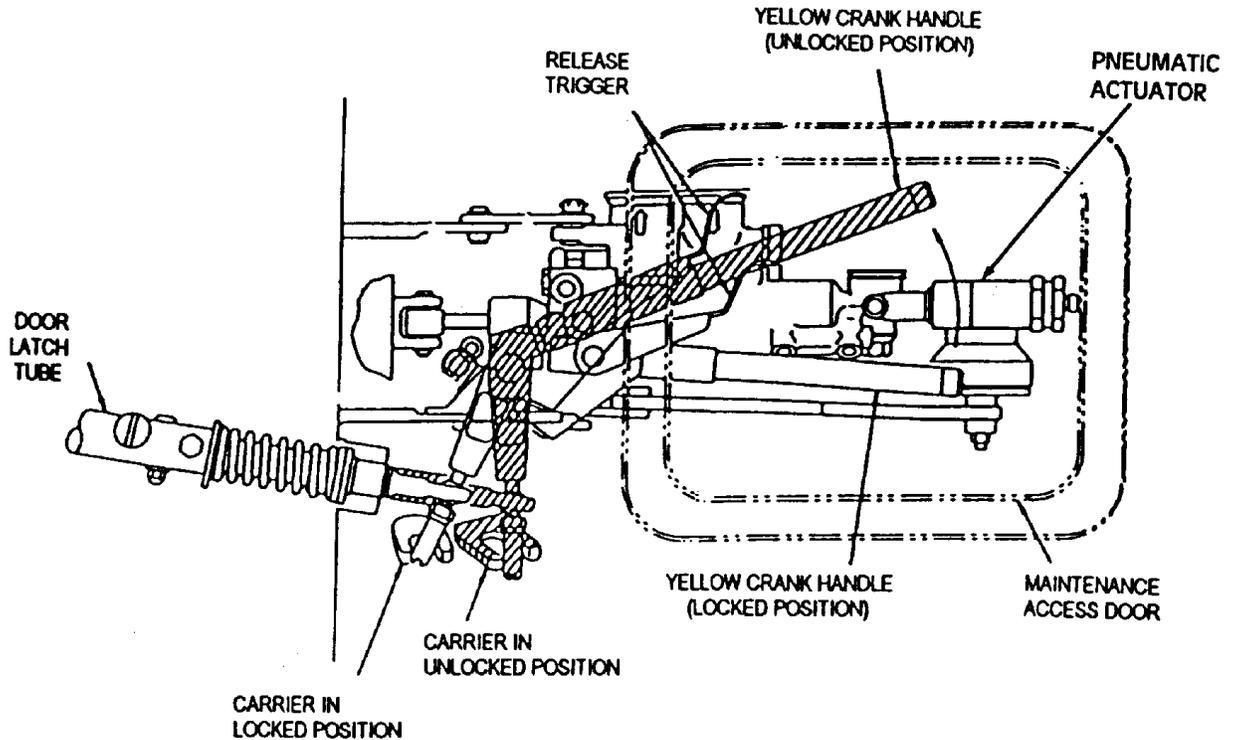
Figure 2.—B-757 Off-Wing Escape Slide Actuator Assembly

The B-757 off-wing emergency escape slide system is located just above the trailing edge of each wing in the aft wing/body fairing and consists of a ramp/slide folded into a “slide pack” attached to a packboard and installed on a carrier assembly. To service the slide, a mechanic must first open the slide maintenance access door and release the trigger on a round yellow handle. The yellow handle actuates a pneumatic actuator, which unlatches the slide compartment door. The slide compartment door is locked in the closed position by lowering the yellow handle to its lowest position; this secures the door latch tube that is located along the lower edge of the slide compartment (see figure 2). A door sensor (micro switch) located on the aft edge of the door sill activates the “EMER DOORS” light on the cockpit overhead annunciator panel and displays the “L WING SLIDE” or “R WING SLIDE” EICAS message if either off-wing slide door opens more than 0.24 inch at its sensor switch.
