National Transportation Safety Board

Safety Recommendation

Date: December 3, 1998

In reply refer to: A-98-125 and -126

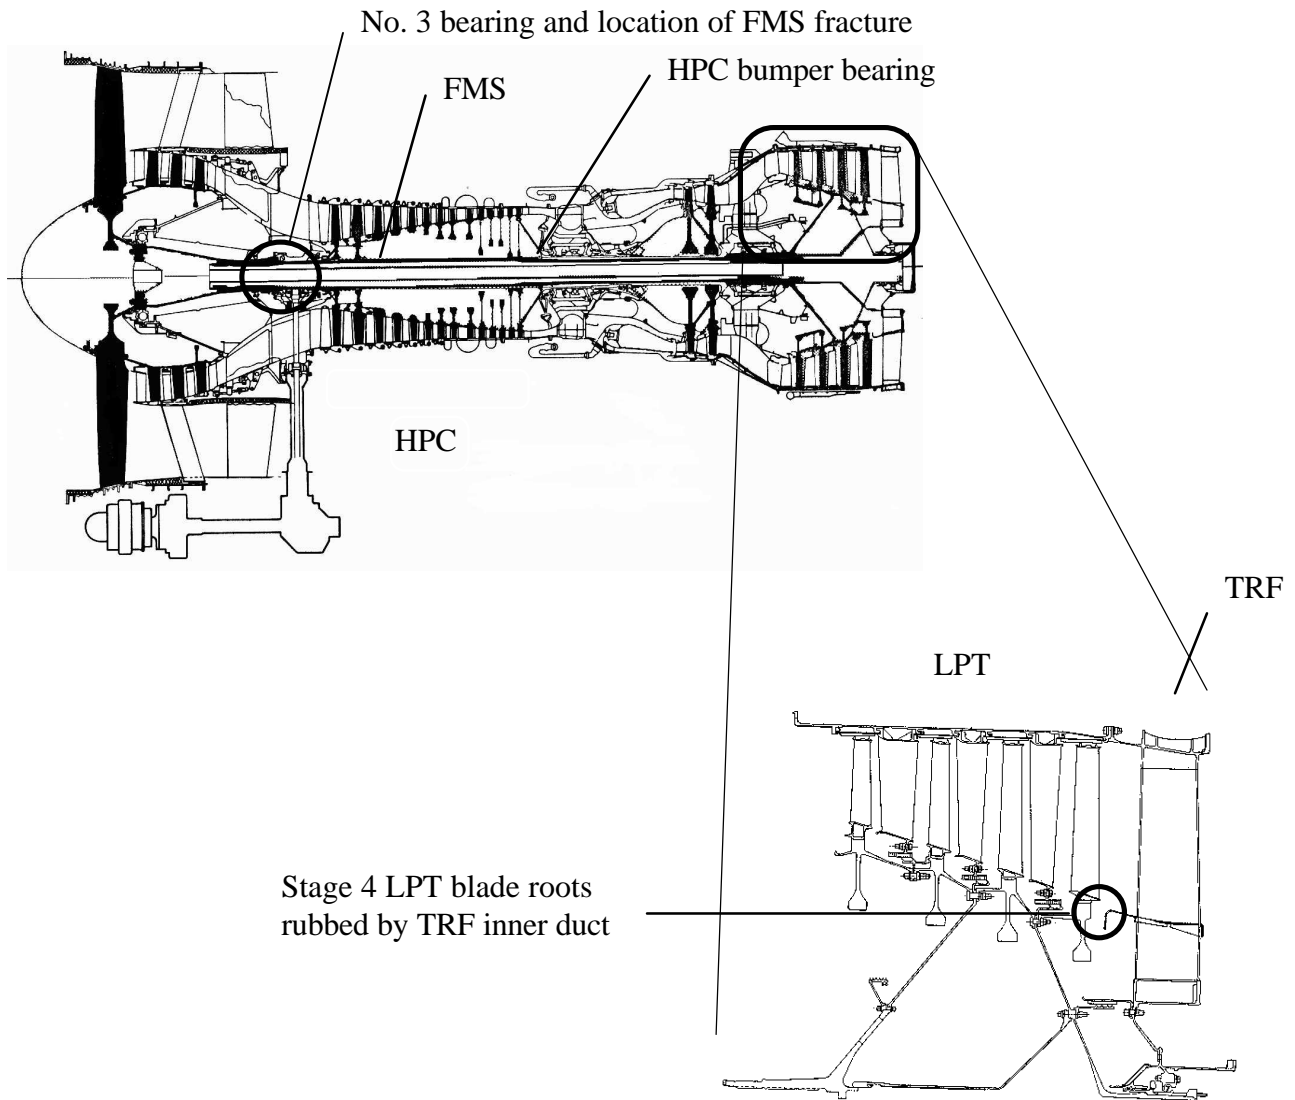
The examination of the No. 2 engine revealed that most of the LPT module was missing (see figure 1). The airplane had punctures to its left wing leading edge slats and to a landing gear door. In addition, the No. 1 engine had hard body impact damage⁴ to 18 of the 38 fan blades, and the fan cowl had impact damage from the debris ejected from the No. 2 engine.

Figure 1. Cross section of CF6-50 engine and expanded view of LPT module

Disassembly of the engine, serial number (SN) 455-954, at GE's Engine Maintenance Center, Ontario, California, under the direction of the National Transportation Safety Board, revealed that the fan midshaft (FMS) was fractured circumferentially, just aft of the No. 3 (roller) bearing. Although the No. 3 bearing was damaged, the damage was typical of secondary damage that would have occurred late in the engine failure sequence.

Examination of the fractured FMS by the Safety Board's and GE's materials laboratories revealed a fatigue fracture with multiple origins on the outer diameter (OD) of the shaft that propagated inward. The examinations also revealed a color variation across the fracture surface and a reduction of the material hardness at the fracture in comparison to the other areas of the FMS and the engineering drawing specification, indicating that the part had been previously

The disassembly of the PIA engine showed that the center section of the FMS had become wedged into the high pressure compressor (HPC) bumper bearings. The design of the CF6-50 engine's FMS is such that the OD of the forward half of the shaft is greater than the inner diameter of the bumper bearing on the inside of the HPC rear hub. On the PIA engine, when the FMS fractured at its forward end, the rear section moved aft, and the larger diameter section of the shaft became wedged into the bumper bearing, limiting the rearward movement of the LPT

Require General Electric Aircraft Engines to modify the CF6-50 engine to eliminate the impediments to the aft translation of the low pressure turbine rotor that limits the amount of meshing that occurs in the event of a fan midshaft fracture. (A-98-125)

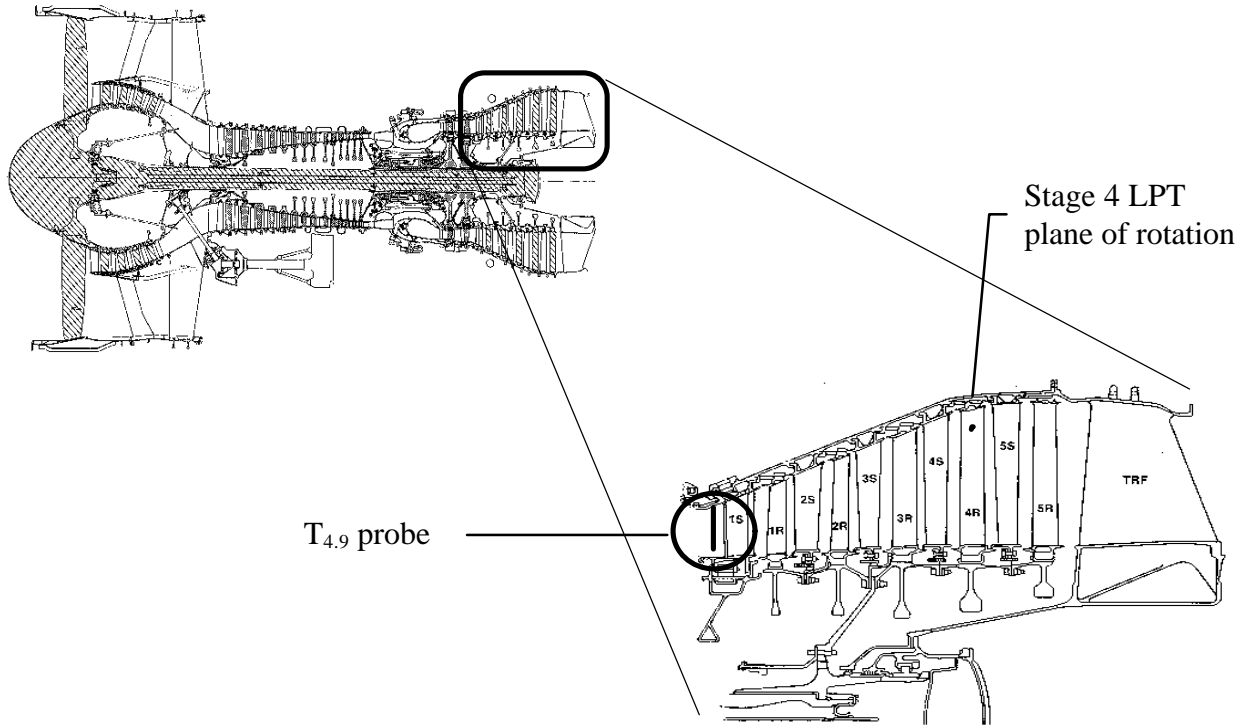
Examination of the No. 1 engine revealed that the core cowl had a 15-inch long (circumferential) by 6-inch wide (axial) hole in the plane of the stage 4 LPT rotor. There were numerous dents and impact marks on the underside of the left wing's inboard aileron and the outboard side of the inboard flap track fairing, both of which are directly aft of the No. 1 engine's exhaust.¹⁴

The engine was disassembled and examined under the direction of the Safety Board at Motoren-und Turbinen-Union (MTU), Hannover, Germany.¹⁵ The disassembly revealed that the tip of one interturbine temperature ($T_{4.9}$)¹⁶ probe had broken off and impacted one stage 1 LPT blade, causing a fatigue fracture of the airfoil near the blade tip shroud (see figure 2). All of the stage 2, 3, 4, and 5 LPT blades were found in their respective disks; however, all were fractured transversely across the airfoils at various lengths above the blade root platforms. The disassembly also revealed that the LPT case had a 17-inch by 2-inch wide hole in the stage 4 LPT plane of rotation. The damage to the LPT rotor was progressively worse along the gaspath, suggesting that the stage 1 LPT blade tip separated first, that all of the blades in the following stages were then fractured, and that the mass of material became larger as it progressed through the rotor, subsequently resulting in a case rupture in the stage 4 area.

Figure 2. Cross section of CF6-80C2 engine and expanded view of LPT module

Require General Electric Aircraft Engines to improve the ability of the CF6-50 and the CF6-80 series engines to prevent fractured low pressure turbine blades from being liberated through the engine cowling. (A-98-126)
