# National Transportation Safety Board

## Safety Recommendation

In reply refer to: A-98-6

On August 20, 1997, the left outboard aileron of a Boeing 747-312 (747), operating as Ansett Airlines flight 826, deflected to the full-down position while the airplane was taxiing for takeoff at Brisbane International Airport, Brisbane, Australia. Postincident examination of the aileron control system was conducted by the Bureau of Air Safety Investigation (BASI), Commonwealth of Australia. The examination revealed that one of the left aileron cables (AA-11) that connect the inboard aileron quadrant to the aileron cable drum was broken. An adjacent cable (AB-13) that connects the aileron cable drum to the outboard aileron quadrant via a turnaround pulley was frayed. The aileron cable drum forward guide pin exhibited signs of wear consistent with abrasion by an aileron control cable. The airplane was manufactured in 1983, production line number 590, serial number (S/N) 23029, and had 11,027 cycles and 62,399 hours since new. The airplane had been operated 1,022 flight hours since both cables were replaced on June 2, 1997.

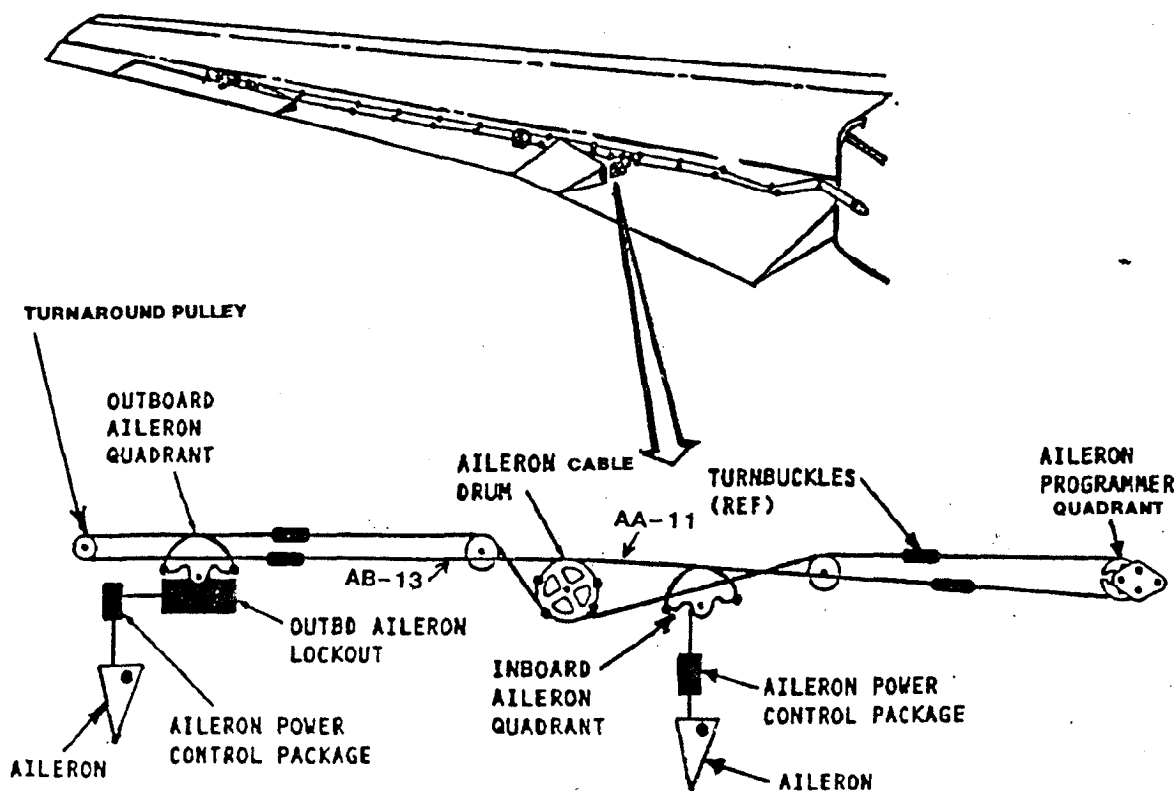
Figure 1. Aileron Wing Control Cable System.

Each wing has two AA and two AB aileron cable assemblies (see Figure 1.), one inboard and one outboard. The inboard AA cable run connects the aileron programmer quadrant to the aileron cable drum, and the inboard AB cable run connects the same quadrant to the inboard aileron PCU quadrant. The outboard AA cable run connects the aileron cable drum to the outboard aileron quadrant, and the outboard AB cable run connects the drum to the same quadrant via a turnaround pulley. The aileron cable drum, which is located at wing station (WS) 776.98, is a four-slotted pulley with a guide pin and is used to provide a complete (closed) cable loop to the inboard aileron even if the outboard segment is lost because of malfunction. The guide pin's purpose is to ensure that all four cables remain in the correct pulley slots at all times.

Further investigation by BASI revealed that the two aileron control cable decals<sup>1</sup> on the aileron cable drum's inboard and outboard mounting brackets at WS767 and WS780 were installed incorrectly. The decal for WS767 was fitted at WS780 and vice versa. BASI also found that a similar 747 aircraft, S/N 23028, production line number 584, had the aileron cable replaced because of excessive wear, and the cable was frayed down to one remaining strand. This aircraft also had the two aileron control cable decals on the aileron cable drum's inboard and outboard mounting brackets at WS767 and WS780 fitted incorrectly and interchanged. Because of the decals' transposition, the Safety Board requested a U.S. operator to randomly inspect its 747 airplane aileron control systems for the aileron cable drum decal identification at WS767 and WS780. An inspection on November 24, 1997, of one 747-251, S/N 21707, production line number 378, revealed similar decal transposition on the right WS767 and WS780.

According to Boeing, if these decals are interchanged during installation, the transposition results in incorrect cable routing information at the aileron cable drum and may lead to incorrect cable positioning during installation. A review of the applicable engineering drawings shows that instructions for the decal installations are correct. A check of undelivered 747s at the Boeing factory (production line number 1130 and onward) revealed correct decal installations.

The BASI investigation concluded that the Brisbane incident was caused by misrouting of cables on the aileron cable drum at WS776.98 and that transposition of the aileron control cable decals on the aileron cable drum at WS767 and WS780 has the potential to cause misalignment of the aileron control cables during installation. The Safety Board is concerned that airplanes with mispositioned aileron cable installation decals may be susceptible to aileron cable failures in flight, which could jeopardize flight safety. The Safety Board believes that the Federal Aviation Administration should issue an airworthiness directive to require operators of 747s, produced before production line number 1130, to conduct a one-time inspection of the aileron control system to ensure correct routing of aileron control cables on the aileron cable drum located at WS776.98 and correct installation of aileron cable decals at WS767 and WS780 at the earliest possible inspection interval.

Issue an airworthiness directive to require operators of Boeing 747 airplanes, produced before production line number 1130, to conduct a one-time inspection of the aileron control system to ensure correct routing of the aileron control cables on the aileron cable drum located at wing station (WS)776.98 and correct installation of aileron cable decals at WS767 and WS780 at the earliest possible inspection interval. (A-98-6)
