National Transportation Safety Board

Safety Recommendation

Date: July 31, 1998

In reply refer to: A-98-62 through 64

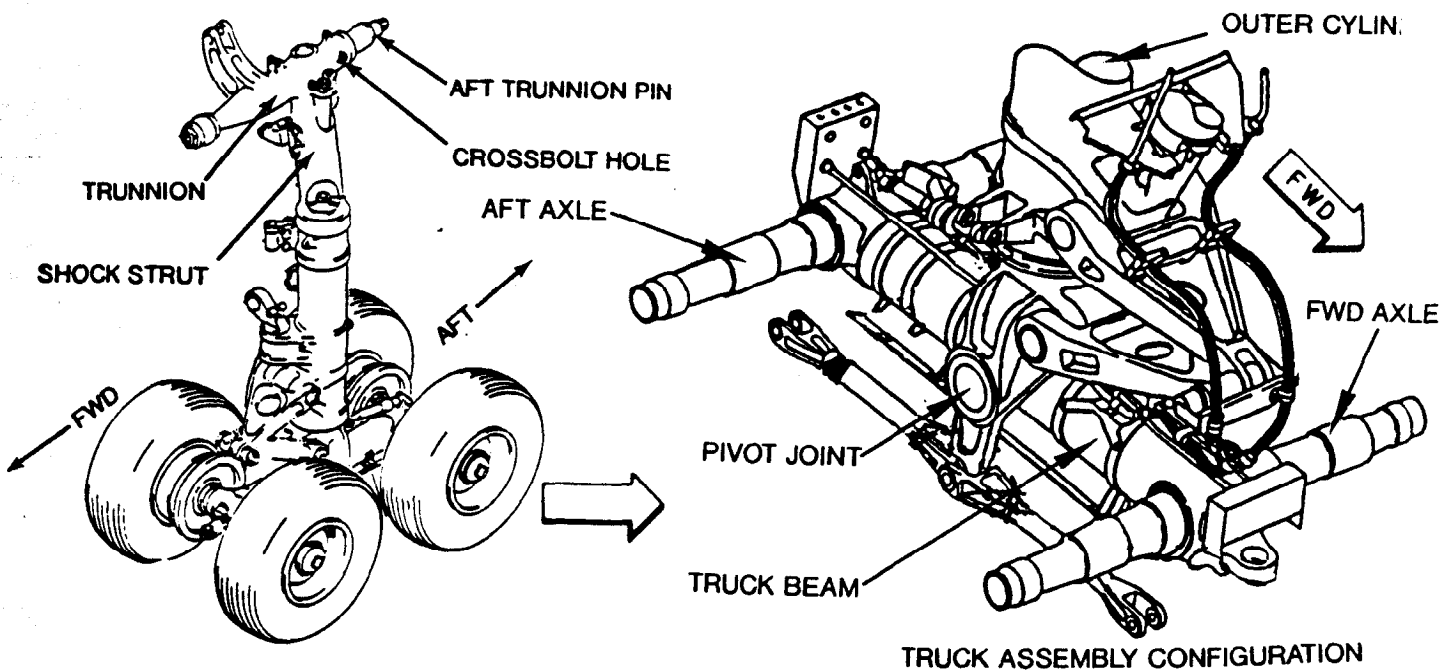
Figure 1. Boeing 757 Main Landing Gear Assembly

The 757 MLG is a conventional, four-wheel, dual-tandem landing gear that has a metering pin orifice shock strut (see figure 1). The gear has four support points: the forward trunnion, the aft trunnion, the drag brace, and the side strut. The shock strut outer cylinder of the MLG assembly transfers operational loads from the truck assembly to the four support points. The assembly consists of a truck beam, axles, wheels and tires, brake rods, and a protective shield. The truck beam is the primary supporting member of the truck assembly. It pivots on the lower end of the shock strut outer cylinder.
