National Transportation Safety Board

Safety Recommendation

In reply refer to: A-98-8

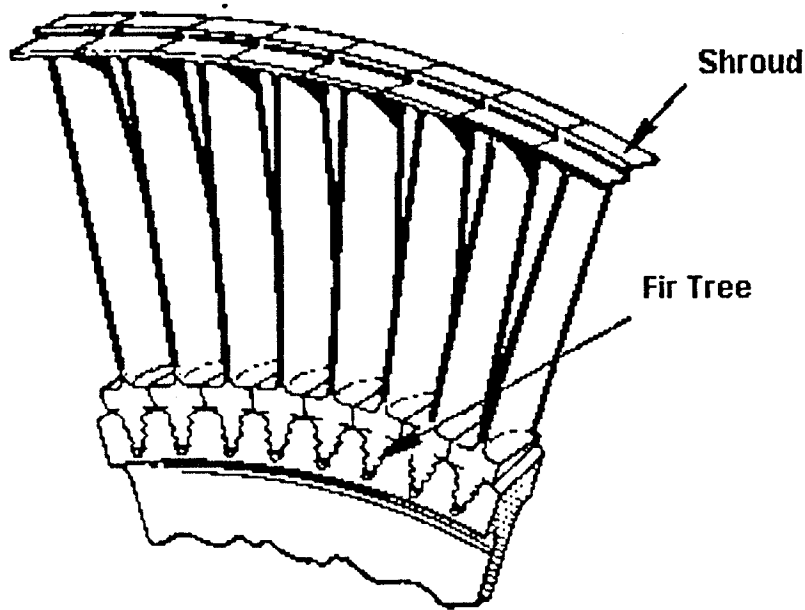
origin area. Examination of the 4th stage LPT blade shroud notches³ that were recovered from the exhaust case revealed evidence of extreme notch wear estimated at 0.030 to 0.050 inch in depth.

The JT8D LPT blade design incorporates a blade tip shroud for structural support and vibration dampening. The blade shrouds interlock to provide stiffness so that they function as a single ring to reduce blade flexing caused by thermal, aerodynamic and centrifugal loads. The shroud notches (contact areas) are coated with PWA 694, which is a cobalt alloy that is a hard temperature and wear resistant material, to help reduce wearing. Worn shroud notch surfaces reduce blade damping and drop the blades' resonance frequency into the engine operating range. This increases the vibratory stresses to levels that can initiate fatigue cracking.

Shroud Notch (contact area)

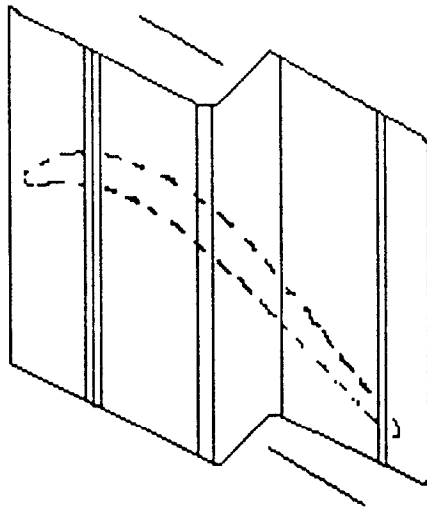
Typical Top View of Blade

Shroud Notch (contact area)
