Solar Turbines

Ceramic Stationary Gas Turbine Development Program

Ceramic Stationary Gas Turbine (CSGT) Program

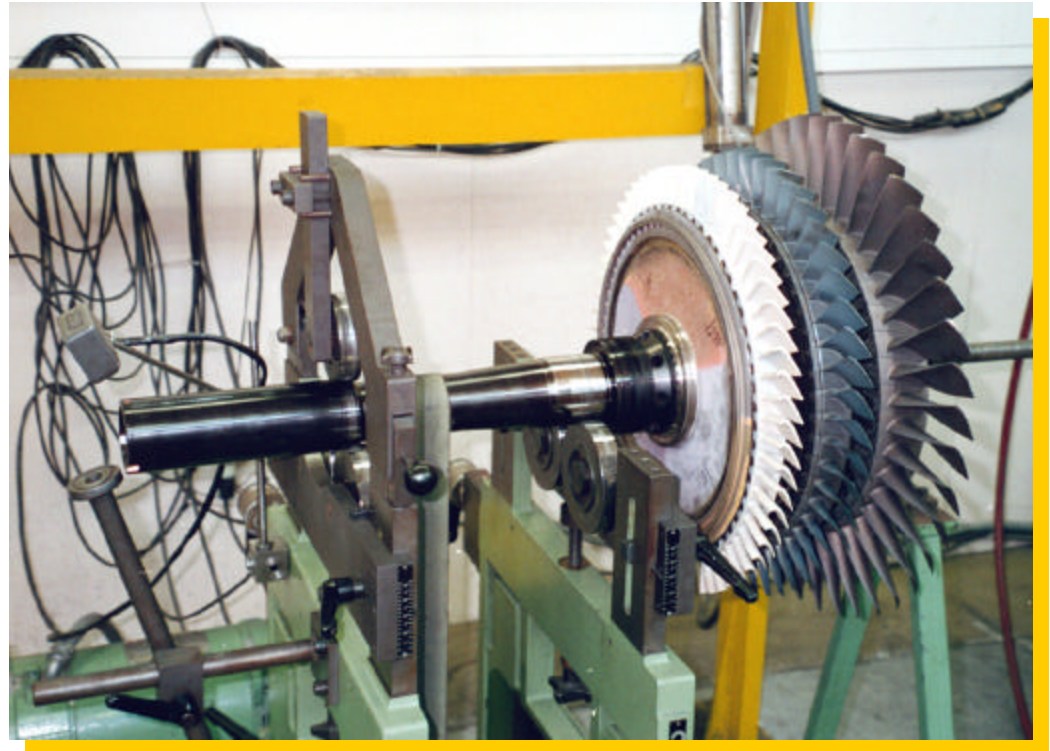
Two Field Installations at Texaco

- **May 1997, AS-800 Blades**
 - Terminated after 948 Hours
 - Foreign Object Damage
- **May 1998, AS-800 Blades**
 - Terminated after 352 Hours
 - Foreign Object Damage

- **Improve Impact Resistance of Ceramic Blade Materials**
 - **Conduct Impact Study**
 - **Improve Material Properties**
 - **Energy Absorbing Coatings**
 - **More Robust Airfoil Designs**
- **Evaluate Alternate Attachments**
 - **More Robust Attachments**
 - **Non-Compliant Layer Designs**

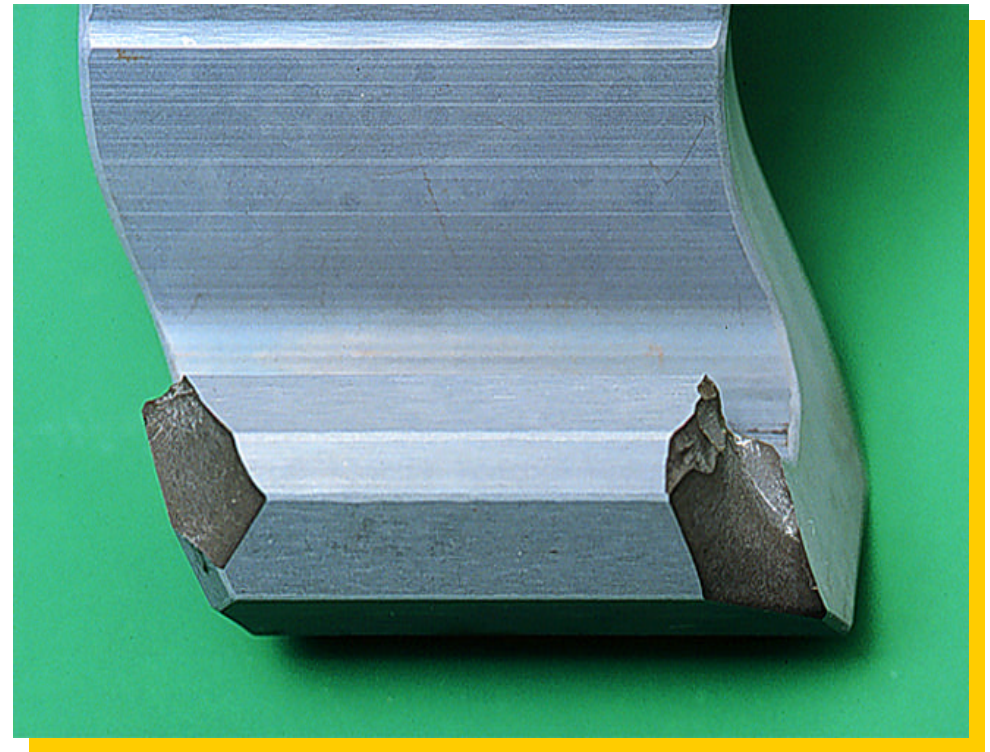
Initial Design Validation

- **Short-Term Engine Test - 1 Hr at Full Load**
- **No-Load Idle, 50% Load, 100% Load**
- **Nozzle Airfoil Performed Well**
- **Chipping in Nozzle Attachment and Outer Shroud Area**

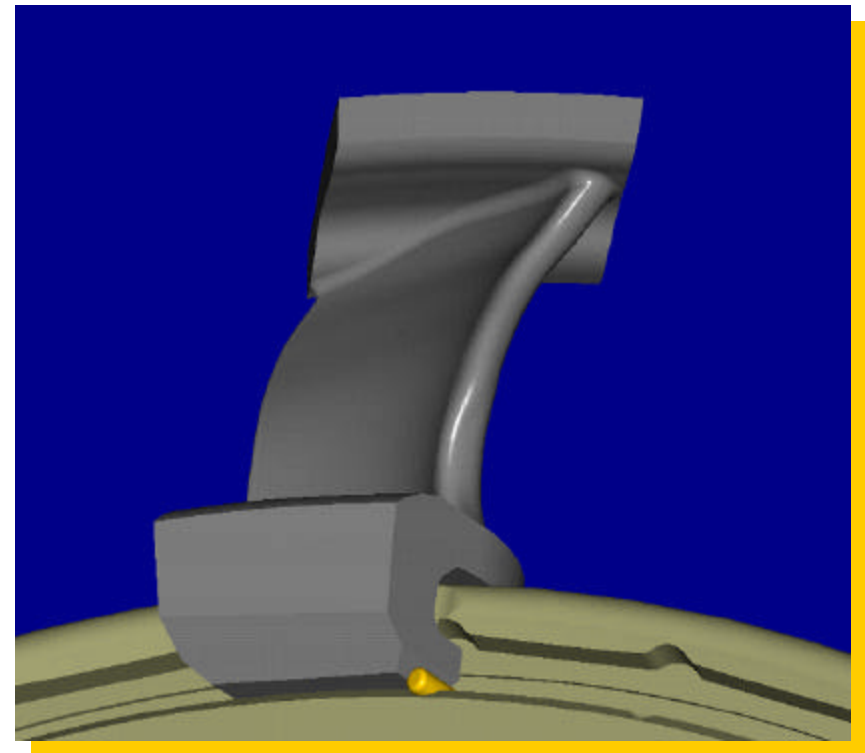
Further Design Validation

- **2nd Short-Term Engine Test
- 1 Hr at Full Load**
- **Design Modifications to
Attachment Structure**
- **Chipping Was Eliminated
during Second Test**
- **100-Hr Cyclic Engine Test**

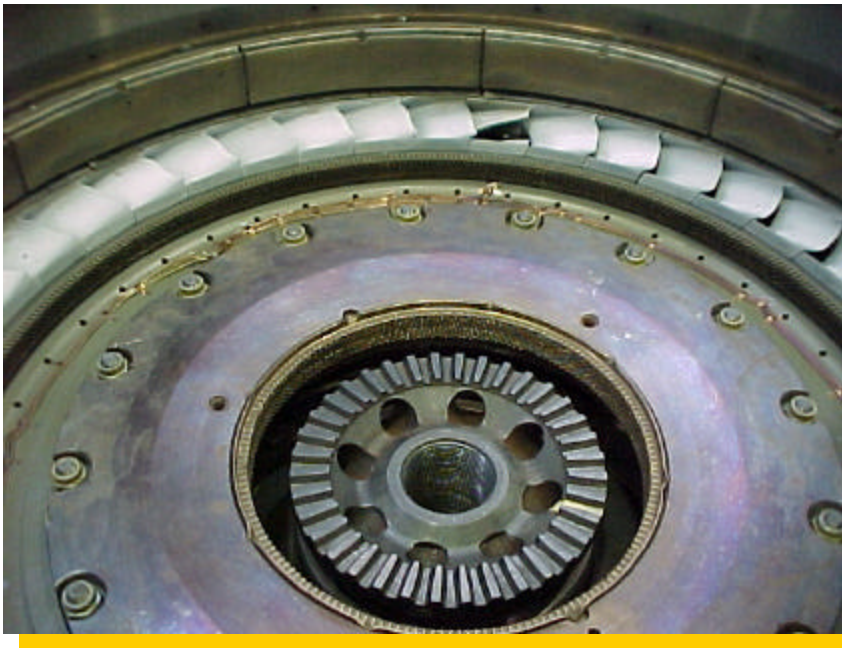
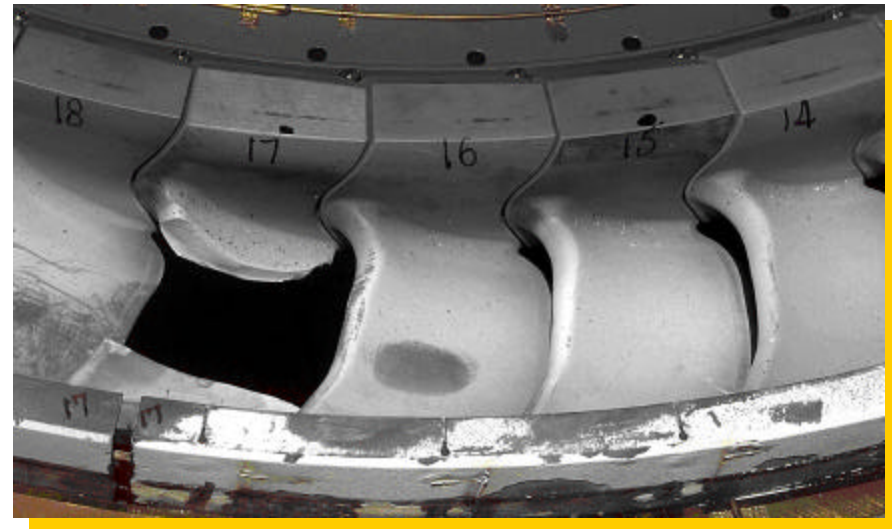
Some Nozzles Cracked in 68-Hr Engine Test

- **Nine of 11 Nozzles in 120° arc**
- **White Deposit on All Airfoils**
- **Cracks Originated From Trailing edge: 3(OD), 6 (ID), 2 (OD+ID)**
- **OD and ID Attachment in Good Condition**

- **Materials Degradation - Need Environmental Barrier Coating**
- **Re-evaluate Ceramic Nozzle and Attachment Structure Design**

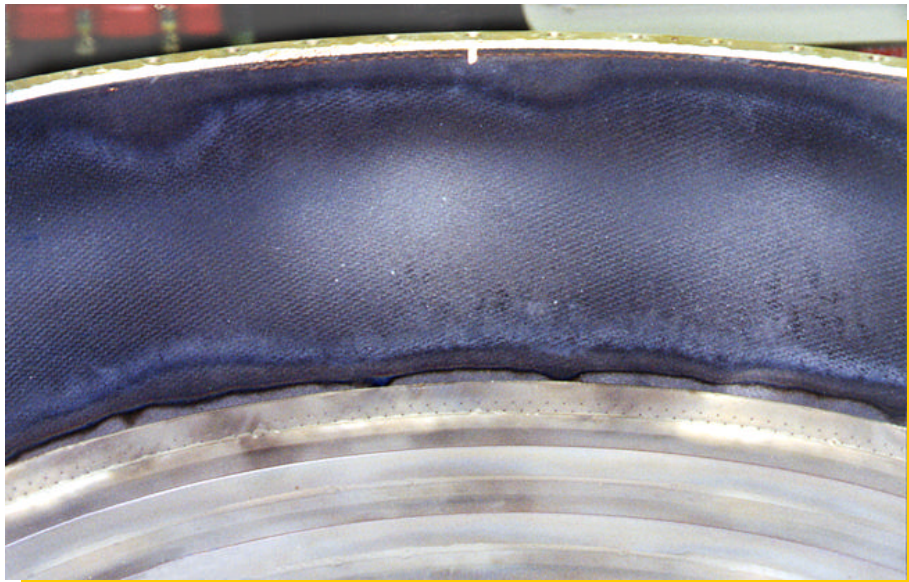
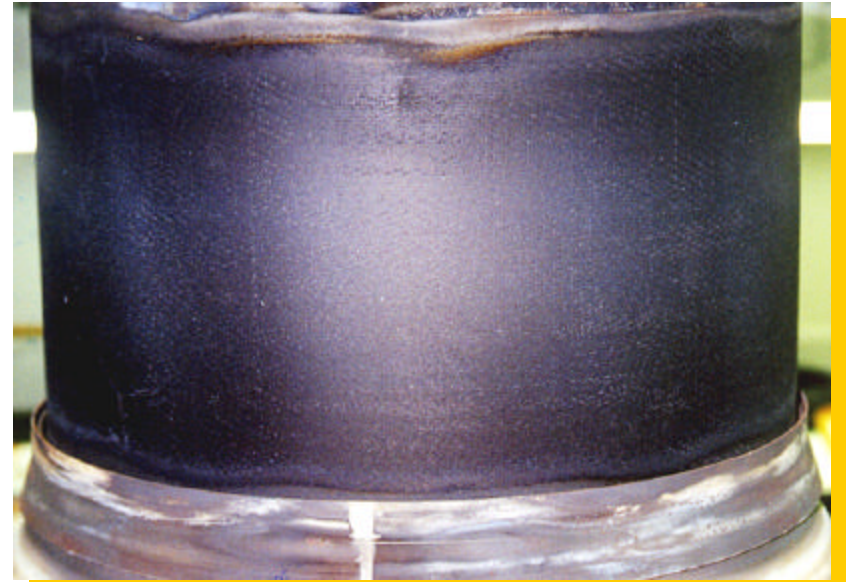
DLC Enhanced SiC/SiC CFCC Combustor Liners after 100-Hr Engine Test

- **> 400 Hr of In-House Engine Test Time**
 - **100 Hr - Max. Time on Single Build**
- **Excellent Durability**
 - **NDE Inspection Before and After Tests**
- **Emissions**
 - **50 - 100% Load Range**
 - **NOx < 15 ppmv**
 - **CO < 10 ppmv**

Acceptable for Field Testing

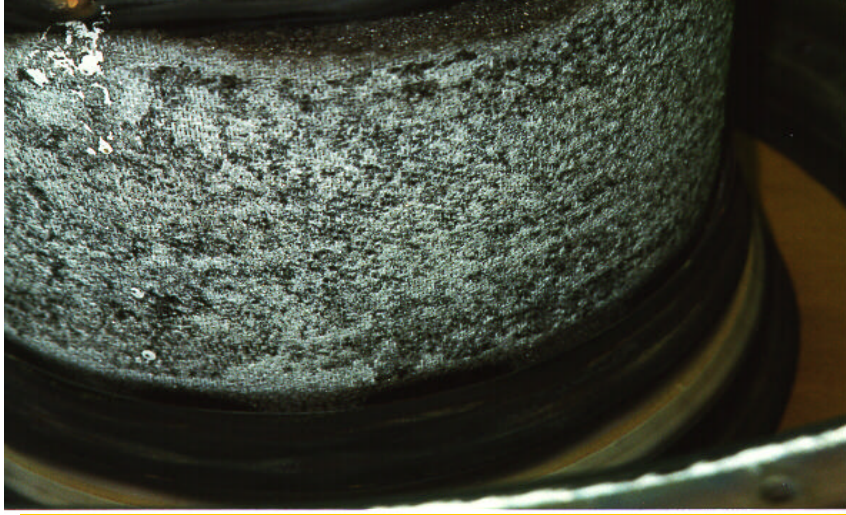
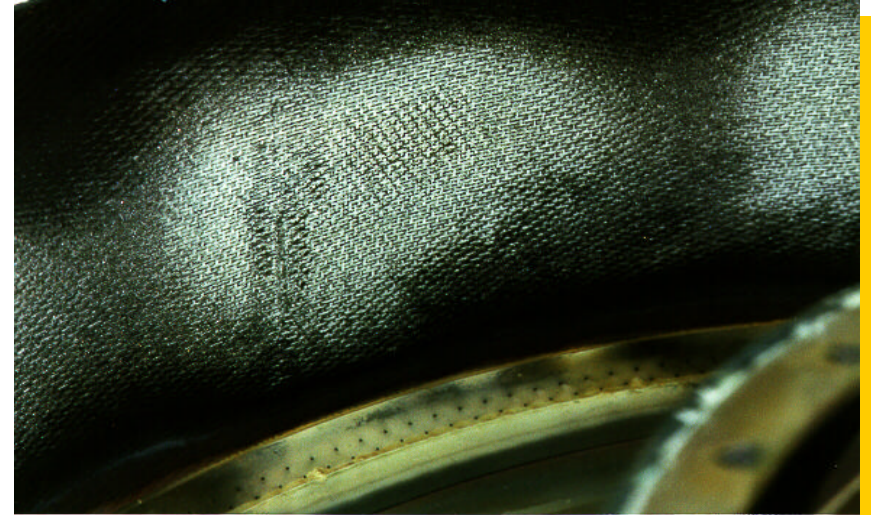
CFCC Liners after 1st Field Test

- **Inner Liner Heavily Oxidized**
- **Localized Oxidation on Outer Liner**
- **No Degradation of Secondary Components**
- **Need for Environmental Barrier Coating and Better Heat Transfer Identified**

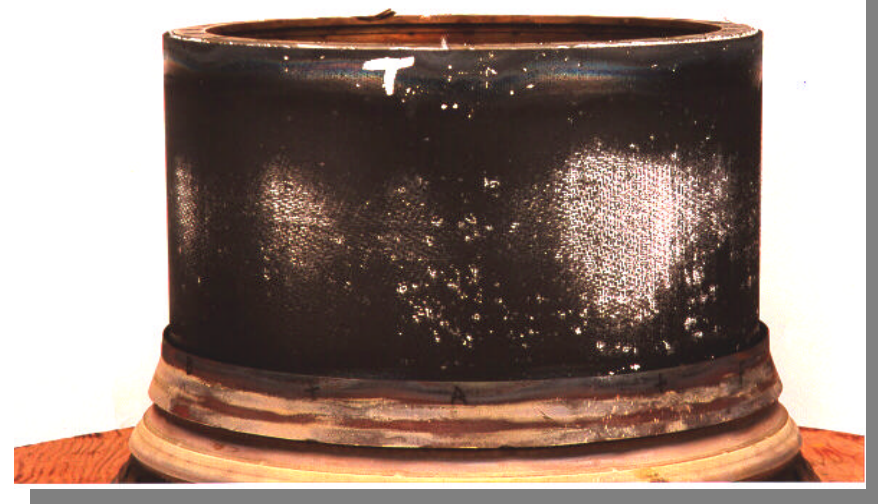
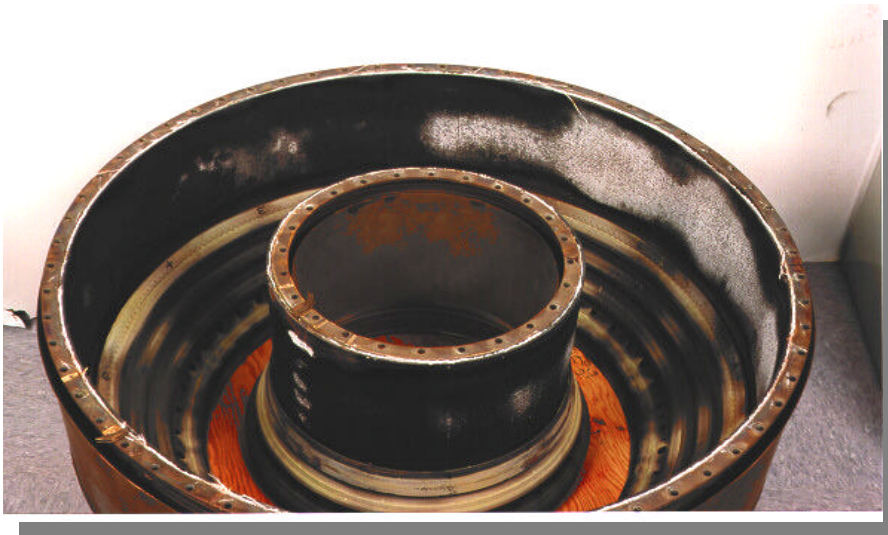
CFCC Liners after 2258-Hr Field Test

- Inner Liner Sectioned for Analysis
 - Oxidized vs Unoxidized Areas
 - Microstructure
 - Recession
 - Residual Strength
- Liner Degradation Closely Matches Exposure Testing at ORNL

- Significantly Less Oxidation than 1st Field Test
- Part Could Have Continued in Service
- Outer Liner Accepted for Additional Field Testing
