**Title: Rolls-Royce Allison Ceramic Vane Project**

**Author:** Richard A. Wenglarz  
Richard.A.Wenglarz@allison.com  
(317) 230-2185  
(317) 230-6193 (fax)  
Rolls-Royce Allison  
PO Box 420, Speed Code S48  
Indianapolis, IN 46206

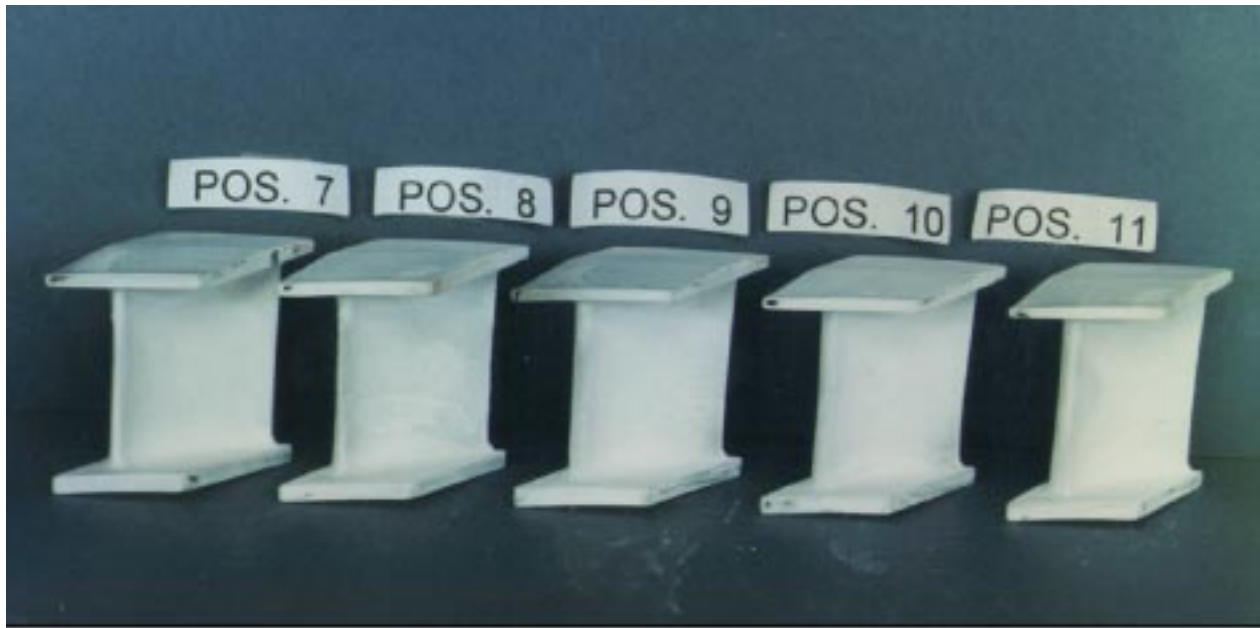
VSK-1887  
TE99-939

Visual evidence of ceramic oxidation was apparent during the turbine inspections. Figure 3 shows five of the ten vanes located downstream of one the turbine combustors. These vanes had operated about 815 hr in the Exxon turbine. The color of the vanes had changed from tan/grey to white. Figure 4 compares the color of an as-processed vane (on the right) to a vane (on the left) that had operated for 815 hr in the turbine. The inspection at 222 hr operation showed that the ceramic vanes were covered by a white powder. The metal rotor blades and vanes in the two rows downstream of the ceramic vanes also had a dusting of white powder. The white powder on the ceramic vanes was analyzed by Oak Ridge National Laboratories (ORNL) and found to be an oxide of silicon and lanthanum from the intergranular phase of the ceramic. Figures 5 and 6 illustrate oxidation material losses visible to the unaided eye on vane concave and convex surfaces, respectively. These vanes had experienced 815 hr operation in the turbine.

**Figure 3. Five adjacent vanes after 815 hr operation in the turbine.**

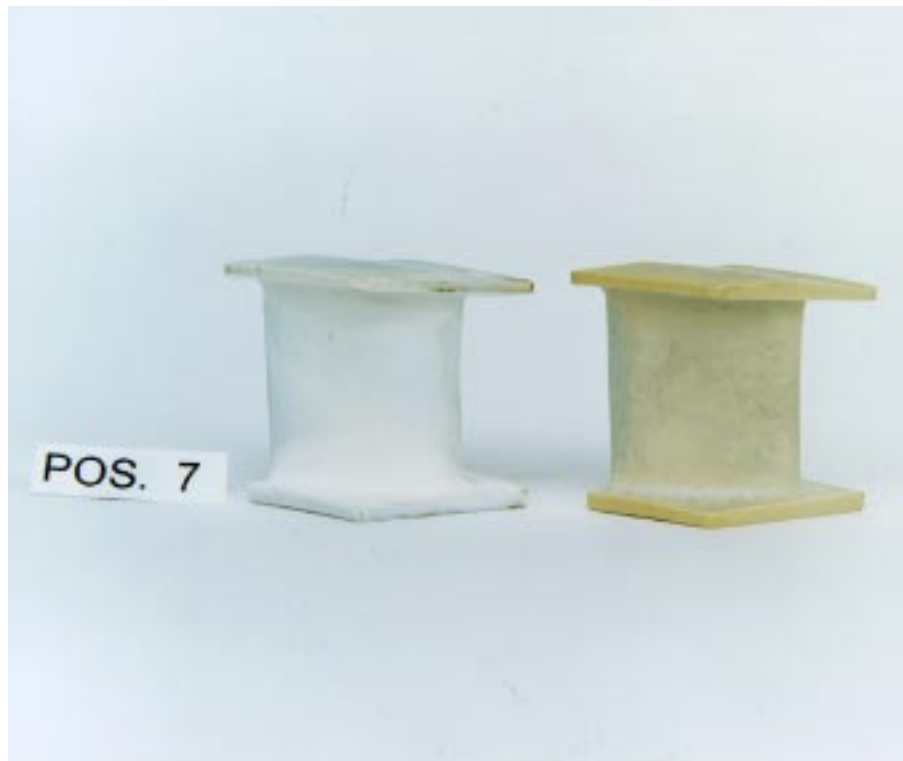
VSK-1328  
TE99-940

**Figure 4. Ceramic vanes before and after 815 hr operation in the turbine.**

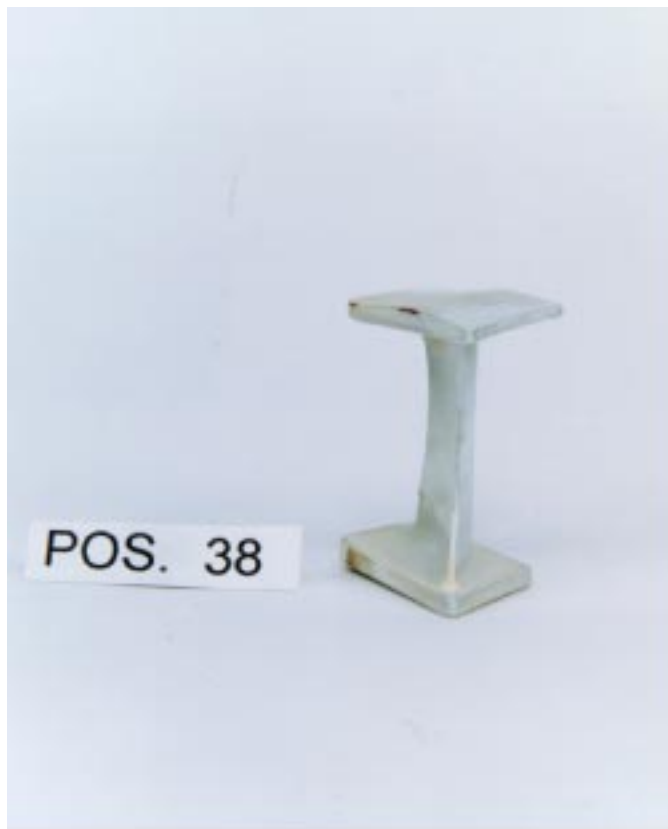
VSK-1327  
TE99-941

All 60 vanes removed from the assembly after 815 hour (793 hr in the demonstration and 22 hr in the engine proof test) operation were measured for trailing edge thickness losses. The decreases in trailing edge mid span thickness ranged from 0.005 in. to a maximum loss of 0.024 in. Percentage decreases in trailing edge thickness range from 12% to 50% of original values. The trailing edge thickness measurements indicated that the rate of oxidation might have been decreasing with time.

**Figure 5. Ceramic material loss on concave surface.**

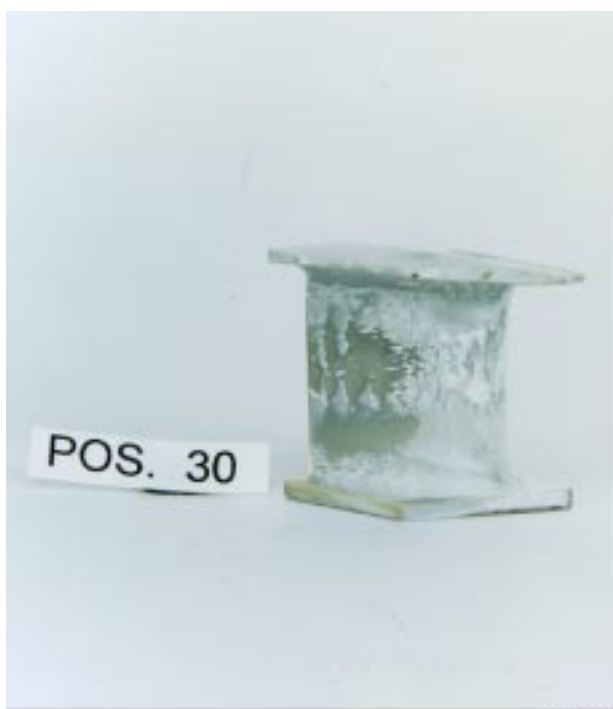
VSK-1329  
TE99-942

**Figure 6. Ceramic material loss on convex surface.**

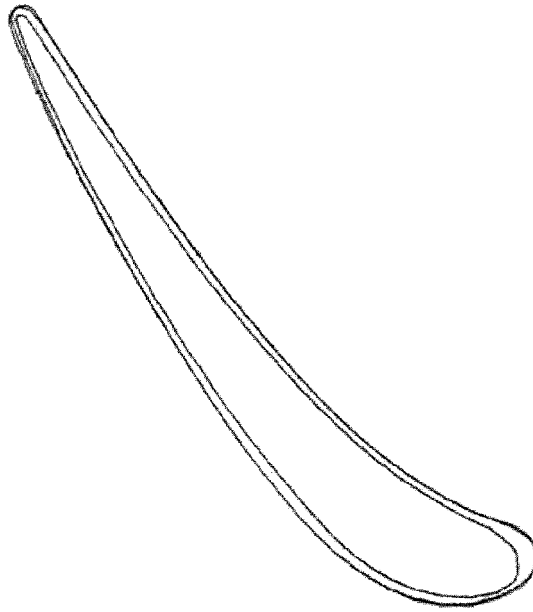
TE99-943

AlliedSignal took profile measurements of several of the ceramic vanes that had operated 815 hr in the turbine and compared those to profiles measured on the same vanes after fabrication. Figure 7 gives the mid span profile comparisons at mid span for the vane that had the greatest materials loss. Although the gas velocity near the airfoil surface varies from near zero at the nose stagnation point to about 1880 ft/sec at the trailing edge, the loss does not greatly differ over the airfoil surface. This suggests that gas velocity is a secondary factor in the rates of oxidation and that relatively expensive high velocity rigs (e.g., cascades) might not be needed for ceramic materials oxidation tests. However, materials tests do need to replicate the water vapor content and pressures of the turbine flow path environments.

**Figure 7. Midspan profile loss.**

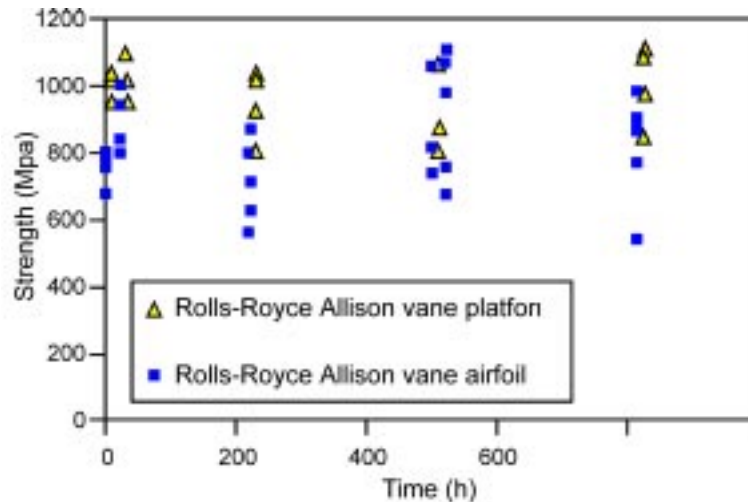
Several of the ceramic vanes removed at various operation intervals from the demonstration turbine were sent to ORNL for retained strength measurements. Small disks (about 6 mm dia. and about 0.6 mm thick) cut from the vanes were then fractured using a load at their centers. Figure 8 shows results of the ORNL retained strength measurements versus operation time. The retained strength after 22 hr exposure to the turbine environment (in the engine proof test) increased over the as-processed strengths (zero time exposure). The average retained strength of specimens did not greatly change from initial values for increasing exposure times although the scatter in the strength measurements did increase with time. The lowest retained strength measurement in Figure 8 of about 500 MPa is approximately 2.4 times greater than the maximum calculated vane stress of 207 MPa at the highest stress vane location and the worst (emergency shutdown) condition. Consequently, the ORNL data suggest that the vane oxidation is a surface phenomenon that does not substantially affect the strength of the underlying substrate material. Much longer vane lifetimes appear possible if the loss of surface material by oxidation can be inhibited (e.g., through use of environmental coatings).

**Figure 8. Strength versus time for specimens from vanes.**
