# Effect of L.E. Roughness on Orbiter Windward Nondimensional Heating

# Effect of RCC Panel #6 L.E. Cavity on Orbiter Fuselage Thermal Mapping

Summary of sensors on Left wing and chronology of failure - FYI. From the HCAT.

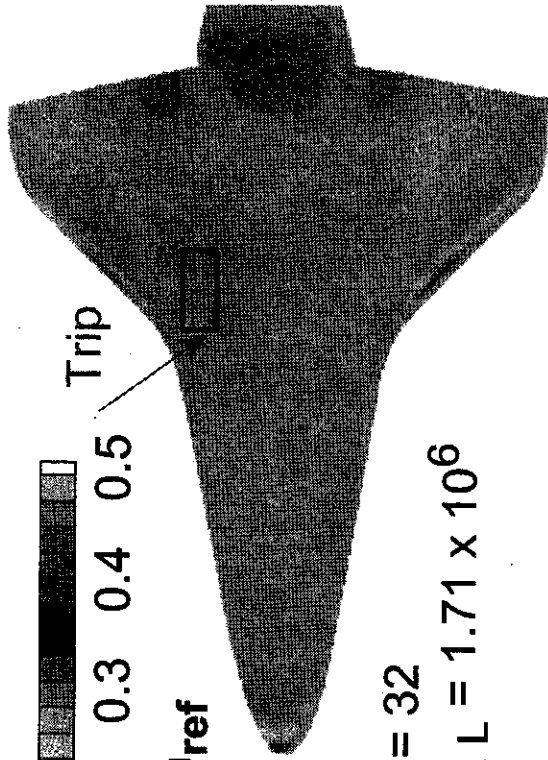
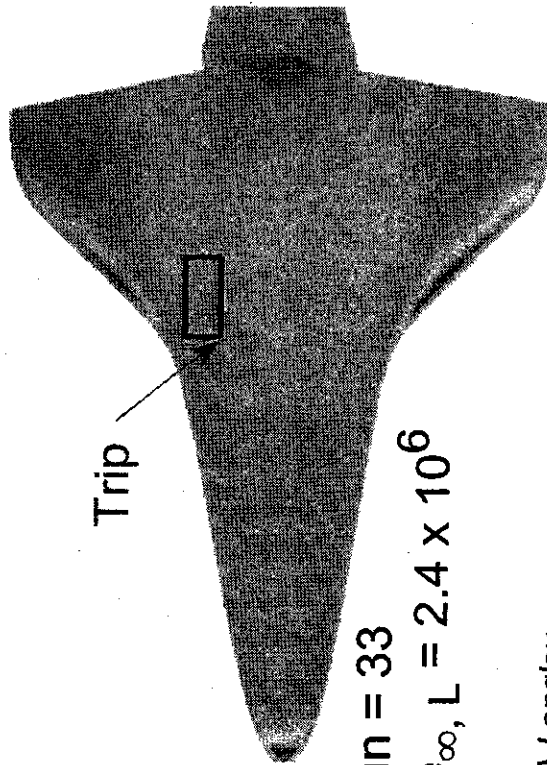
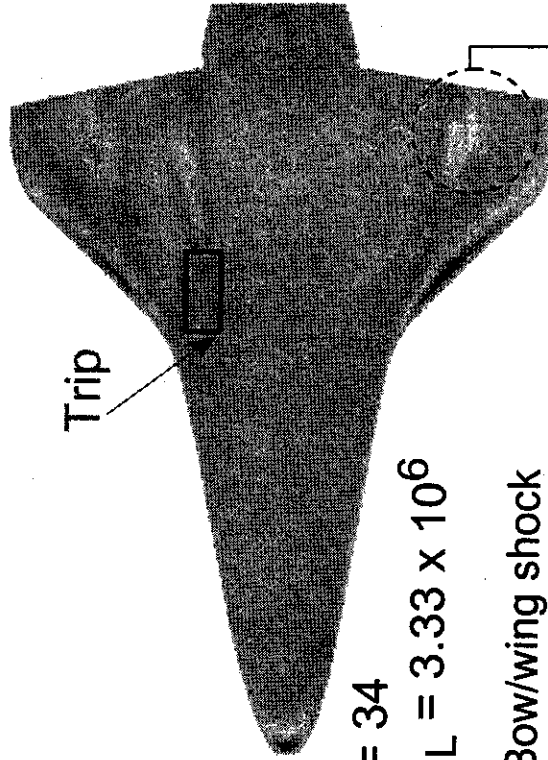
Bow/wing shock  
 interaction induced transition

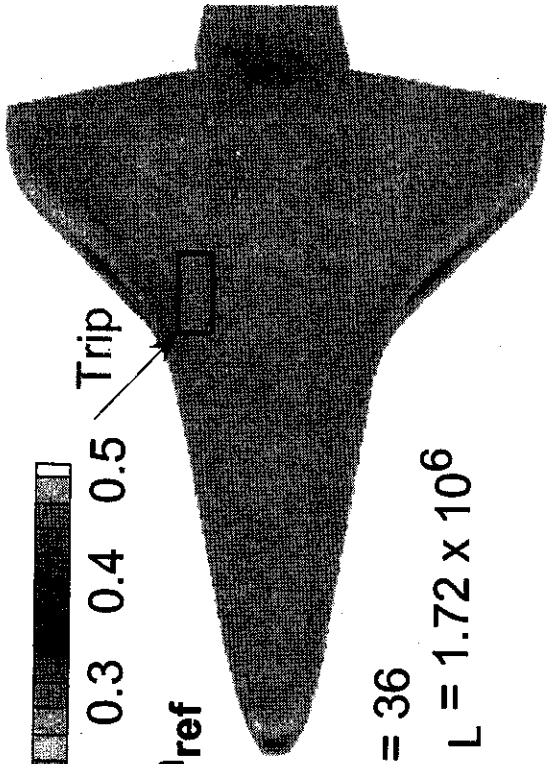
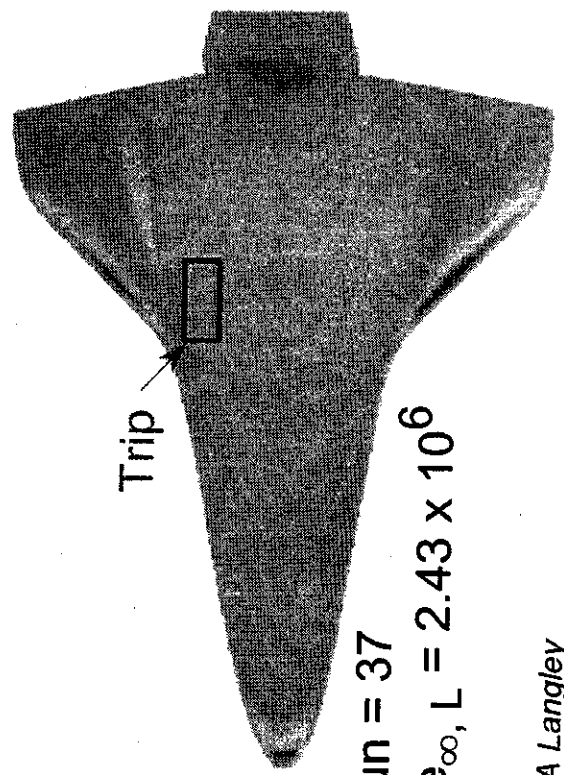
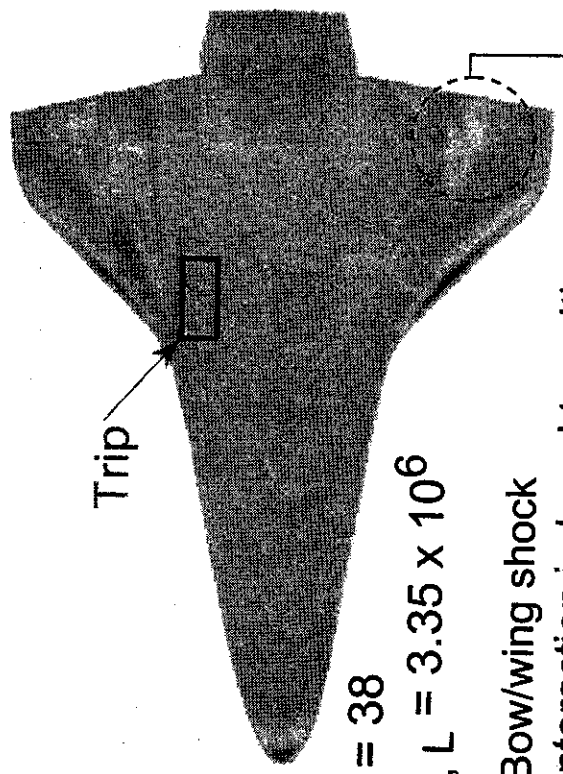
Bow/wing shock interaction induced transition

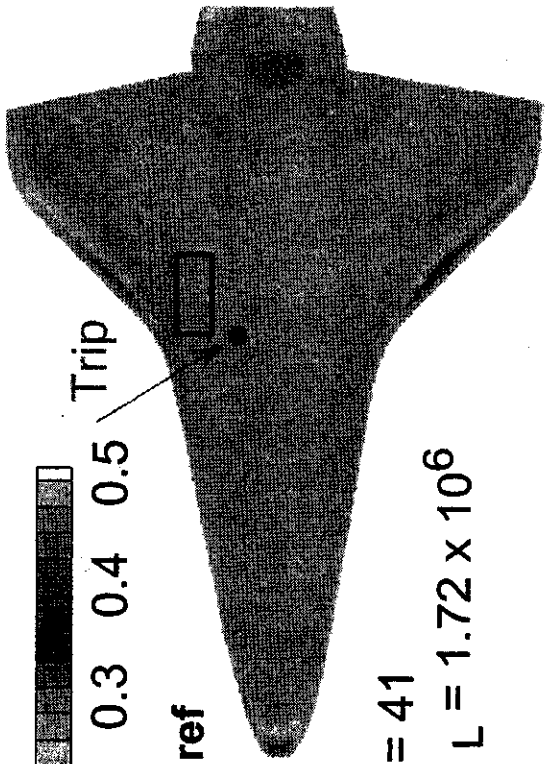
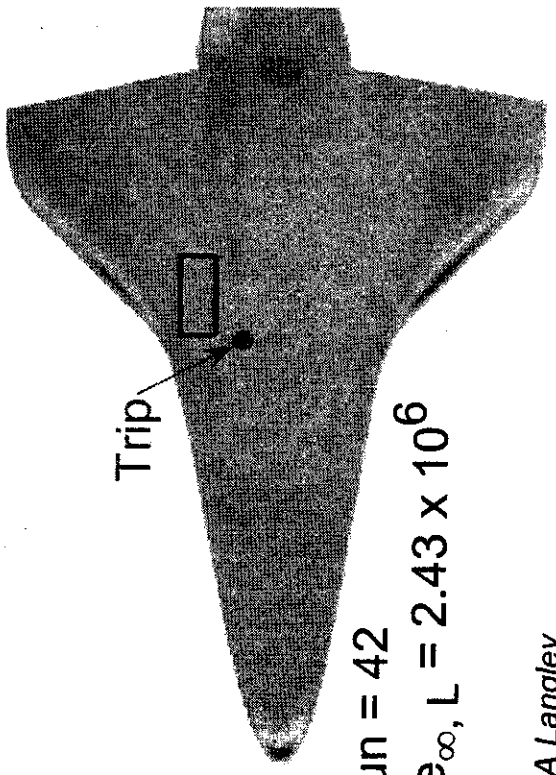
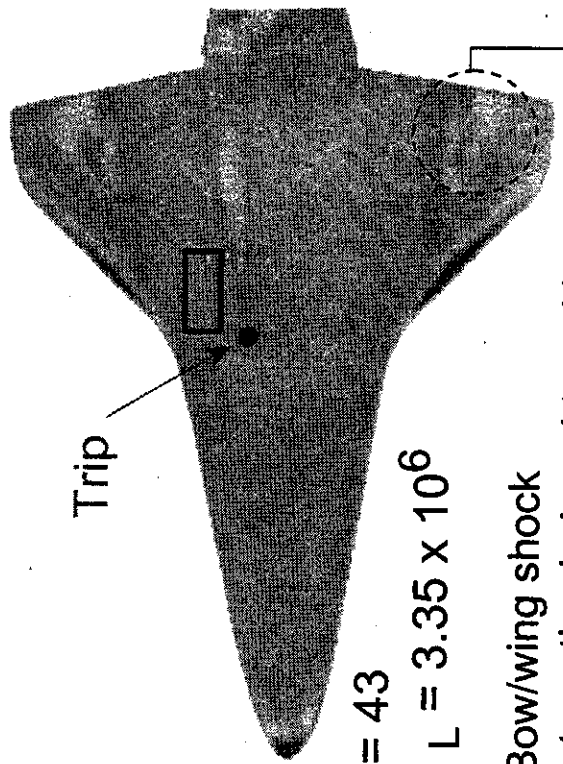
Bow/wing shock  
 interaction induced transition

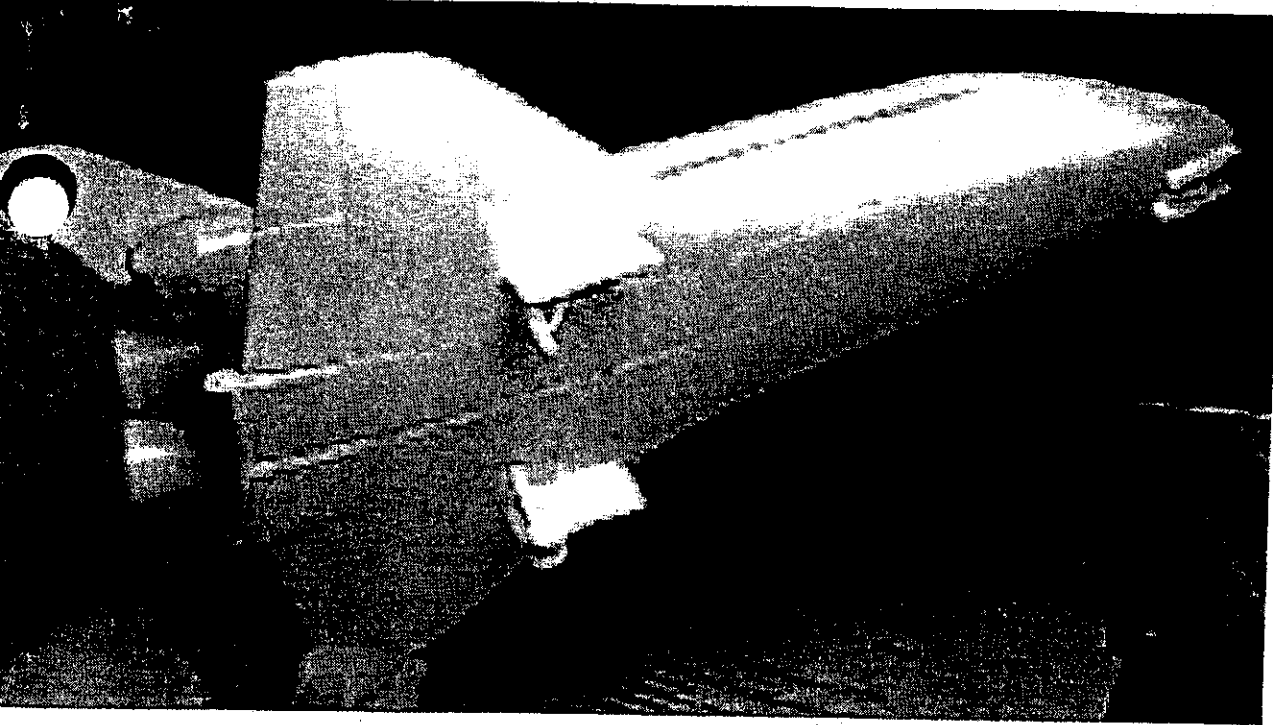
[compShuttle.jpg](#)

As a concerned supporter of the space program, I hope that you will take a moment to look at the attached image. It seems to explain to so-called "jagged" edge of the left wing seen in the blurry AF telescope picture. The image seems to be consistent with current theories regarding the left landing gear.

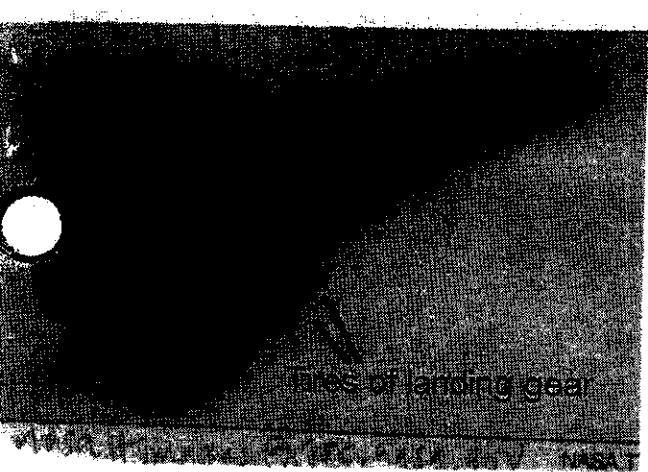
In your investigations, please consider that the main landing gear under the left wing was somehow in the down position. At the angle at which the photo was taken, the tires of the landing gear would appear before the leading edge of the left wing. It is more likely that the two "bumps" on the front edge of the left wing were the two tires rather than damage. Damage would most likely appear as missing wing. The dark smoke behind the wing is probably smoke from the burning tires. The high temperatures near the left landing gear makes sense since the landing gear doors were open. It also makes since that signals were lost at other area of the wing, because the fire in the wheel well burned through the nearby control wires. This also explains the excessive drag on the left side. It was only a matter of time before the extra drag put the shuttle out of control.

miss of landing gear

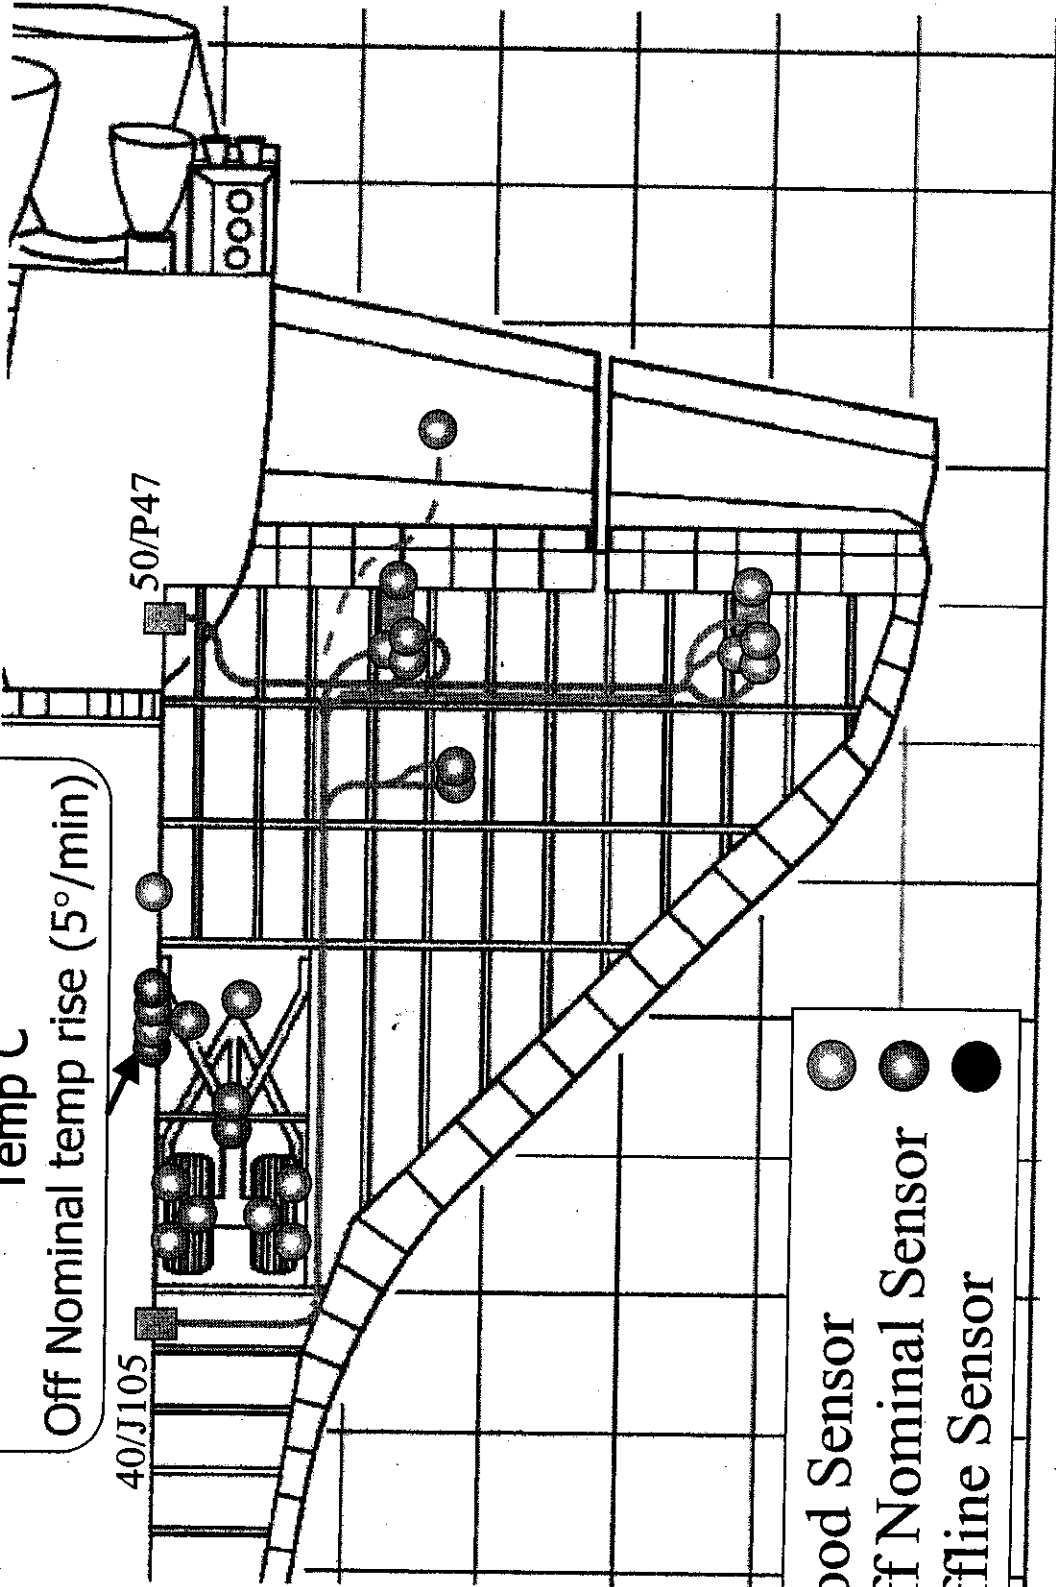
V58T1702  
Left Main Gear Brake Line  
Temp C  
Off Nominal temp rise (5°/min)

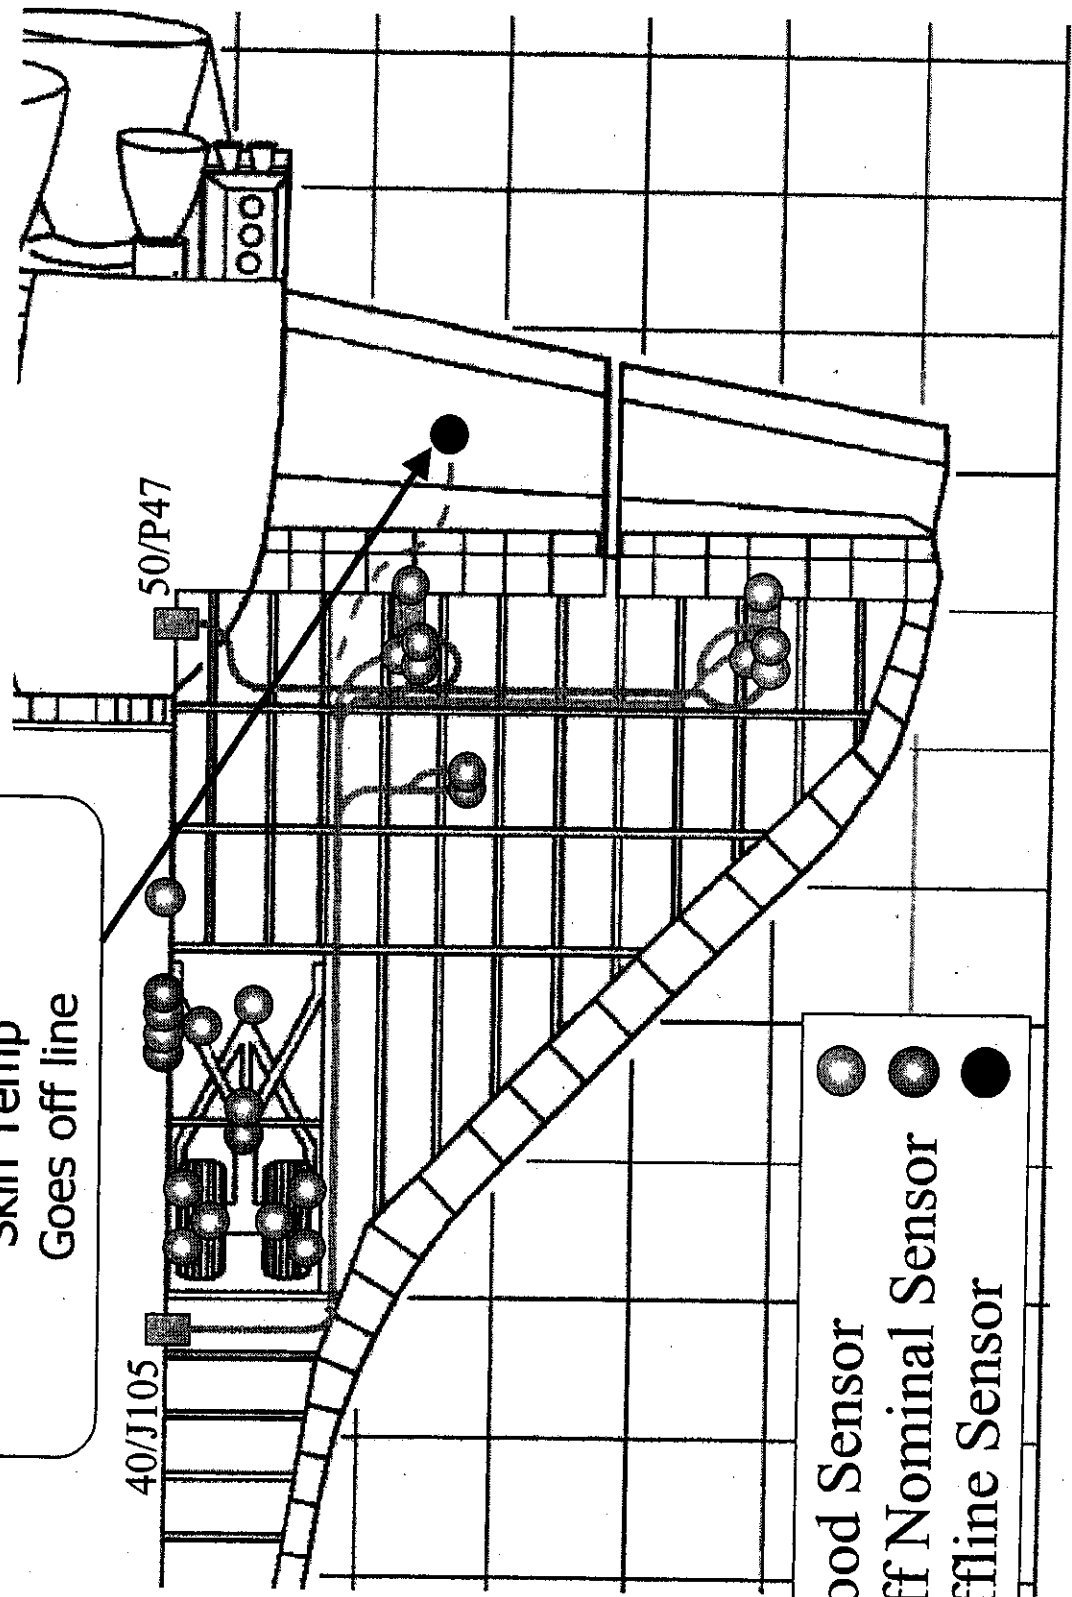
V09T1006  
Left Inboard Elevon Lower  
Skin Temp  
Goes off line

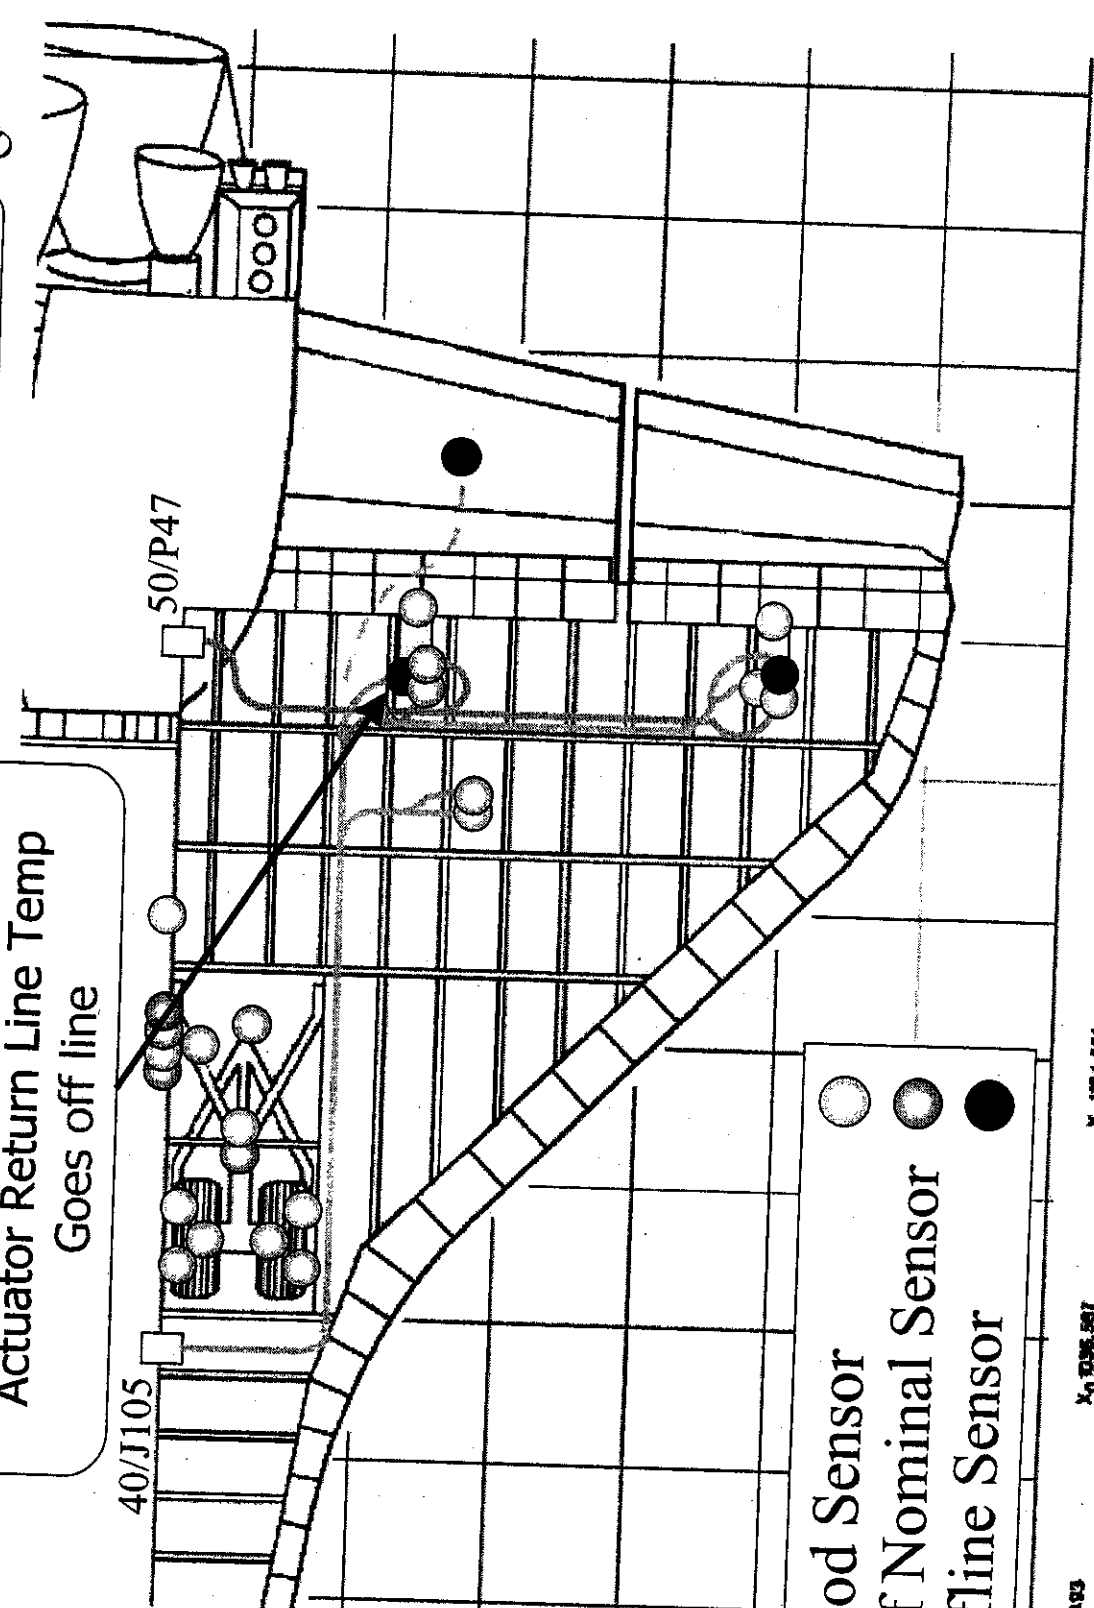
Hyd Sys 1 Left Inboard Elevon Actuator Return Line Temp Goes off line

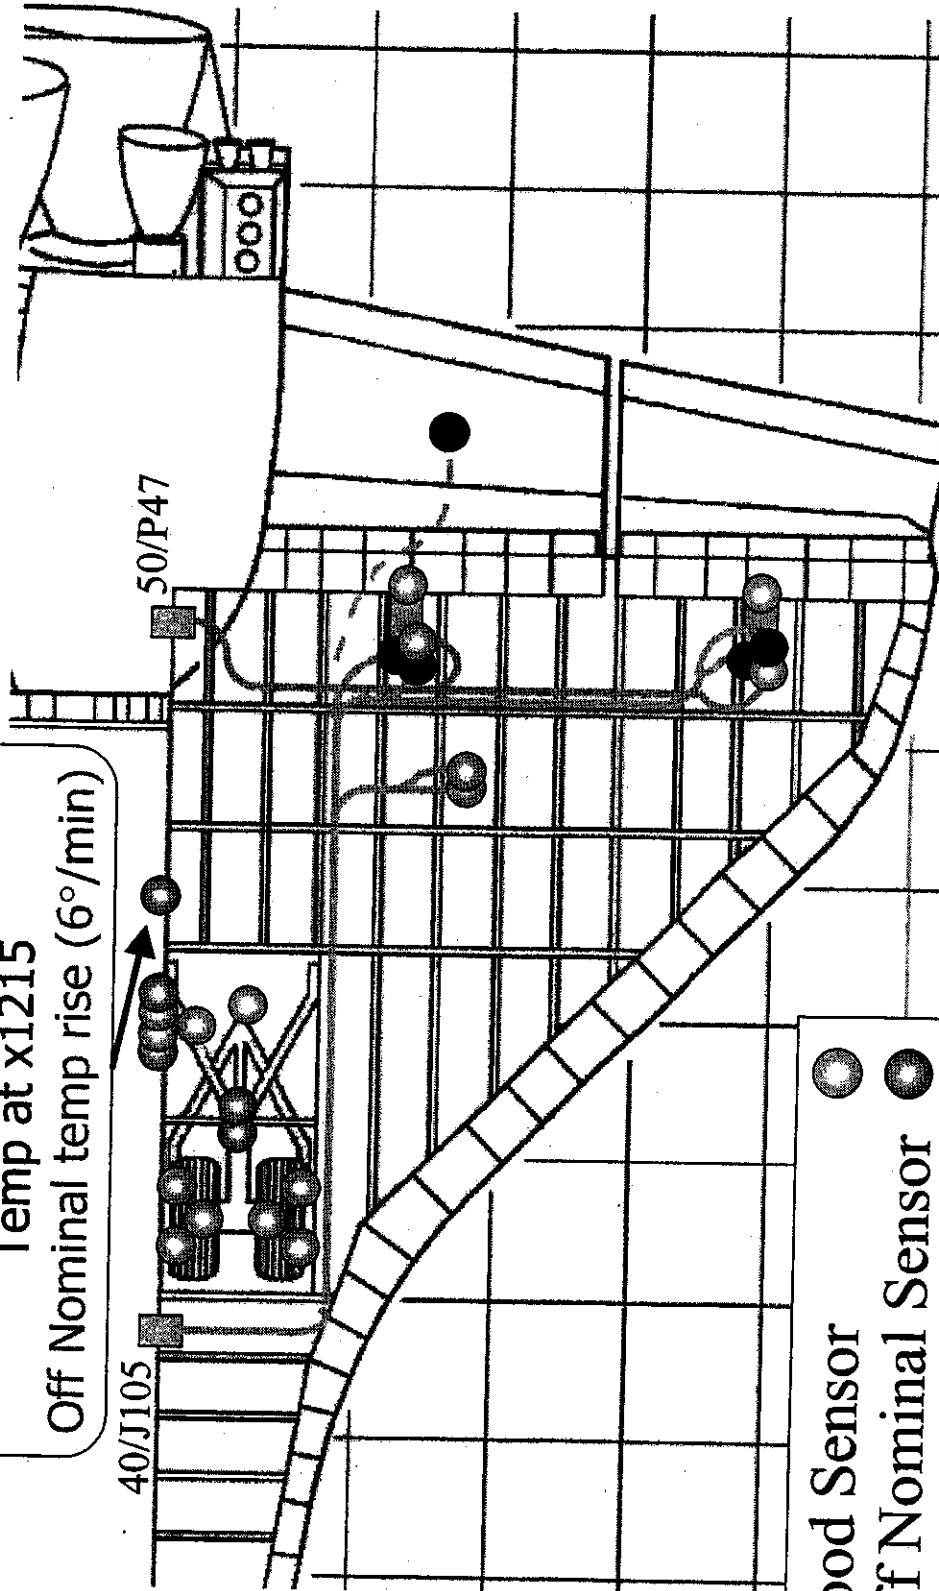
Temp at x1215  
Off Nominal temp rise (6°/min)

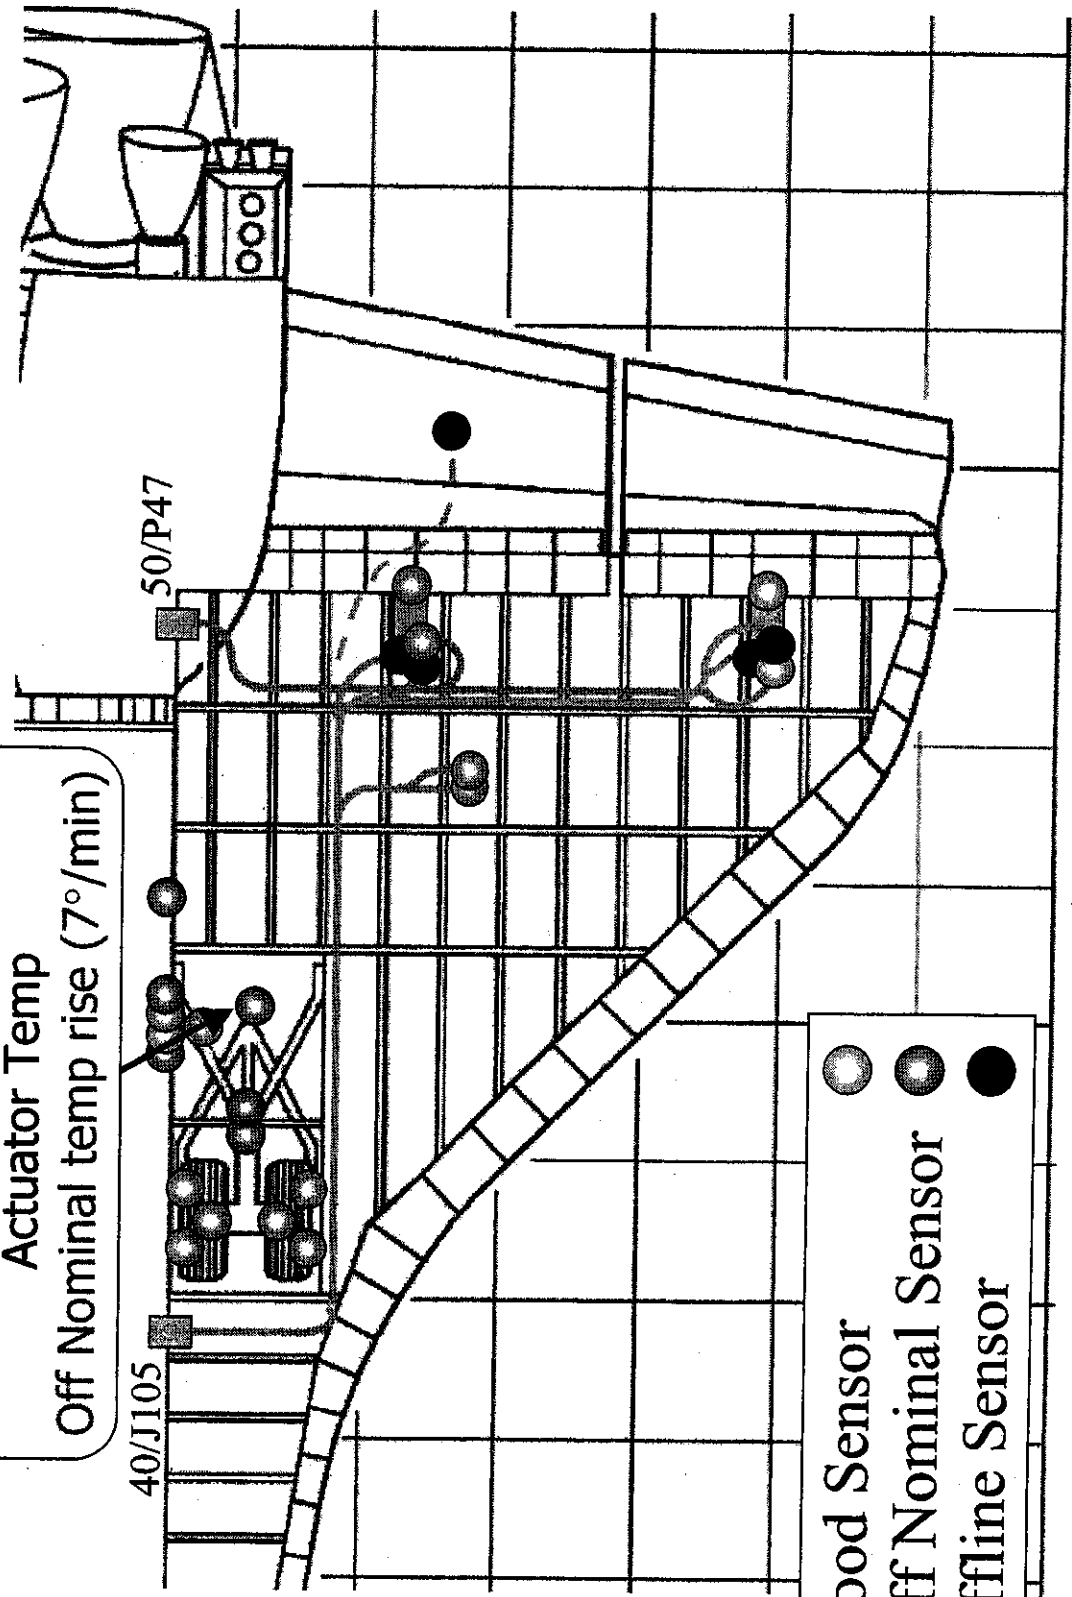
V58T0405  
Left Main Gear Strut  
Actuator Temp  
Off Nominal temp rise (7°/min)

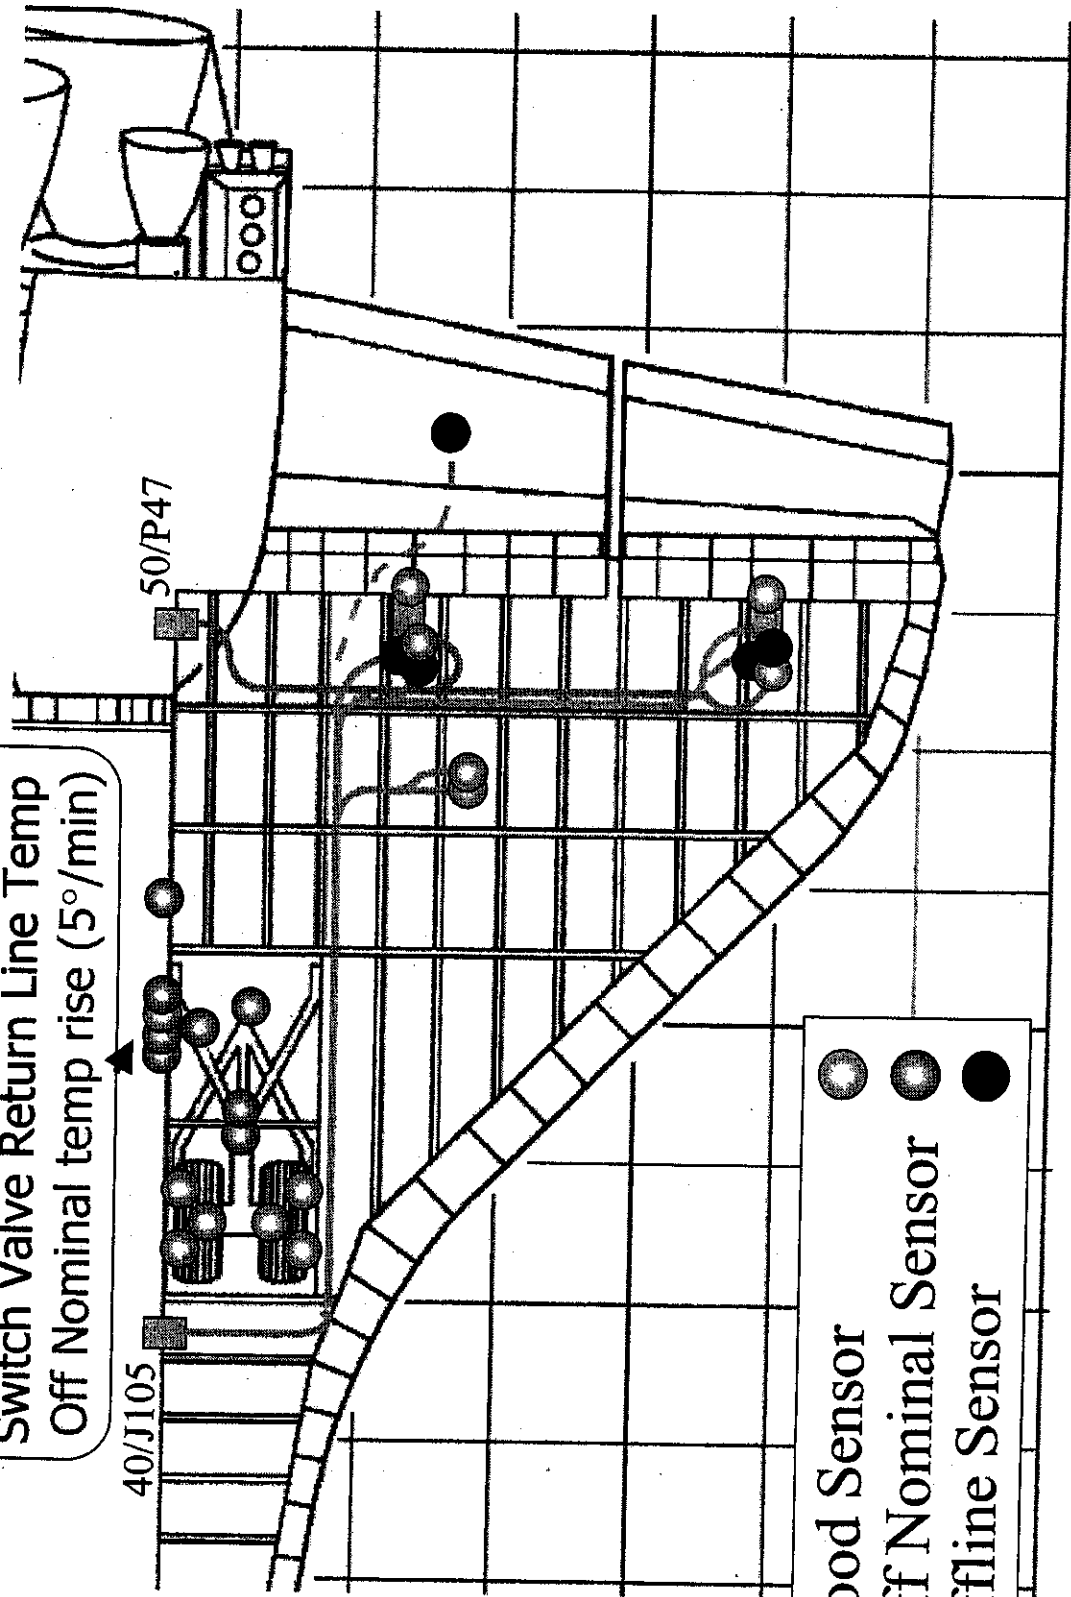
System 3 LH Forward Brake  
Switch Valve Return Line Temp  
Off Nominal temp rise (5°/min)

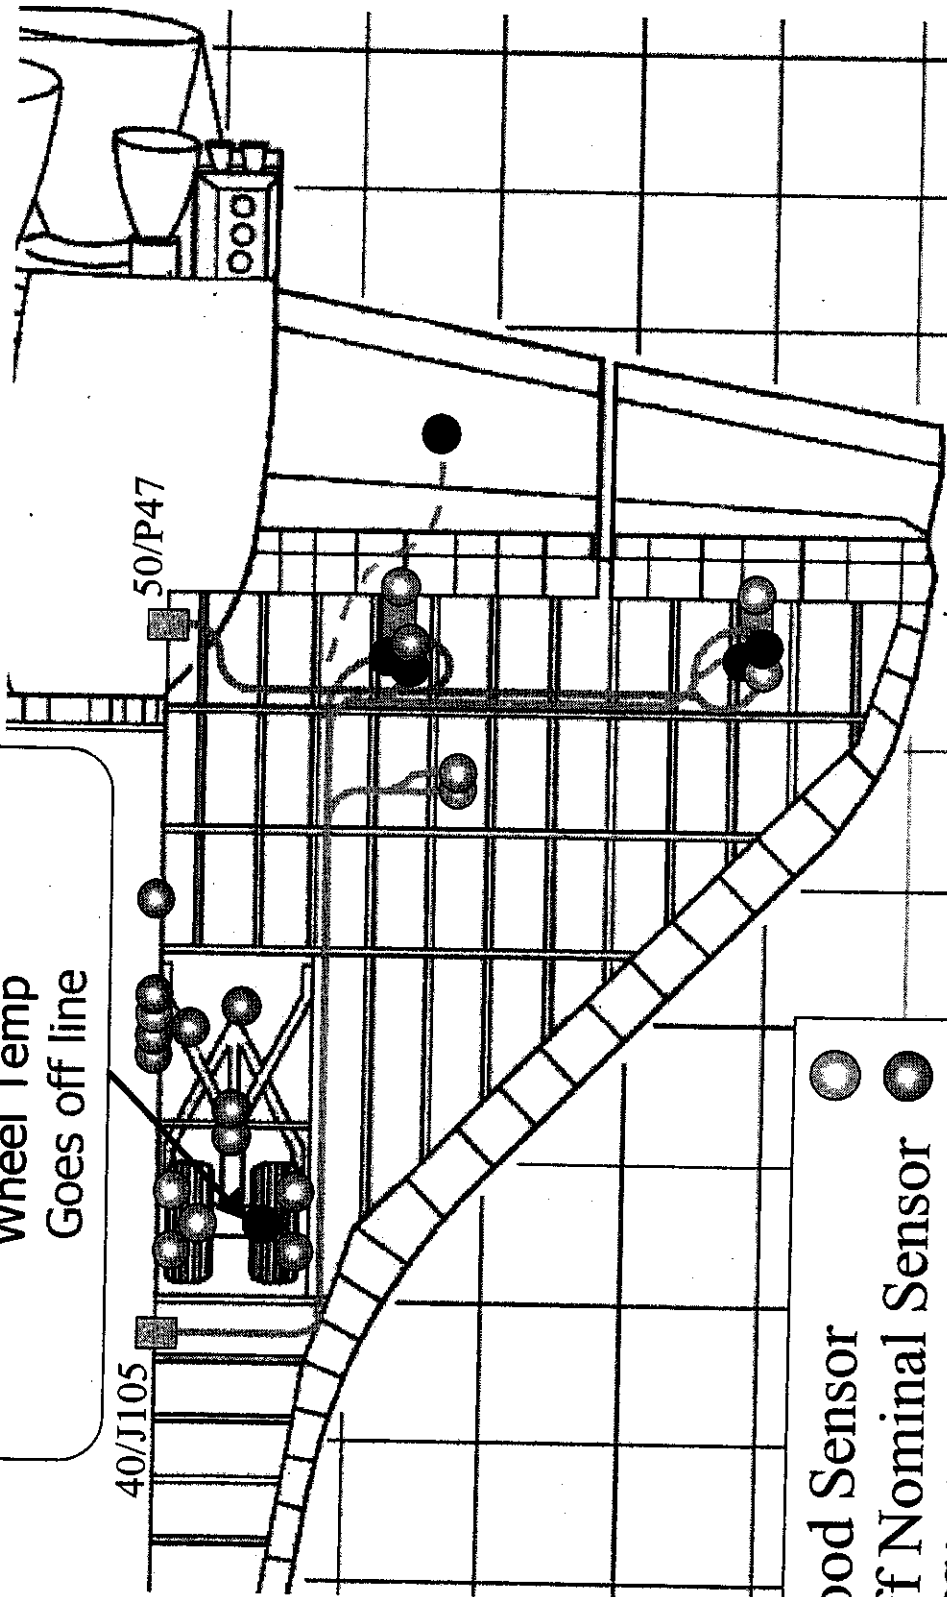
MLG Left Outboard  
Wheel Temp  
Goes off line

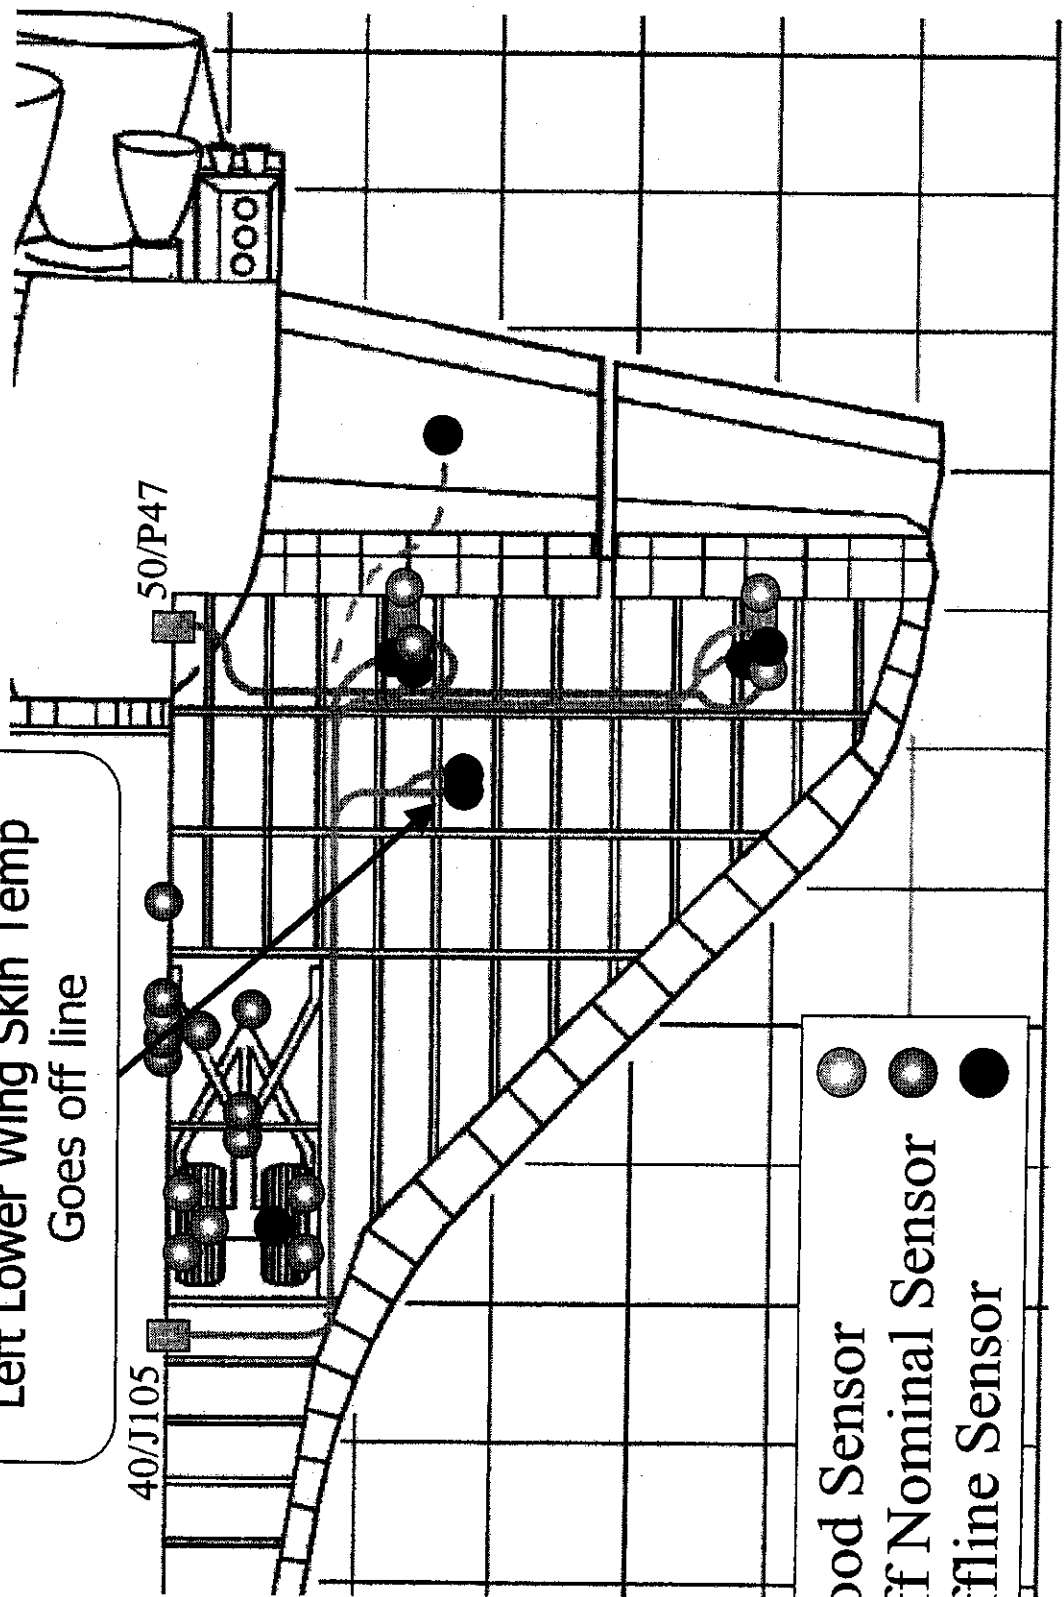
V09T1024 ; V09T1002  
Left Upper Wing Skin Temp  
Left Lower Wing Skin Temp  
Goes off line
