NASA TN D-6722

APOLLO EXPERIENCE REPORT -  
LUNAR MODULE DISPLAY AND  
CONTROL SUBSYSTEM

*by Andrew J. Farkas*

*Manned Spacecraft Center*

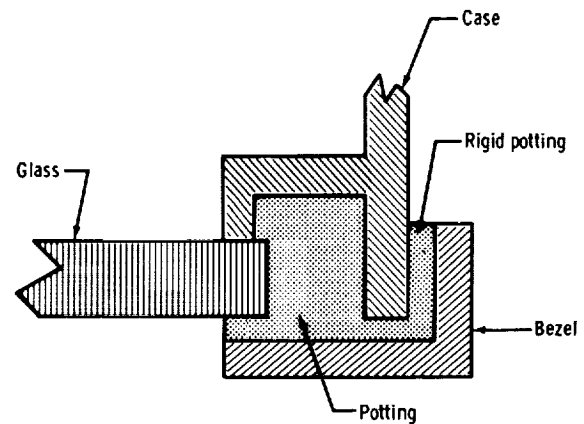
Figure 4. - Meter case seal.

4. Sealing cases — The most significant problem during early testing of meters was in sealing the front glass within the case. Failures occurred during thermal vacuum testing. Specifically, breaks occurred in the bond between the glass and the case. During the thermal vacuum test, stresses developed which pulled the bond apart. Changing the potting to a stronger, more rigid material improved the bond, but caused the glass to crack. In analyzing the problem (fig. 4), the determination was made that a material had to be selected that had the proper shear strength, yet was flexible. The potting material between the meter case seal, the glass, and the case was changed to a flexible polyurethane, and the glass was made smaller to allow more potting. This change reduced the stress at the bond line so that seal breaking was prevented and the bond was flexible enough at a low temperature to prevent the glass from breaking.

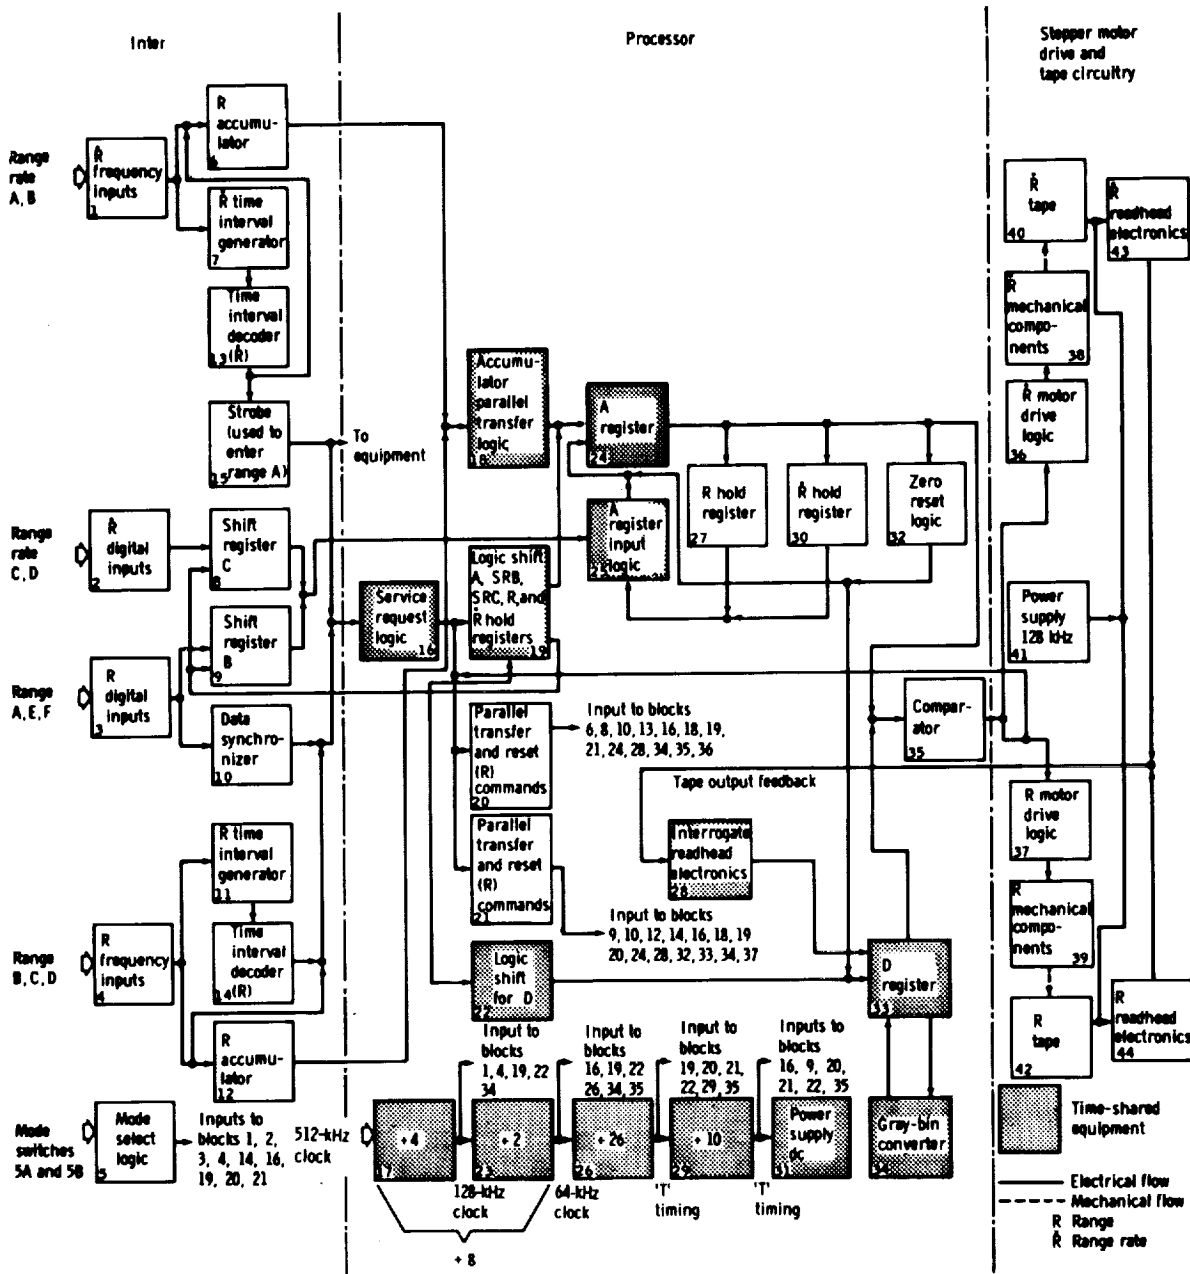
Figure 5. - Simplified signal flow diagram, lunar module range/range-rate indicator.

The high-reliability indicator has been the source of many problems throughout the program. The most significant problem occurred on the Apollo 9 mission (LM-3) just before launch. Test personnel observed erratic range tape operation while conducting various tests. The tape dropped below zero off-scale, oscillated below zero, or moved slightly below zero and then continued normal operation. Extensive testing on the vehicle could not duplicate the failure. A decision was made to replace the indicator and return the malfunctioning equipment to the manufacturer for failure analysis. Extensive testing by the manufacturer, including vibration and thermal environment, reproduced the failure; however, failure occurrence was random. Analysis finally identified two causes for the problems:

1. Oscillation below zero was caused by the serial number on the tape. This failure occurred only if the tape went below zero, not a normal condition.

2. A dual inverter gate micrologic circuit was found to have a poor weld on the common emitter connection. Visual inspection showed the lead surface to be mottled. This failure caused incorrect information to be shifted into the comparator, and this shift resulted in the tape slewing below zero.

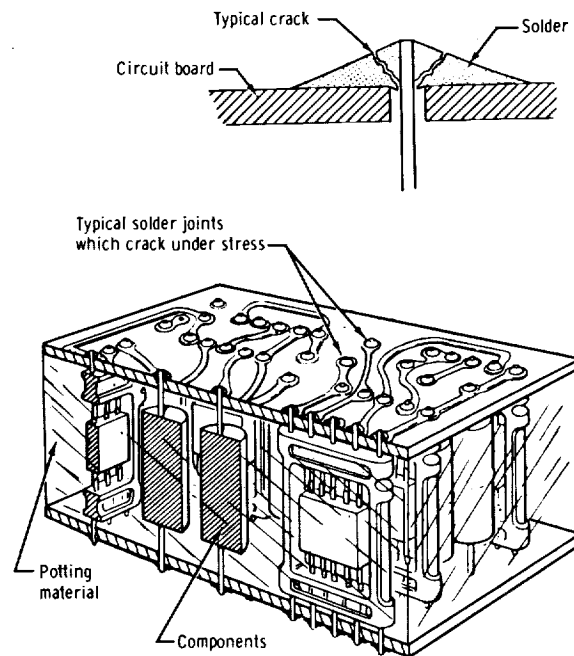
Figure 6. - Typical modular construction.

The mission timer program is notable for numerous problems that eventually required complete redesign and repackaging by a different manufacturer. The basic design of the original mission timer was of modular cordwood construction. This type of construction has electrical components (resistors, capacitors, diodes, etc.) soldered between two circuit boards. The void between the boards is filled with a potting compound (fig. 6). Differential expansion between the potting compound and the circuit boards caused the solder joints to crack, thus breaking electrical contact. Initiation of thermal acceptance testing accelerated the interaction, causing failures to occur. Corrective action, whereby the timers were disassembled and additional solder was added to the connections, was attempted. This work created many new problems and did not solve the original problem. After many additional ground failures and a flight failure during the Apollo 11 mission (LM-5), a decision was reached to procure newly manufactured timers. The new timers were mechanically and electrically interchangeable with the old timers. The new timers, in addition to correcting the solder problem, included design changes to correct other timer problems.

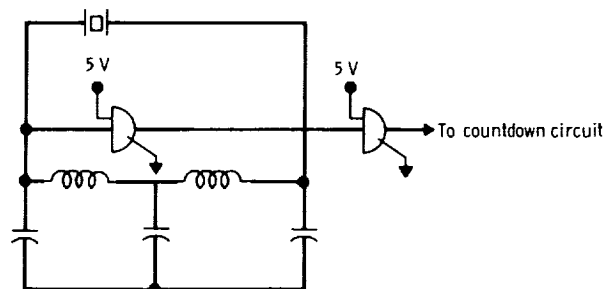
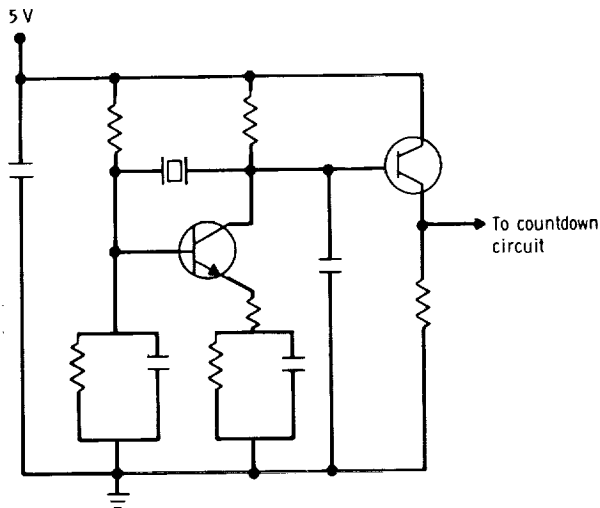
Figure 7. - Oscillator circuit.

The new internal oscillator circuit used, as did all other circuits, an integrated circuit. During panel testing, a discovery was made that at certain narrow temperature bands, the oscillator would not start once it had been stopped. During continuous operation over the required temperature range, no difficulties were encountered. After extensive analysis of the circuit (fig. 7(a)), a determination was made that some combination of resistance, inductance, capacitance, and temperature reduced the circuit gain. This reduction in gain would not allow the circuit to start reliably. The final solution of this problem was a design change using transistors (fig. 7(b)) instead of logic gates.

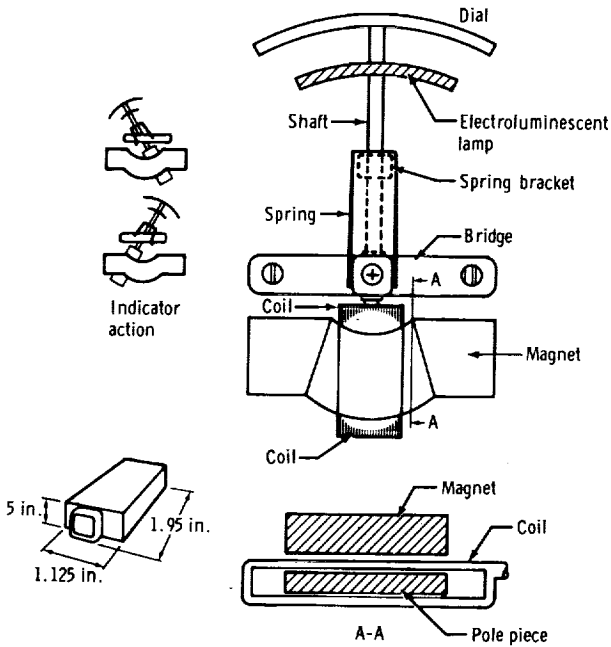
Figure 8. - Flag indicator.

The flag program, from initial development to present usage, has had many problems. The most annoying problem has been flag hangup, or hesitation. Although many corrective actions have been taken, this problem has never been solved. An analysis of acceptance and qualification failures identified the following failure modes.

1. Bearing bridge resonance — The bearing bridge resonated under random vibration, causing the flag to hang up. Design changes were made to the bridge to increase the resonant frequency above the critical level.
2. Coil clearance — The clearance between the coil and the pole piece or magnet (or both) was not sufficient; under random vibration, the coil would bind. Corrective action included increasing clearance and more accurate part alignment.
3. Spring system — Many flag hangups were caused by improperly formed springs. Procedures were implemented for proper spring formation and for spring tension measurement.

A review of these problems and earlier flag problems indicates that the best corrective action would be flag redesign. Redesign would provide enough dial restoring torque to overcome any slight increase in friction or sticking. Steps were taken to improve the yield without redesign. A quality control audit was conducted to eliminate contamination; acceptance thermal cycling was added; manufacturing procedures were refined; and additional screening was added to acceptance testing. These actions, while reducing the number of field failures, have not eliminated them. Field failures that do occur are not hard hangups. The flags recover after a few seconds or require tapping to cause transfer. Because of low mission criticality of the flags, this solution to the problem was considered acceptable. Failures of this type (hesitation) have occurred on almost every flight of the LM.

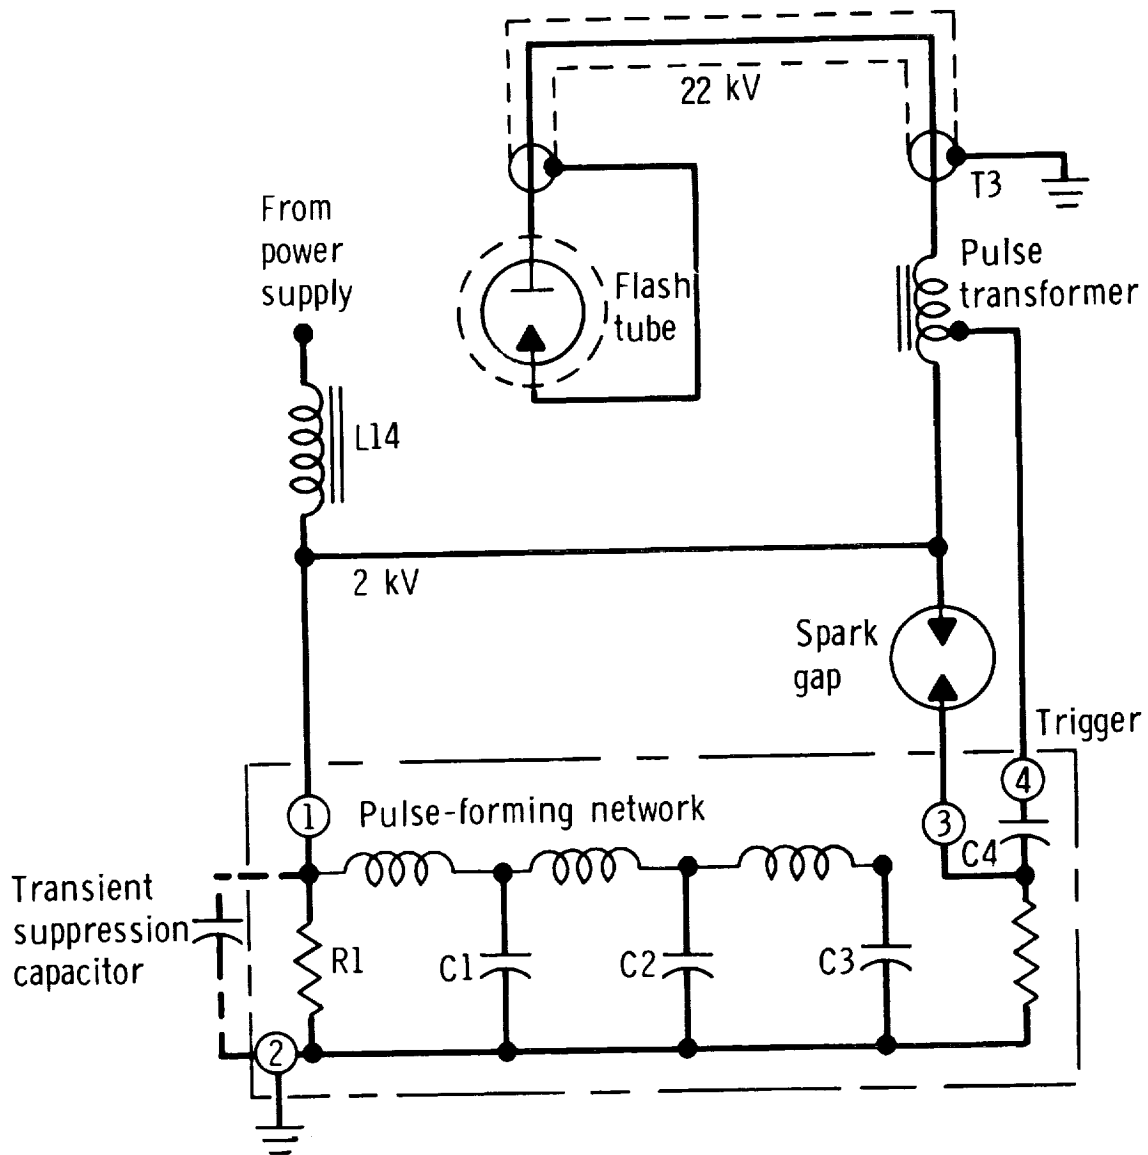
Figure 12. - Pulse-forming network, trigger, and lamp circuits.

Tracking light history has been marked by numerous failures that have occurred in testing, acceptance and qualification, and flight during the Apollo 9 and 12 missions. As a result of design problems, the contract with the original light manufacturer was terminated before any manned Apollo missions were flown, and a new manufacturer was obtained. The new manufacturer, along with the prime LM contractor, was responsible for design and fabrication of the light used during all LM flights. Failures

that occurred were attributed to high-voltage section problems. These failures, and the corrective action listed as follows were encountered after the Apollo 9 failure.
