**HEALY CLEAN COAL PROJECT**

**QUARTERLY TECHNICAL PROGRESS REPORT No. 33-36**

**JANUARY 1 TO DECEMBER 31, 1999**

**ALASKA INDUSTRIAL DEVELOPMENT AND EXPORT AUTHORITY**

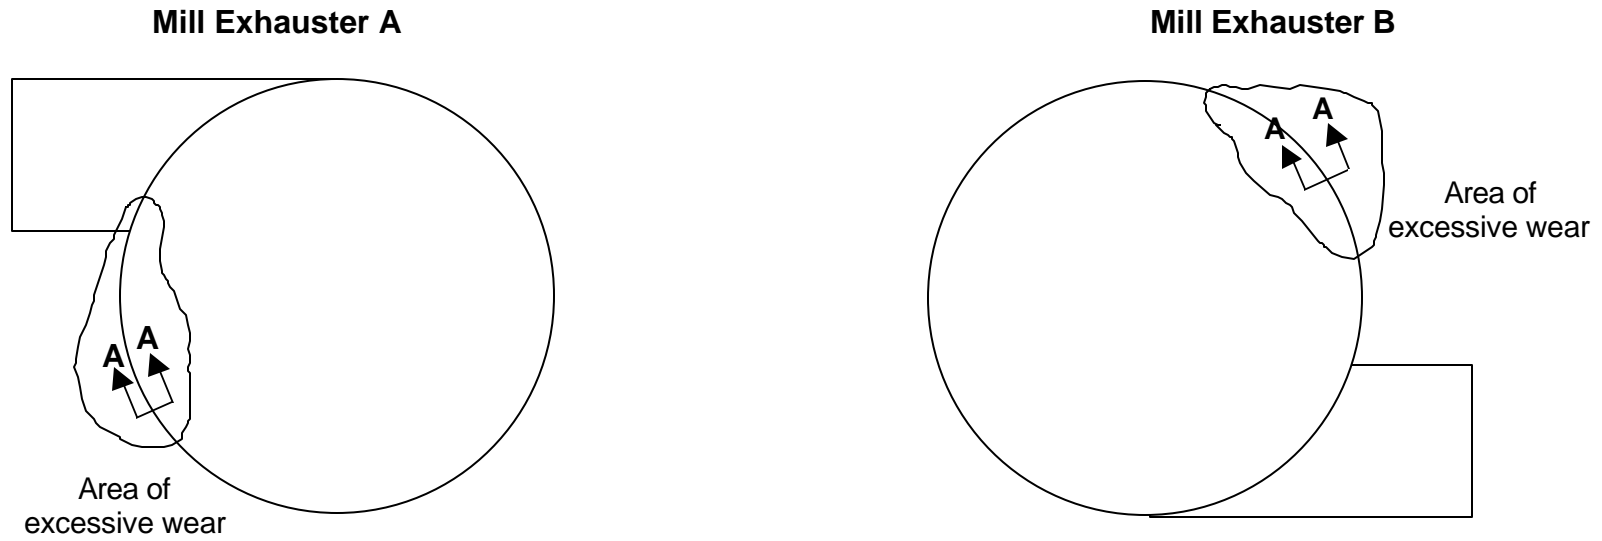
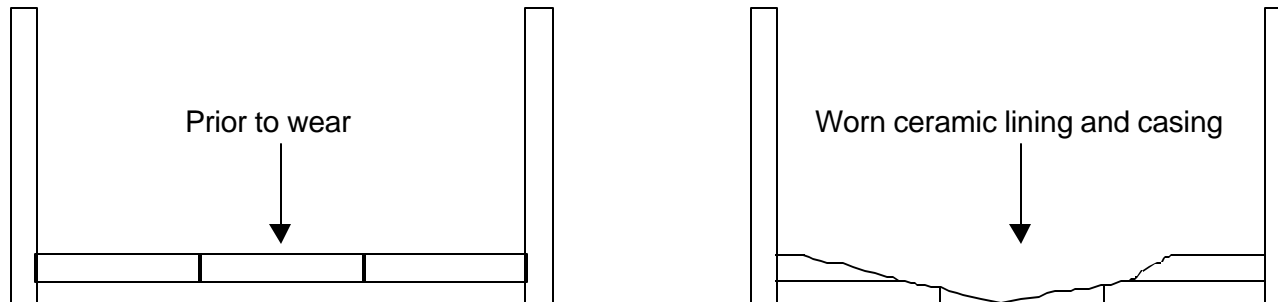
# Figure 5.0.2 – Mill Exhauster Casing Wear Pattern

HCCP mill exhauster wear rate exceeds normal levels for two primary reasons:

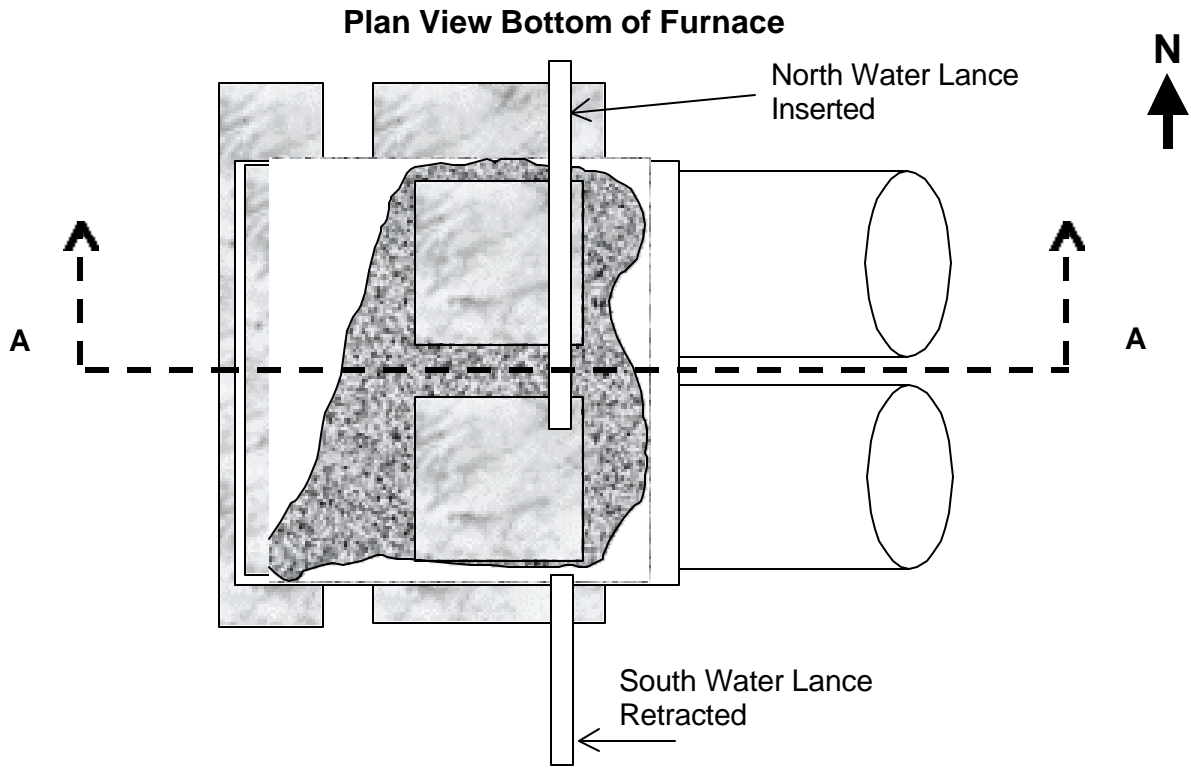
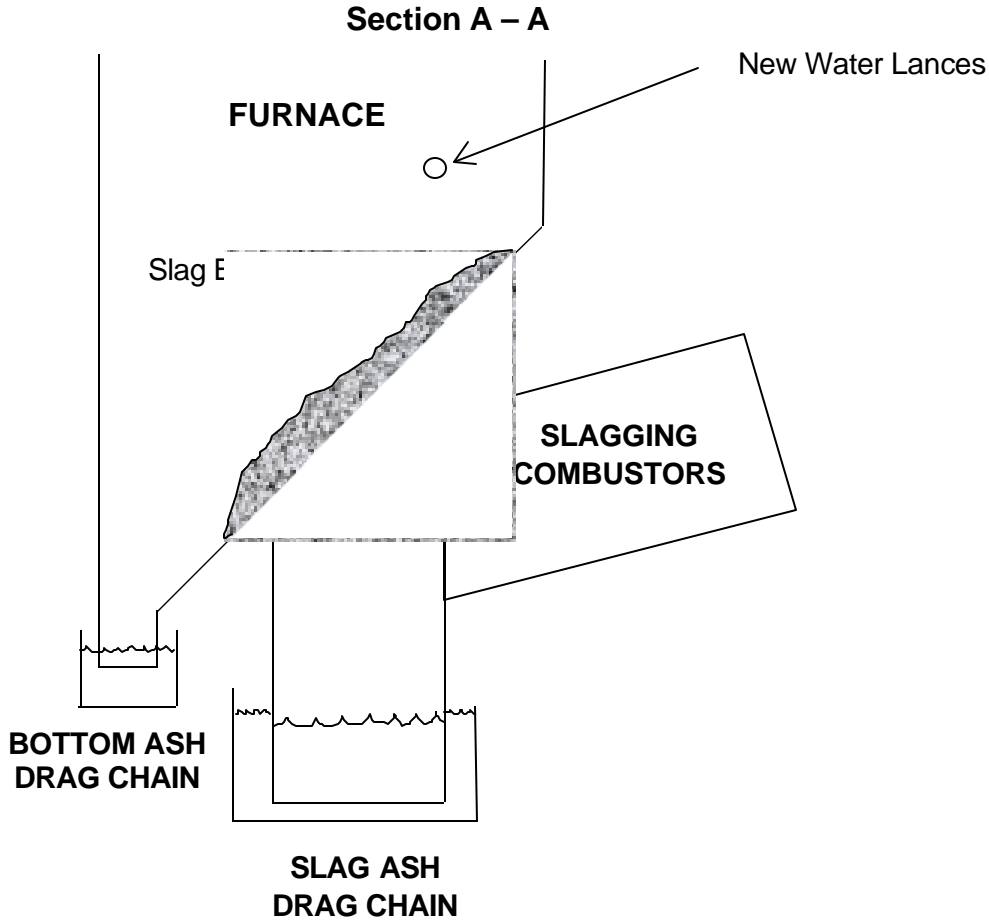
**FIGURE 5.0.4 - SLAG ACCUMULATION ON SLOPED FURNACE HOPPER**

The buildup accumulated until it fell back down through the two rectangular slagging combustor discharge openings into the sloped furnace hopper. This slag ash fell into the slag ash drag chain reservoir and is believed to have caused the rapid vaporization of sufficient water to upset the furnace pressure beyond the ability of the induced draft fan inlet dampers to react and control it, resulting in a main fuel trip (MFT). Since the potential problem of buildup on the sloped hopper

During March, a correlation was noticed between the unit tripping as a result of furnace pressure excursions and a severe impulse (as in a water hammer) in the slag drag chain reservoir. The cause of these events was attributed to large masses of slag disengaging and falling from the sloped hopper down into the slag drag chain reservoir. It is postulated that such an impulsive force is caused by a very rapid vaporization (as in an explosion) of slag reservoir water when the slag falls into it and/or the sudden collapse (or implosion) of a large steam void (or bubble) because of its submersion in subcooled reservoir water. This was also confirmed to some extent when hot slag fell into the slag drag chain reservoir after the unit was off between March 15 and March 18 and the impulsive water hammer phenomenon was noted. Engineering and design efforts to eliminate this problem began in March.

The unit was online for most of April 18 through April 24, except for three trips, two of which were caused by slag falling from the furnace hopper. Total downtime was sixteen hours for this six-day period. The slag falls caused the slag drag chain reservoir to bow outward slightly and column grout was sprawled out where the support columns were anchored to the ground floor.

The grout was repaired and the slag ash drag chain reservoir support columns were reinforced with triangular bracing to a parallel line of support columns. The manufacturer's engineers were

involved in the evaluation of the hopper damage and the resulting remedial work. Design of the water lances was completed and the lances were ordered to resolve the falling slag problem.

The furnace pressure excursion problem, caused by large slag falls, occurred on May 20 and again on May 29. Water lances had been ordered in April to resolve this problem and the engineering and design changes to provide and install the water lances were in progress.
