# **Heat Pipe Corrosion Test Report EPRI/NYSEG HSTC Unit**

Report prepared by ABB API for NYSEG, EPRI, and Radian Corporation.

# Heat Pipe Corrosion Test

## EPRI/NYSEG HSTC Unit

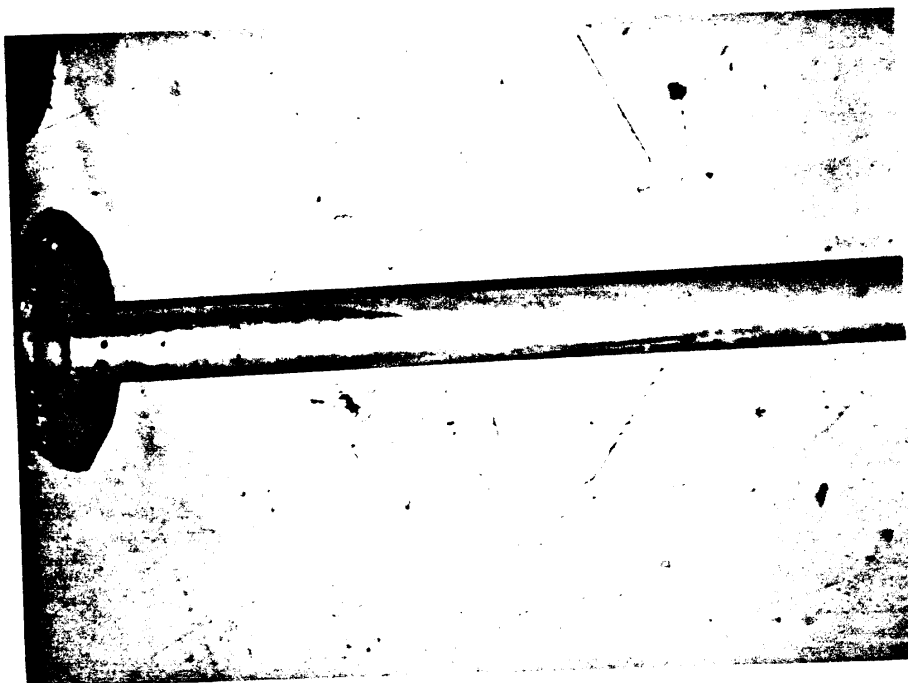
**Figure 8**

Showing the corrosion  
patterns on the AL-6XN<sup>®</sup>,  
Location A, return side.

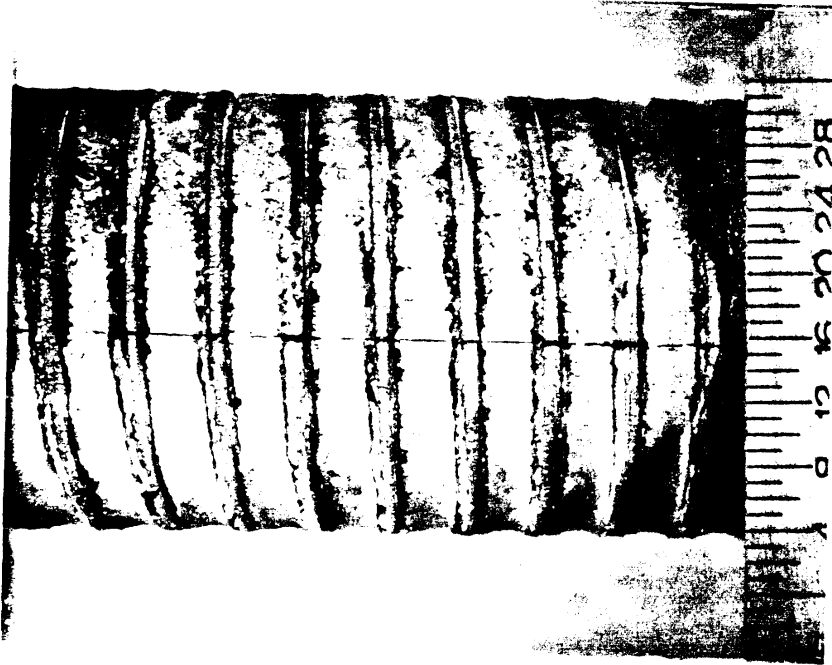
**Figure 19**

This heat pipe had severely corroded fins; however, the tube material appeared to have suffered little corrosion. The fins on this heat pipe were AISI 409 stainless steel. When the fins were removed from a section of return side tubing, the tube exhibited varying degrees of corrosive material removal between the fins. Figures 19, 20, 21, and 22 show this attack about the diameter of the tube.

Showing the corrosion attack on the bottom of the alloy 2205 tube. Return side.

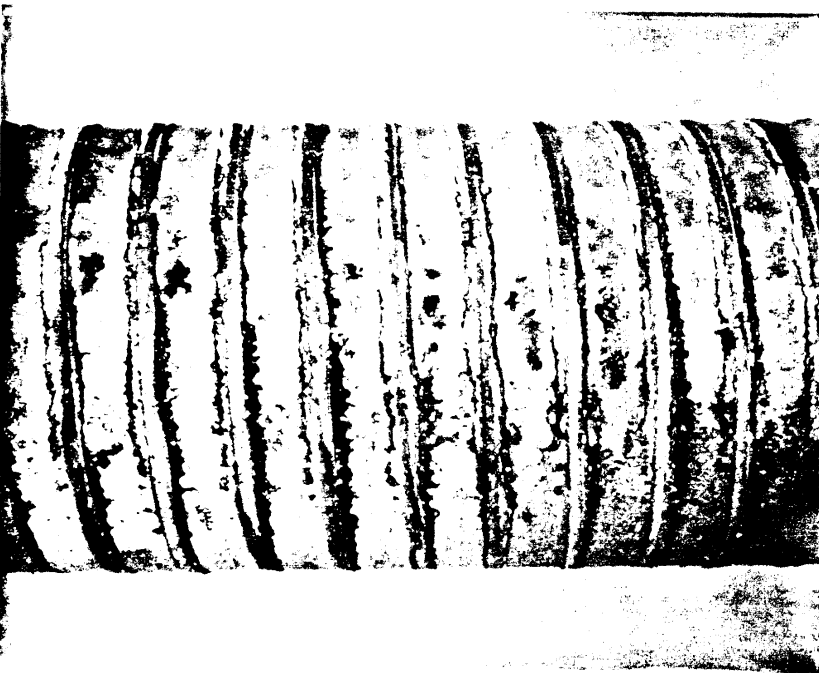
**Figure 20**

Showing the corrosion attack on the leading edge of alloy 2205 tube. Return side.

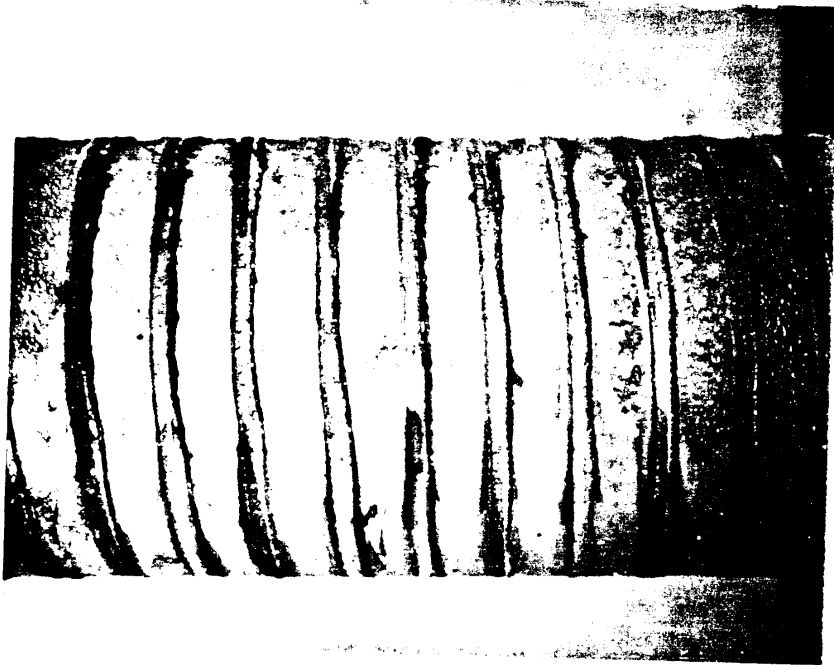
**Figure 21**

Showing the corrosion attack  
on the bottom of the alloy  
2205 tube. Return side.

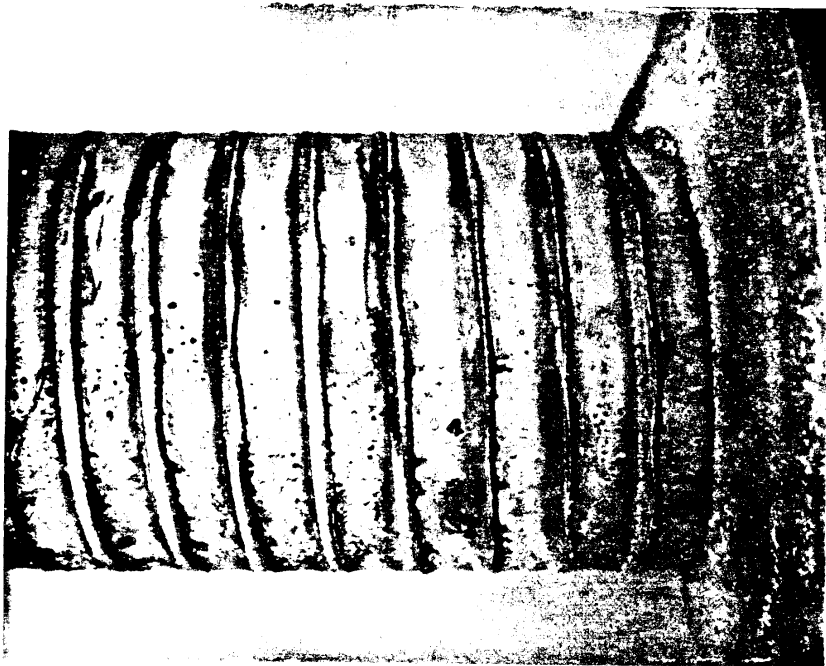
**Figure 22**

Showing the corrosion attack  
on the trailing edge of the alloy  
2205 tube. Return side.

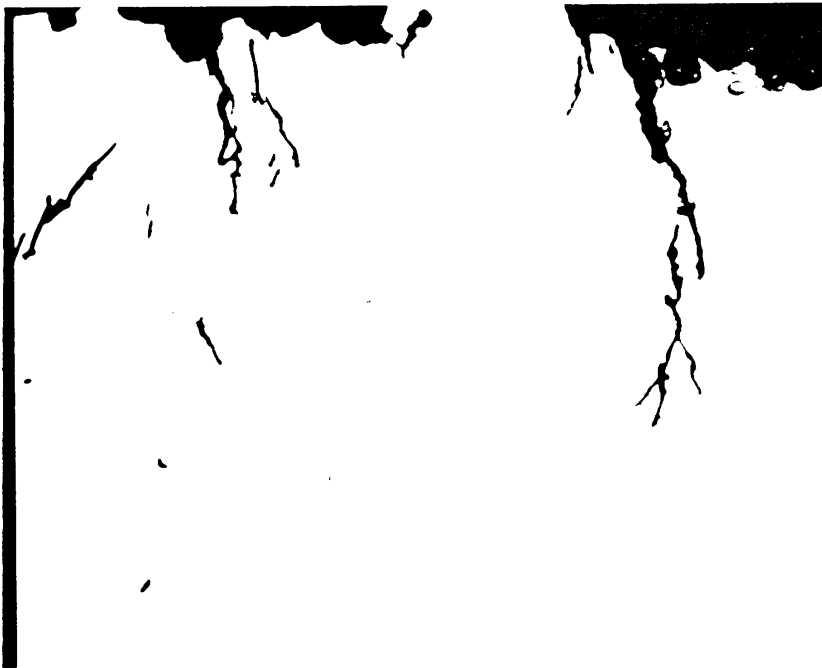
**Figure 28**

Showing the details of the AL-6XN<sup>®</sup> cracking.

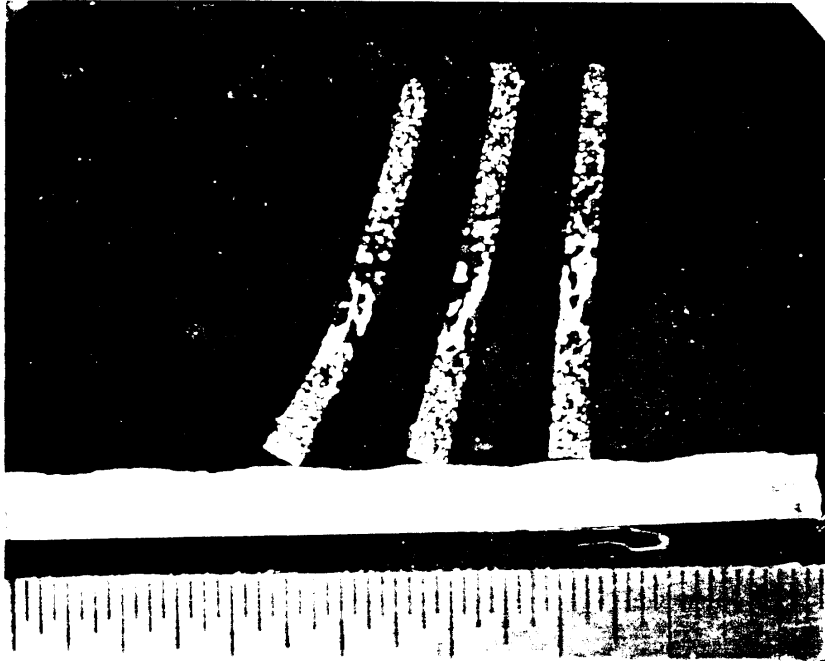
**Figure 29**

The return side of the alloy 2205 heat pipe showed a preferential corrosive attack between the fins (see Figure 29). The fin-to-tube braze joints were not complete and exhibited cracks (see Figure 30).

Showing the preferential corrosion attack of the leading edge of the alloy 2205 tube.

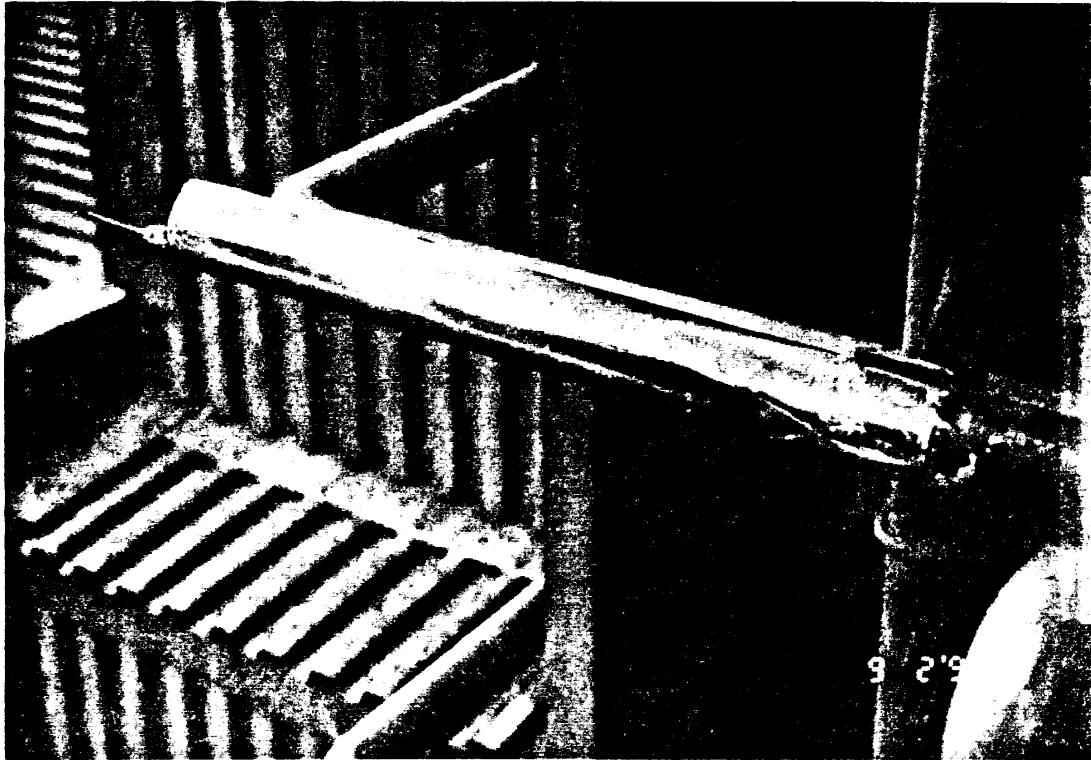
Figure 30. Condition of No. 1 air-cooled, Cor-Ten A corrosion probe after 1168 hours in operation. Surface deposits were bone dry when probe was removed from system.

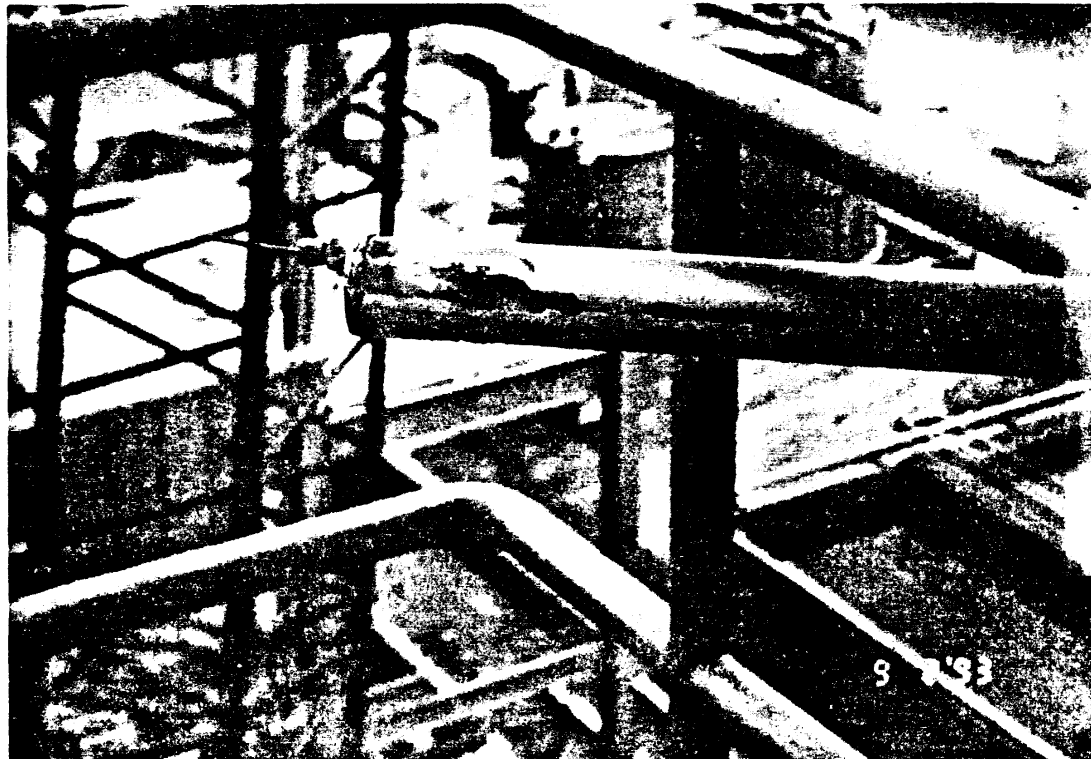
Figure 31. Condition of No. 2 air-cooled, Cor-Ten A corrosion probe after 832 hours in operation. Surface deposits were bone dry when probe was removed from system.

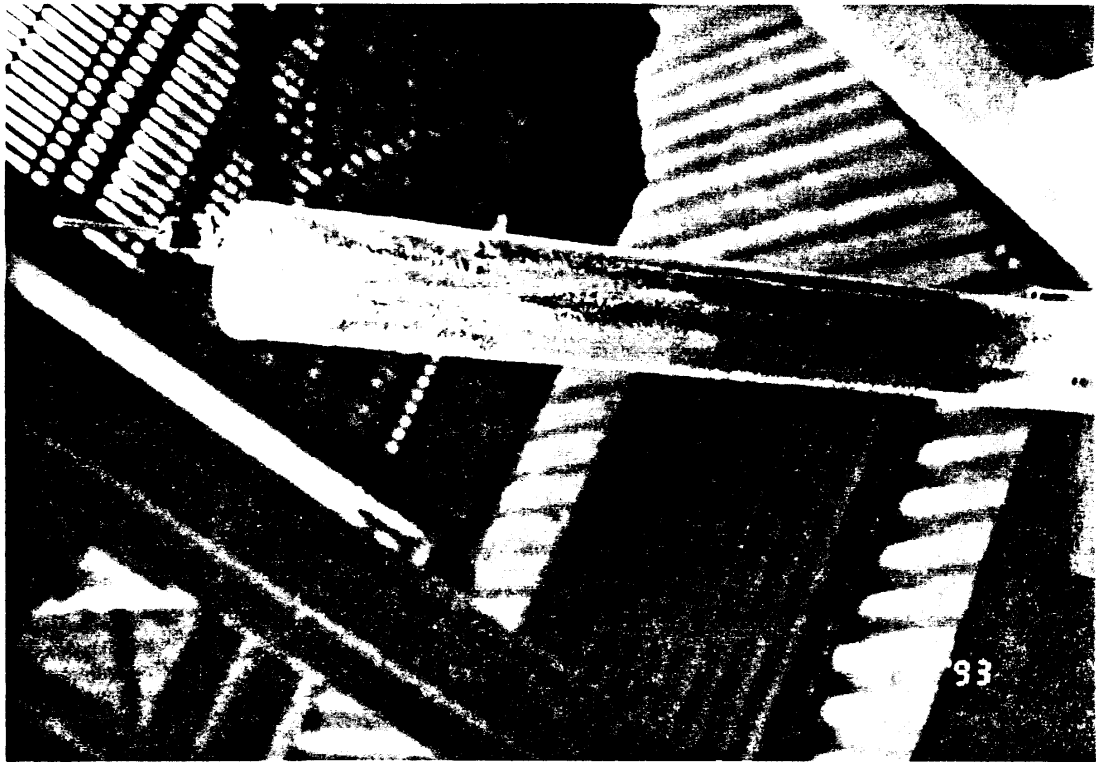
Figure 32. Condition of No. 3 air-cooled, 2205 SS corrosion probe after 832 hours in operation. Like for the Nos. 1 and 2 air-cooled probes, the surface deposits were bone dry when probe was removed from system.

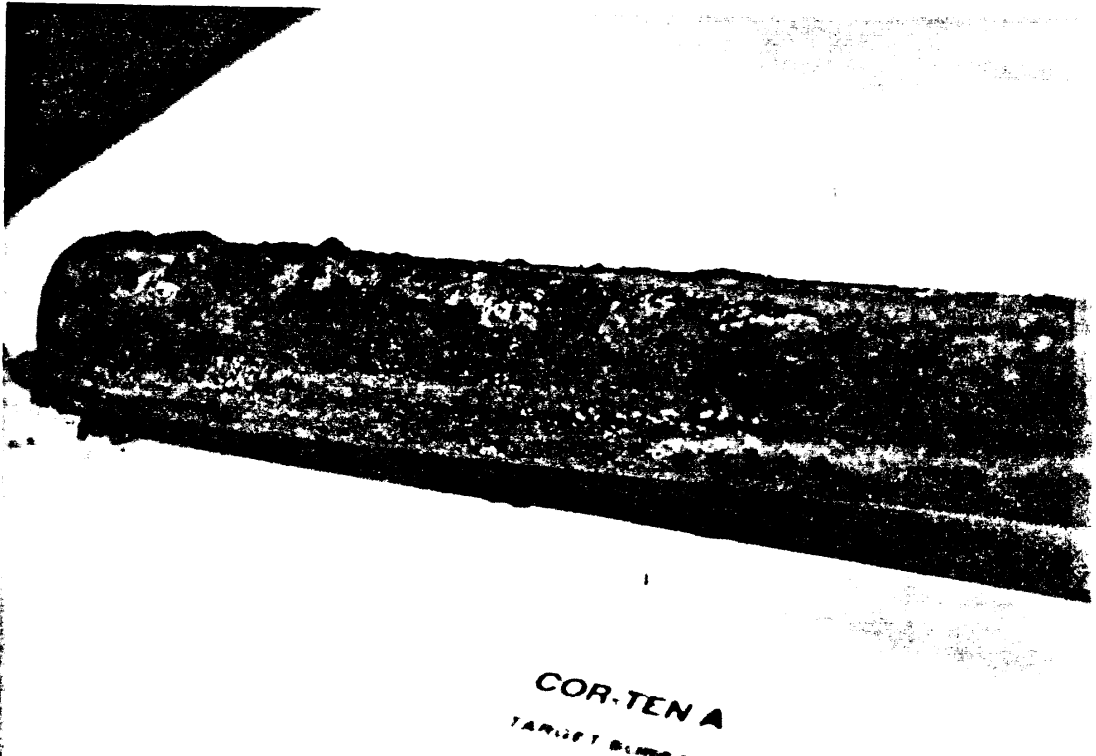
Figure 33. View of cold-end tip of No. 1 air-cooled, Cor-Ten A corrosion probe (1168 hours in operation) after removal from system and one day exposure to humid air. Note spalling damp deposits.

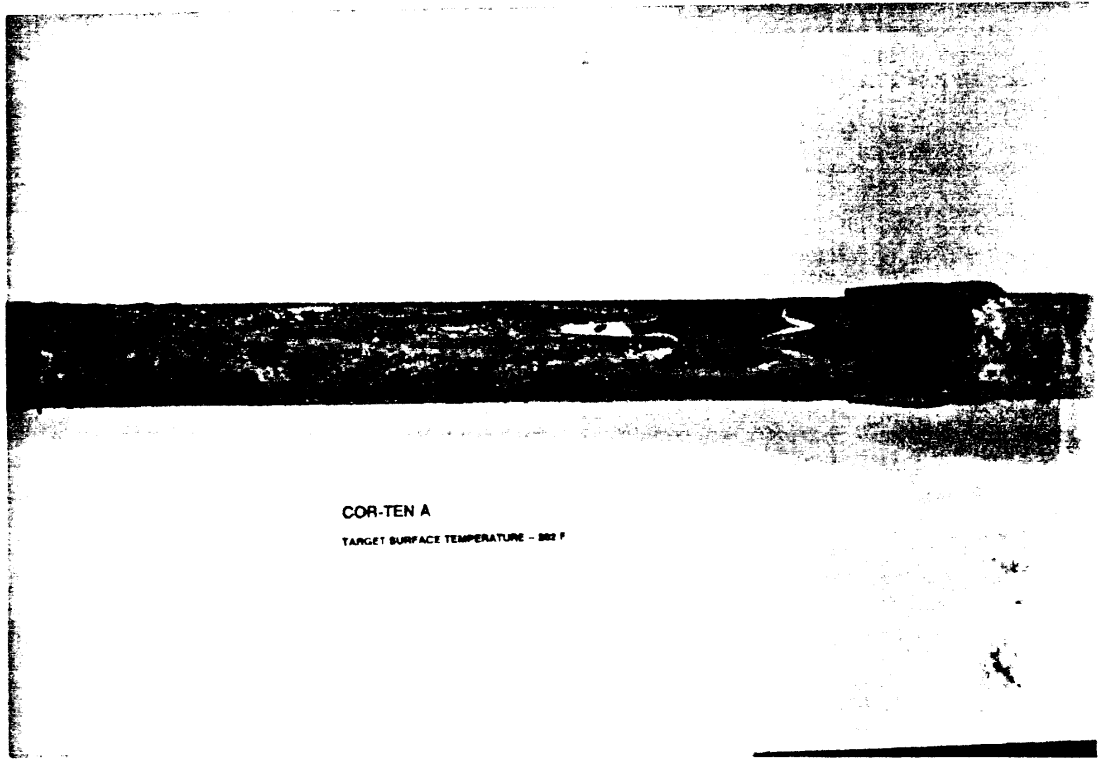
Figure 34. Overall, windward side view of No. 2 air-cooled, Cor-Ten A corrosion probe (832 hours in operation) after removal from system and one day exposure to humid air. Solids are damp.

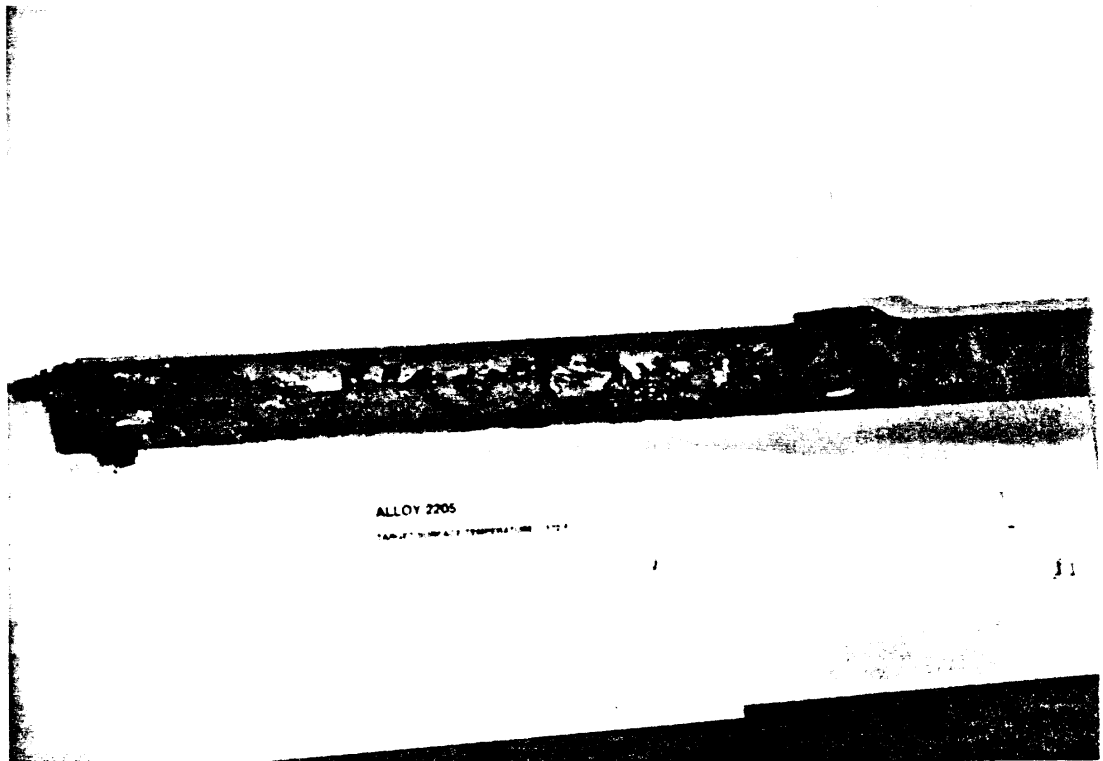
Figure 35. Overall view of No.3 air-cooled, 2205 SS corrosion probe (832 hours in operation) after removal from system and one day exposure to humid air. Solids were damp to wet and surface was partially coated with an oily liquid.

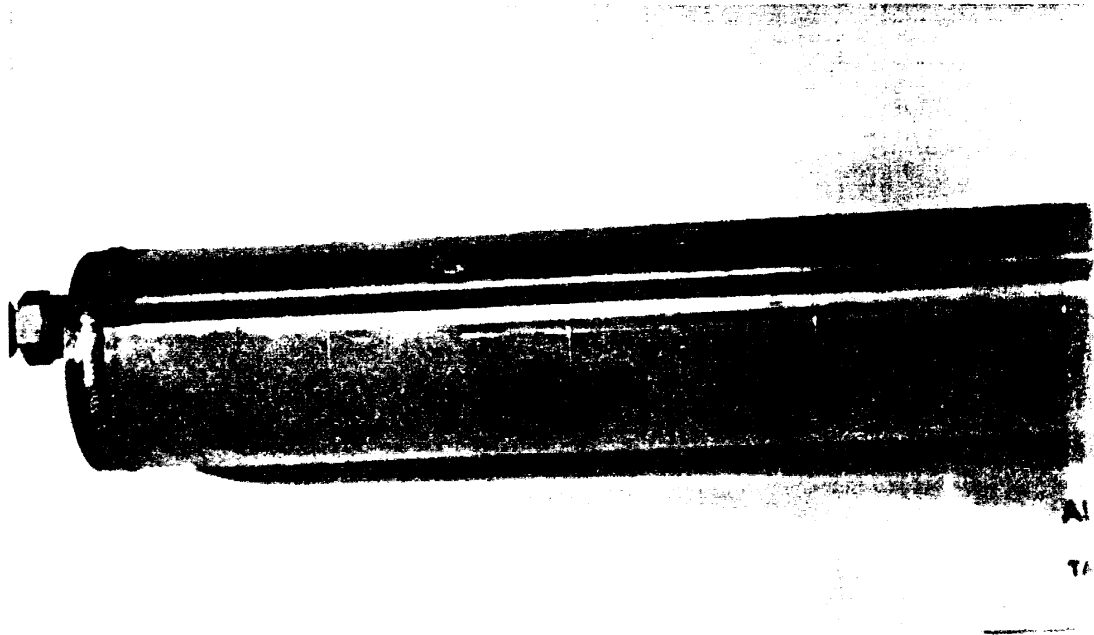
Figure 42. Close-up of cold-end tip of cleaned No. 3 air-cooled, 2205 SS corrosion probe (832 hours in service). Areas which were covered by deposits are dull and pitted.

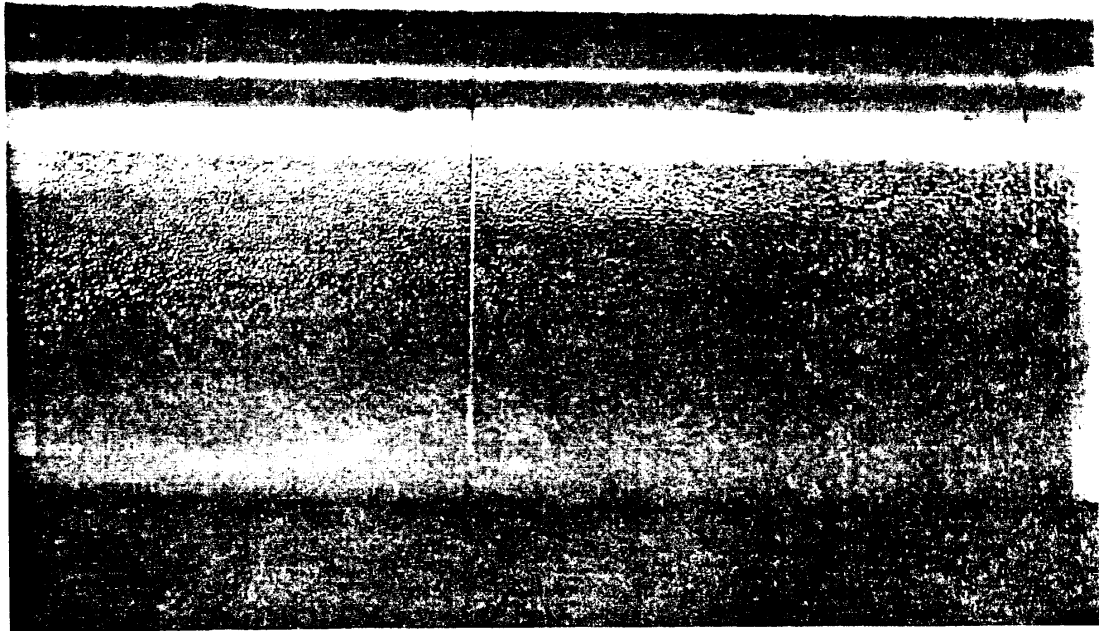
Figure 43. Close-up view of probe shown in Figure 42 between 2" division scribe lines which bracket the middle and top skin thermocouples. Note heavy pitting of surfaces which were covered by deposits.

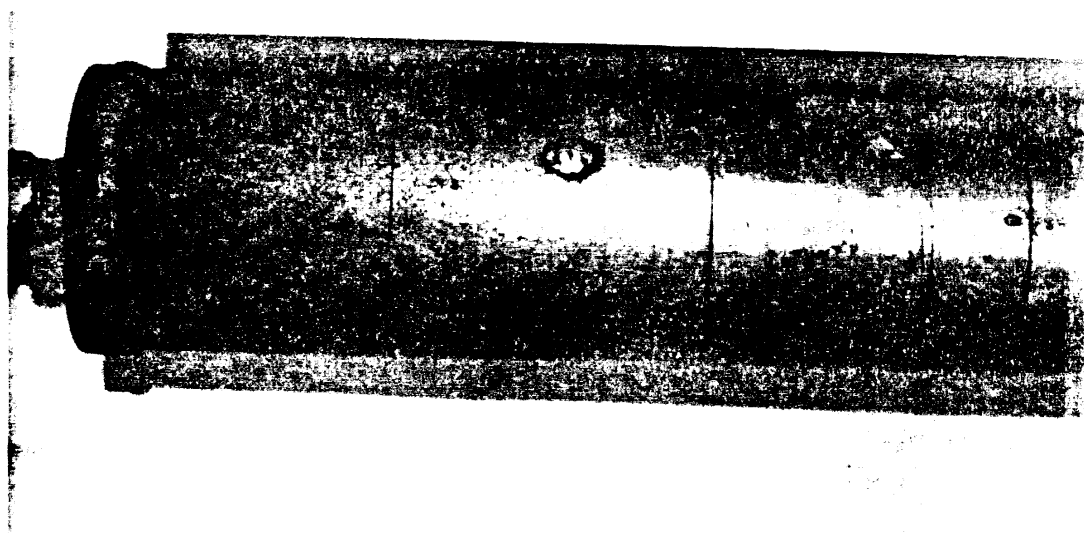
Figure 47. Close-up of cold-end of probe shown in Figure 46. Note surface roughness at cold-end tip (compare with Figure 45).
