INSPECTION AND DEMOLITION OF
STEBBINS TILE TEST MODULE

CONSOL Inc.
Research and Development
4000 Brownsville Road
Library, Pennsylvania 15129-9566

New York State Electric & Gas Corporation
Corporate Drive
Kirkwood Industrial Park
P.O. Box 5224
Binghamton, New York 13902-5224

February 1998

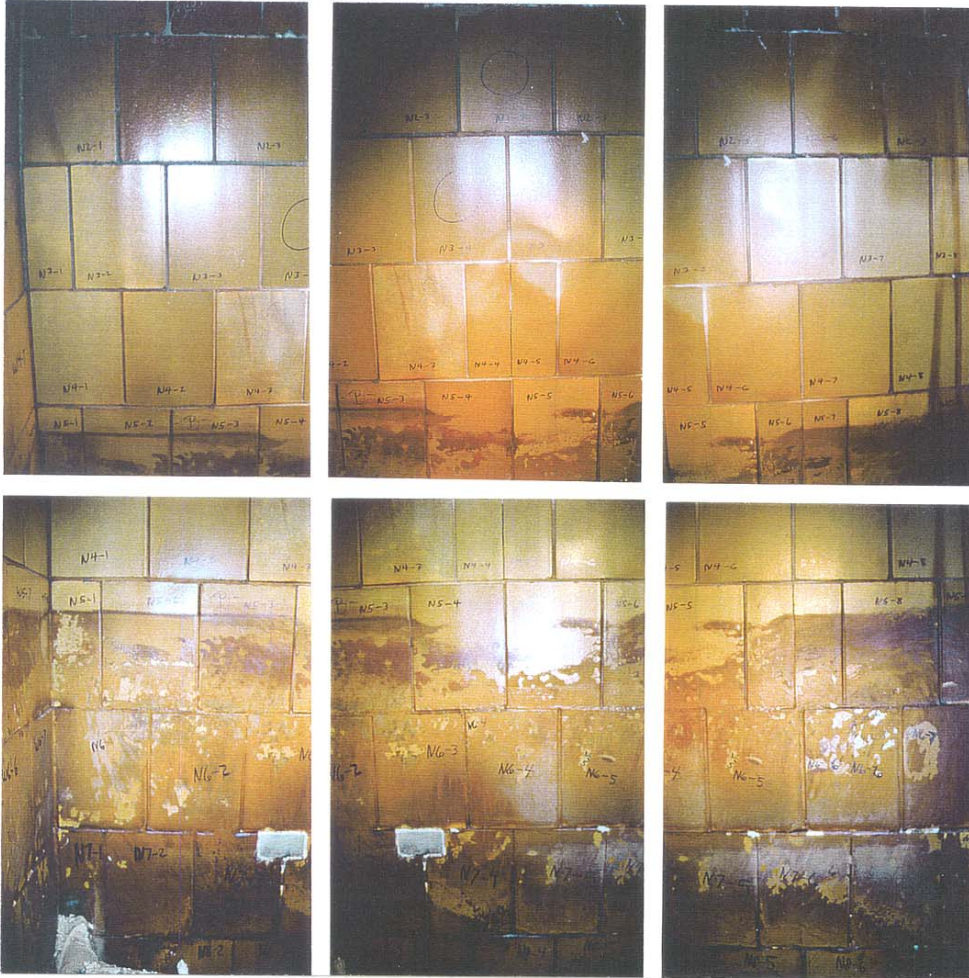
Photo 1.1 North wall, areas circled indicate where 4" diameter cores were removed.
(see appendix 2.0 for tile identification).

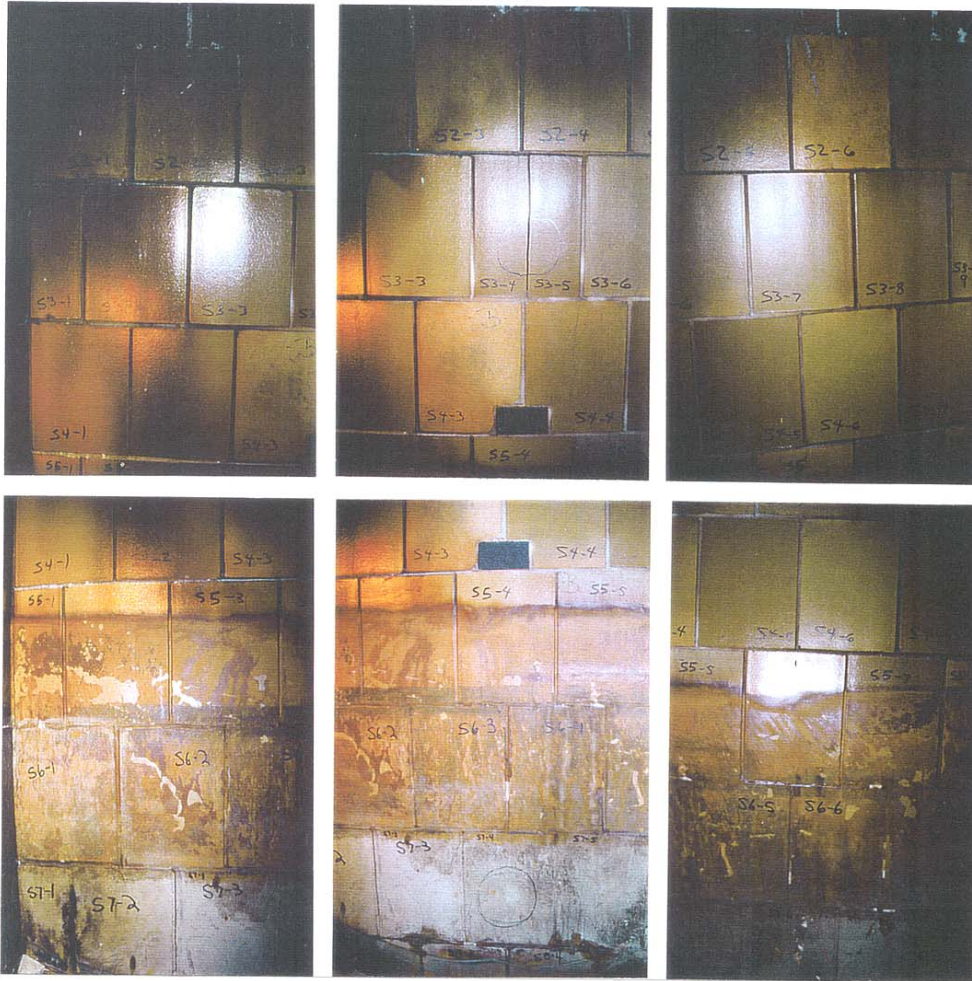
Photo 1.2 South wall, areas circled indicate where 4" diameter cores were removed.
(see appendix 2.0 for tile identification).

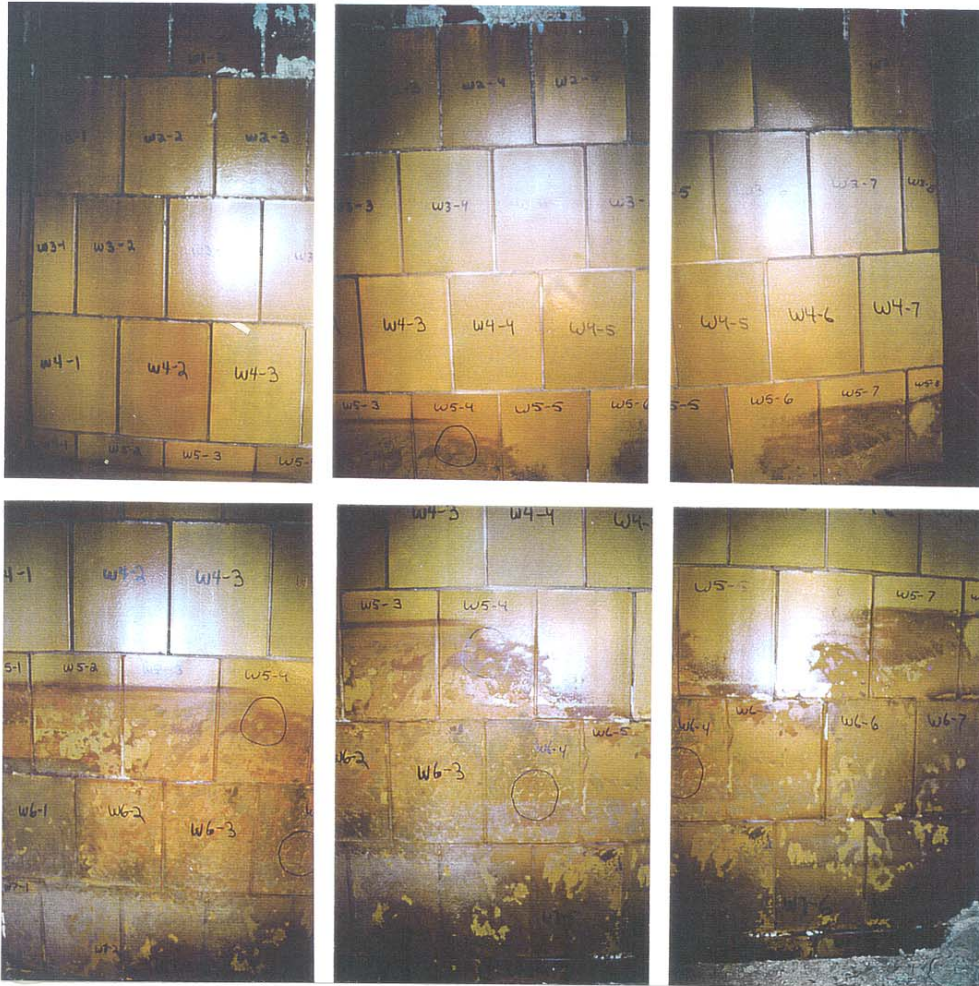
Photo 1.3 West wall, areas circled indicate where 4" diameter cores were removed.
(see appendix 2.0 for tilt identification).

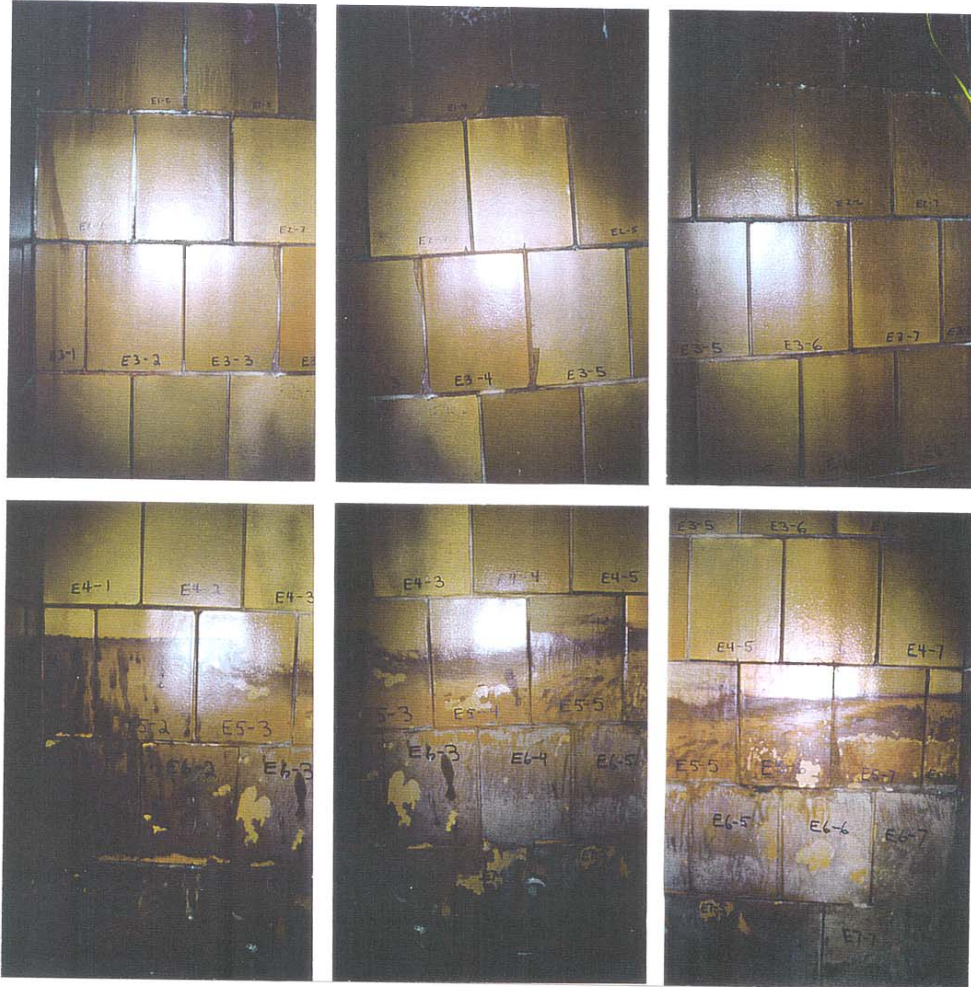
Photo 1.4 East wall, areas circled indicate where 4" diameter cores were removed.
(see appendix 2.0 for tile identification).

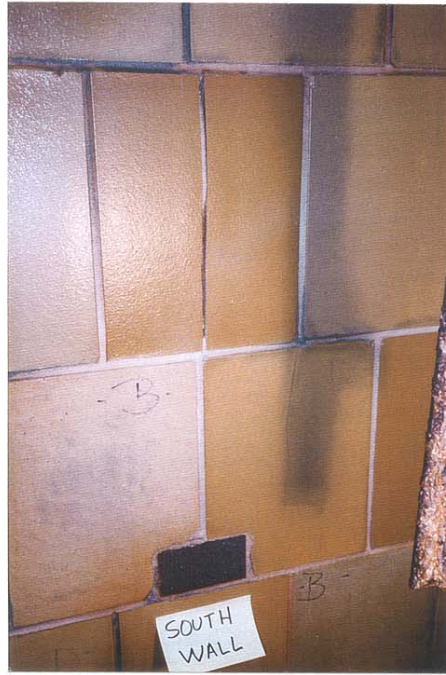
Photo 1.5 Split tile and refrax plug in spray impact area, photographed in October 1995 after 7,986 hours of operation.

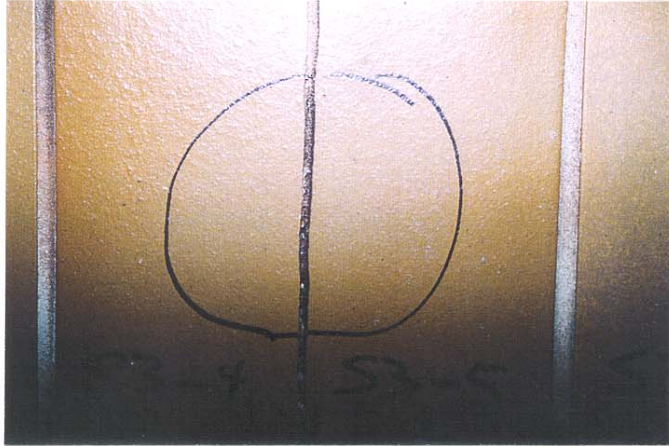
Photo 1.6 Split tile on south wall, photographed on December 8, 1997 after 16,239 hours of operation shows no change in the grout.

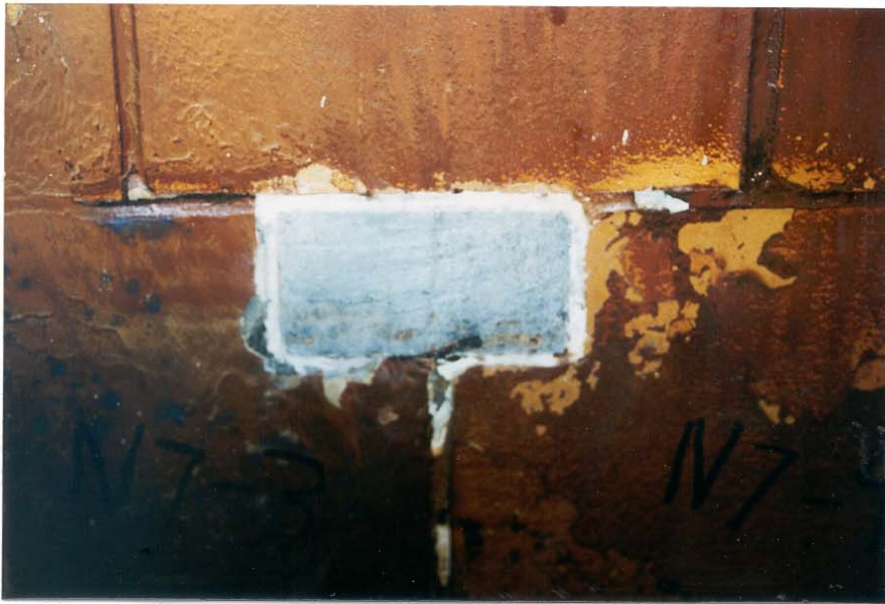
Photo 1.7 "Refrax" plug on north wall shows grout to be in good condition after scale had been scraped off. This plug was located below the normal slurry level.

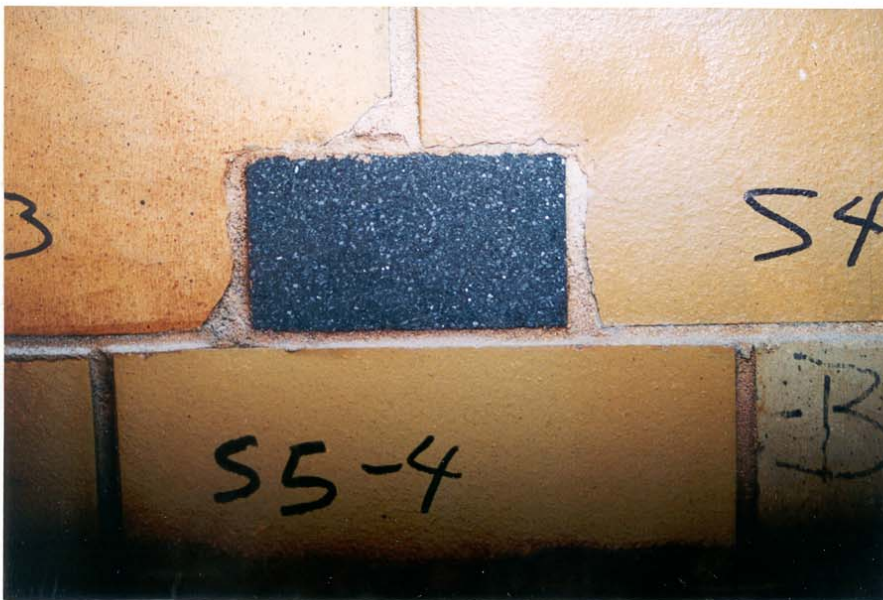
Photo 1.8 "Refrax" plug on south wall shows grout to be in good condition. This plug was located in a spray impact area above the normal slurry level.

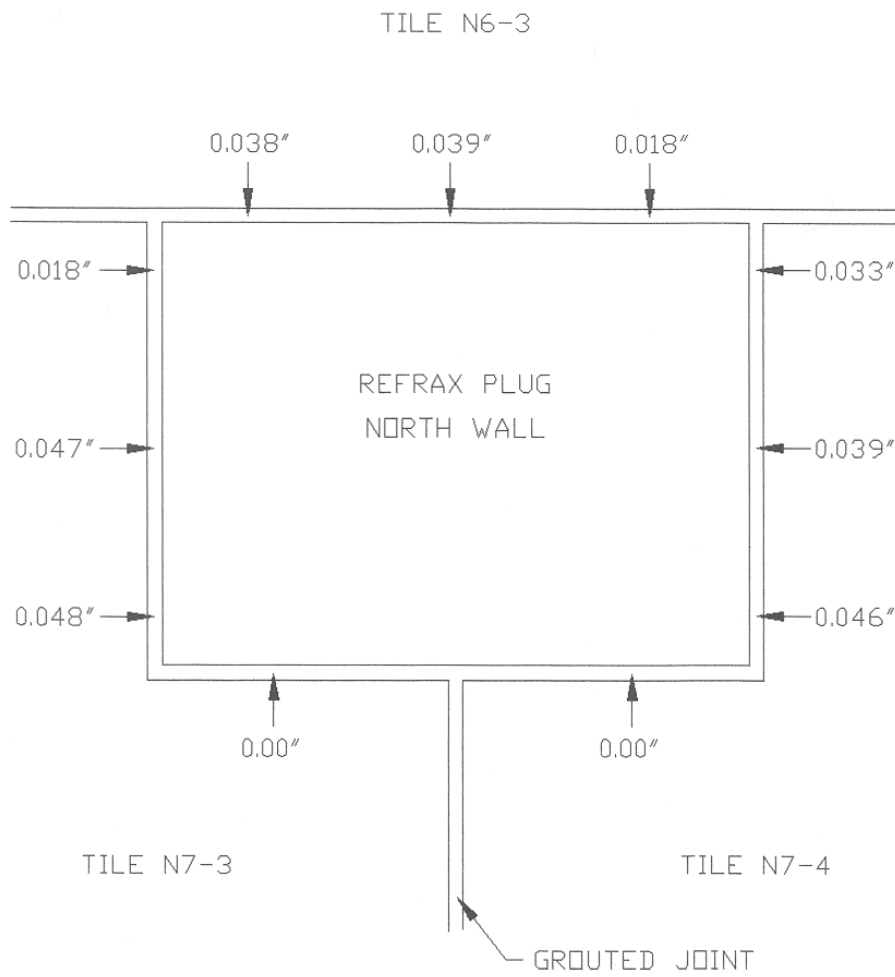
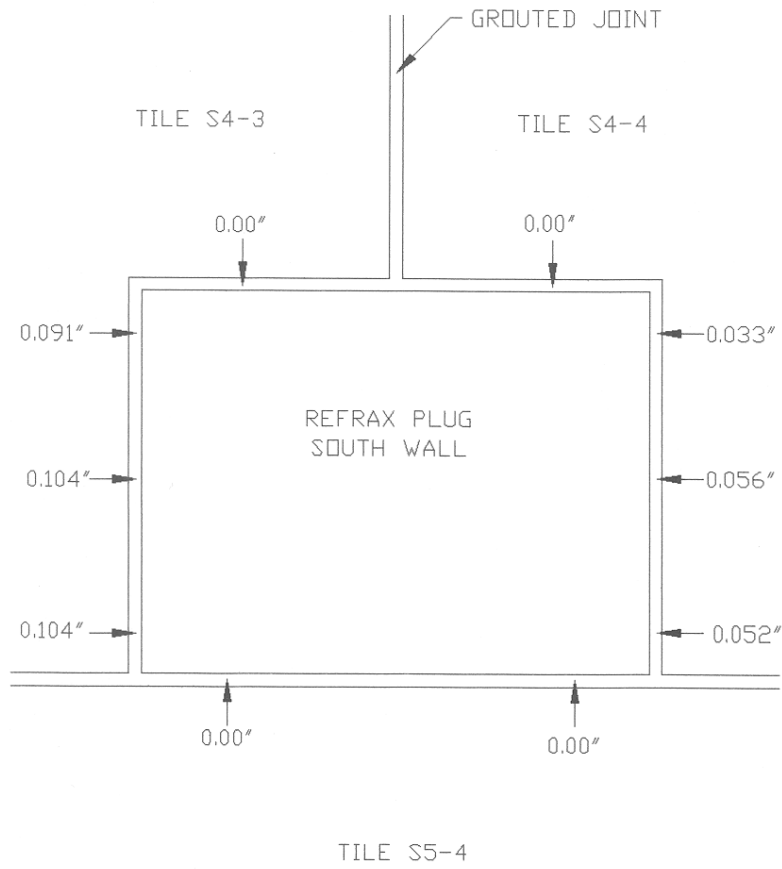
Appendix 1.0 contains overall photographs of the four walls, photographs showing the condition of the grout between a split tile on the south wall, and photographs of the "Refrax" plugs on the north and south walls. Figures 1.1 and 1.2 show the results of joint profile depth measurements at the "Refrax" plugs. The maximum depth measured was 0.104" and minimum of 0.00" indicating a very little or no loss of grout in the joints.

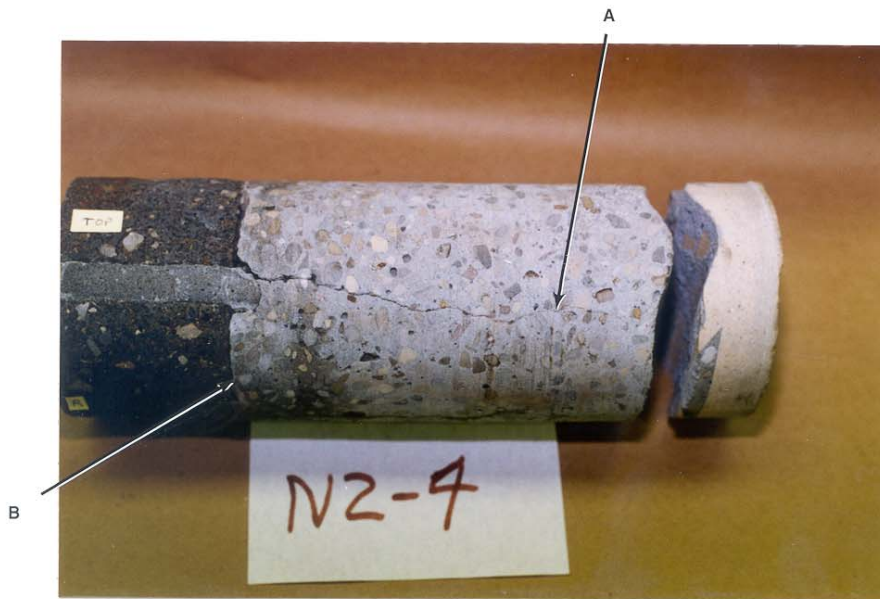
Photo 2.1 "A" shrinkage or thermal crack starting at a vertical mortar joint which protruded into the concrete. Crack "B" see photo 2.2.

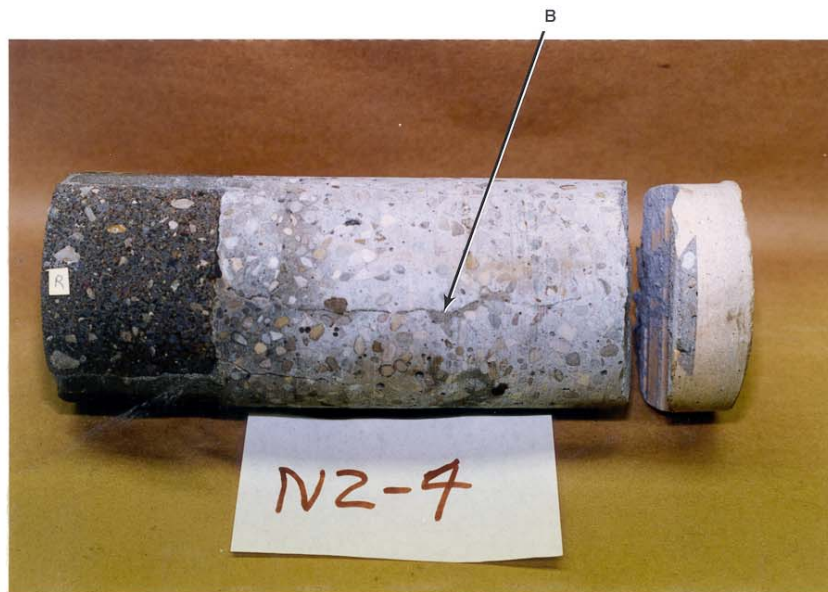
Photo 2.2 Crack "B" appears to be a parting line between concrete pours since core was removed from the middle of a row of tile.

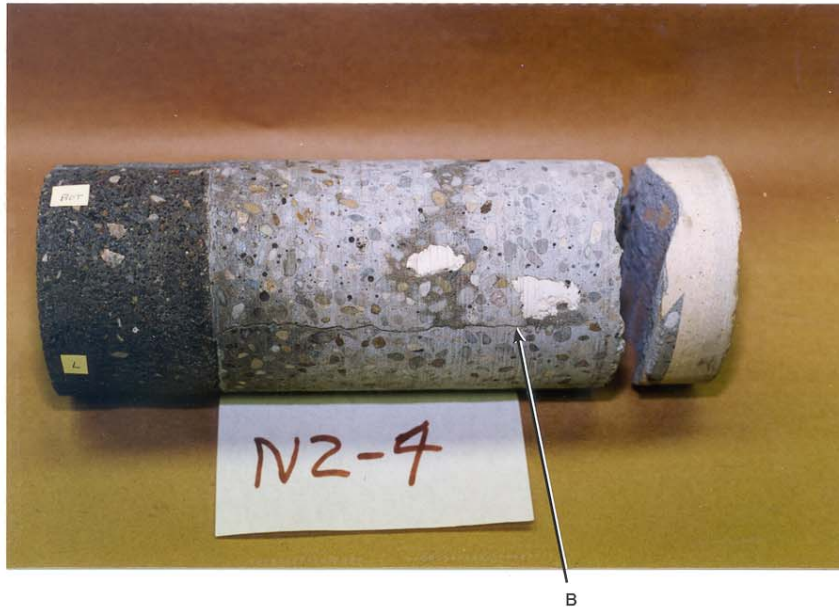
Photo 2.3 Crack "B" appears to be a parting line between concrete pours. (see photo 2.1).
Two pieces of cement from the tile joint are also evident.

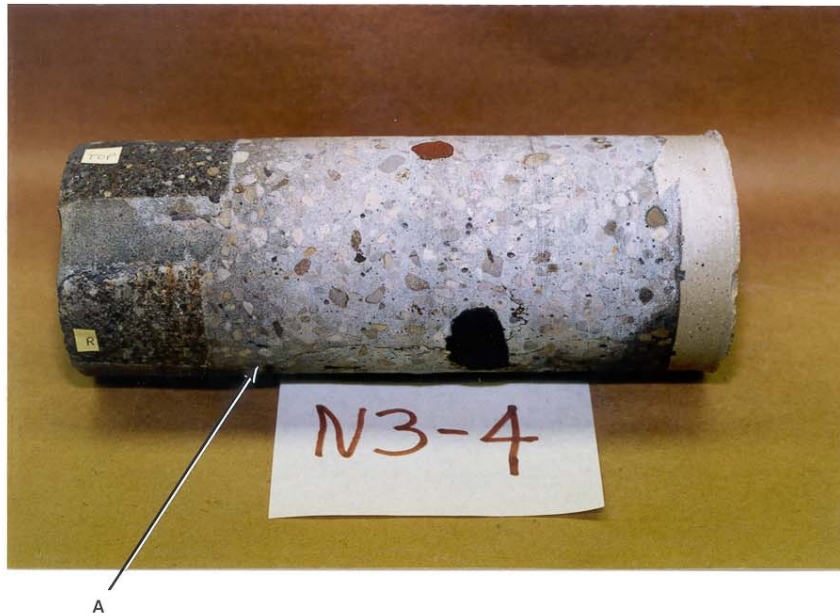
Photo 2.4 Crack "A" appears to be a parting line between concrete pours due to the presence
of the mastic sealant normally applied to the previous pour.

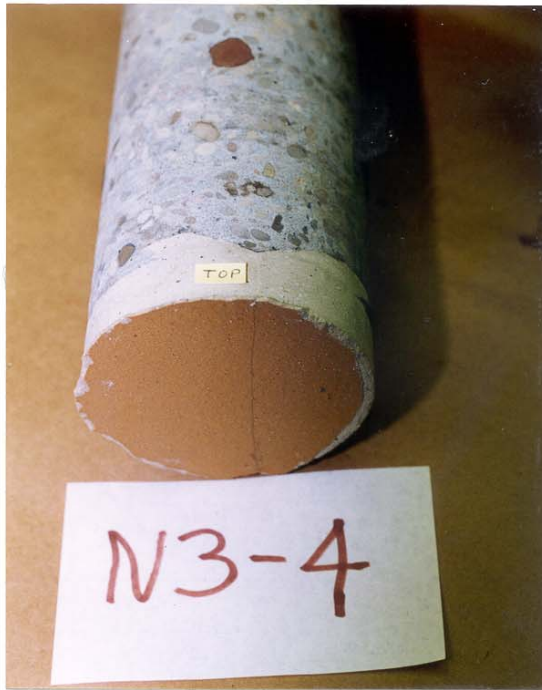
Photo 2.5 Cracked tile and no evidence of leakage.

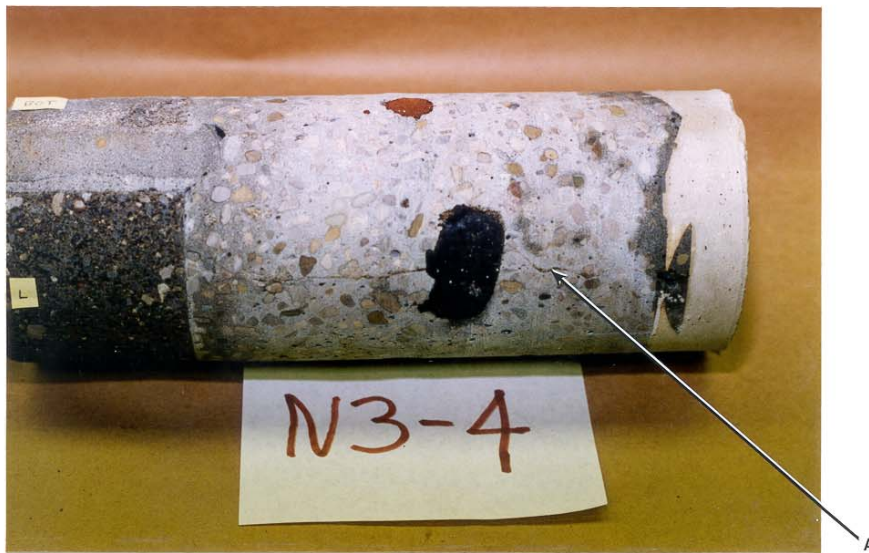
Photo 2.6 Same as photo 2.4 and no evidence of shrinkage and thermal cracks.

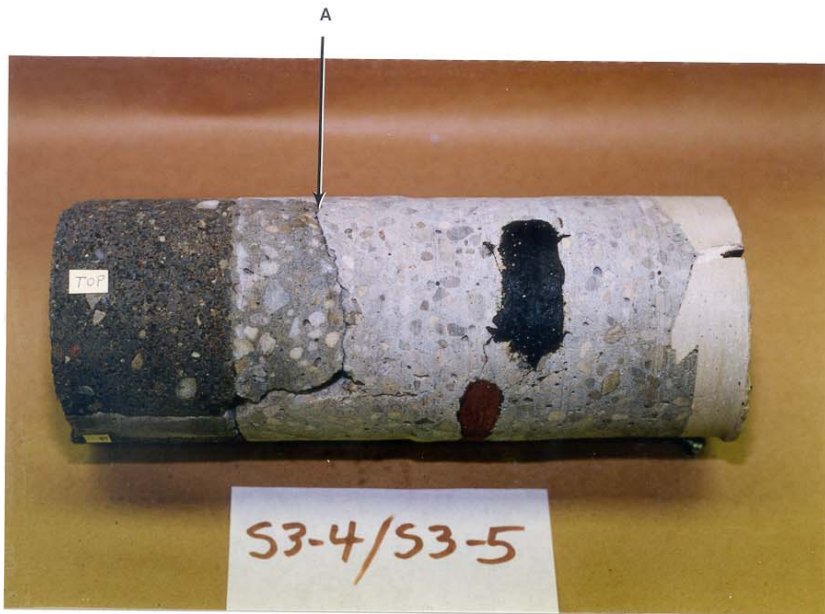
Photo 2.7 "A" shrinkage of thermal crack starting at a mortar joint.

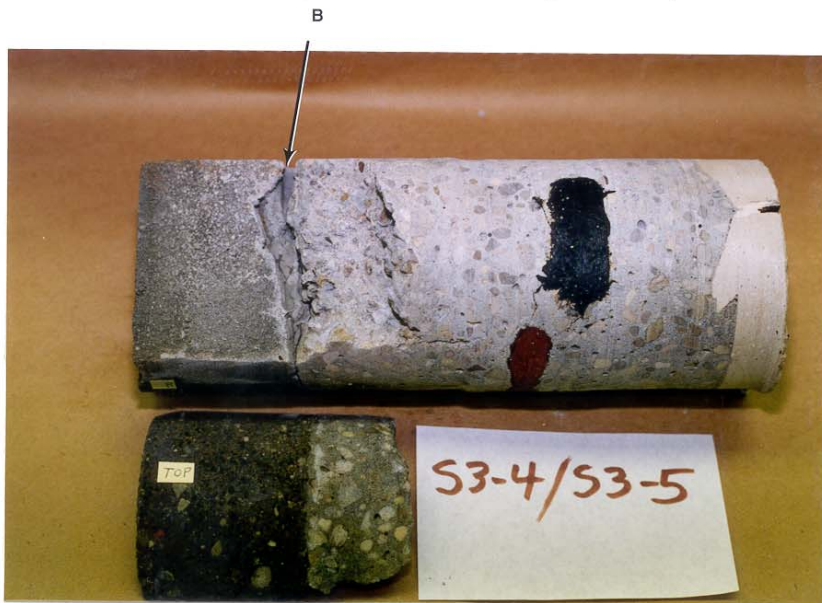
Photo 2.8 Removal of cracked piece shows a void "B".

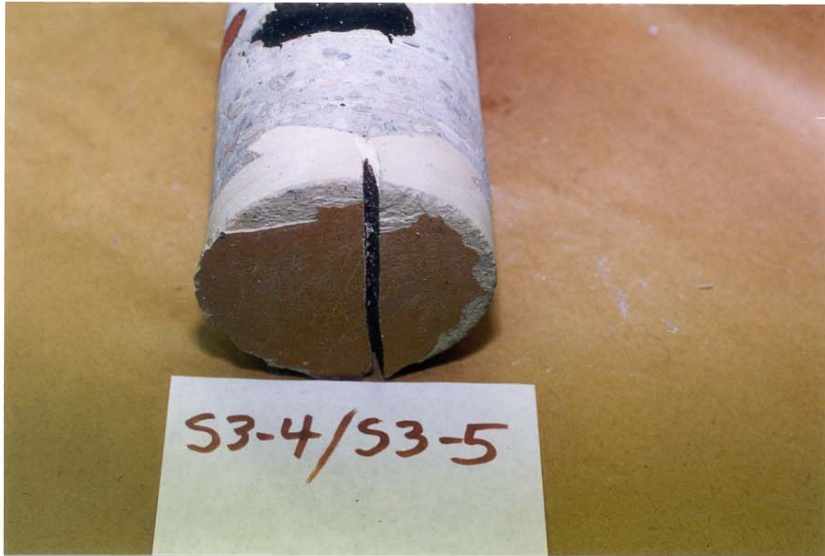
Photo 2.9 Split tile repaired with cement.

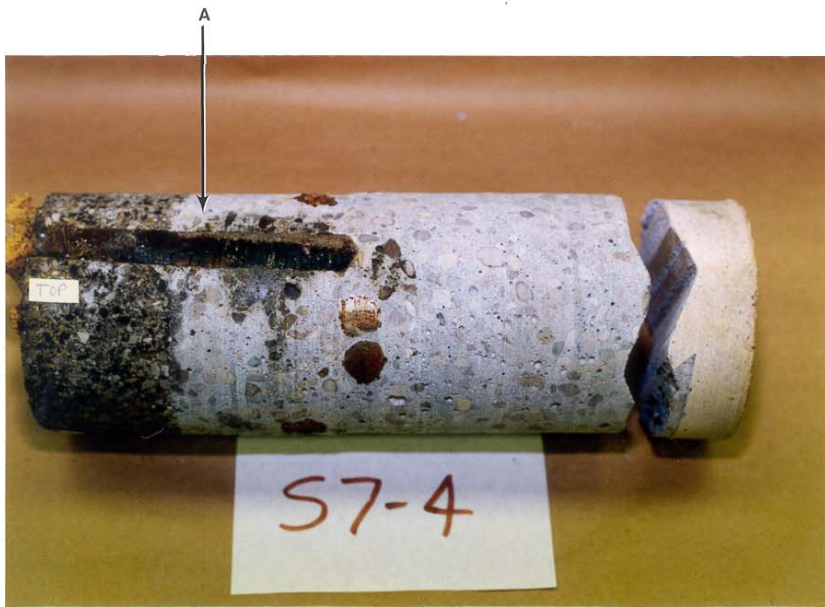
Photo 2.10 "A" drilled hole with sealant. No evidence of cracks.

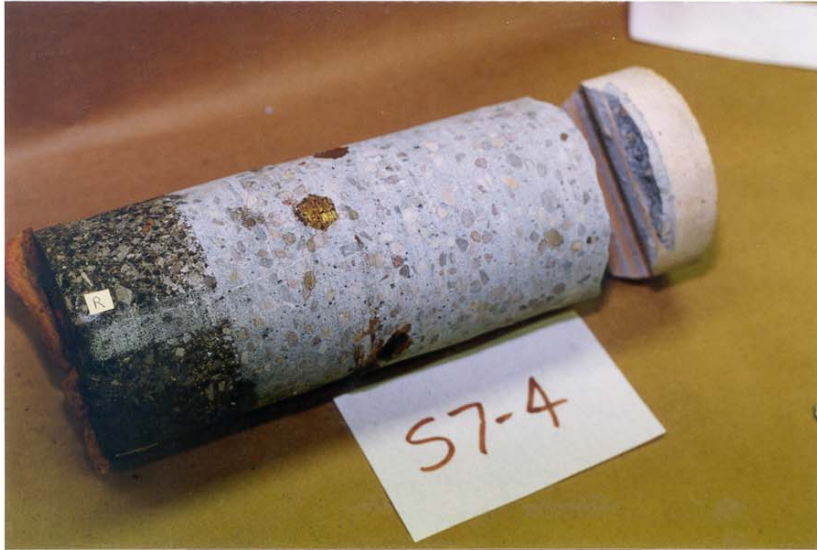
Photo 2.11 No evidence of cracks or leakage.

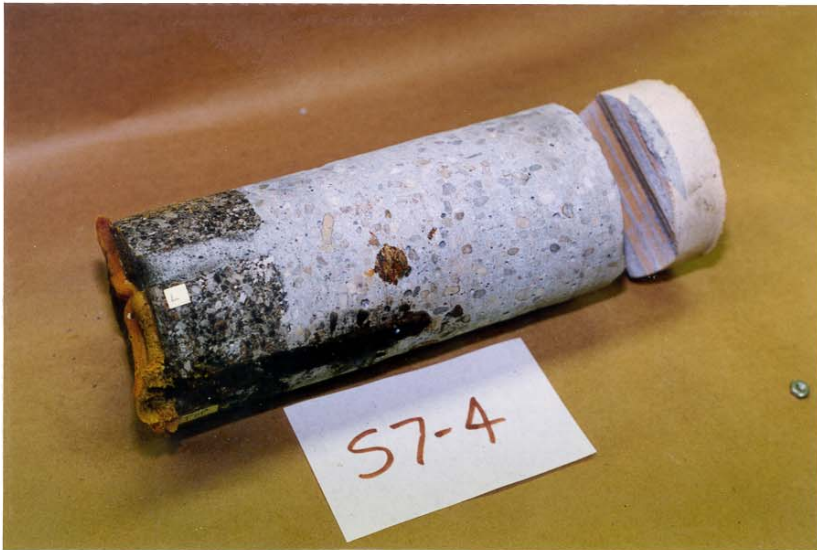
Photo 2.12 No evidence of cracks or leakage.

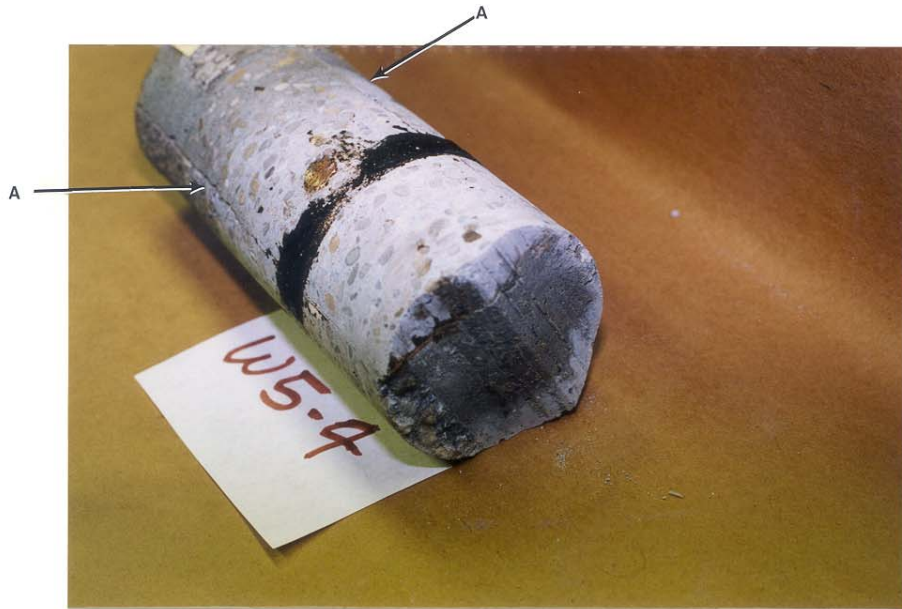
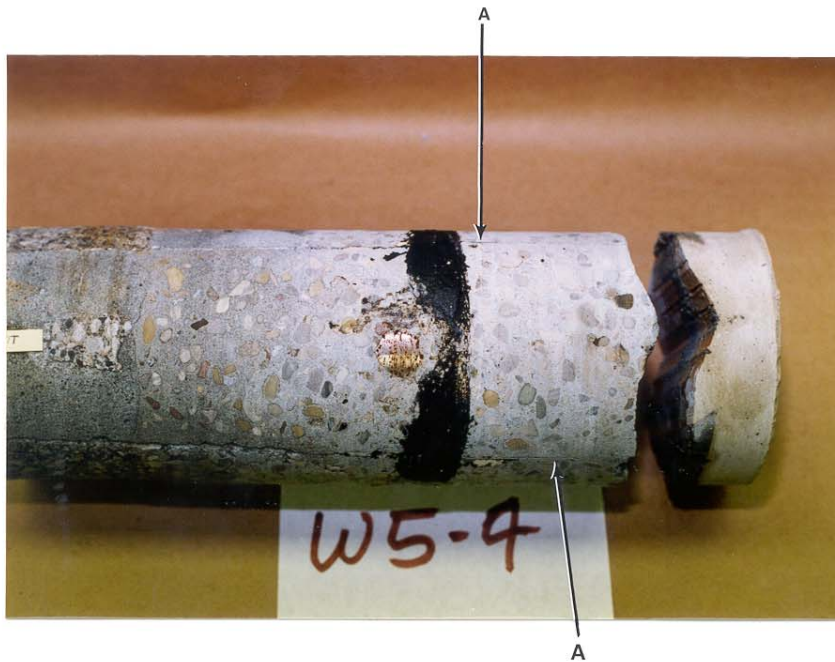
Photo 2.13 Crack "A" appears to be a parting line between concrete pours due to the presence of mastic sealant placed between pours.

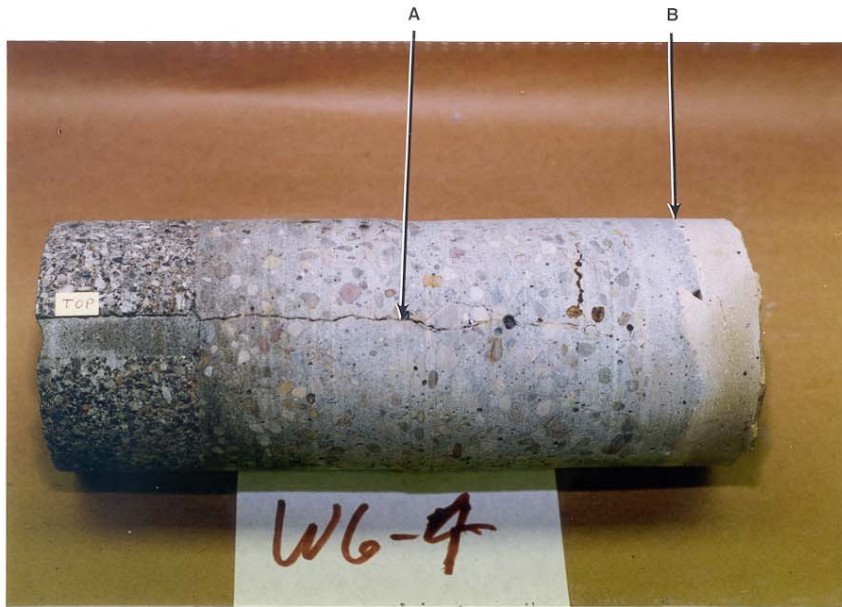
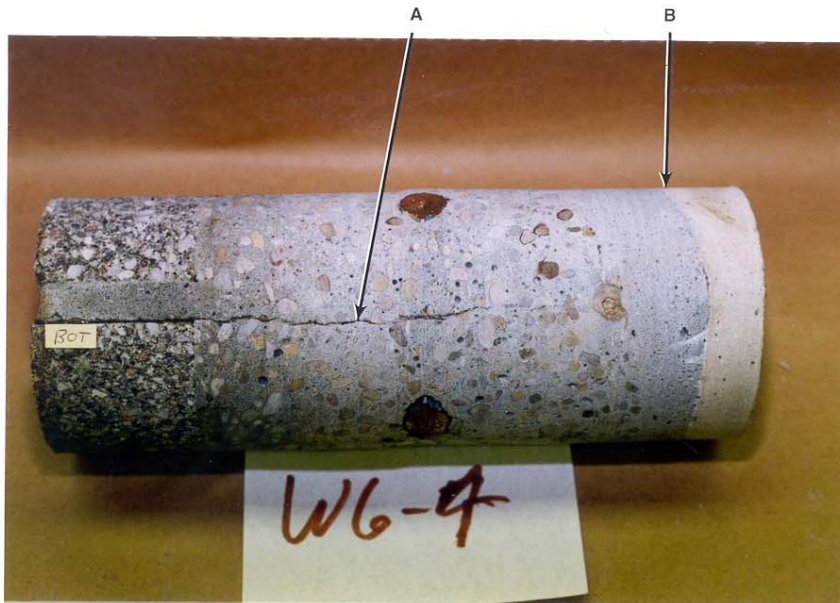
Photo 2.15 "A" shrinkage or thermal crack starting at a mortar joint in the insulating block wall. "B" sand/cement mix placed behind a tile which was replaced.

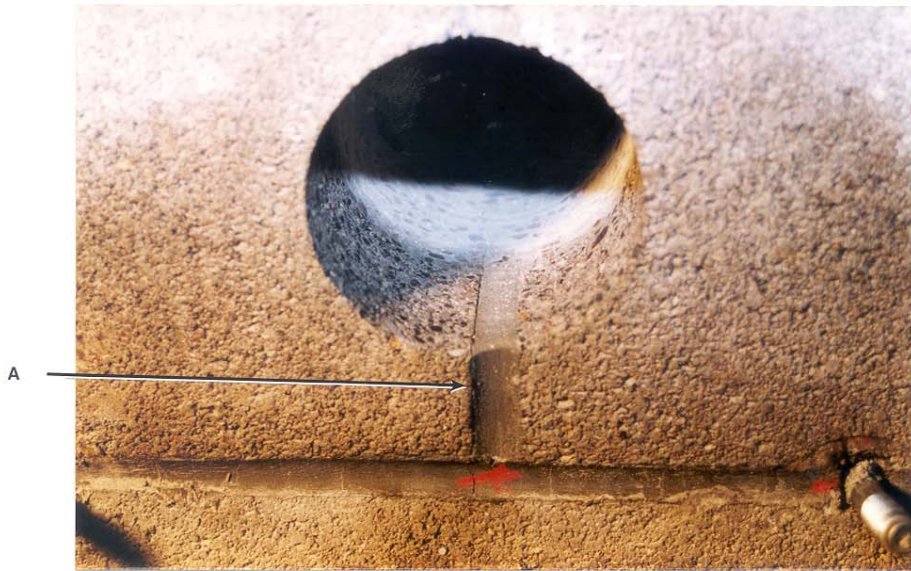
Photo 2.17 Core hole N2-4, "A" shrinkage or thermal crack in mortar joint extending into the concrete wall.

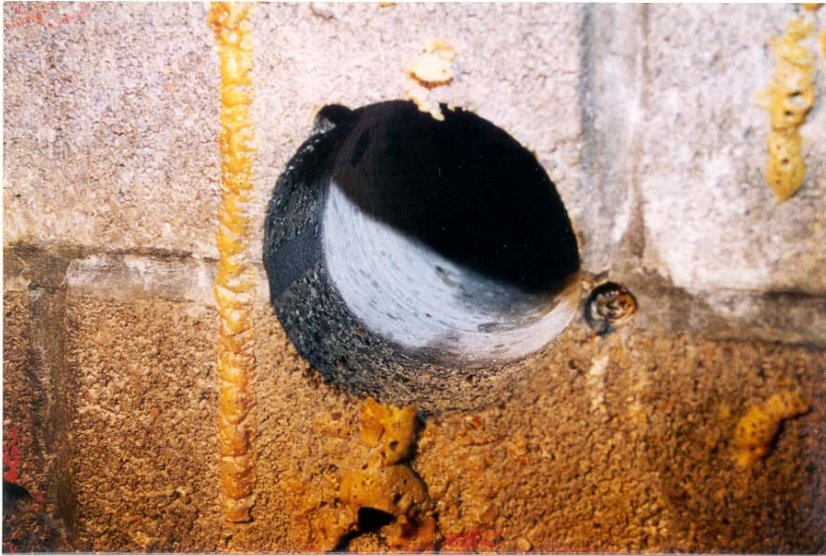
Photo 2.22 Core hole S7-4, sealant used to plug drilled holes is evident.

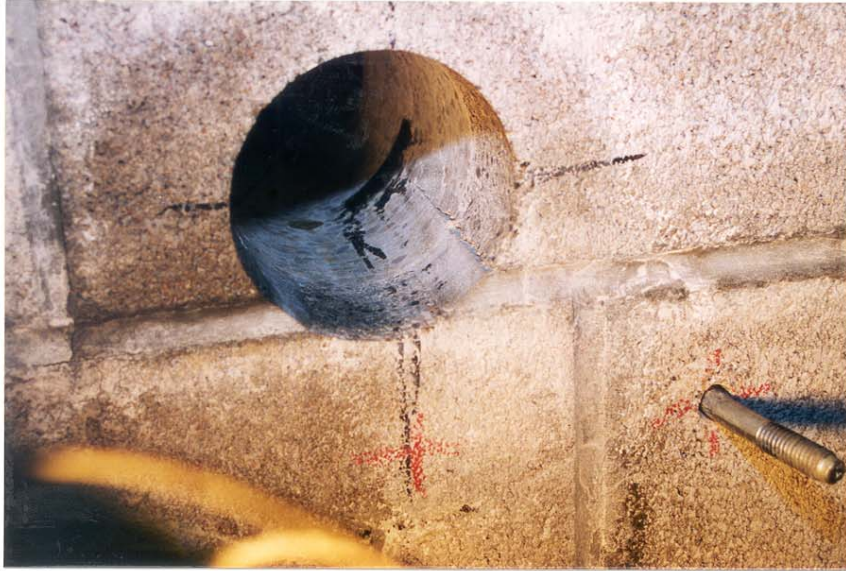
Photo 2.23 Core hole W5-4, parting line between concrete pours corresponds to the parting line in the core.

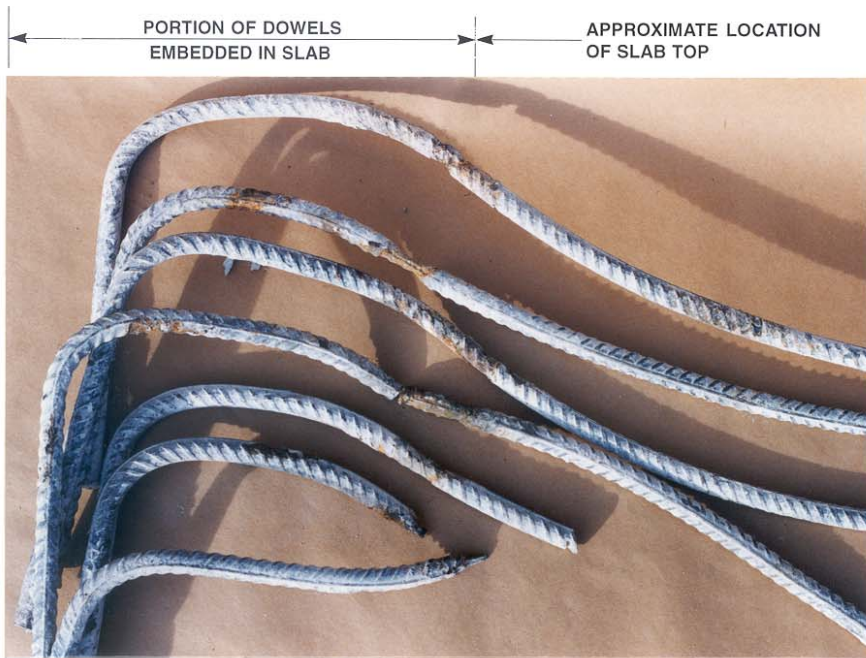
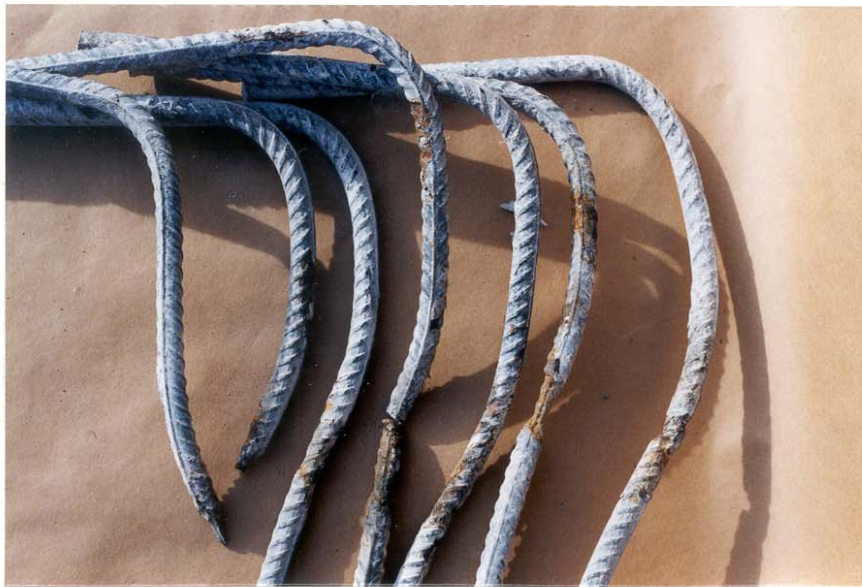
The steel reinforcement bars in the walls were in good condition and no corrosion was found in areas deliberately allowed to leak. Appendix 3.0 contains photographs of corroded reinforcement bars removed from the concrete foundation slab of the test module that were found at the bottom of the east and south walls. The reinforcement bars were used as dowels to connect the walls to the concrete foundation slab and extended from the concrete in the slab to the concrete in the wall. Based on an examination during demolition, the location of the corrosion on the dowels is at the parting line between the concrete in the slab and the wall, which were poured at different times. Some corrosion was also found at a location lower on the dowel which would be further into the slab. During the demolition, it was also noted that the mastic sealant, normally applied between pours, was adhering to the dowels which was not observed at all the other areas where the mastic sealant had been applied.

The presence of corrosion on the dowels in these areas seems to indicate that some leakage occurred in the grout joint between the floor tile and wall tile. The mastic sealant failed to keep the liquid from contacting the dowel bar. The amount of leakage was apparently very small since there was never any sign of leakage at the exterior of the slab.

Photo 3.1 Corroded #5 dowels removed from concrete slab along east and south walls.

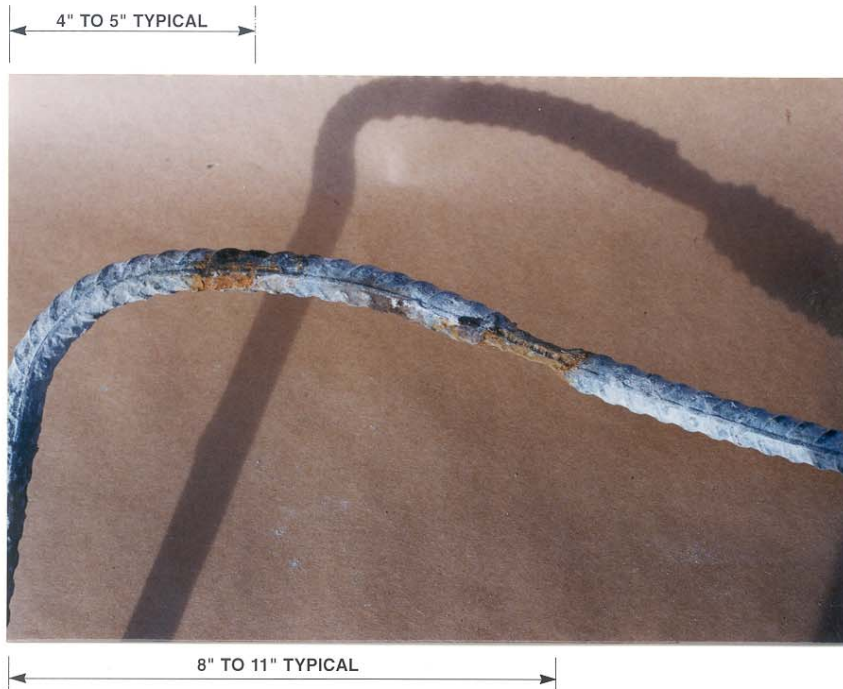
Photo 3.3 Dowel "A" showing corrosion at two locations.

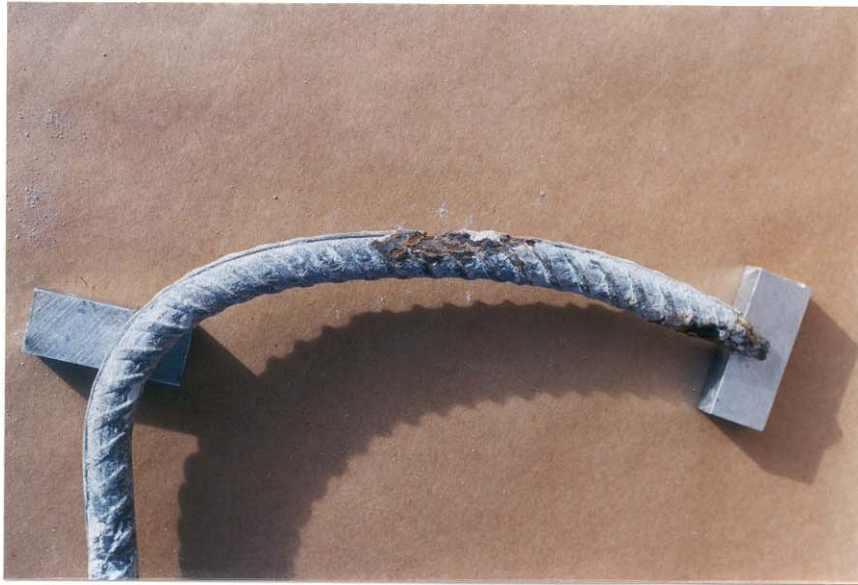
Photo 3.7 Dowel "D" showing corrosion at two locations. Vertical portion of dowel broke off during demolition.

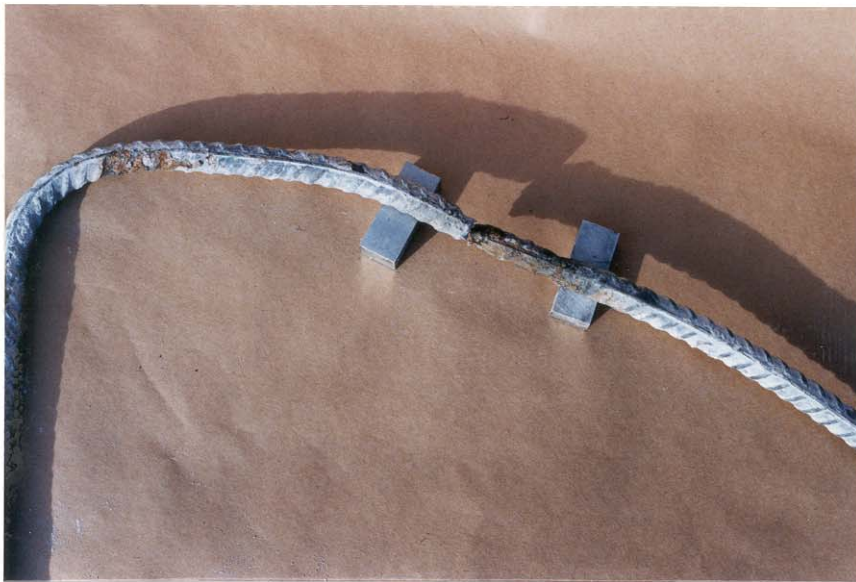
Photo 3.8 Dowel "E" showing corrosion at two locations. Vertical portion of dowel broke off during demolition.

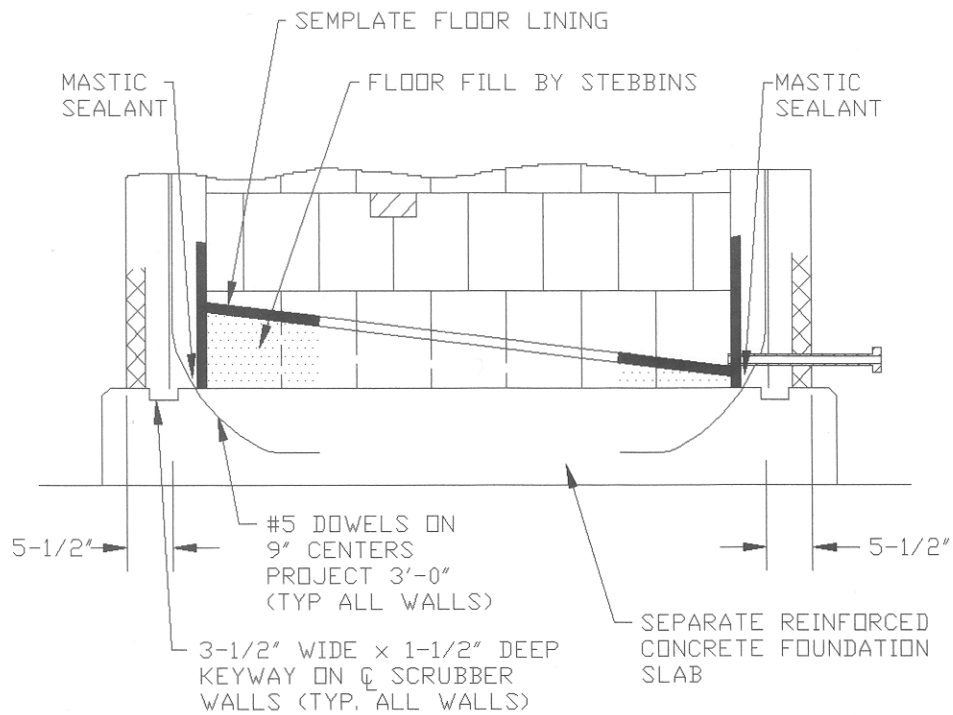
Figure 3.2 shows the actual location of the dowels based on photos taken during construction and observations during demolition. According to the original drawings, the dowels were to pass through a keyway in the slab. Instead, the dowels were set just behind the first row of tile. This may have prevented the mastic sealant from being set down to the concrete surface of the slab at the dowels.

Figure 3.2 Actual dowel location based on photos 3.9 & 3.10 and observations during demolition.
