NP-33-04-002-00

LER 2004-002-00
Davis-Besse Nuclear Power Station, Unit No. 1
Date of Occurrence – August 4, 2004

4. TITLE
Reactor Trip During Reactor Trip Breaker Testing Due To Fuse Failure

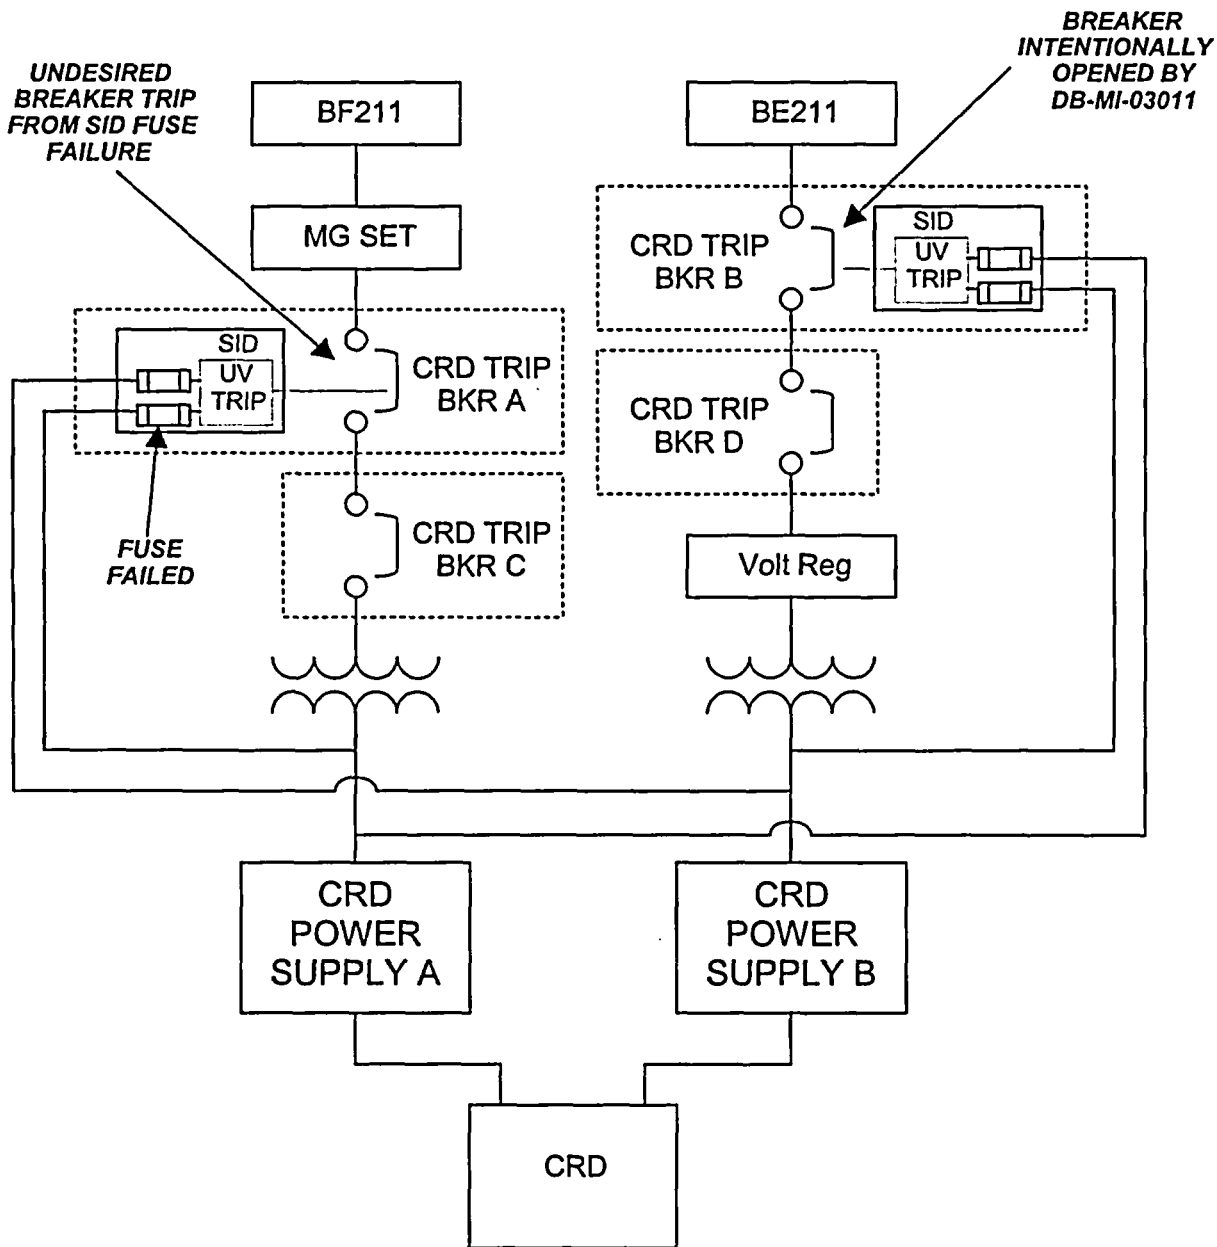
FIGURE 1

Electric power to the Control Rod Drives (CRDs) and Motors [AA] is supplied by redundant power channels, and the Reactor Trip Breakers are arranged such that breaker "A" or "C" AND "B" or "D" must be open to remove power from the CRDs. When Reactor Trip Breaker "B" was opened as part of the surveillance test, Reactor Trip Breaker "A" also opened unexpectedly removing power to the CRDs allowing the Control Rods to insert into the Reactor Core.

Reactor Trip Breaker "A" opened due to a fuse failure in a circuit designed to open the breaker when an undervoltage condition is detected on either redundant CRD System power channel. The circuit, part of the Source Interruption Device (SID) installed in both Reactor Trip Breakers "A" and "B", receives undervoltage detection input from both redundant CRD power channels. Refer to Figure 1 for a simplified functional diagram of the CRD circuitry. The fuse in the Reactor Trip Breaker "A" power channel undervoltage detection input that receives power from Reactor Trip Breakers "A" and "C" had failed prior to the test, leaving the Reactor Trip Breaker "A" Source Interruption Device in a half-tripped condition. When Reactor Trip Breaker "B" was opened as intended during the test, input from Reactor Trip Breaker "B" supplied power channel into the Reactor Trip Breaker "A" Source Interruption Device also depowered, indicating an undervoltage condition. With both inputs indicating an undervoltage condition, the Source Interruption Device responded as designed, initiating a shunt trip of Reactor Trip Breaker "A", which resulted in a trip of the reactor due to the depowering of the remaining CRD power source.

Simplified Functional Diagram of the CRD Circuitry
