**Report on the preliminary  
fact finding mission  
following the accident at the  
nuclear fuel processing  
facility in Tokaimura, Japan**

INTERNATIONAL ATOMIC ENERGY AGENCY, VIENNA, 1999

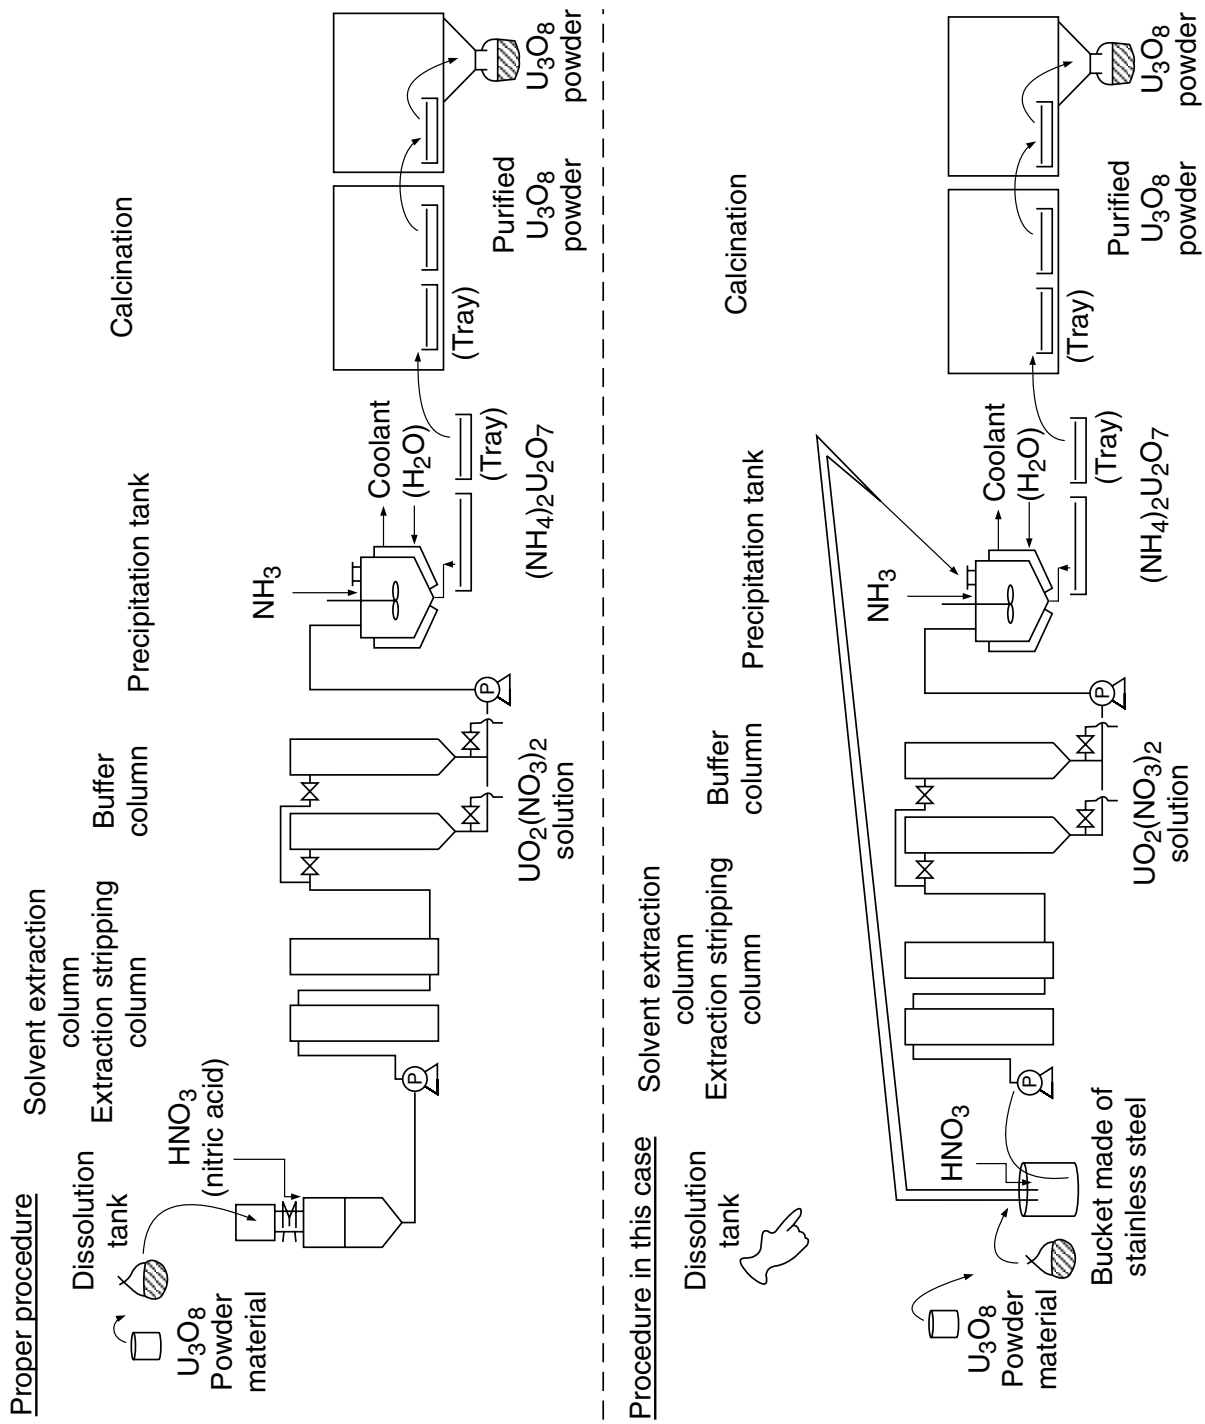
The work procedure was modified in November 1996, without permission for the modification having been given by the regulatory authorities, to allow the dissolution of uranium oxide ( $U_3O_8$ ) to be performed in stainless steel buckets. According to the information provided at the meetings with the IAEA Secretariat team, this new procedure had been followed several times before this accident occurred.

Furthermore, when the criticality event occurred, homogenization of uranium oxide was being performed by mechanical stirring in the precipitation tank instead of in the mass control equipment. This was done by pouring uranyl nitrate solution (made by dissolving uranium oxide ( $U_3O_8$ ) in nitric acid) directly from the steel bucket into the precipitation tank. The tank was not designed with a geometry conducive to preventing criticality, being 450 mm in diameter and 610 mm high (Fig. 8). This means of homogenization in the precipitation tank is not even described in the revised procedure and was a further deviation from the approved procedure.

buckets and poured the solution directly into the precipitation tank. About 26 L of the solution, with uranium enriched to 18.8%  $^{235}U$  by mass, had been poured into the precipitation tank in four batches on 29 September. In the morning of 30 September, the workers continued to prepare uranyl nitrate solution and poured three additional batches into the precipitation tank (Figs 7 and 8).

Fig. 7. Schematic diagram of the proper procedure and the actual procedure used in this case for dissolution and precipitation.

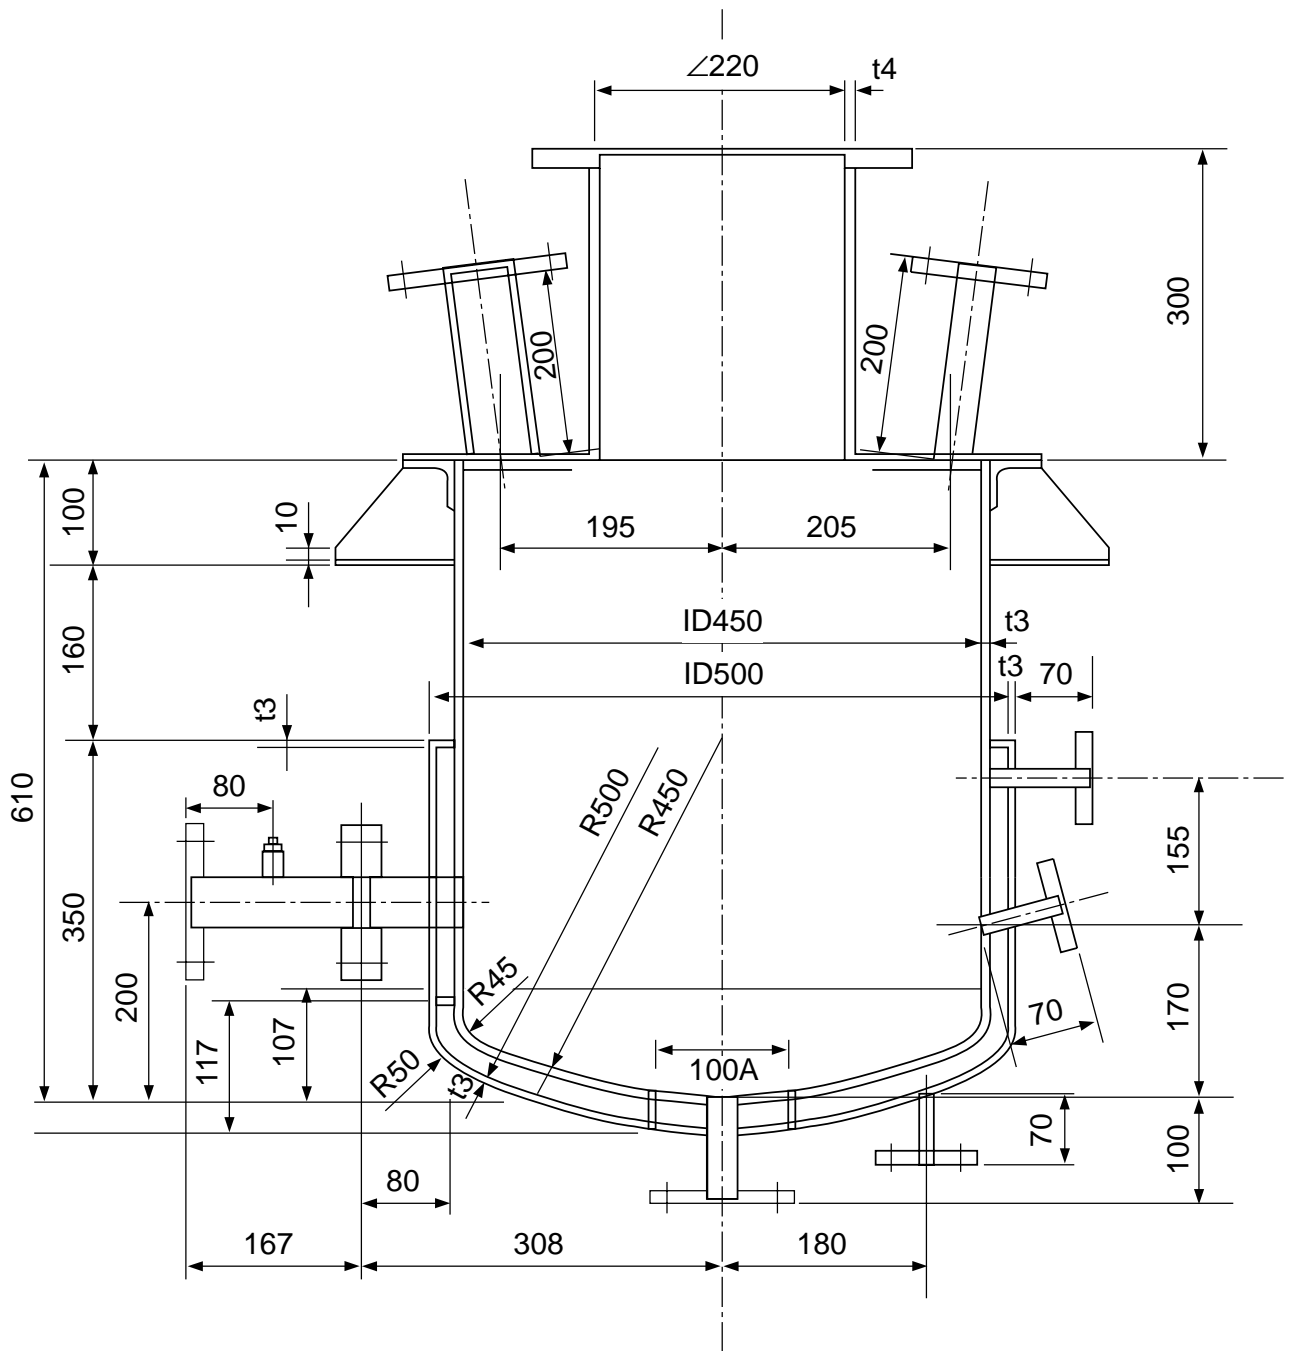
At around 10:35 on 30 September (all times are local times unless otherwise stated), when the volume of solution in the precipitation tank reached about 40 L, equivalent to about 16 kg U, a critical mass was reached. At the point of criticality, the nuclear fission chain reaction became self-sustaining and began to emit intense gamma and neutron radiation [14]. The area gamma monitoring device detected a high level of gamma radiation and the area alarms sounded. The three workers concerned evacuated the building (there was apparently no explosion). They were subsequently given assistance by emergency service workers. The other workers on site assembled in the muster zone (Fig. 4).

Fig. 8. Cross-section of the precipitation tank indicating dimensions (in mm).

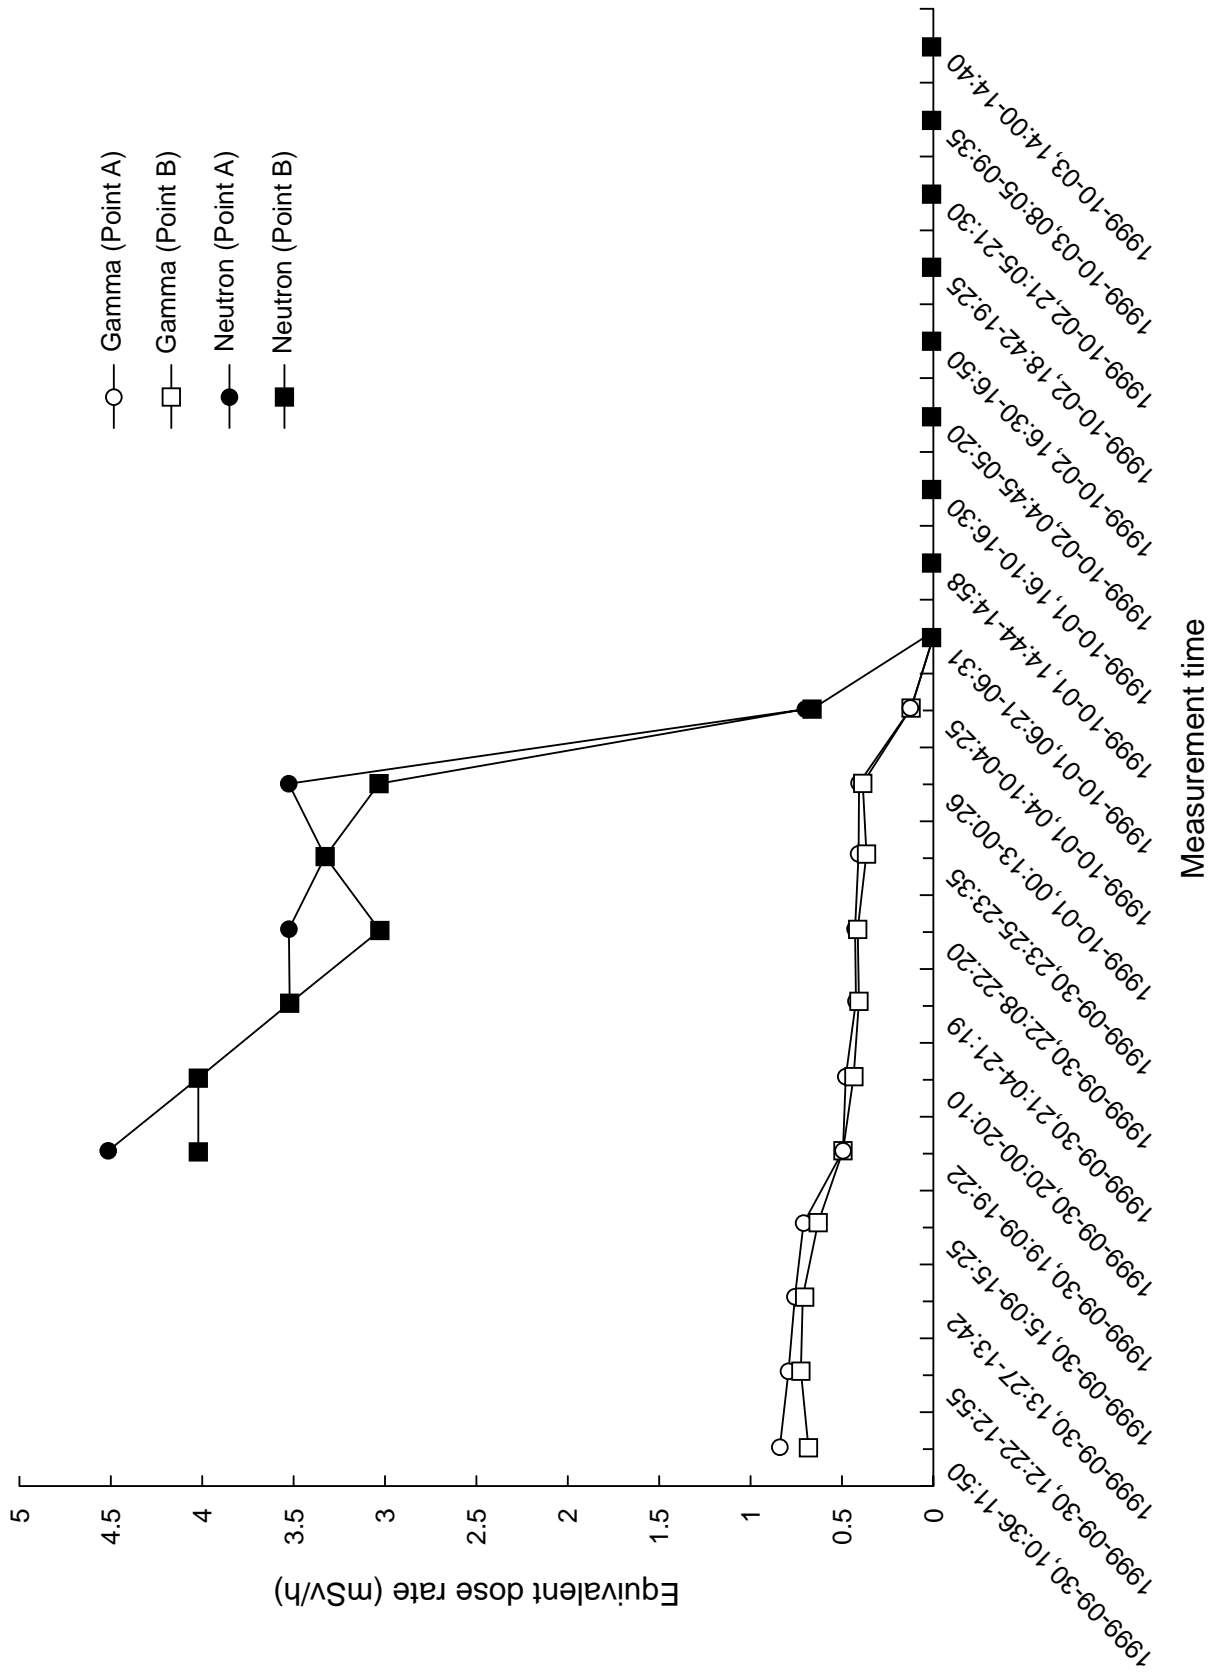
At 11:40, a maximum gamma dose rate of 0.84 mSv/h was measured in an area around the facility [4, 13, 14] (Fig. 9). At around 14:00, the Mito Atomic Energy Office of STA started monitoring gamma dose rates. The results were provided to the LCH and to the Government Accident Countermeasures Headquarters (GACH) which had been established at 15:00.

After 17:00, the maximum neutron dose rates at the site boundaries were measured to be around 4 mSv/h (Fig. 9), which indicated a continuing state of criticality [4, 13].

Fig. 9. Gamma and neutron dose rates at monitoring points A and B (see Fig. 4).

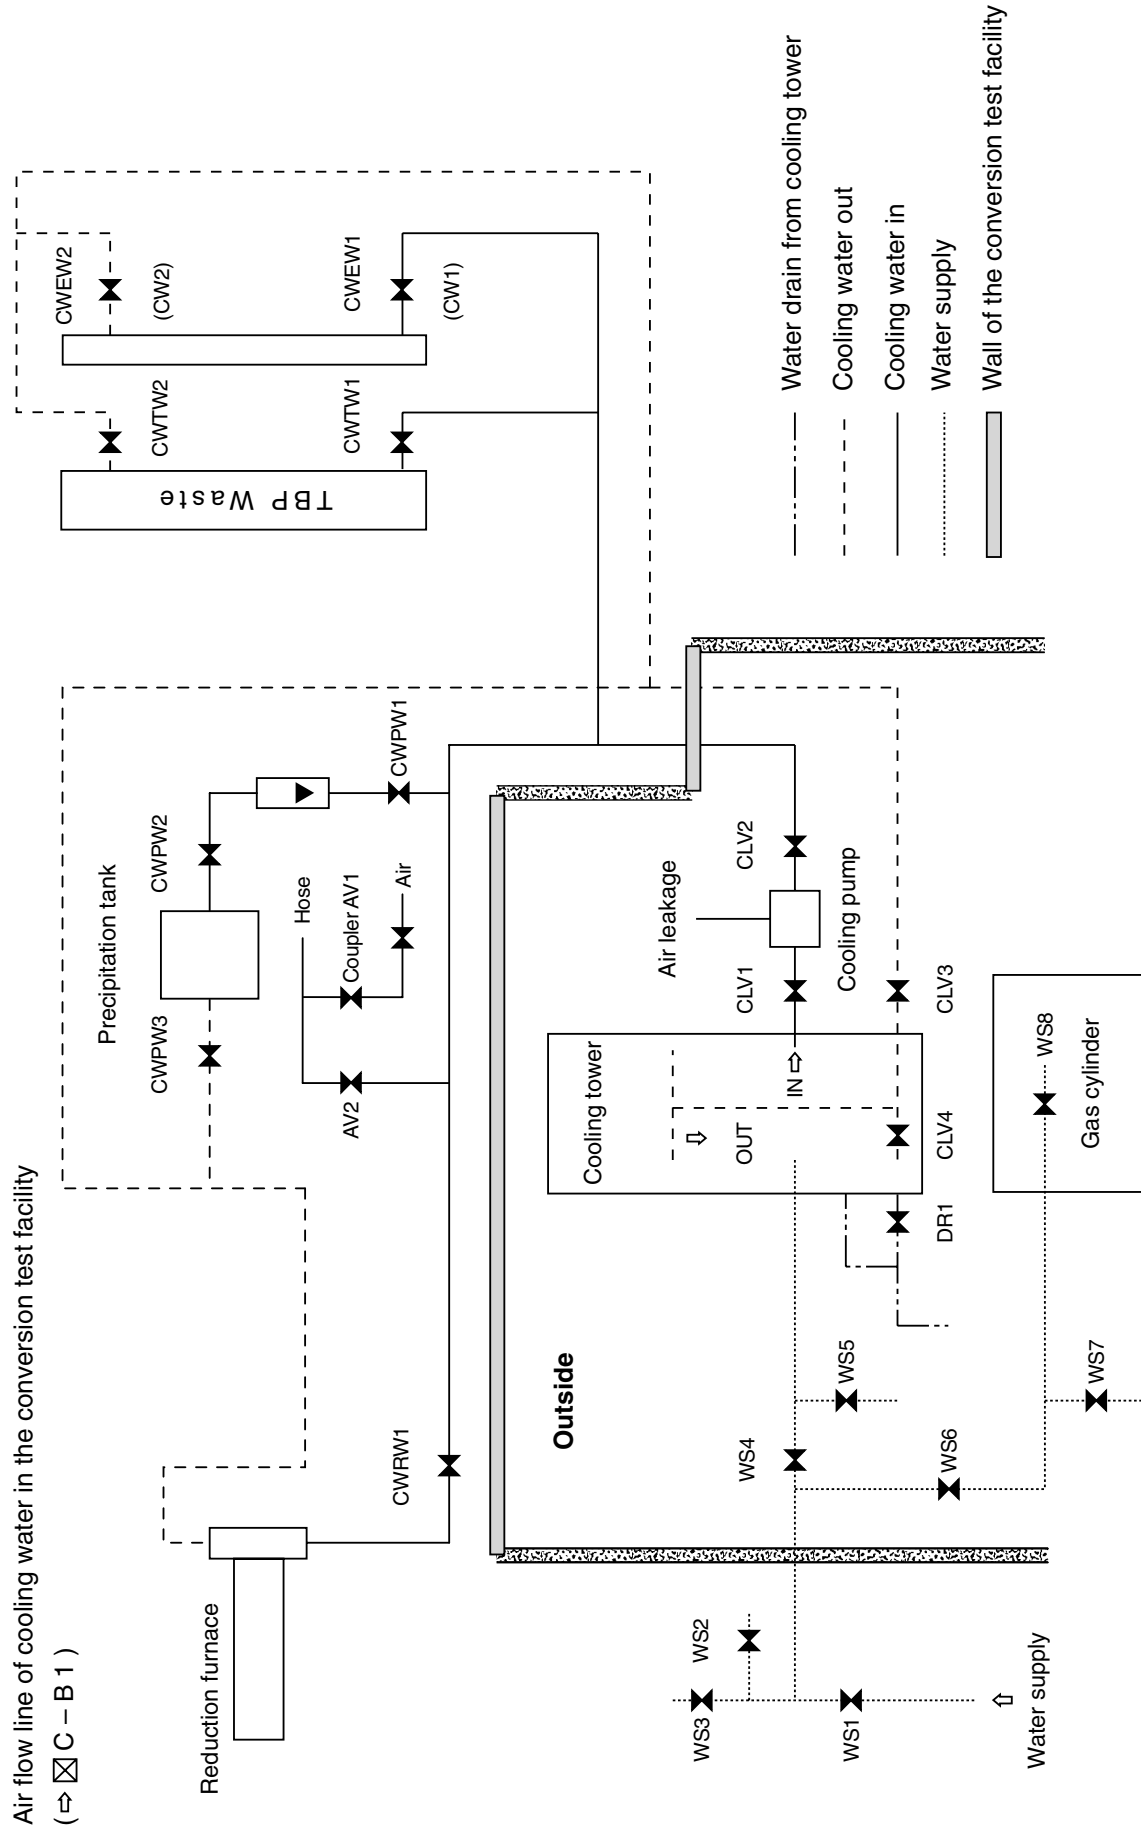
removal of water from the cooling jacket could help to terminate the state of criticality. The cooling jacket acted as a neutron reflector, thereby enhancing nuclear fission [14]. At the second meeting at the GACH, held at 23:15 on 30 September, it was concluded that the cooling water should be drawn off from the water jacket surrounding the precipitation tank in order to end the state of criticality and thereby terminate the self-sustaining nuclear chain reaction [13].

Fig. 10. Schematic diagram of the cooling system for the conversion building (TBP: tributyl phosphate).

The cooling pump, the valves and the cooling tower were located outside the building, making them easier to access (Fig. 10). Attempts to drain the water were made between 02:35 and 06:04 on 1 October. Ten approaches were made, the purpose of the first being to photograph the cooling tower and pump area. First the cooling tower feed valve (WS4 in Fig. 10) was closed and the drain valve (DR1 in Fig. 10) was opened. At this stage, only a little water was drained, but the neutron dose rate decreased somewhat. The water pipe was then broken and cut to drain the water. Finally, at around 06:15, argon gas was pumped into the water pipe to force out much more water. At around 06:30 the neutron dose rate was below the detection limit [14] (Fig. 11).

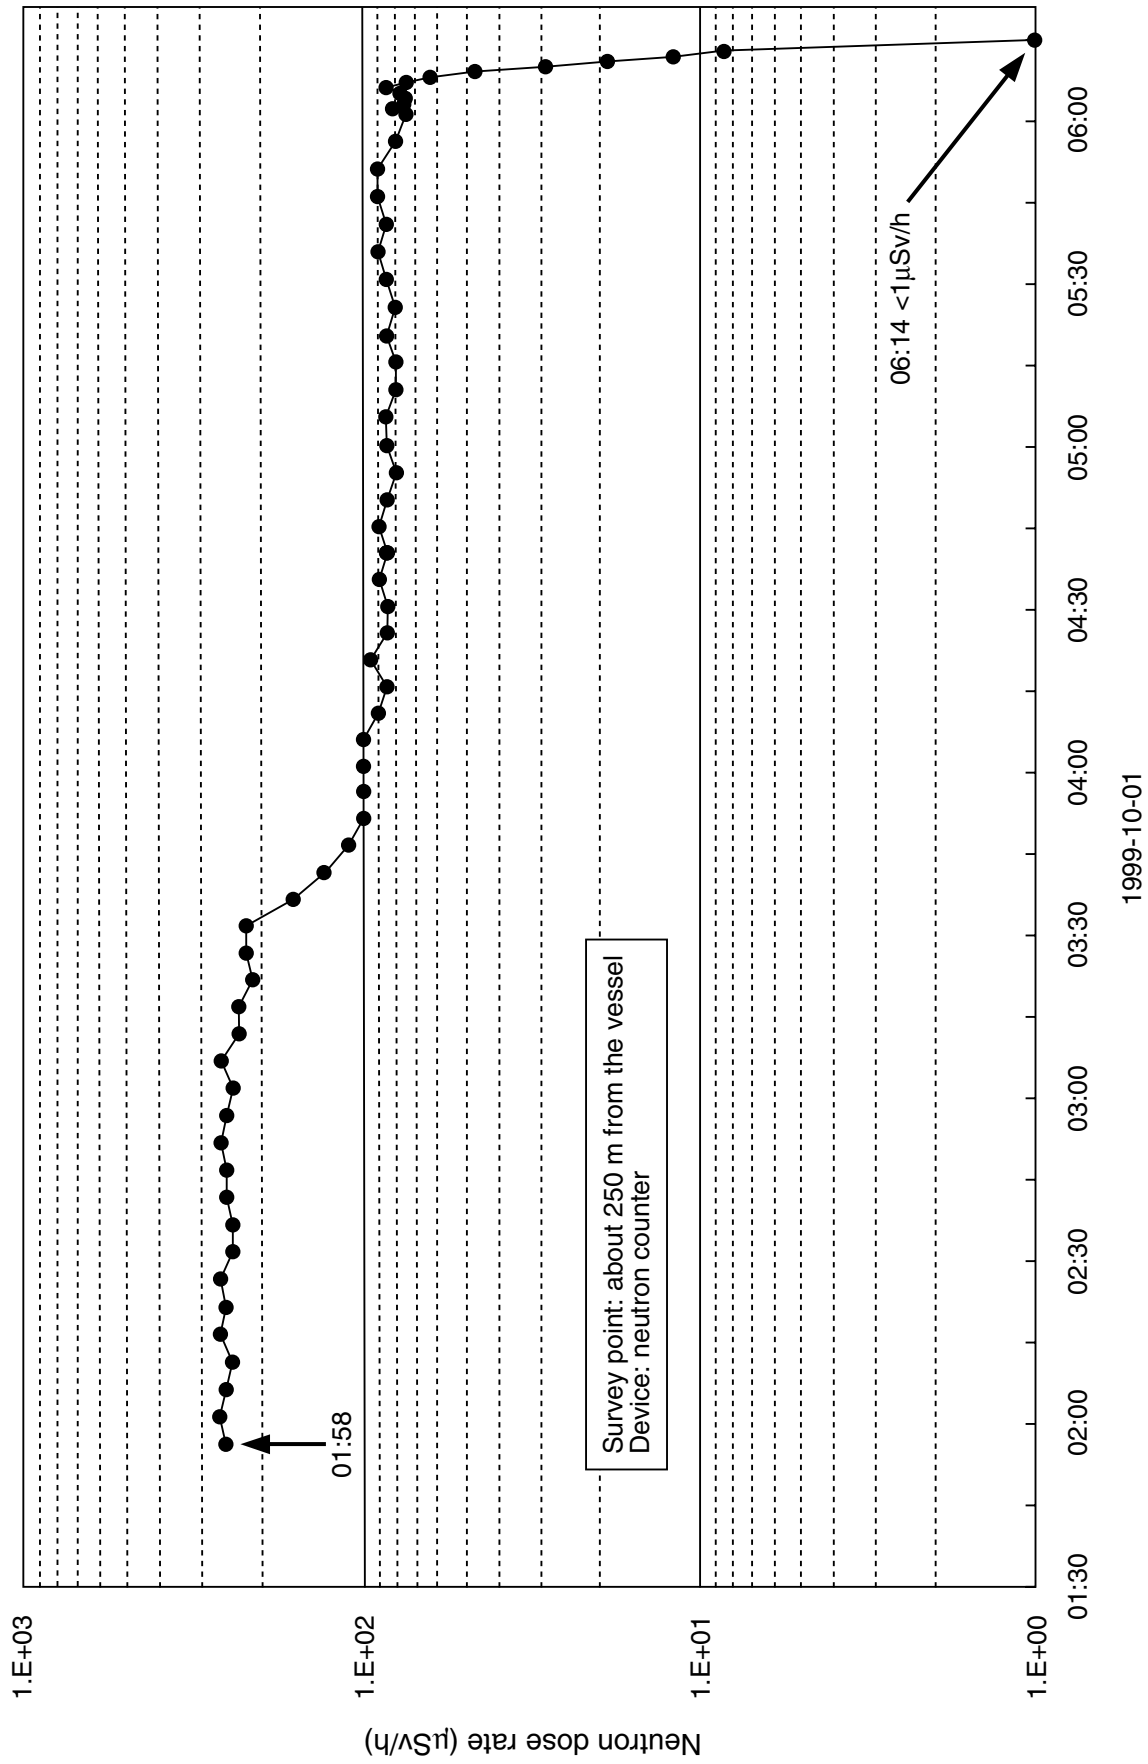
Fig. 1.1. The trend of neutron dose rate during mitigation (measured by JNC).

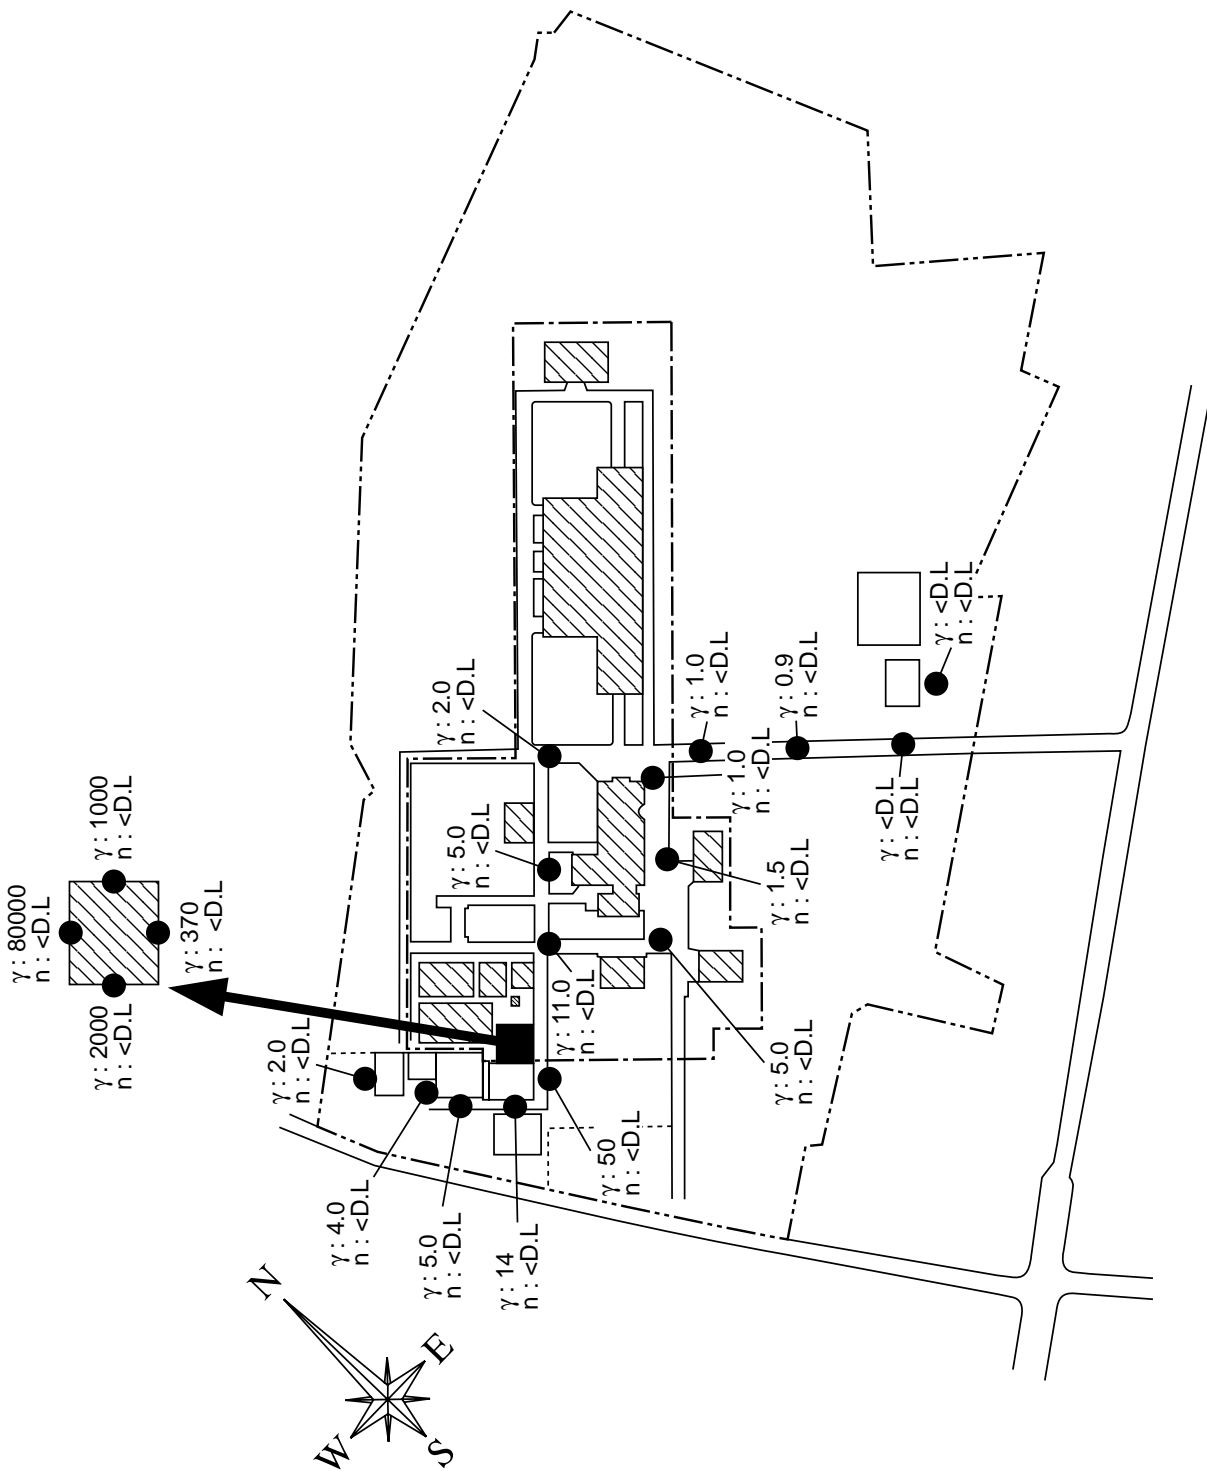
- With regard to the remaining radiation fields, gamma radiation dose rate measurements were performed at 06:20 on 1 October. These measurements yielded gamma dose rates of several millisieverts per hour close to the building and several microsieverts per hour at the boundary of the site (Fig. 12). Shielding material such as sandbags were placed around the building on the morning of 2 October (Fig. 13). Walls made of concrete shielding material were assembled in some places around the facility (Fig. 14).

Fig. 12. Gamma and neutron dose rates after the end of criticality (units:  $\mu\text{Sv/h}$ ). The measurements were made by JNC at 06:20 on 1 October 1999.

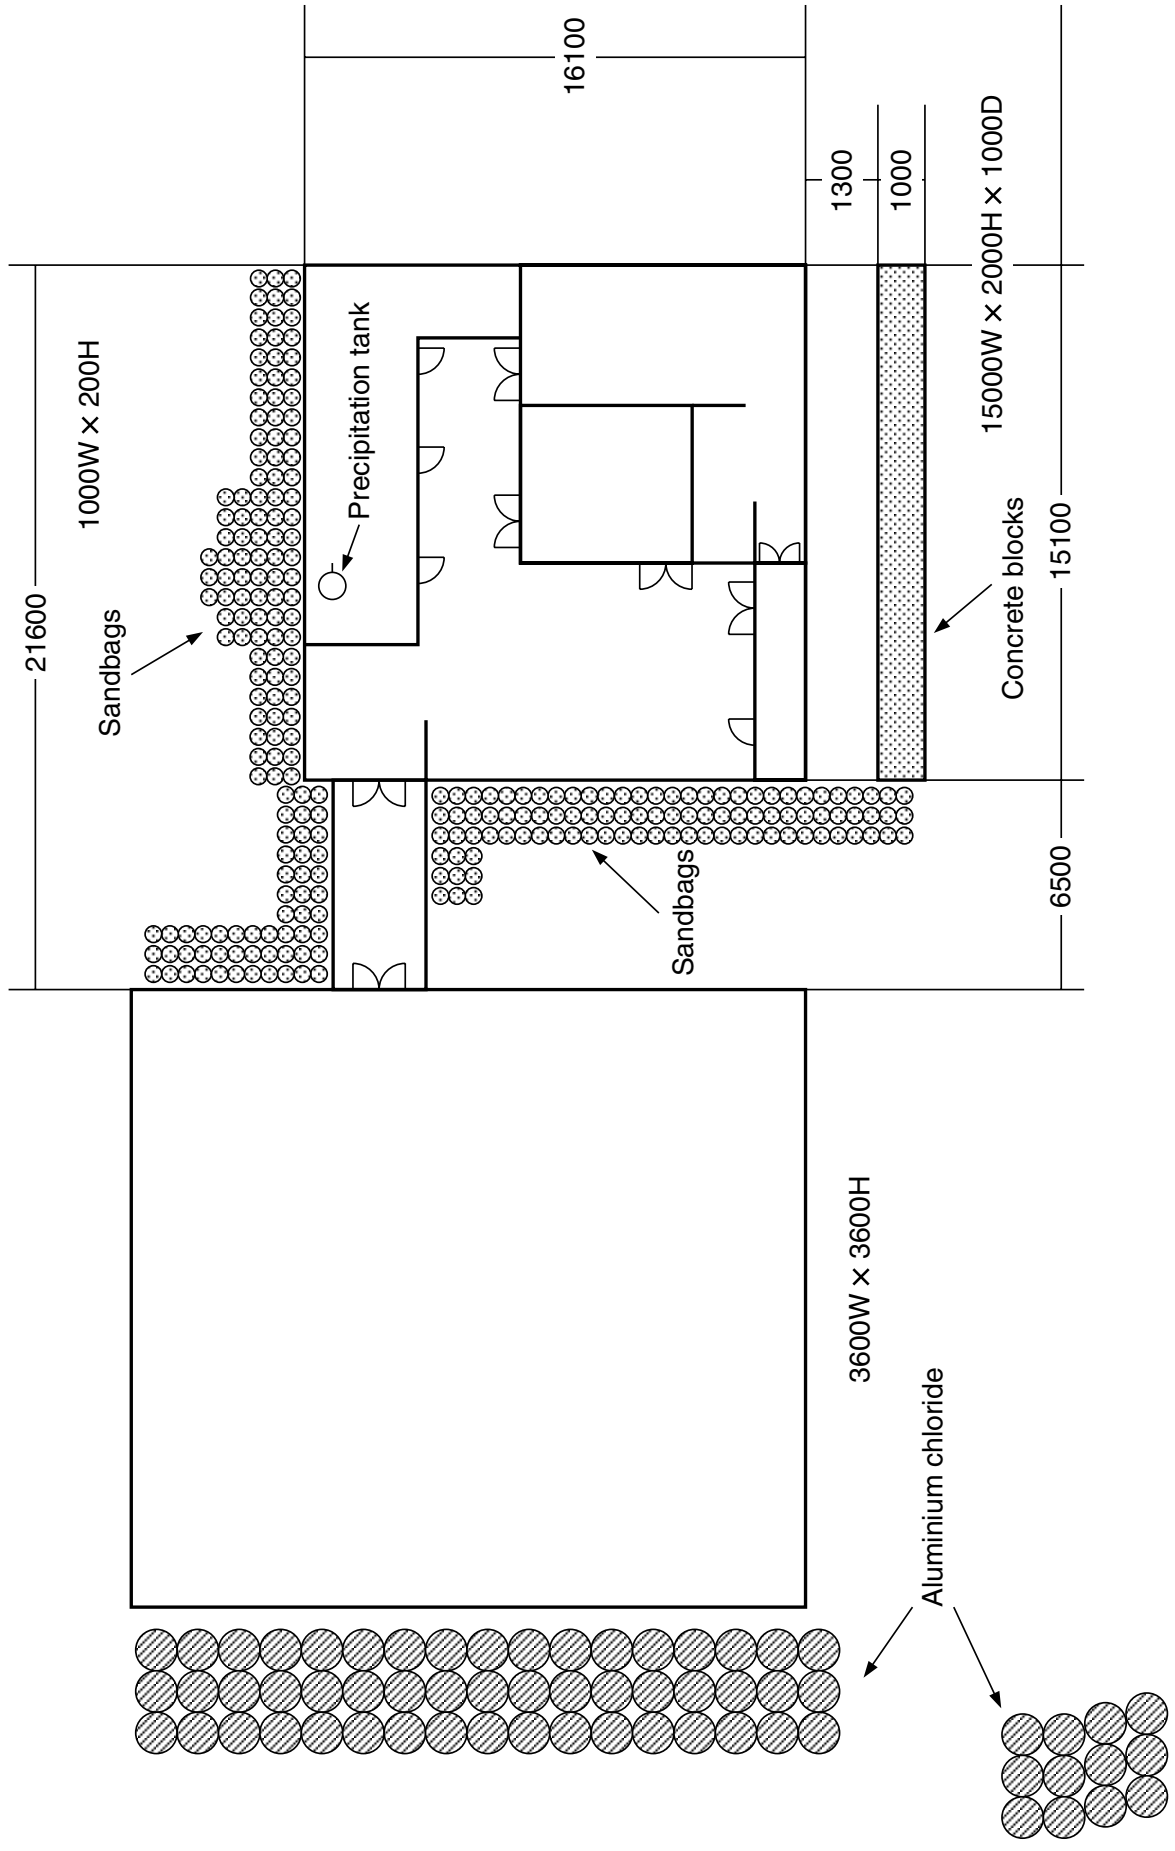
Fig. 13. Detailed plan of the conversion building indicating supplementary shielding arrangements (dimensions in mm).

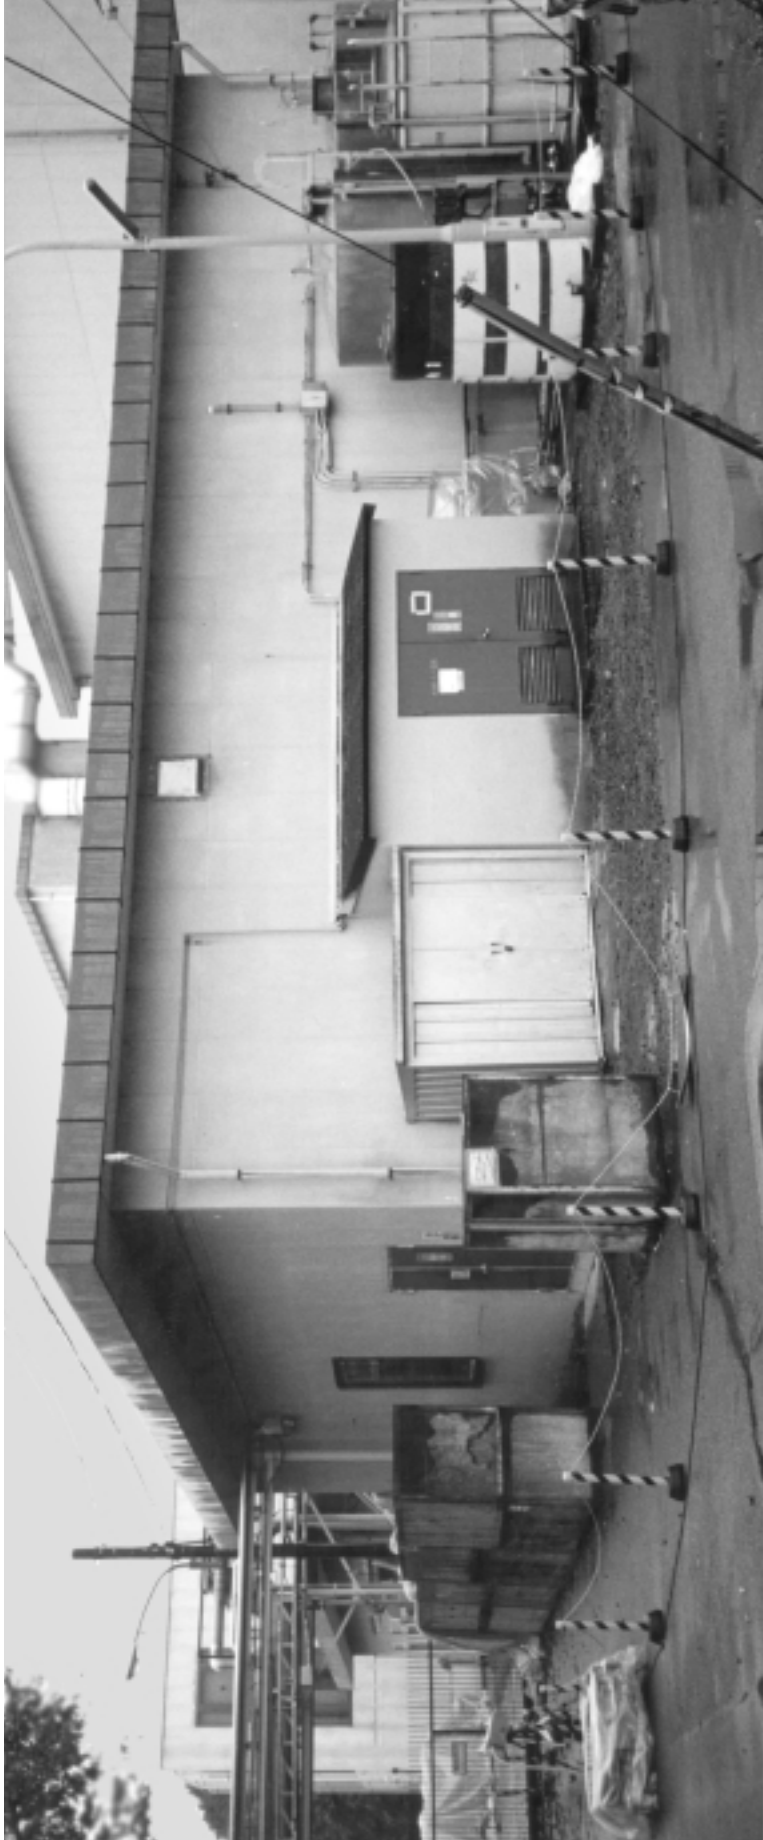
*Fig. 14. The conversion building with supplementary shielding in place.*

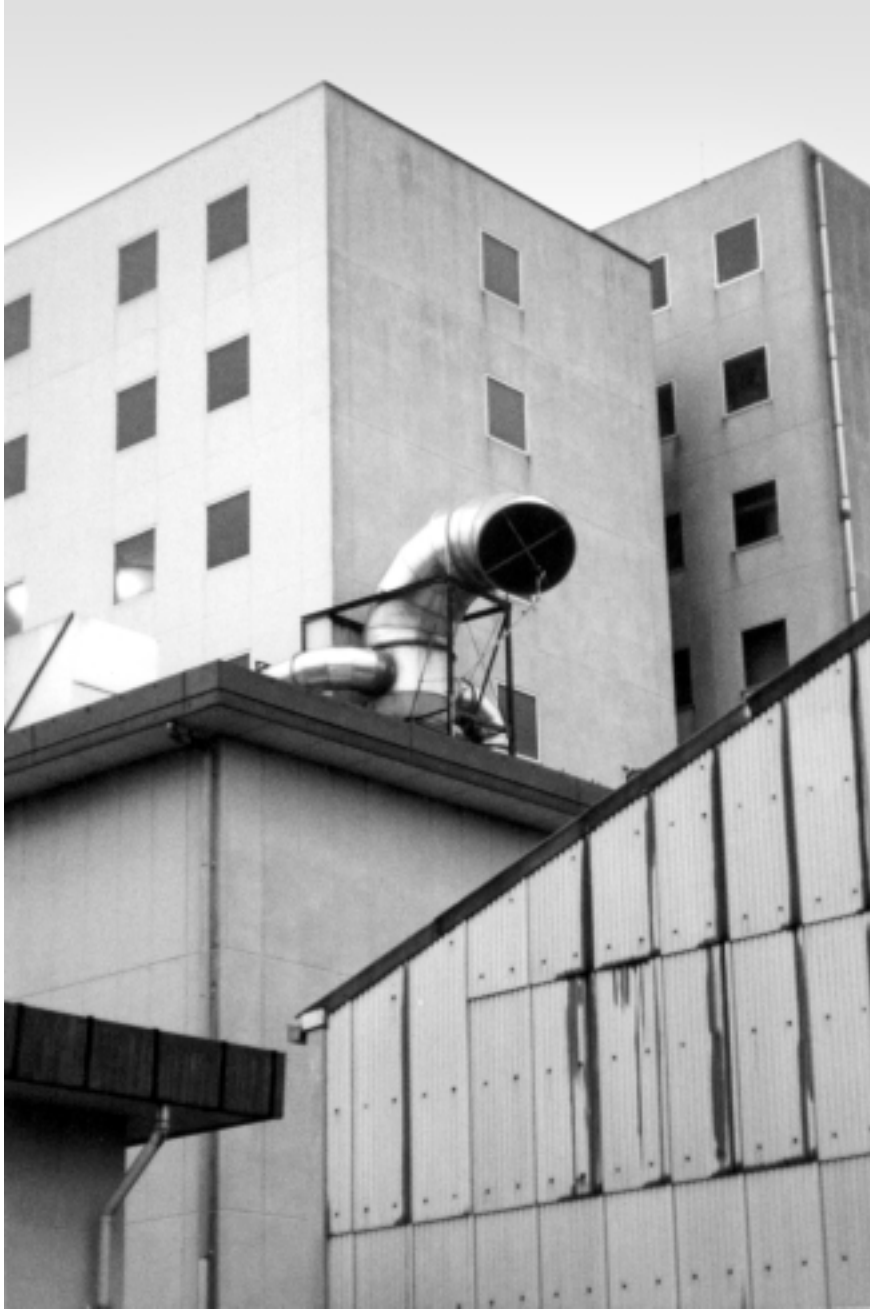
The high efficiency particulate air (HEPA) filters in the conversion building had filtered out particulates collected by the building's ventilation system, whose exhaust is connected to a general ventilation system that also serves other buildings. It had been reported by the workers who injected the boric acid into the precipitation vessel that an underpressure had been maintained, since air flow into the building was found. A smoke test on 5 October confirmed that there was an underpressure and that the ventilation system was working [14]. The integrity of the building confinement had therefore been provided primarily by active maintenance of an underpressure by the ventilation system and by the HEPA filters. However, owing to the detection of  $^{131}\text{I}$  released to the environment on the basis of exhaust point measurements (see Section 4.2.2) (Fig. 16), it was later decided to stop ventilation and to reinforce the passive confinement provided by the building.

*Fig. 16. The exhaust for the ventilation system.*

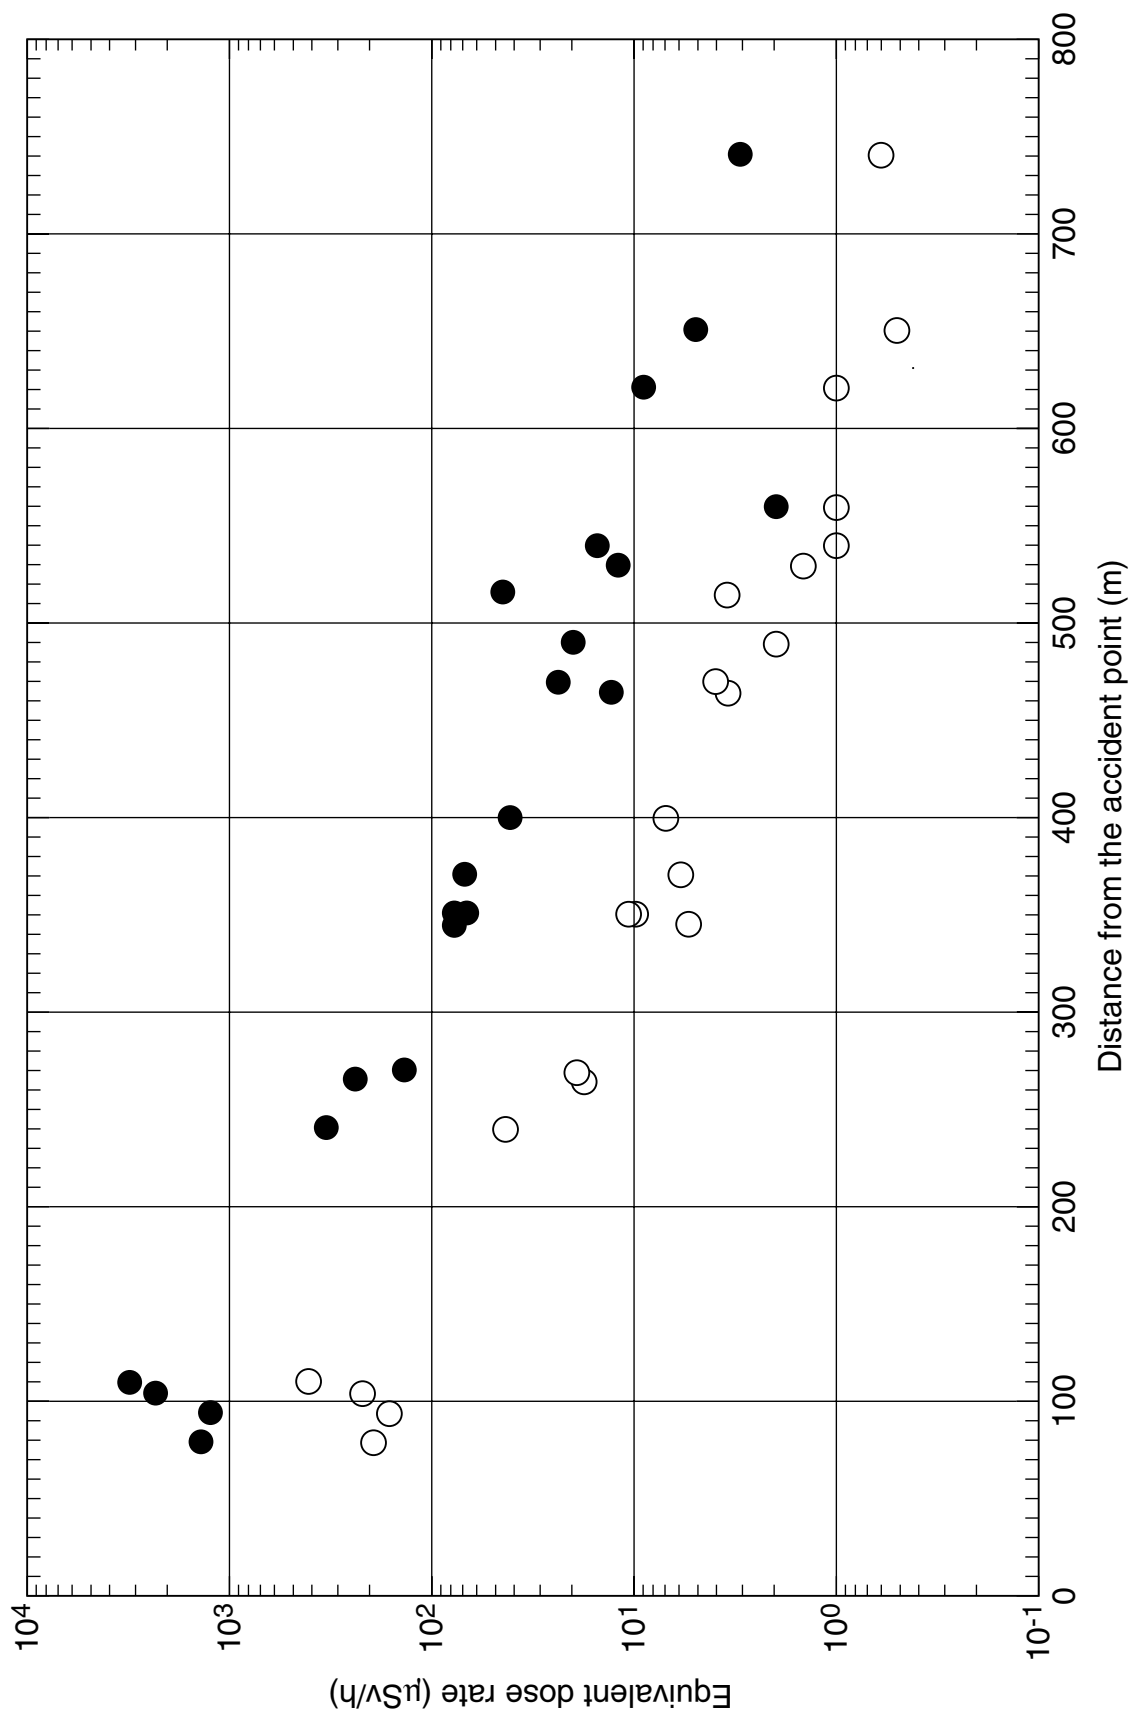
Fig. 17. Gamma and neutron equivalent dose rates around JCO at about 20:45 on 30 September 1999 at the monitoring posts indicated in Fig. 3 as a function of distance. (●: neutron; ○: gamma).

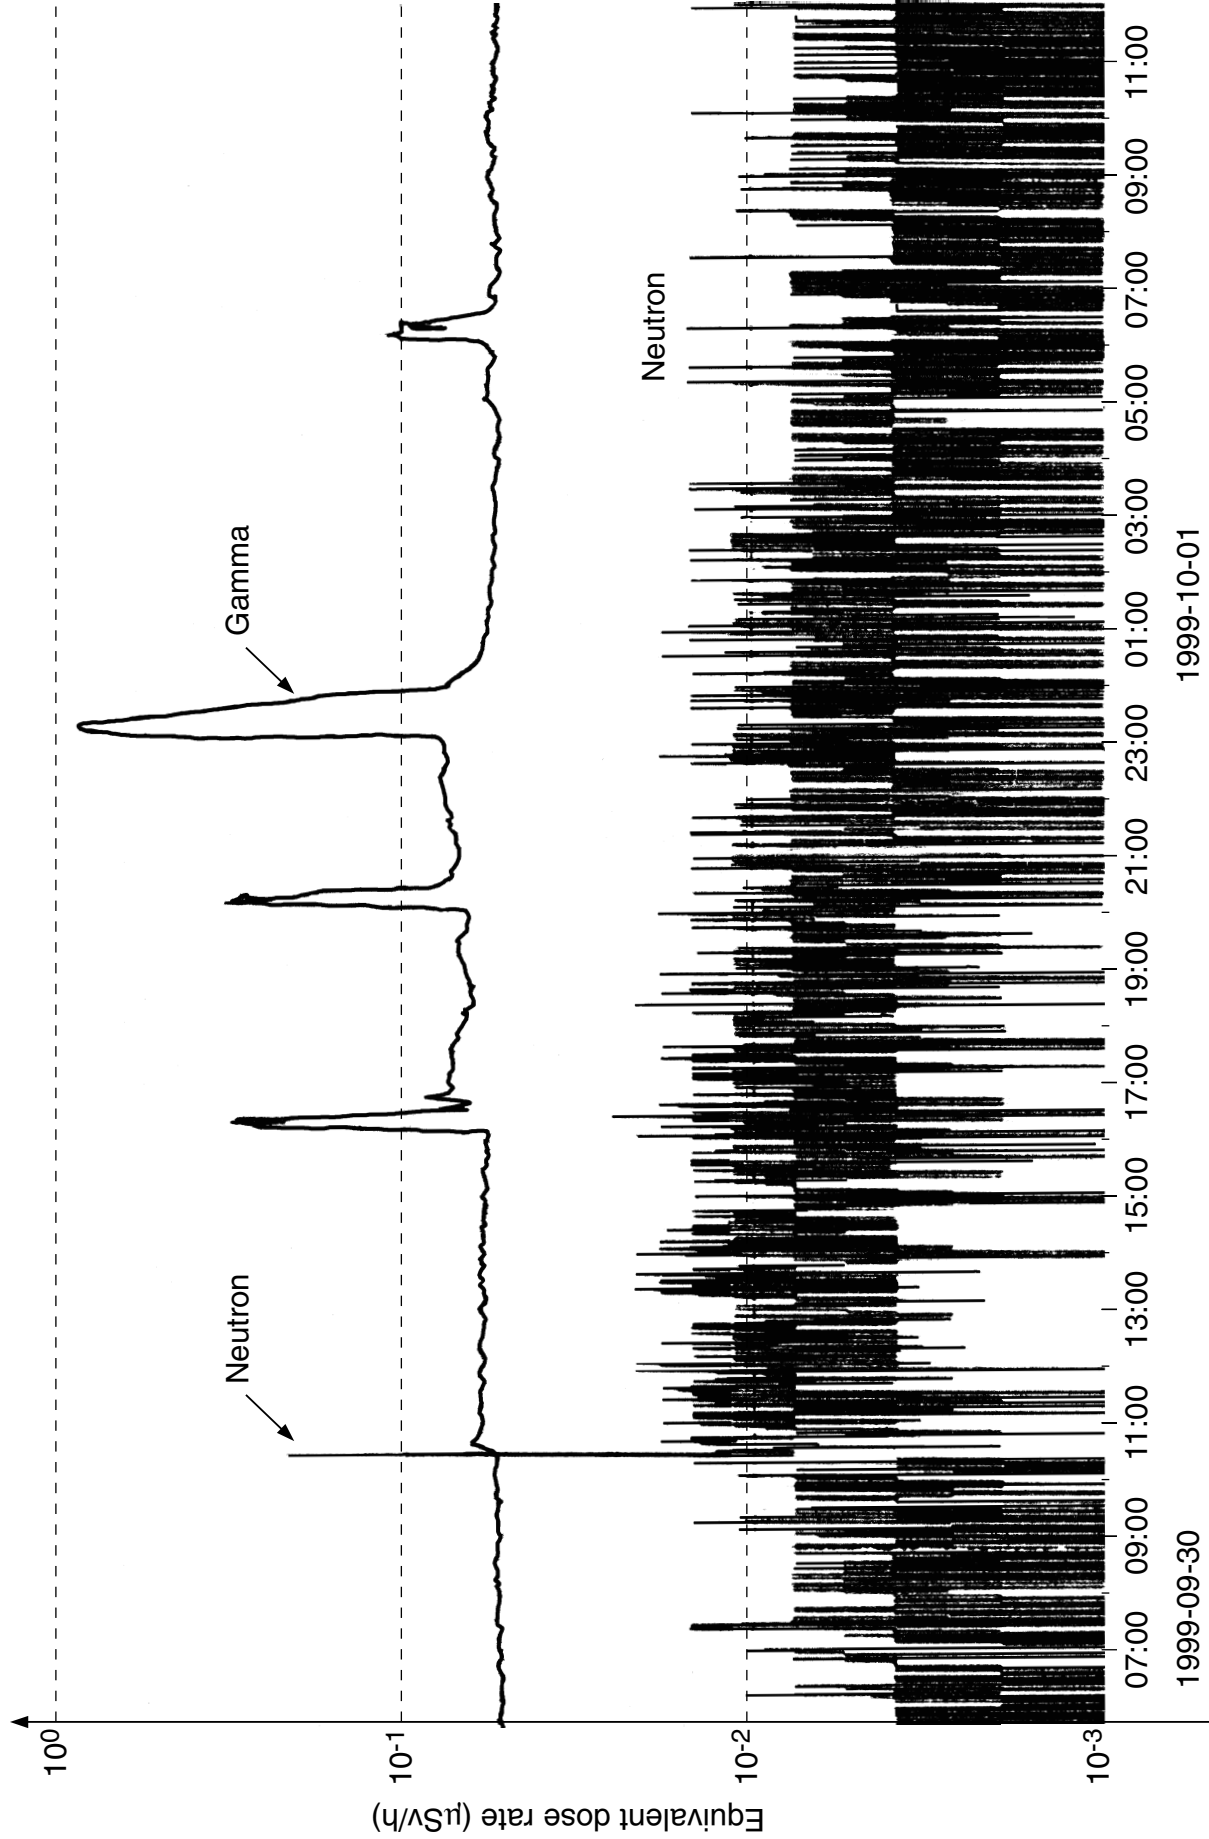
Intermittent increases in gamma dose rates were also observed at MP-1 and MP-2 monitoring posts at the JAERI Naka site after the accident and continued until 00:00 on 1 October (see Fig. 18). The JAERI experts considered that the increase in the gamma dose rate immediately after the accident began was due to direct gamma radiation associated with the criticality reaction, and the subsequent peaks were due to gamma radiation from the plume borne by the wind, which may have contained radioactive noble gases and iodine released into the atmosphere from the conversion building during the criticality event [23].

Fig. 18. Gamma and neutron equivalent dose rates at JAERI Tokai Site monitoring post MP-1 (1.7 km from the conversion building).
