**Trip Report**

**Visit to Tokyo and Tokai-Mura, Japan**

**Information Exchange with  
Government of Japan Concerning  
The September 30, 1999  
Tokai-Mura  
Criticality Accident**

**Frank R. McCoy, III  
Thomas P. McLaughlin  
Leroy C. Lewis**

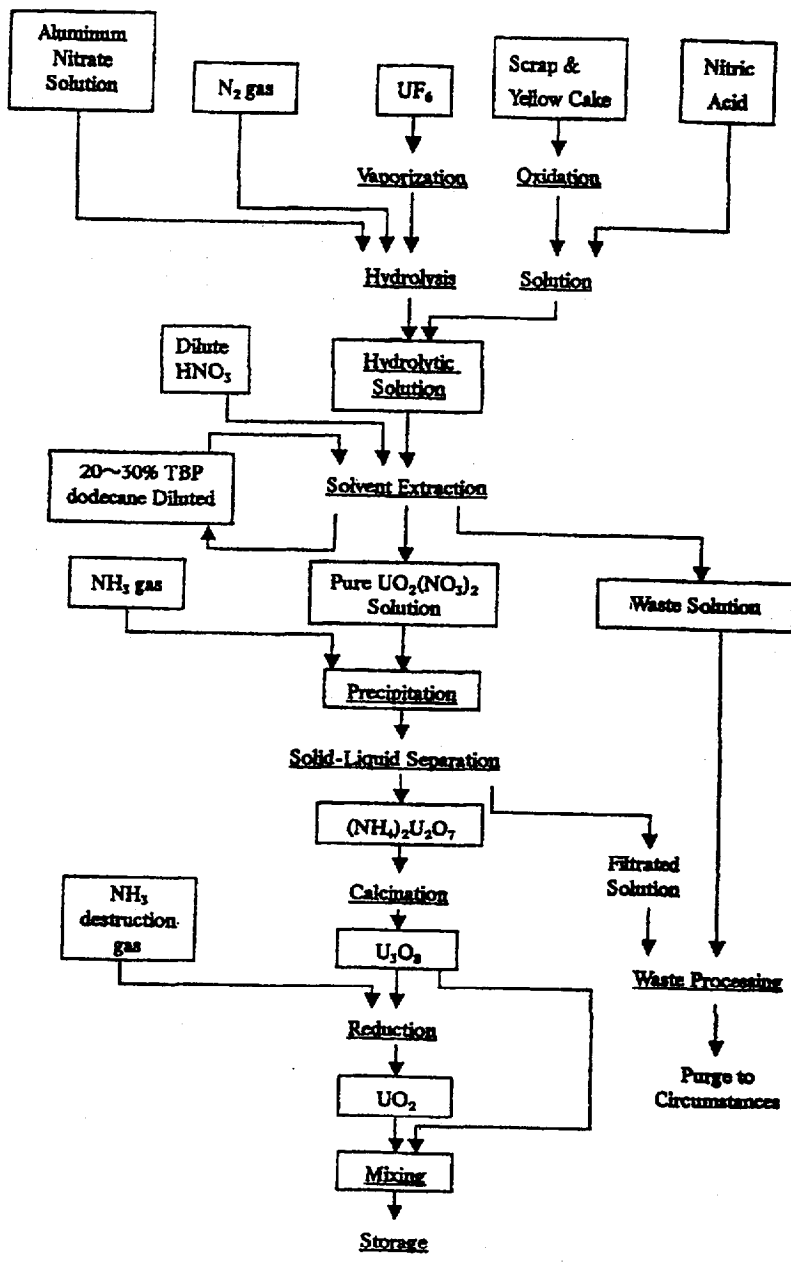
Figure 1. A schematic diagram of the JCO conversion process

The entire process described above and shown in Figures 1 and 2 of Attachment D was the process approved by the Science and Technology Agency.

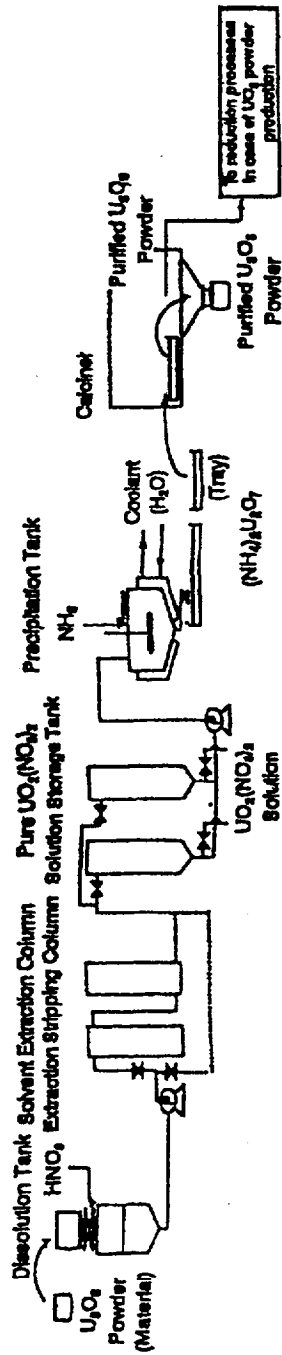
Figure 2. The JCO conversion process as it was permitted under the license granted in 1984. This license permitted the dissolution of 2.4 kg  $U_3O_8$  when the enrichment was between 16 and 20 %. It allowed the option of taking off  $UO_2(NO_3)_2$ ,  $U_3O_8$ , and  $UO_2$  as products. It also allowed the feed to be from either the hydrolysis of  $UF_6$  up to 20% enriched, or from the direct dissolution of  $U_3O_8$  up to 20% enriched or of scrap up to 50% enriched.

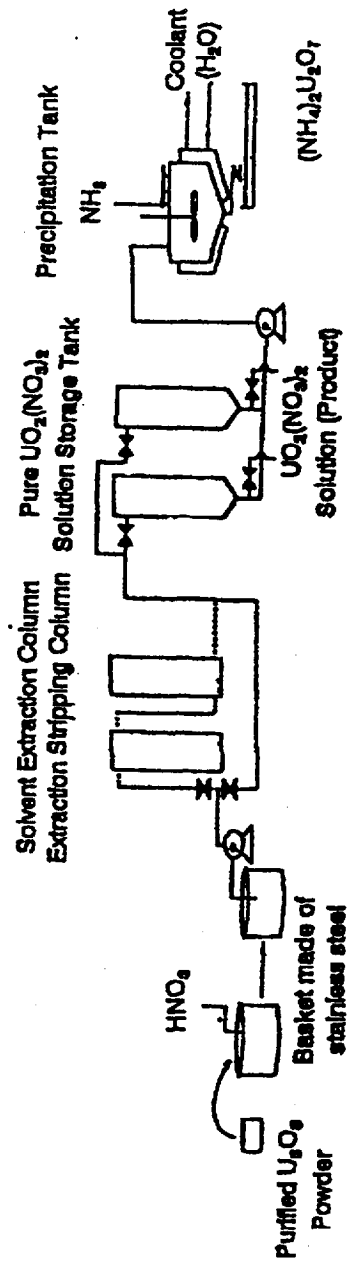
Subsequent to initial operations in the Conversion building for intermediate enriched uranium, in 1986, an unreviewed and unapproved change was made to the flow sheet where the dissolution was carried out in a stainless steel bucket and then pumped into the geometrically favorable storage tanks. This reduced the amount of time needed to complete a processing cycle. A second unreviewed and unapproved change was later made to a company procedure in which the dissolver was formally removed from the process and a bucket for the dissolution put in its place. This procedure still required the dissolved product to be pumped into the geometrically favorable tanks for storage. The procedure and flowsheet, which were provided to the delegation by Japanese officials, indicated that multiple batches (six to seven) containing about 15,000 grams of intermediate enrichment uranium, could have been accumulated in the geometrically favorable storage tanks. This unreviewed provision would have allowed for violation of specified mass limits contrary to the license. These changes are shown Figure 3 of Attachment D.

Figure 3. The modified procedure that allowed the use of a stainless steel bucket as a dissolution vessel. The resultant solution was to be pumped into the system for storage in the geometrically favorable solution storage tanks.

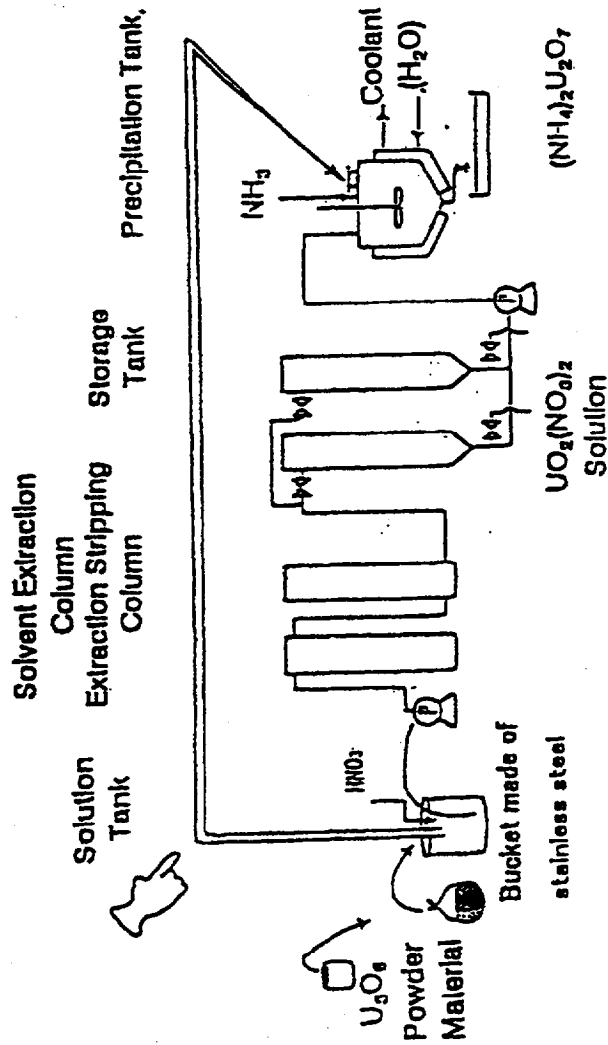
A final unreviewed and unapproved modification to the process was informally made prior to the 1999 conversion of uranium oxide to uranyl nitrate. A decision, apparently made to save time and facilitate ease of handling of the uranyl nitrate solution, provided for continuing dissolution in the stainless steel buckets but, instead of pumping the uranyl nitrate product into the geometrically favorable storage tanks, provided for transferring the solution directly into the precipitation vessel by pouring it through a funnel in the large 10" diameter nozzle in the top of the vessel. This decision also provided for accumulating several batches of uranyl nitrate in the precipitation vessel thereby significantly exceeding specified mass limits established by the license. These activities were conducted contrary to procedures, the license, and established safety controls. This final process modification is shown in Figure 4 of Attachment D.

Based on the information presented, the delegation believes that the cause of this accident was the accumulation of uranyl nitrate, contrary to specified mass limits, directly into a precipitation vessel, contrary to its designed use and contrary to procedure, until a sufficient quantity of intermediate enriched uranium was available to initiate and sustain a nuclear criticality reaction.

Figure 4. The procedure that was used at the time of the criticality accident. Batches containing 2.4 kgU<sub>3</sub>O<sub>8</sub> were dissolved in a stainless steel bucket. The batch was then transferred to a 5-liter beaker and then physically transported to the precipitation tank where it was poured through a funnel into the tank. Seven batches of solution were added to the tank before it went critical.
